Archeological Survey of the Loop 20 Improvement Project Webb County, Texas

Report for Archeological Survey

Christopher Ringstaff, Principal Investigator,
Antiquities Permit No. 7289

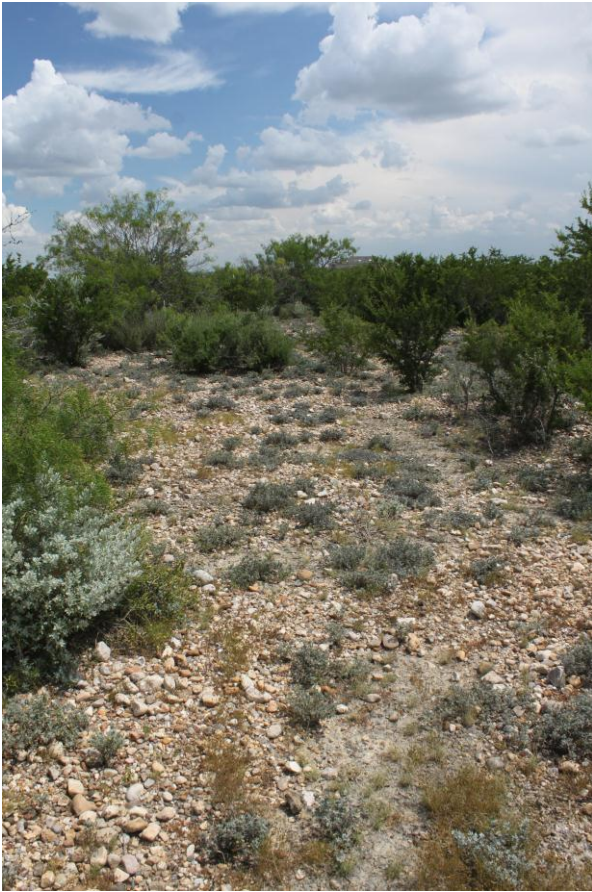
Figure 6. Upland gravels at 41WB357.

In terms of its physiographic setting, the site is located on the adjacent uplands northwest of the Chacon Creek. The drainage dissects Eocene Laredo Formation exposing siliceous gravel, sandstone, caliche, conglomerate, and unconsolidated sand, silt, and clay. Despite areas of thick brush, surface visibility was typically good. The southern portion of the site has relatively thin sandy soils with the mineral fraction likely localized alluvial and/or colluvial in origin. The site was originally recorded by TxDOT in 1992 and measures approximately 810 meters north-south by 280 meters east-west. As shown in Appendix A, the site has been redelineated within the new ROW extending approximately 380 meters to north and approximately 110 meters to the east in the southeast corner.

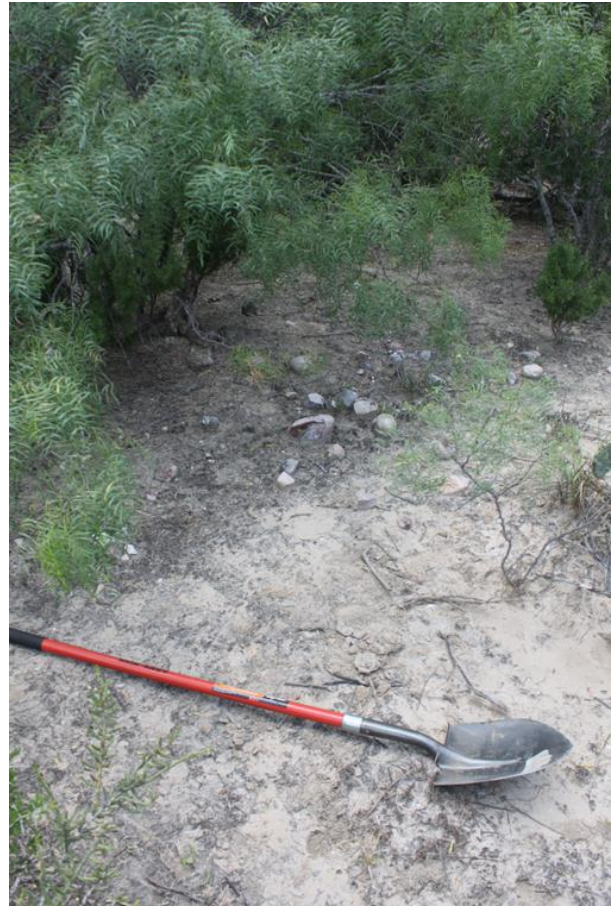
Figure 7. Feature 1 in southern portion of 41WB357.
(shovel in foreground is 150 cm for scale)

A total of ten shovel tests were excavated across the site (see Appendix B). Three of the shovel tests excavated in the southern portion of the site yielded fire-cracked rock (FCR). Surficial artifacts noted at the site include chipped stone flaking debris, failed stage bifaces, tested cobbles, scattered and clustered burned rock. The western portion of the site has procurement debris. Cores, stage biface failures and discards, flaking debris, and tested cobbles. Two burned rock clusters (features) were noted in the southern portion of the site. The first, designated Feature 1, is a surficial cluster of large burned chert cobbles (Figure 7) measuring approximately 1.5 by 2 meters in size. The second feature, Feature 2, was discovered in a front-end loader blade scar adjacent to the fence line access road. The feature was composed of tightly clustered burned gravel with sediment staining and charcoal (Figures 8 and 9). Due to a non-collection clause in the Right of Entry, the feature was left in place for potential further work upon New ROW acquisition. Hence, the dimensions of Feature 2 are presently unknown.

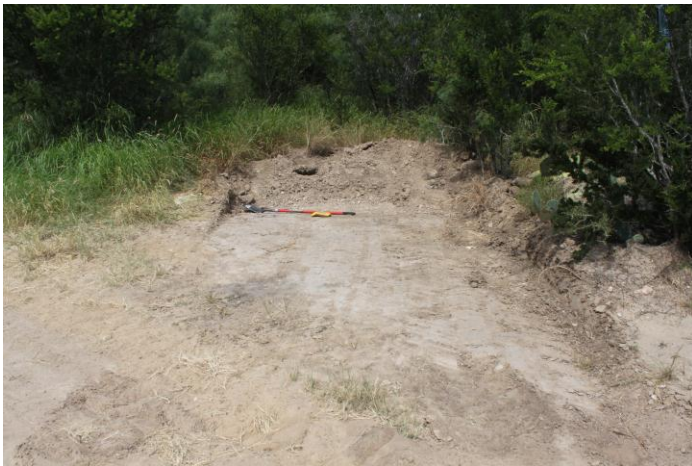
Figure 8. Front-end loader scar exposing Feature 2.

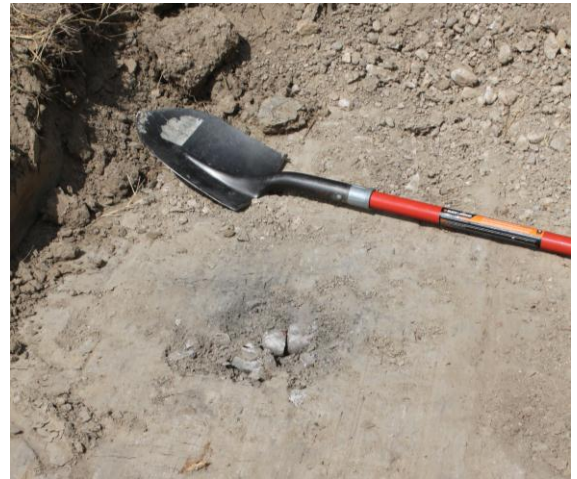
Figure 9. Close-up Feature 2, 41WB357.

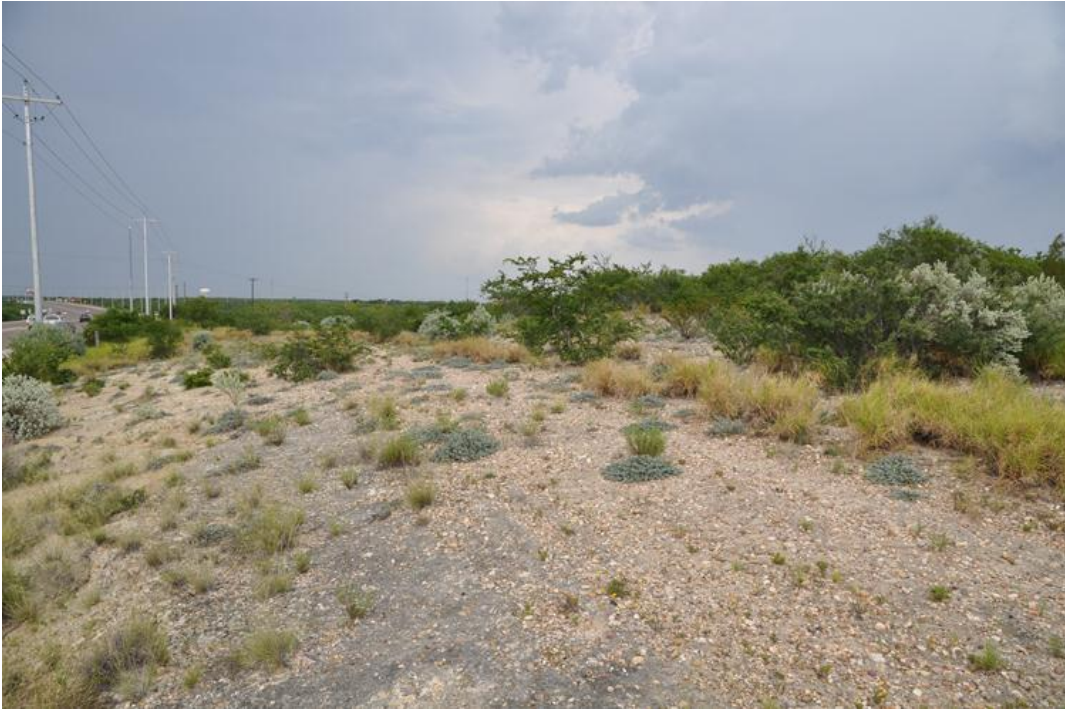
Figure 10. Surface gravels overlying Eocene substrate on central hilltop at 41WB358.

Site 41WB358 is a lithic procurement site and prehistoric open campsite marked by scattered chipped stone artifacts and scattered and clustered burned rock. The cultural material density is highest in the central portion of the site. Outcropping gravel on a hilltop in the central portion of the site functioned as a lithic procurement area (Figure 10) with burned rock features and scatters found on the southern and northern slopes of the hill. However, the overall scatter of lithic artifacts is continuous from north to south. Landuse impacts, possibly small scale quarrying, were observed in central portions of the site and already thin soils in this area are further denuded due to slopewash erosion.

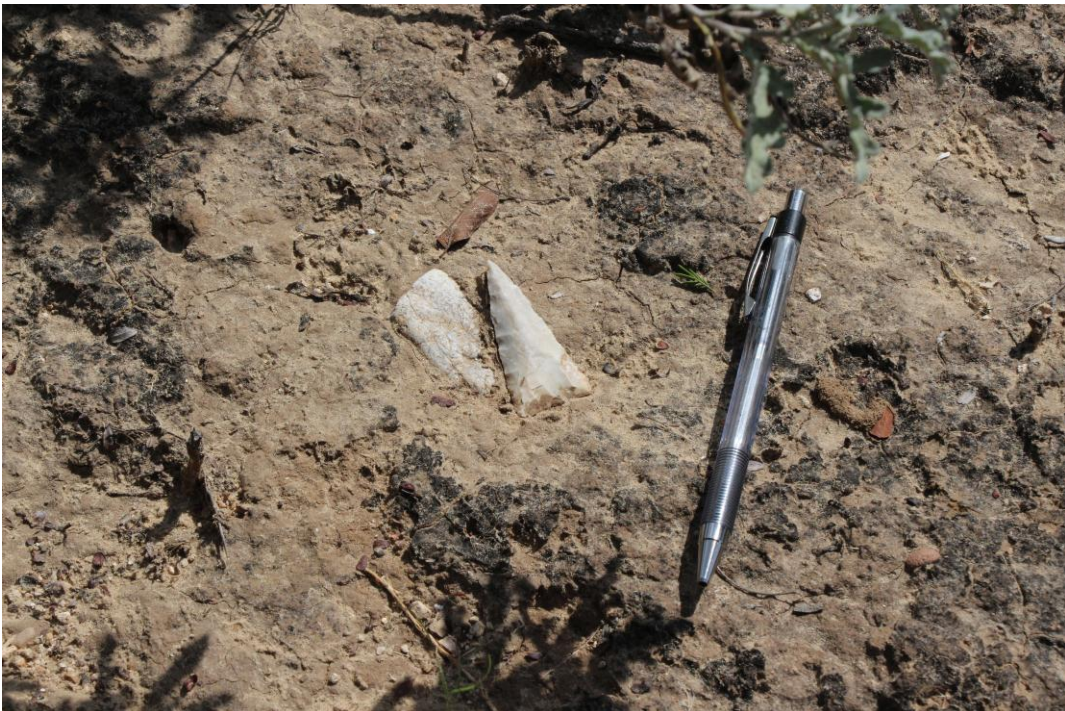
Figure 11. *Tortugas* point in central portion of 41WB358.

As shown in Appendix B, a total of seventeen shovel tests were excavated across the site. Fifteen were sterile and two yielded FCR. Both positive shovel tests were located in shallow soils near Feature 2. Surficial artifacts noted at the site include chipped stone flaking debris, a complete *Tortugas* point (Figure 11), failed stage bifaces, tested cobbles, scattered and clustered burned rock. The central portion of the site has procurement debris including cores, stage biface failures and discards, flaking debris, and tested cobbles. Two burned rock features were noted in the central portion of the site. The first, designated Feature 1, is a semi-circular surficial cluster of large burned chert cobbles (Figure 12) with an approximate diameter of 80cm located on the southern slope of the central hilltop. The cobbles appear largely intact and not heat fractured. On the northern slope, Feature 2, was observed and is composed of a cluster of angular fractured burned chert gravel approximately 1.6 by 1.1 meters in size.

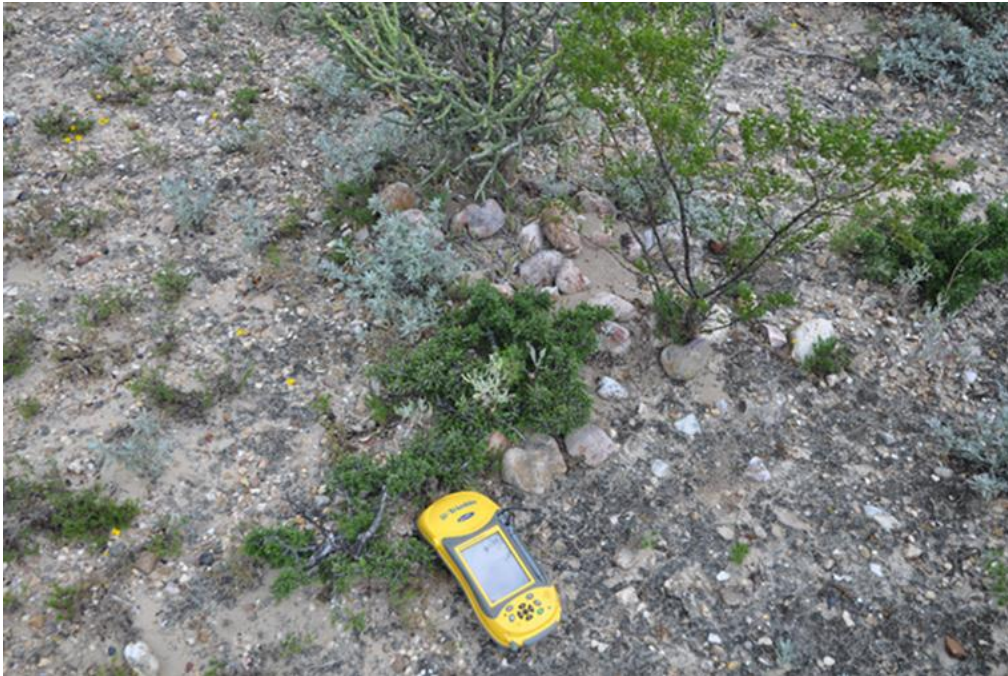
Figure 12. Feature 2 at 41WB358.

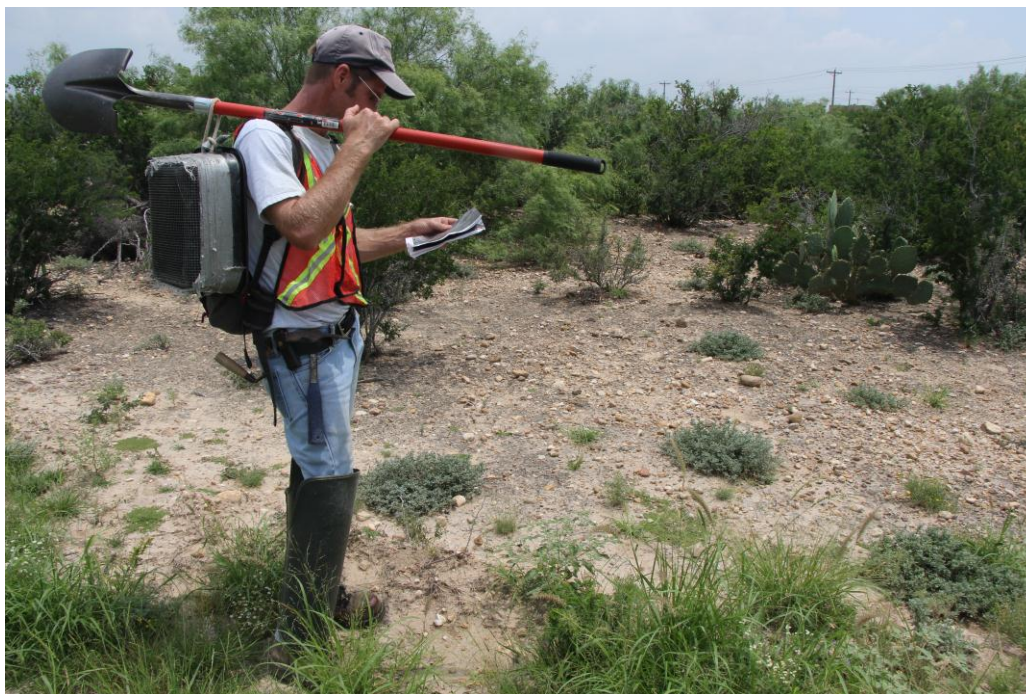
Figure 13. Typical setting at 41WB359 note thorny vegetation and good surface visibility.

The physiographic setting of 41WB359, is located on the adjacent uplands northwest of the Chacon Creek. This portion of the APE is near Quaternary Uvalde Gravel outcrops immediately to the north that drape thick gravels into the APE. The drainage basin itself dissects Eocene Laredo Formation exposing sandstone, caliche, conglomerate, and unconsolidated sand, silt, and clay. Despite areas of thick brush, surface visibility was typically good (Figure 13) The northern portion of the site is gravel draped substrate with the southern and central portions of the site exhibiting thin sandy soils. Like 41WB357 and 358, the site was originally recorded by TxDOT in 1992. The site, as recorded, measures approximately 1130 meters north-south by 390 meters east-west. It is worthy to note that the 1992 site form map clearly differs from the digitized Atlas plotting and both plots are shown on the site map presented in Appendix A. Based on the survey, the site has been re-delineated within the proposed new ROW extending approximately 150 meters to the north and 85 meters to the east (see Appendix A).

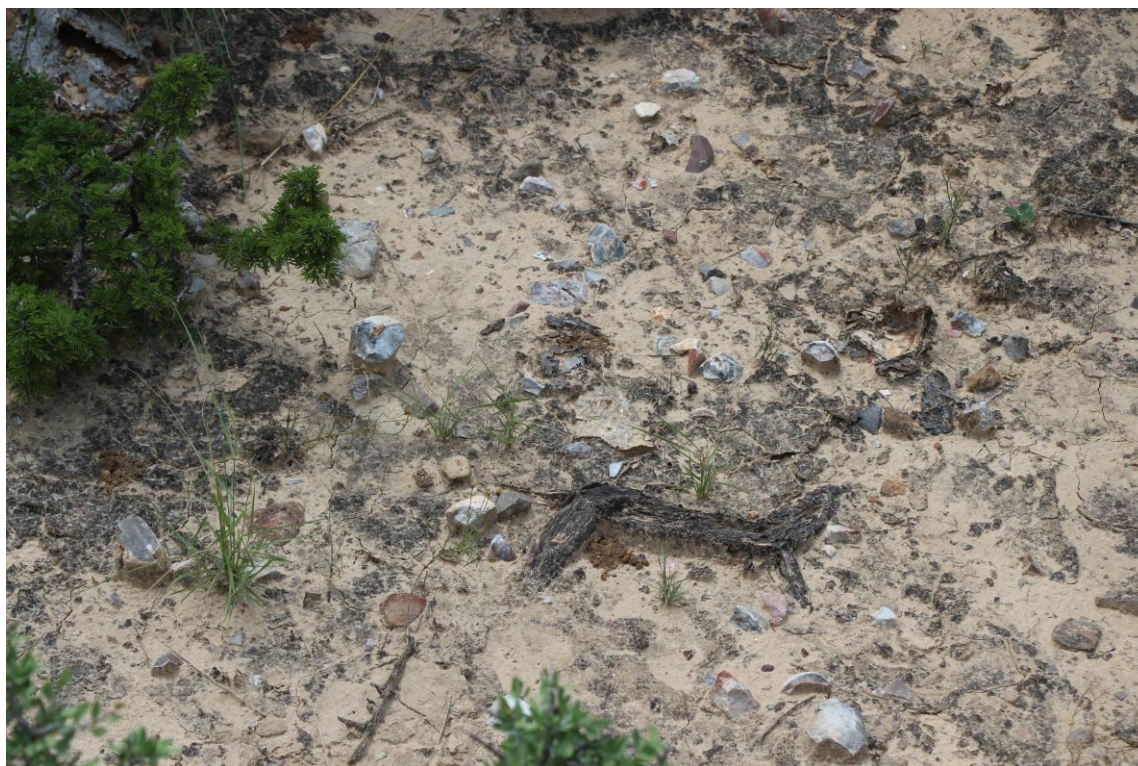
Figure 14. Close-up of burned chert cluster designated Feature 1 at 41WB359.

A total of twelve shovel tests were excavated across the site. Three shovel tests excavated in the southern part of the site near Features 1 and 2 (described below) yielded FCR (see Appendix B). Surficial artifacts noted at the site include chipped stone flaking debris, a, failed stage bifaces, tested cobbles, scattered and clustered burned rock. The northern portion of the site has procurement debris including cores, stage biface failures and discards, flaking debris, and tested cobbles. Two burned rock clusters (features) were noted in the southern portion of the site. The first, designated Feature 1, is a sizable surficial cluster of highly fractured burned chert cobbles (Figure 14) with an approximate size of 2,5 by 3 meters. A second feature, Feature 2, was observed approximately 20 meters to the northeast and

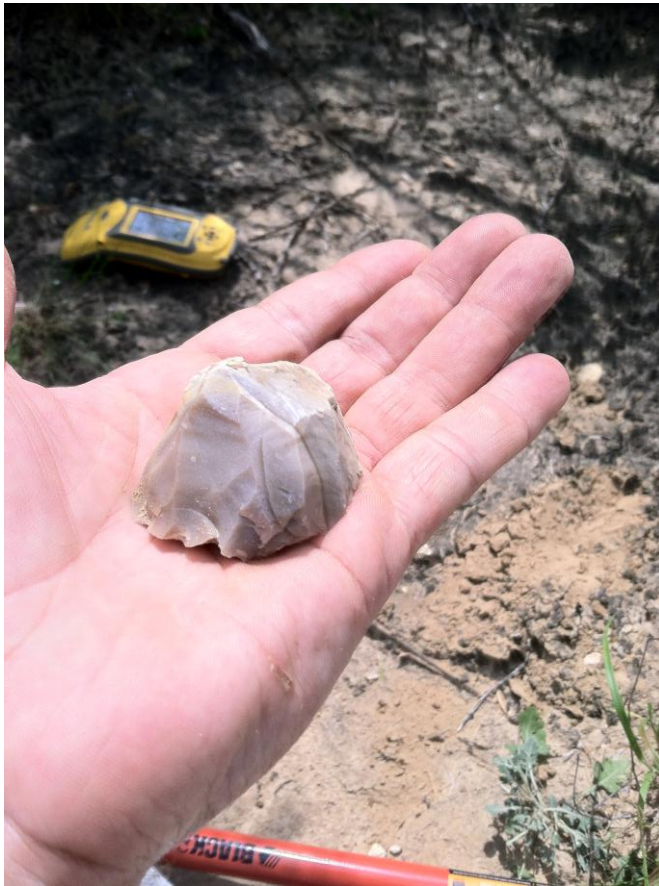
Figure 15. Small prismatic blade core from Feature 2 at 41WB359.

is composed of a cluster of angular fractured burned chert gravel approximately 2.0 by 1.5 meters in size. In addition to scattered chipped stone debitage in the areas of Feature 1 and 2, near Feature 2, a small prismatic blade core was indentified (Figure 15). Otherwise, no other chipped stone tools were observed.

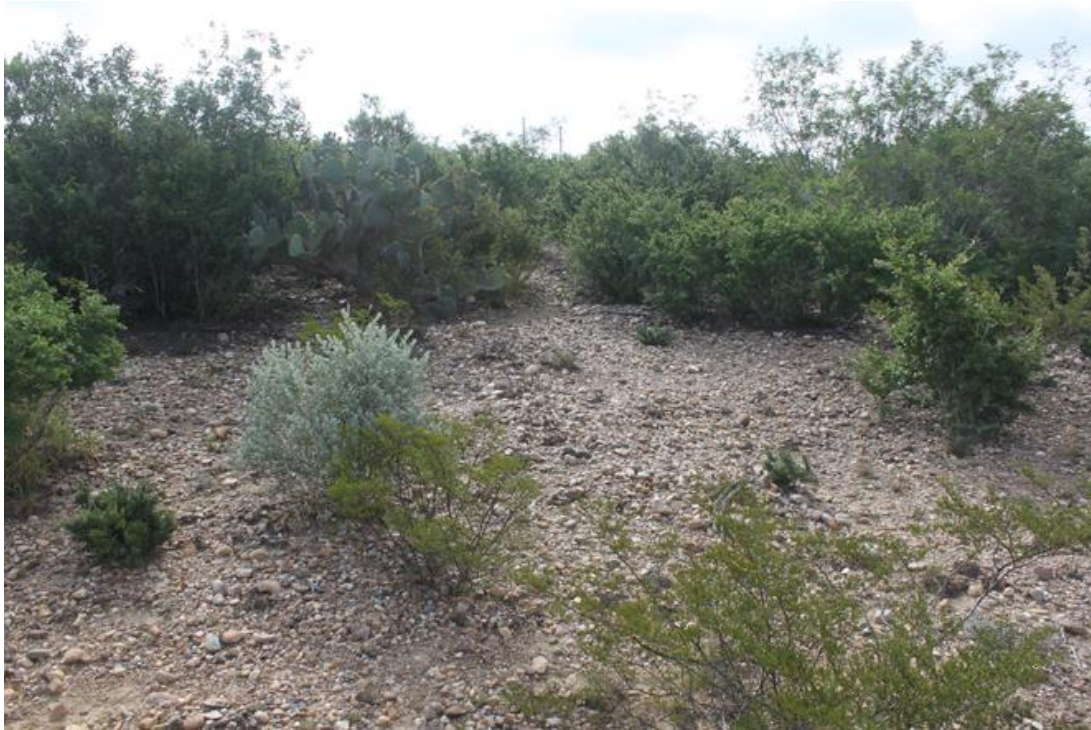
Figure 16. Gravel outcrop at 41WB360 note thorny brush and good surface visibility.

Site 41WB360 is a lithic procurement site prehistoric marked by a scatter of chipped stone artifacts amongst a broad expanse of Uvalde Gravel. The physiographic setting consists of rolling uplands northwest of the Chacon Creek. The site was originally recorded by TxDOT in 1992 and measures approximately 1170 meters north-south by 310 meters east-west. As shown in Appendix A, the site has been re-delineated within the proposed new ROW extending south-eastward approximately 350 meters and eastwards approximately 115 meters.
