Cultural Resources Services Report for Archaeological Survey and Monitoring

Salado Wastewater Line Project
Salado, Bell County, Texas

Final Report – Public Version

Terracon Project No. 90167360

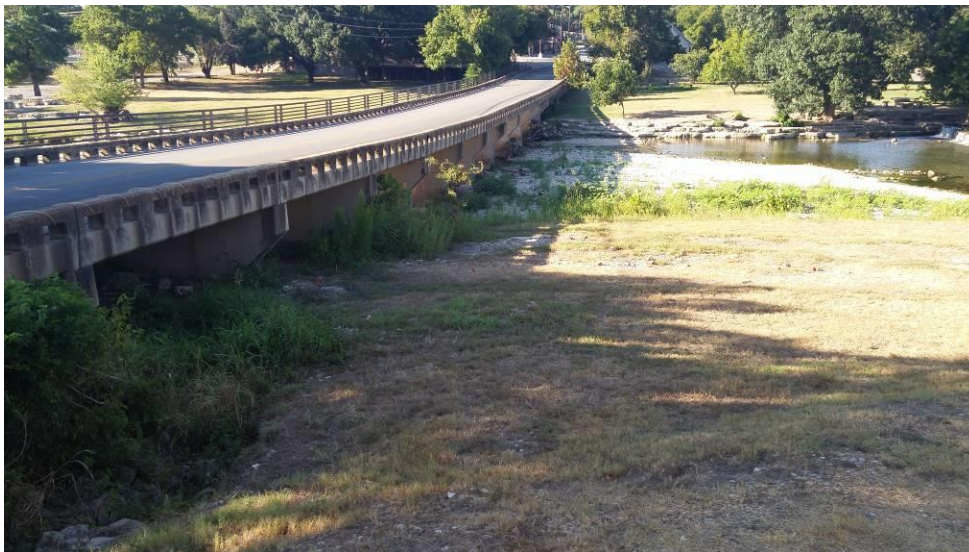
Photo #2: Looking south along Main St. on west side of bridge. Bedrock is exposed at the surface in midground and waterline marking is in foreground.

(i.e., water) installation, and bedrock exposed at the surface in the general area suggests that there is relatively little sediment to excavate (Appendix B, Photos 2 and 3). In the remaining three locations, trenches were excavated to deposits that are not capable of containing intact cultural material (i.e., Pleistocene and/or channel deposits).

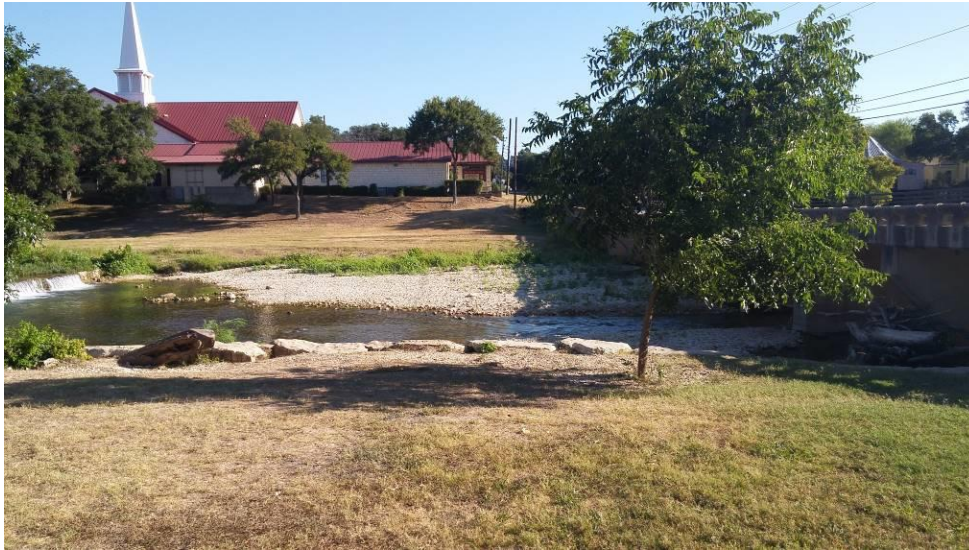
Photo #3: View north across Salado Creek on the west side of the Main St. bridge.

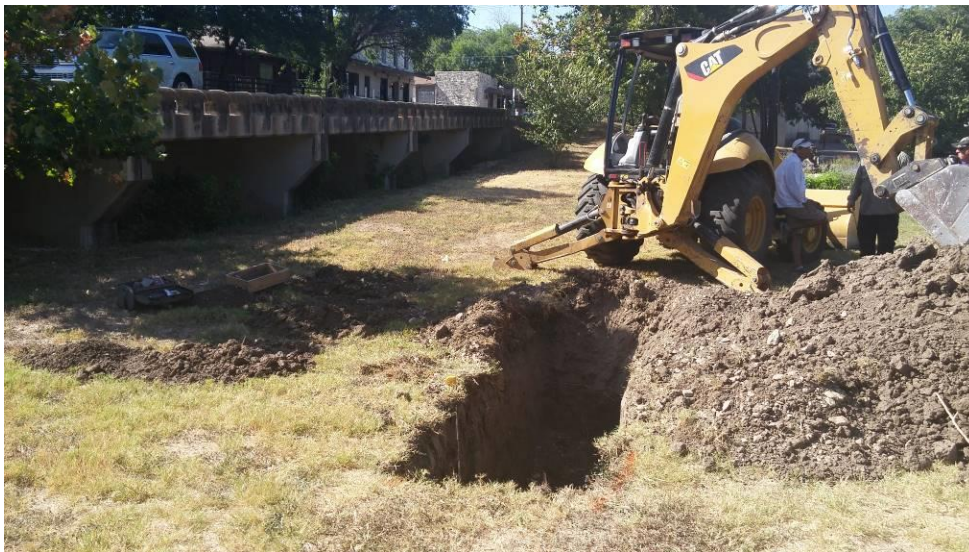
Photo #4: Completion of BHT 1 excavation. Note sample piles on the left side of photo and undivided backfill on the right side.

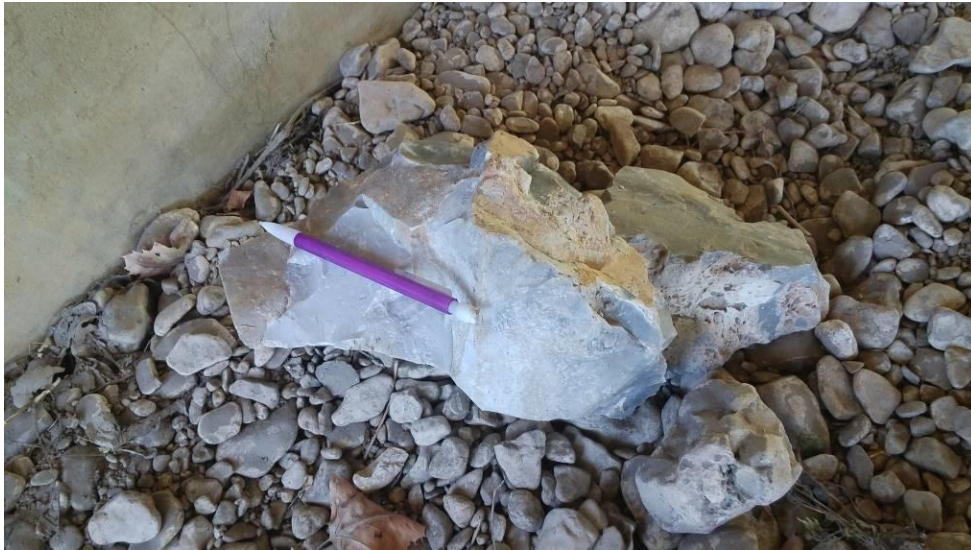
Photo #5: Big cherty cobble found beneath Main St. bridge near BHT 1.

Focusing on the deposits in the footprint of the bore pit on the south side of Salado Creek, BHT 1 was excavated approximately 20 meters south of the channel and approximately 10 meters west of Main Street in a maintained park setting (Appendix A, Exhibit 2). The trench measured approximately five meters long, one meter wide, and one and a half meters deep (Appendix B, Photo 4). Surface visibility was relatively good in the area, but no artifacts were observed in the park; beneath the Main Street bridge, which is a historic-age structure, was a large chert cobble that appeared battered and possibly flaked (Appendix B, Photo 5). The cobble's context, however, did not lend itself to archaeological interpretation.

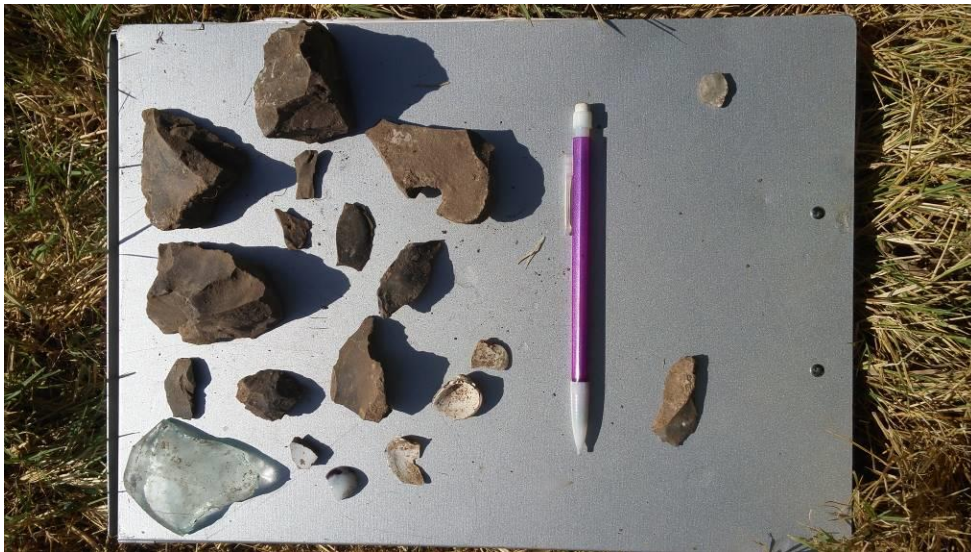
Photo #6: Artifacts recovered from sample piles. The collection of chert, glass, ceramic, marble, and shell on the left side of the picture are from approximately 0-50 cm below surface. The pieces of chert on the right side are from 50-100 cm (upper) and 100 cm to depth (lower). Site 41BL1401.

The excavation of BHT 1 yielded historic and prehistoric artifacts, as well as supplemental information about the physical and historical geography of the location. In the upper 50 centimeters, between approximately 15 centimeters and 55 centimeters in depth, one small marble fragment, one small sherd of stoneware, one colorless bottle glass fragment, three small bivalve shell fragments, and 11 pieces of chert were recovered from one large backhoe bucket load of excavated sediment (Appendix B, Photo 6). The chert artifacts were a mixture of angular chunks and few, small flake fragments. A small heat spall or cherty pebble was recovered from a backhoe bucket representing approximately 50 to 100 centimeters below surface, and an angular cherty pebble was recovered from a bucket representing 100 centimeters to depth (see Appendix B, Photo 6).

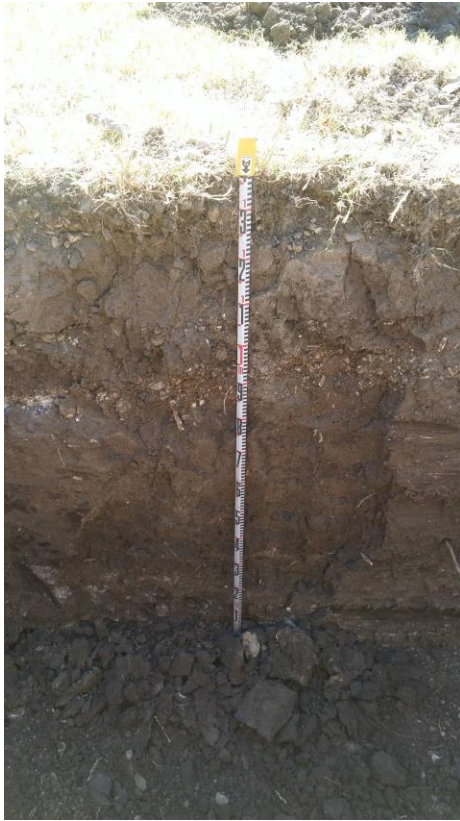
Photo #7: Eastern trench wall profile of BHT 1.

The profile exposure of BHT 1 consisted of a dark grayish brown gravelly loam modern surface on top of relatively finer textured dark grayish brown loamy clay with abundant krotovina and worm casts (Appendix B, Photo 7). Within the second zone, which extends to approximately 50 centimeters below surface, is a gravelly lens in which a single colorless glass sherd was observed. Beneath the second zone was another relatively thin gravelly zone, composed of slightly coarser grain clasts, that stretched the length of the trench. Below this gravel bed was very dark grayish brown loam, which contained a single, small angular cherty pebble, above brown clay. At the bottom of the trench, another gravelly zone with calcium carbonate nodules was observed directly atop limestone bedrock (Appendix B, Photo 8).

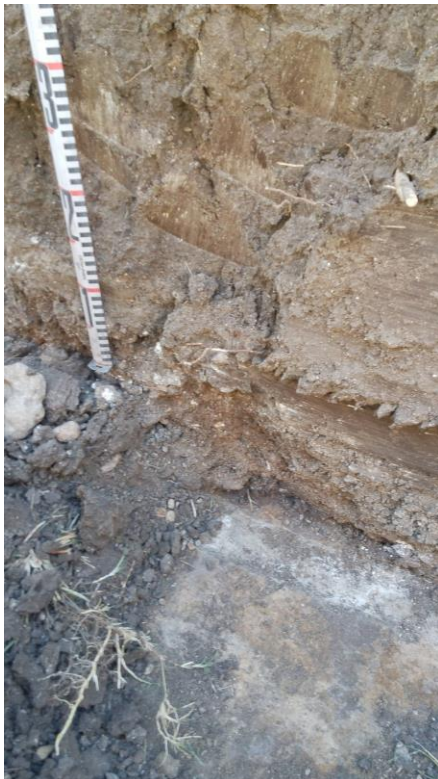
Photo #8: Zoomed in picture of sediment meeting bedrock at the bottom of BHT 1.

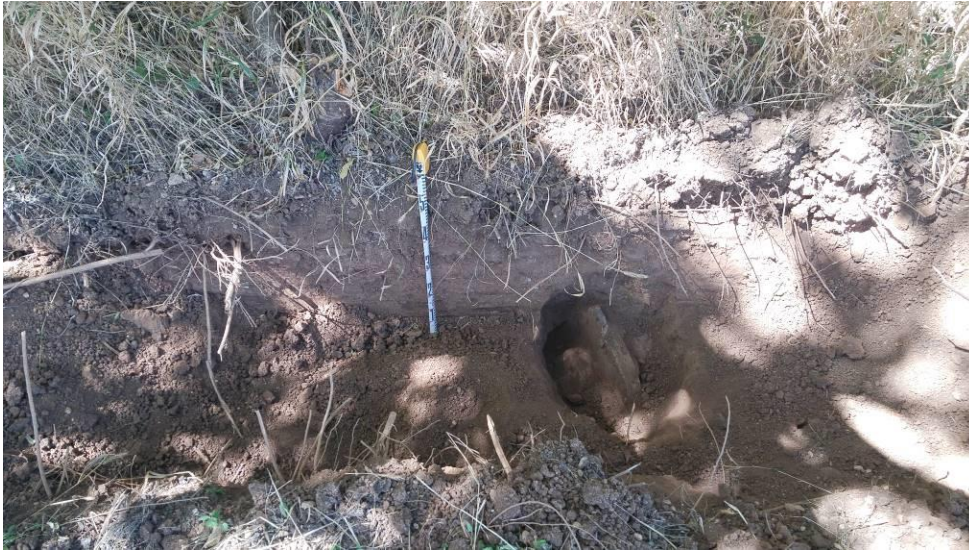
Photo #9: Relatively large existing wastewater line exposed in BHT 2.

Approximately 40 centimeters below the modern surface, the top of a relatively large end cap on a 12-14-inch wastewater line was encountered (Appendix B, Photo 9). As utilities were marked ahead of excavations and none were marked at the location, encountering the existing line was unexpected. Village of Salado staff on site at the time also indicated no previous knowledge of the line at the location. After careful excavation around the line using shovels and trowels, we observed that the larger line to the west was capped and a smaller line, approximately two inches in diameter, continued east for an unknown distance.

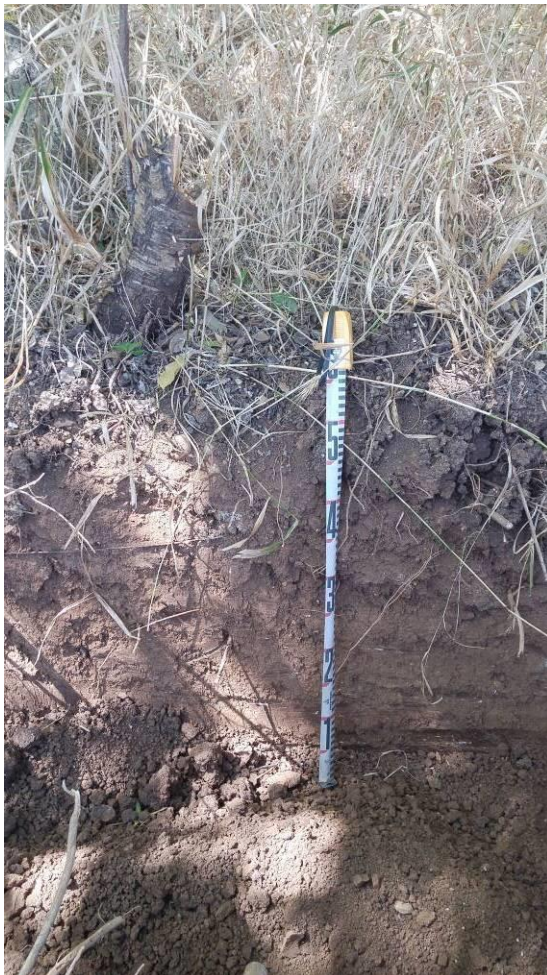
Photo #10: South trench wall exposure from BHT 2. (Exposed utility line out of frame to the right.)

Aside from some slight organic enrichment of the upper approximately 15 centimeters, the sediment encountered was homogeneously strong brown clay with common stones and carbonate nodules (Appendix B, Photo 10). Considering the existing pipeline, much of the soil, if not all encountered in the trench, was previously disturbed. One angular cherty cobble, one flake fragment, and two brown bottle glass fragments were identified among the backfill; modern debris including fibrous pipe insulation and plastic was also observed (Appendix B, Photo 11).

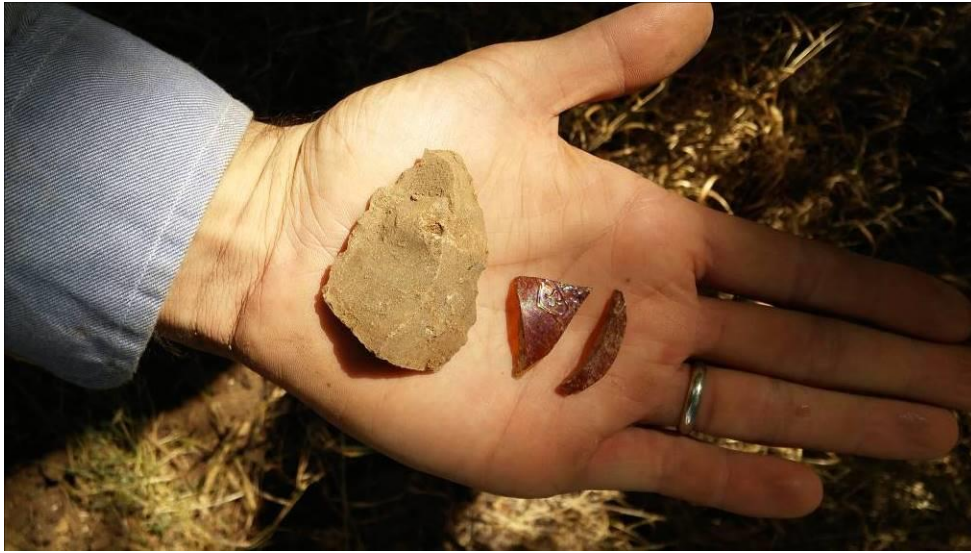
Photo #11: View of flake fragment and brown glass shards recovered from backfill of BHT 2.

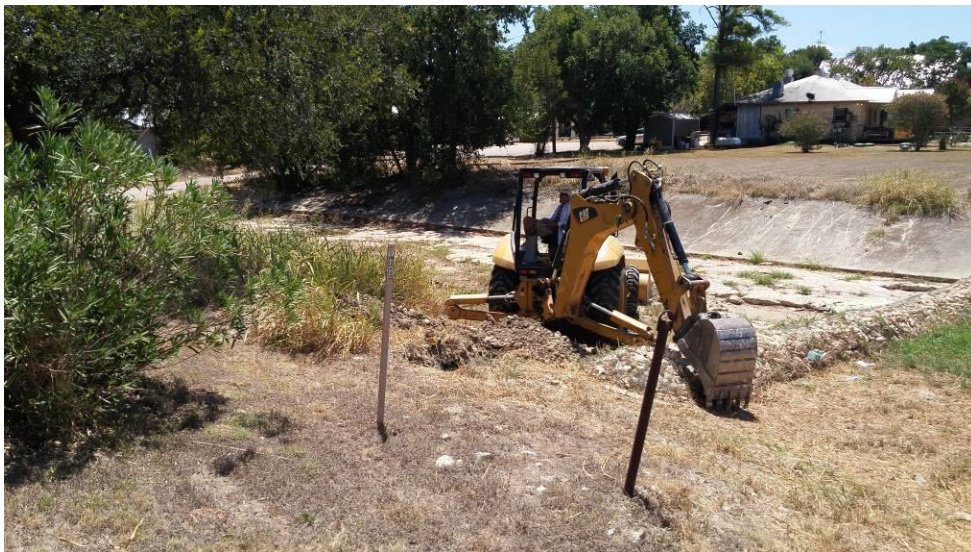
Photo #12: BHT 3 at beginning of excavation. Note excavated sediment in the midground between the two pole in the foreground.

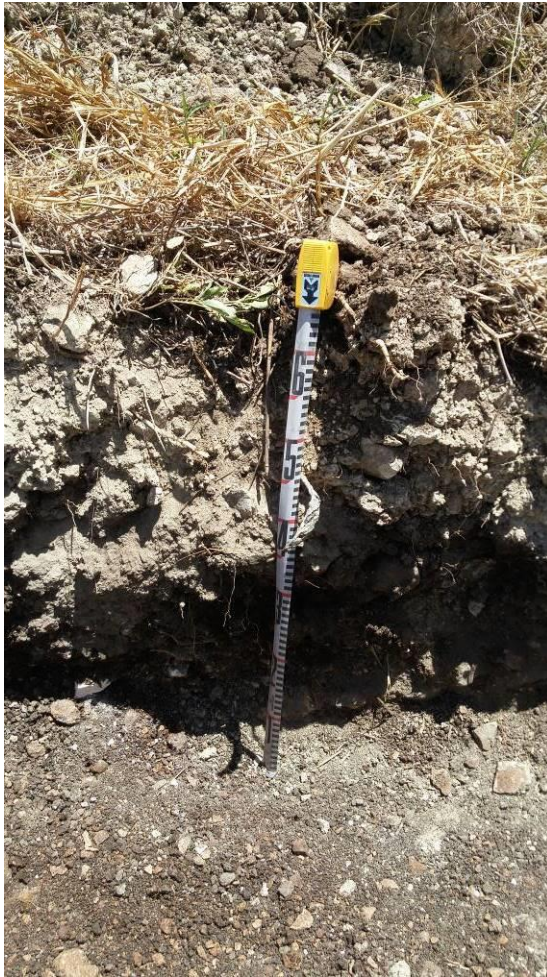
Photo #13: North trench profile exposure from BHT 3.

The upper approximately 20 centimeters of the sediment profile consisted of very pale brown, gravelly construction fill, and from approximately 20 centimeters to depth was brown (very) stony clay with abundant chert and limestone cobbles (Appendix B, Photo 13). The rocks rested directly on top of weathered limestone bedrock. A single fragment of colorless bottle glass was

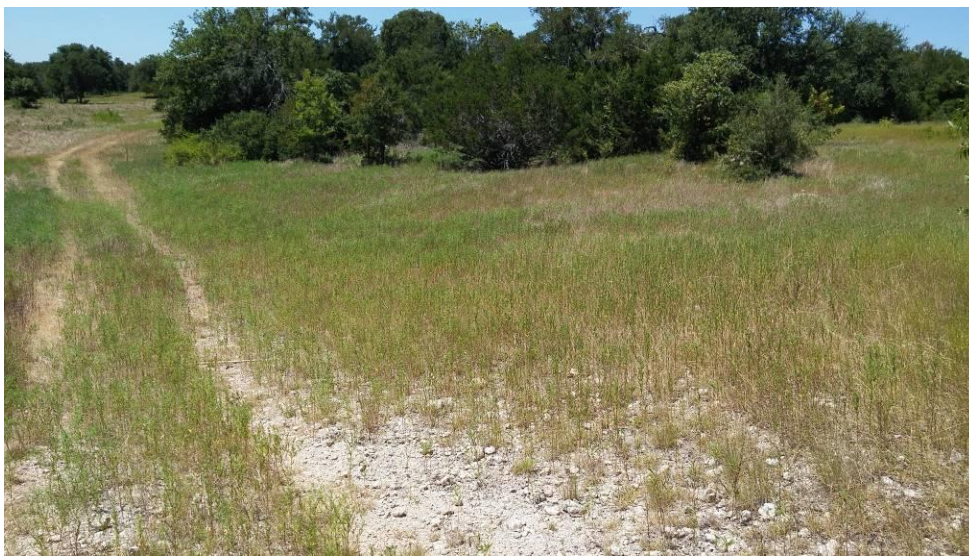
Photo #14: Exposed weathered bedrocks at the surface near the transition from upland to descent to Smith Branch near the eastern end of the proposed alignment.

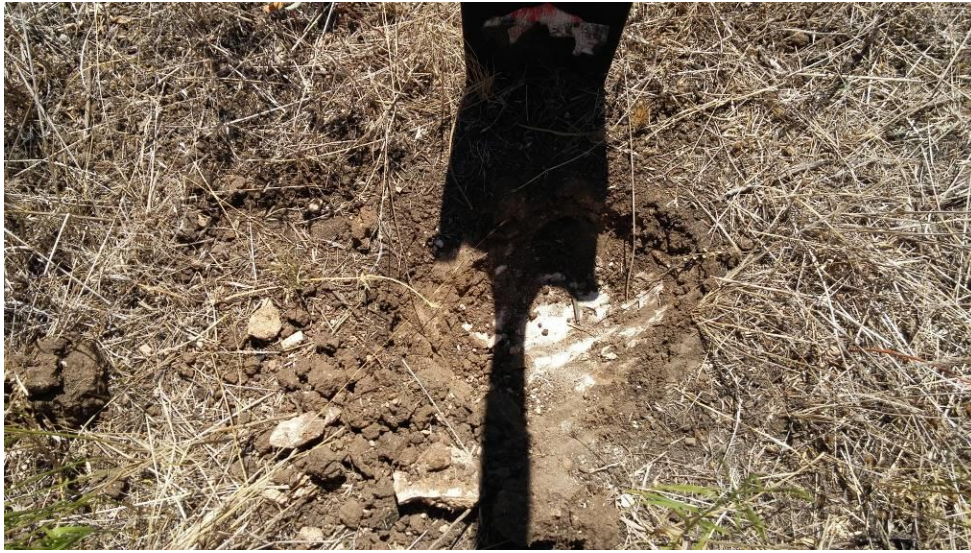
Photo #15: Shallowly buried bedrock from Shovel Test 01.

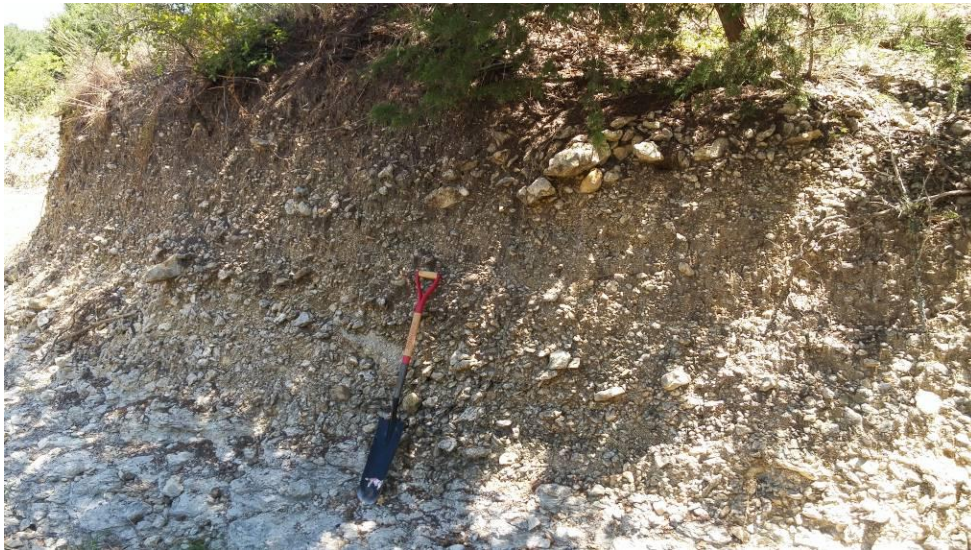
Photo #16: Smith Branch cutbank profile exposure in the vicinity of the proposed alignment crossing.

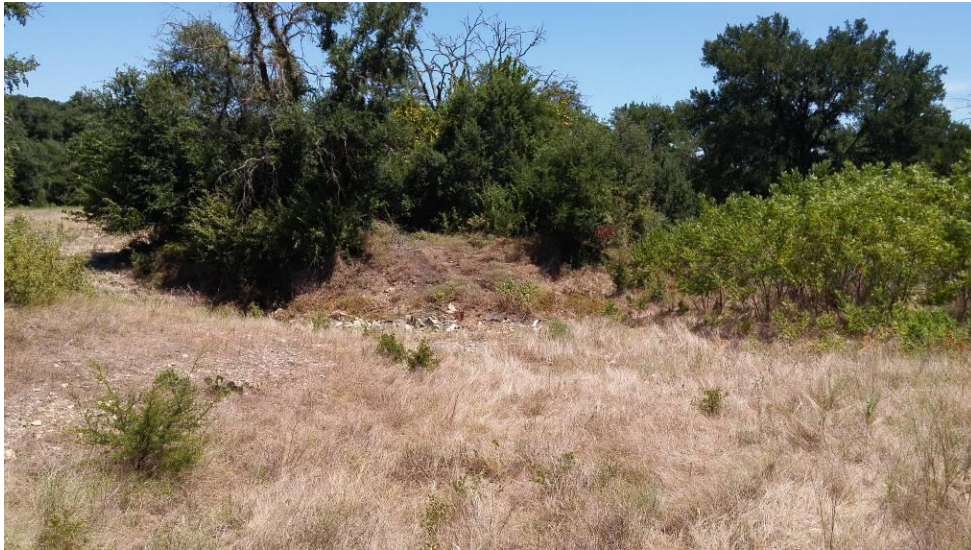
Photo #17: Vicinity of previously surveyed wastewater treatment plant. Note the woody vegetation in the midground that appears to sit on a pedestal above the shallow basin.

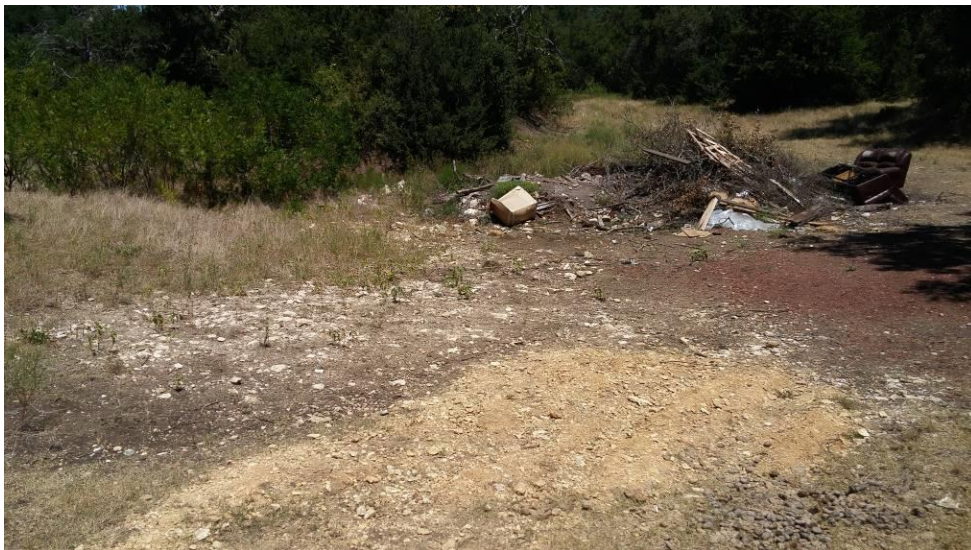
Photo #18: Gentle slope towards modern dumping in the shallow basin. The slope exposes shallowly buried weather limestone bedrock/cobbles.

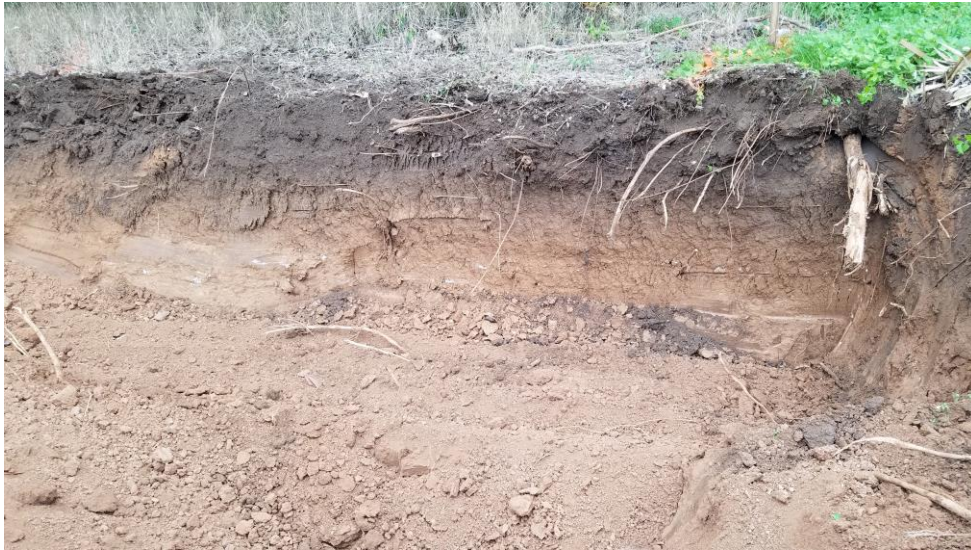
Photo #27: Soil profile observed while monitoring excavation at Royal Street lift station.

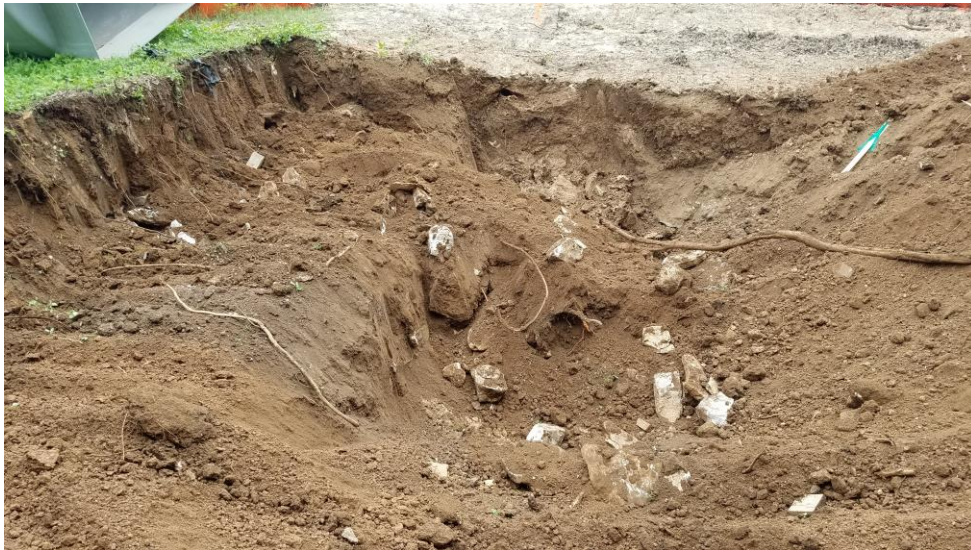
Photo #28: Bedrock chunks observed while monitoring excavation at Royal Street lift station.

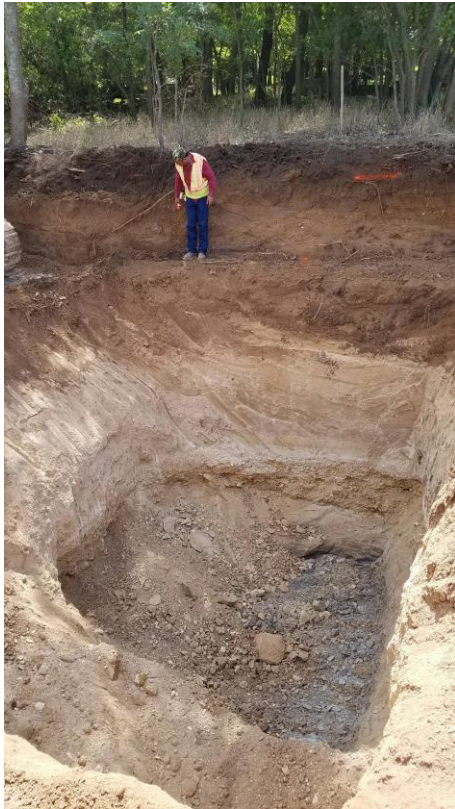
Photo #29: Soil profile at Royal Street lift station.

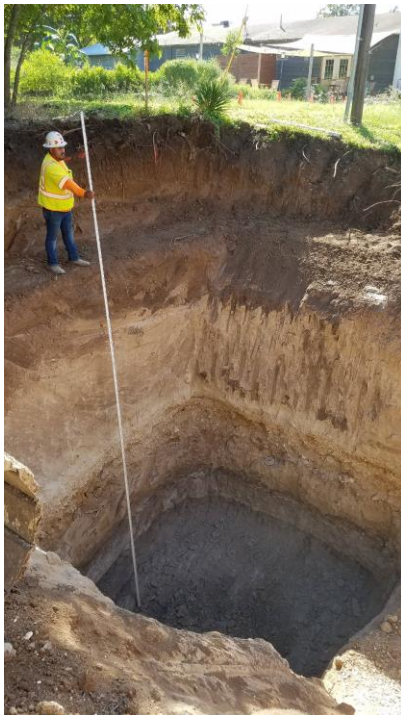
Photo #30: Excavation to bedrock at Royal Street lift station.
