## **Intensive Archeological Survey: State Highway 6 at Farm-to-Market Road 2, Grimes County, Texas**

Intensive Archeological Survey:  
State Highway 6 at Farm-to-Market Road 2,  
Grimes County, Texas

Bryan District

CSJ: 0050-03-096

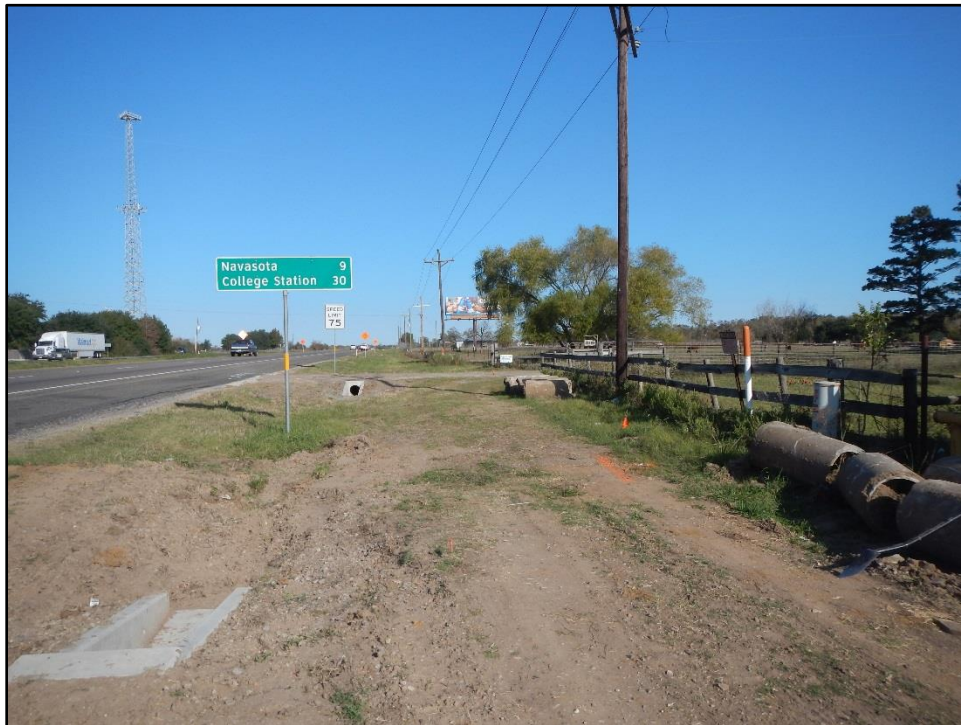
**Figure 5.** Overview of APE within existing and proposed ROW northeast of SH 6 and FM 2 intersection, facing north. Note disturbances such as buried and overhead utilities.

The existing ROW has been heavily modified as a result of road construction, ditches, driveways, infrastructure, and buried and overhead utilities (Figures 5–9). For instance, an AT&T fiber optic line runs along the entire eastern existing ROW within the APE. In addition, adjacent commercial and industrial development, including a communications tower, gas station, and metal scrap yard, has heavily impact the existing ROW (Figures 10–12). No evidence of the historical railroad depicted on the 1914 Navasota USGS map was identified in the APE; the railroad was likely removed when the northbound SH 6 roadway was constructed.

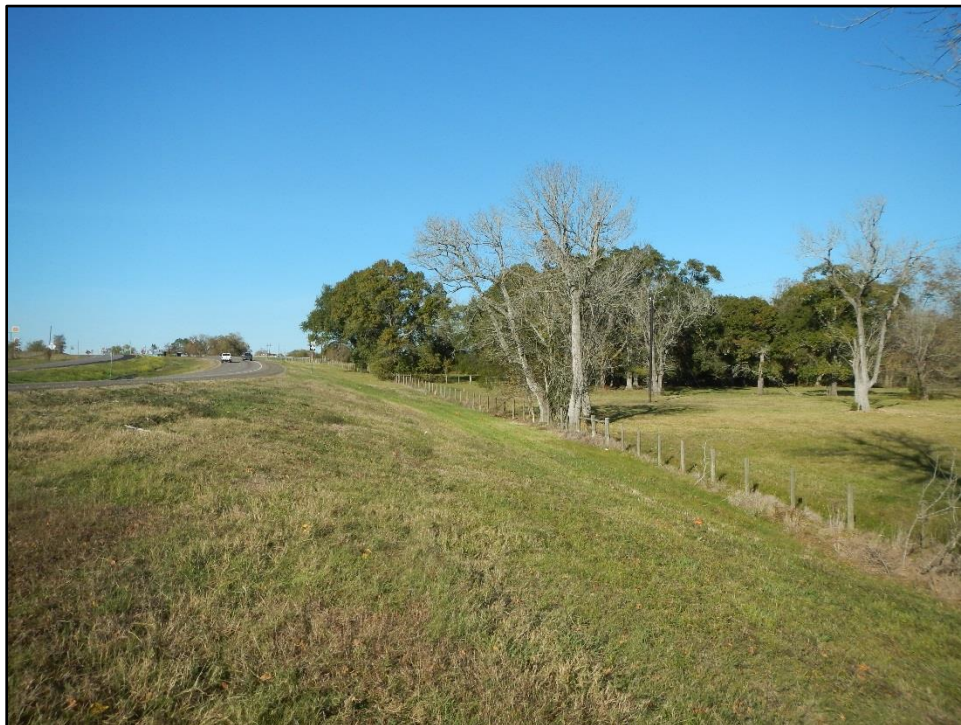
**Figure 6.** Overview of APE within existing and proposed ROW southeast of SH 6 and FM 2 intersection from just north of Beason Creek, facing north. Note disturbances such as buried and overhead utilities and substantial fill section.

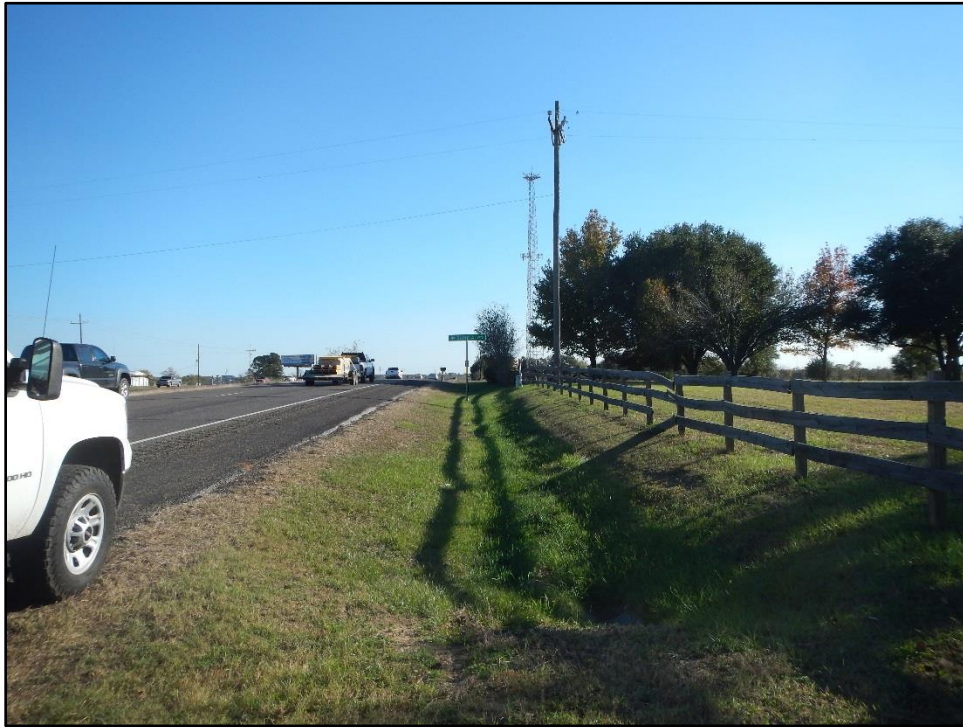
**Figure 7.** Overview of APE from near northern margin within existing ROW northwest of SH 6 and FM 2 intersection, facing south. Note disturbances such as buried and overhead utilities and ditches.

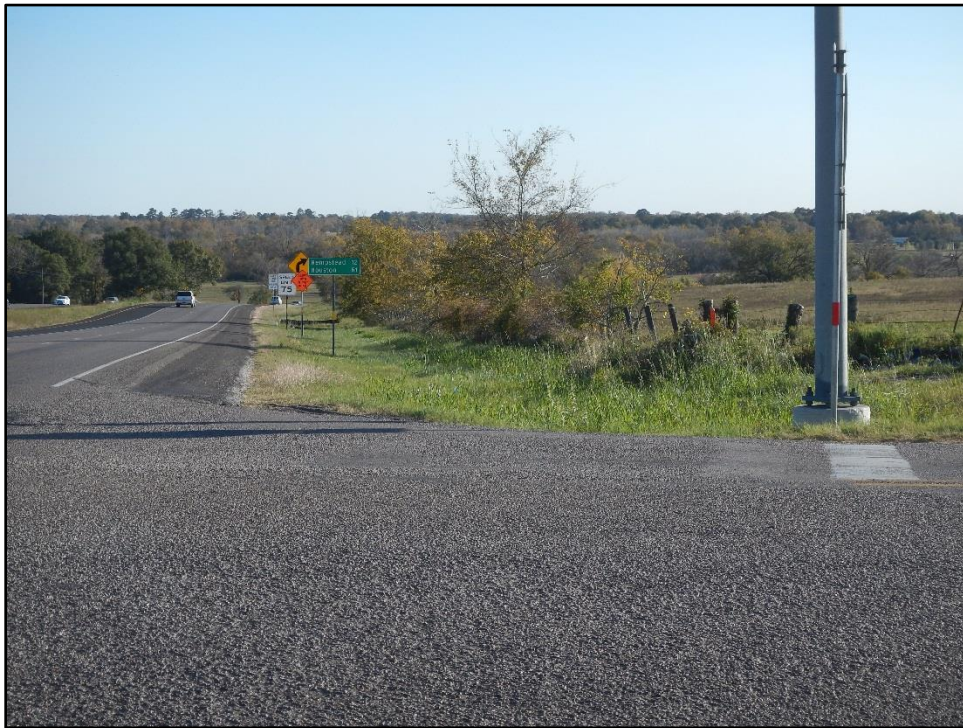
**Figure 8.** Overview of APE within existing ROW southwest of SH 6 and FM 2 intersection toward Beason Creek, facing south. Note disturbances such as buried and overhead utilities and ditches.

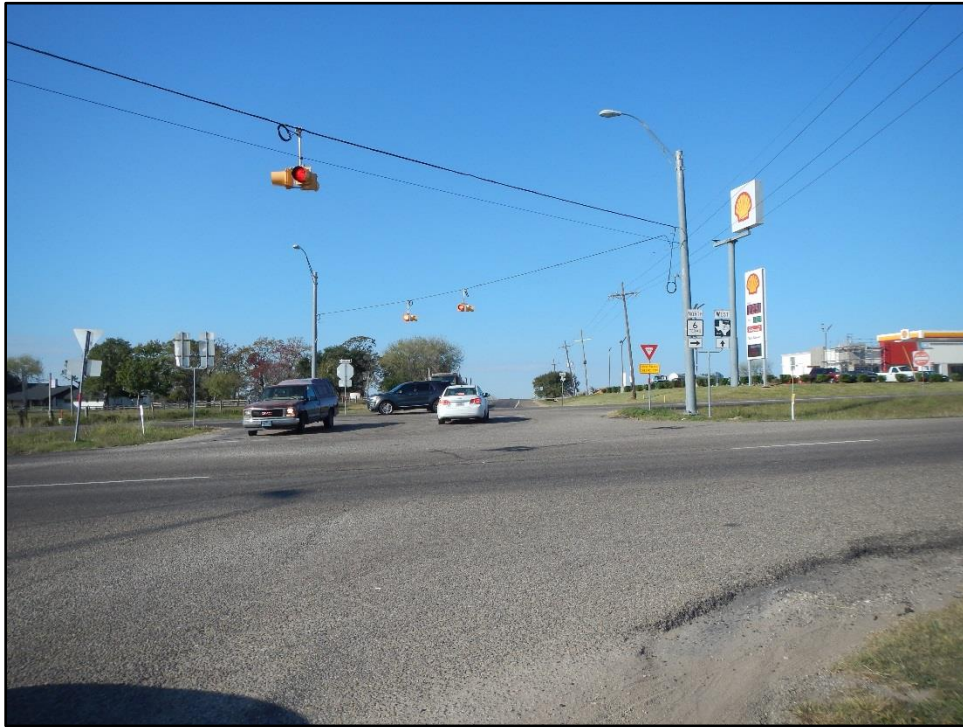
**Figure 9.** Overview of SH 6 and FM 2 intersection, facing west. Note extensive disturbances and modifications to the area.

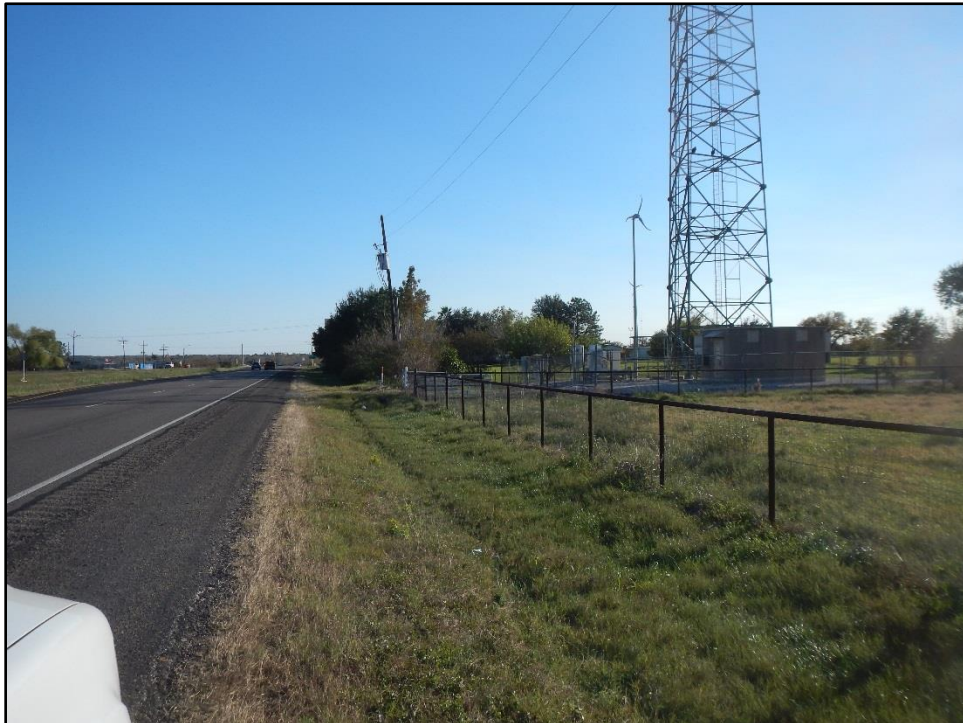
**Figure 10.** Overview of communications tower immediately adjacent to existing ROW northwest of FM 6 and SH 2 intersection, facing south.

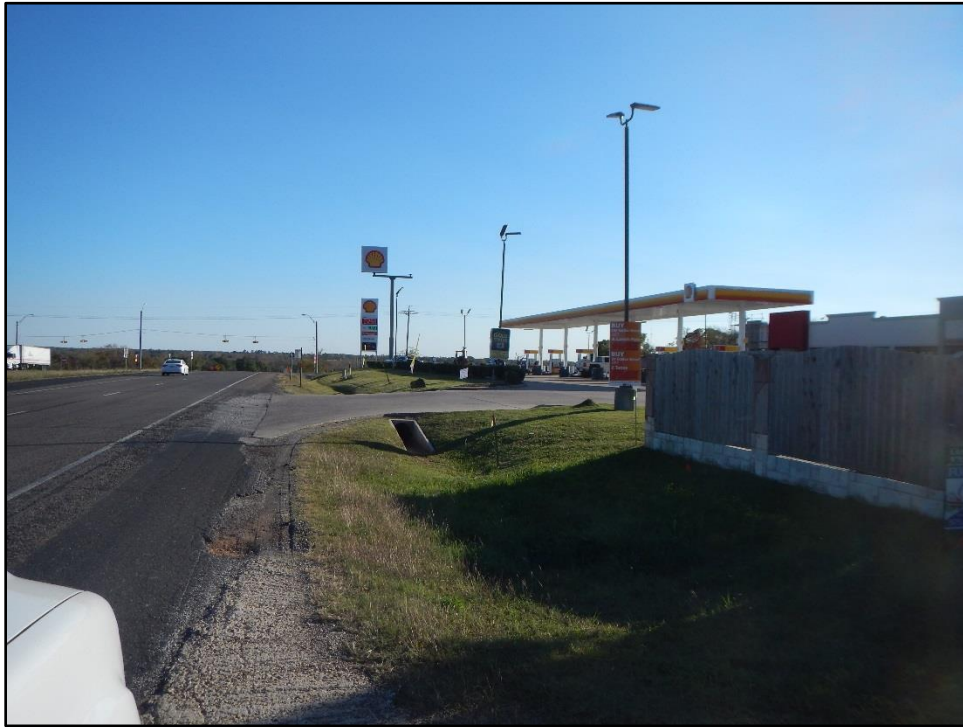
**Figure 11.** Overview of gas station immediately adjacent to existing ROW within northwest quadrant of the SH 6 and FM 2 intersection, facing south.

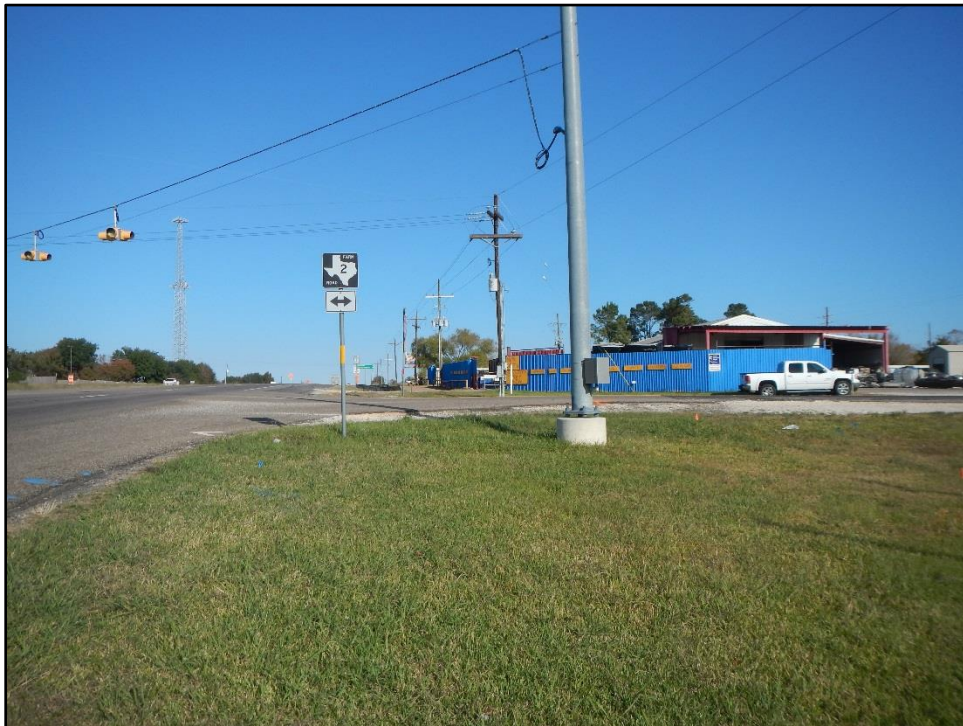
**Figure 12.** Overview of metal scrap yard within existing and proposed ROW at northeast quadrant of the SH 6 and FM 2 intersection, facing north.

The proposed new ROW has been modified by farming and ranching practices and infrastructure, including two-track roads, overhead utilities, buried waterlines, stock ponds, and fence lines (Figures 13 and 14). The proposed ROW has also been impacted by some commercial development, such as the metal scrap yard mentioned above located in the northeast quadrant of the FM 6 and SH 2 intersection (see Figure 12).

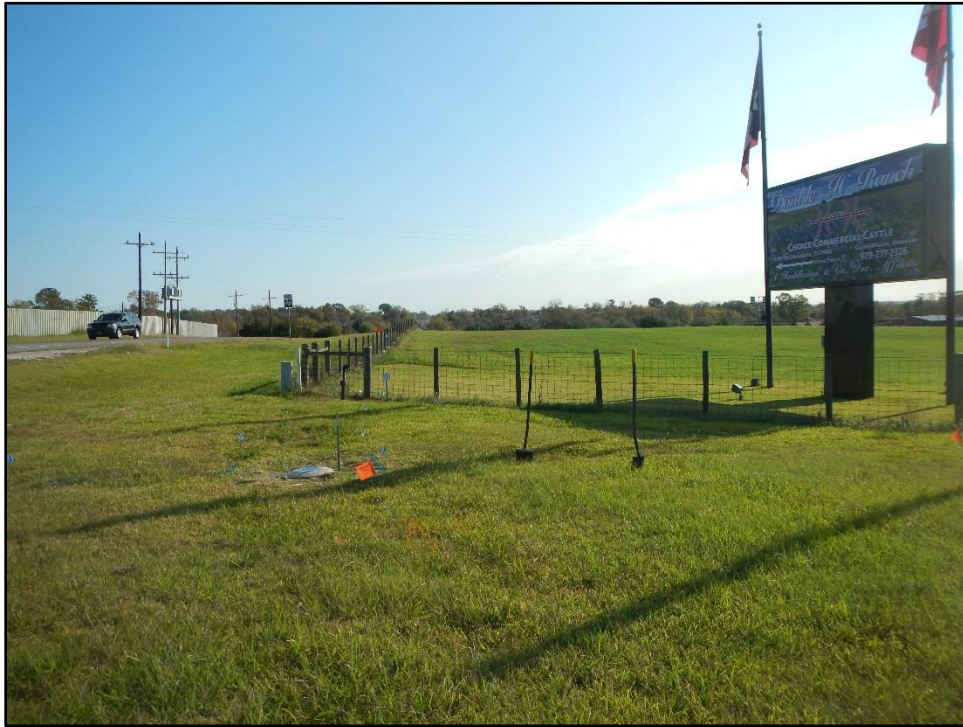
**Figure 13.** Northern portion of Parcel 11789 (Double H Ranch) within southeast quadrant of SH 6 and FM 2 intersection, facing east. Note buried utilities consisting of an AT&T fiber optic line and a water line that extends onto property.

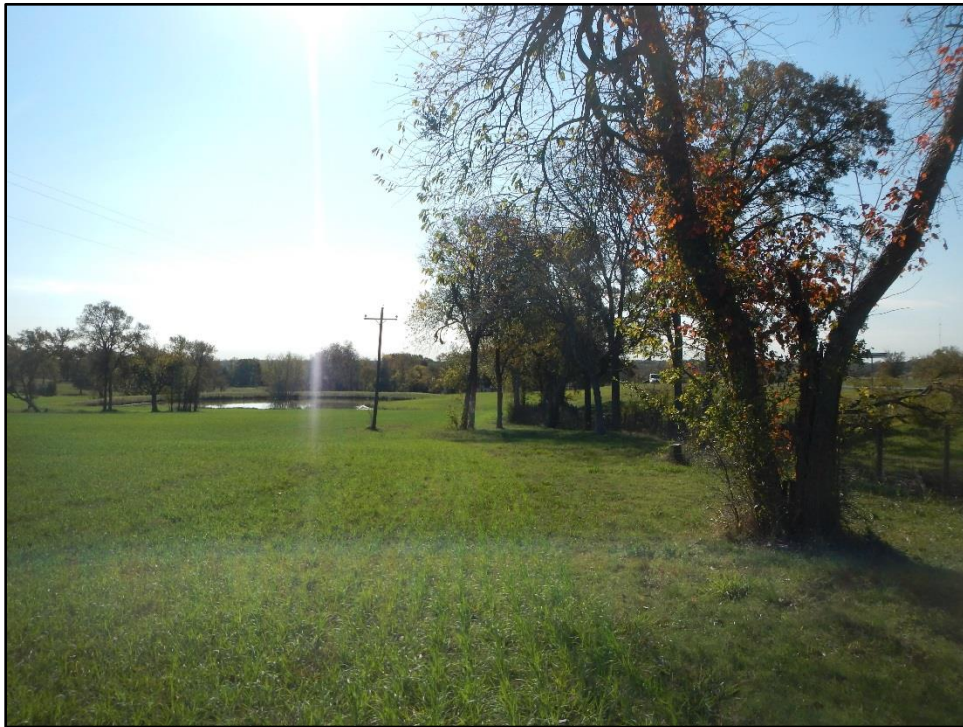
**Figure 14.** Overview of proposed ROW within Parcel 11789 (Double H Ranch), facing southeast. Note overhead utilities and stock pond.

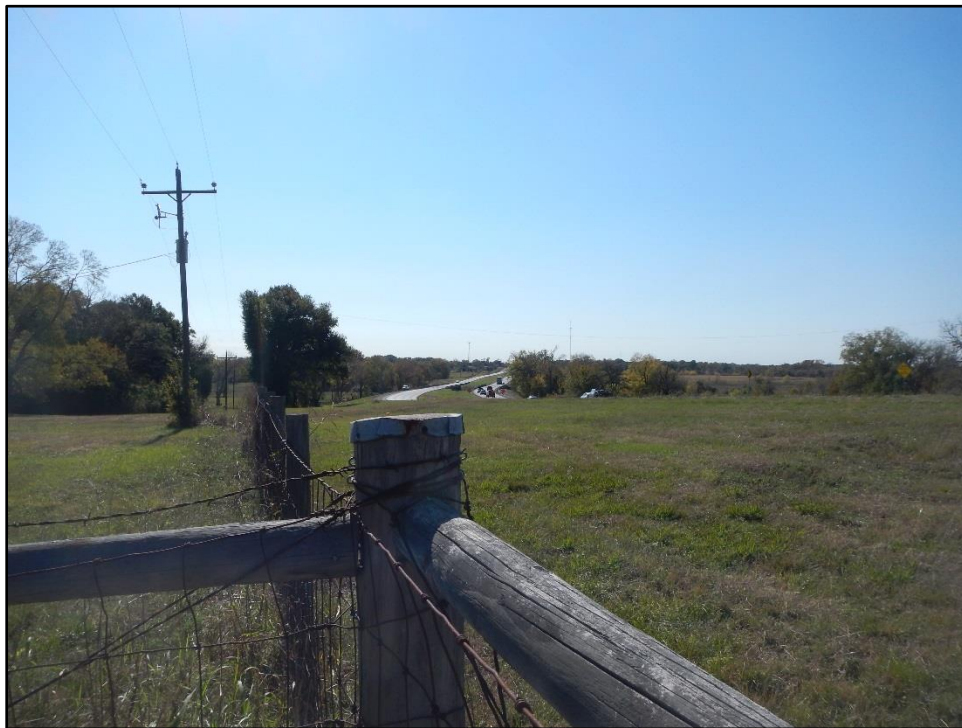
**Figure 15.** Overview of side-by-side bridges along SH 6 over Beason Creek from Parcel 11789 (Double H Ranch) within proposed ROW, facing southwest.

The portion of the APE slated for mechanical excavations was at Beason Creek along both the bridges (Figure 15). Both sides of the APE along Beason Creek are densely vegetated. The natural landform is a T<sub>0</sub> terrace and likely constitutes a forested wetland with long-term water saturation. SWCA excavated a single BHT within the project APE (see Figure 4). Additional trenches were originally planned, but ground conditions along Beason Creek precluded access due to existing bridge height, frequently flooded terrain, and wetland areas marked by stakes as an environmentally sensitive area, particularly under the southbound bridge (Figure 16). The area by the northbound bridge afforded one spot for a backhoe trench, BHT01, between the eastern side of the bridge and a buried AT&T fiber optic line situated slightly outside of the environmentally sensitive staked area (Figure 17). BHT01 was oriented north-south and measured 8.0 feet (2.44 m) long, 3.0 feet (91 cm) wide, and 5.12 feet (156 cm) deep. The natural stratigraphy in BHT01 consisted of two strata in profile and soils were moist from the frequently flooded terrain and surrounding wetland area (Table 4; Figure 18). The trench encountered thick, massive to blocky angular/subangular, black to dark gray clays. As indicated by the presence of calcium carbonate development, the bottom dark gray layer is likely a pre-Holocene unit.

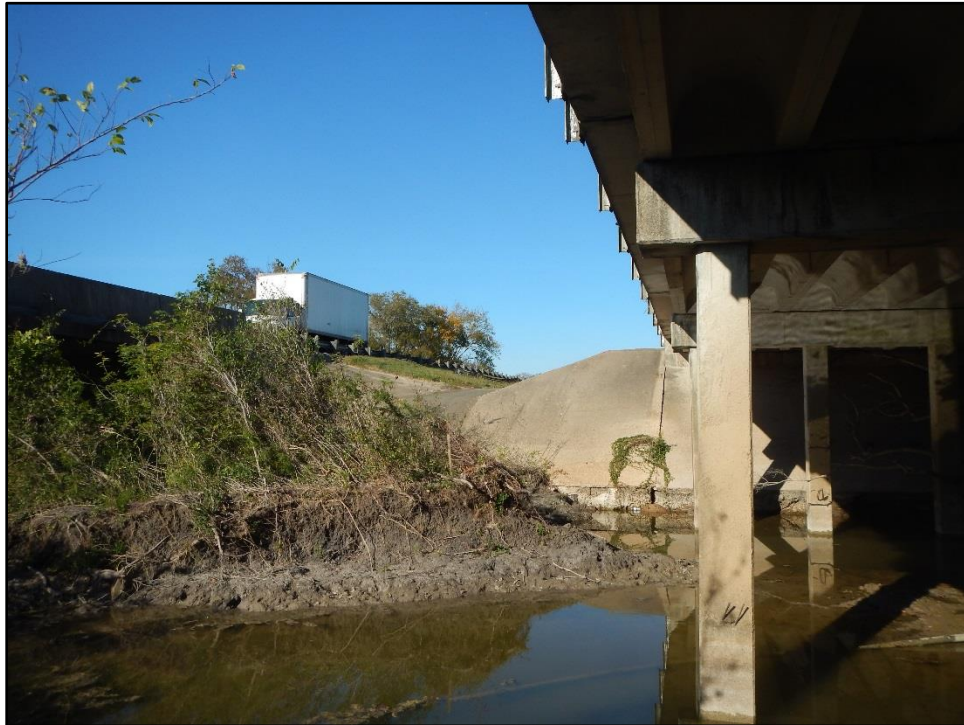
**Figure 16.** Overview of frequently flooded terrain and wetland area staked as environmentally sensitive area mostly under southbound bridge, facing northwest.

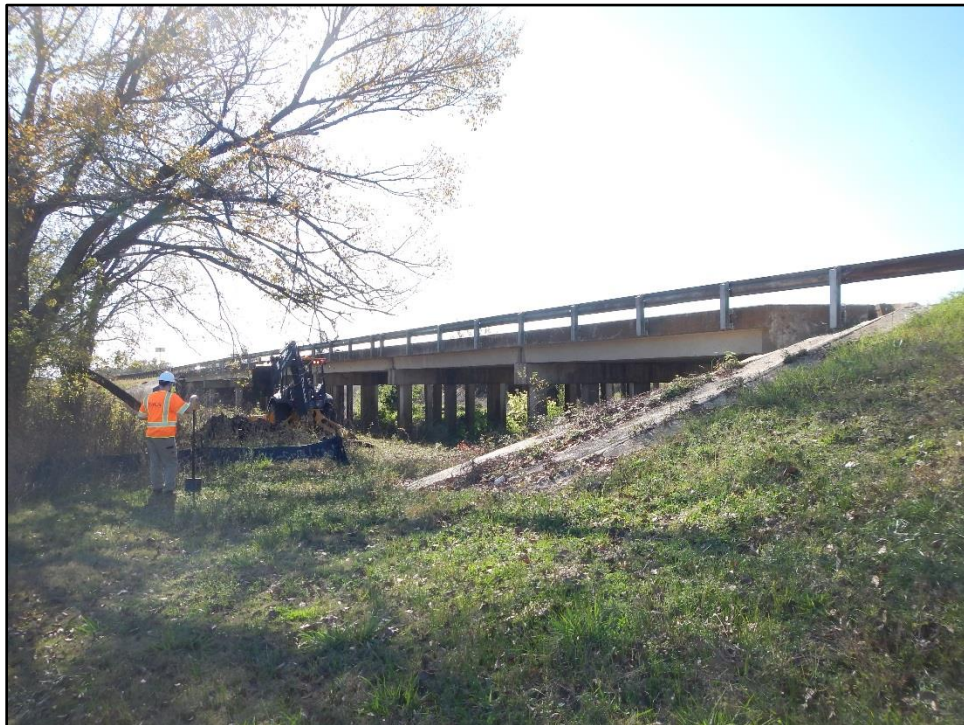
**Figure 17.** Overview of BHT01 excavation between the eastern side of the bridge and a buried AT&T fiber optic line within the existing ROW, facing southwest.

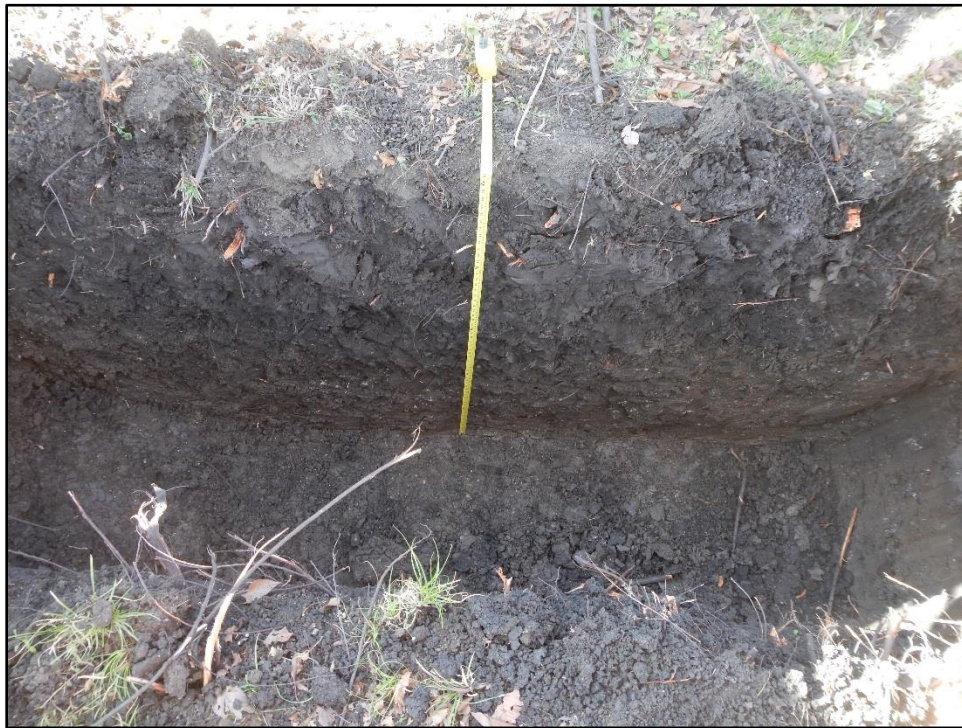
**Figure 18.** BHT01 western profile.

Trench Number	Depth (cmbs)	Munsell Value	Soil Color	Soil Texture	Consistency	Structure	Grade	Inclusion Type	Lower Boundary	Comments
BHT01	0-115	10YR 2/1	Black	Clay	Extra Firm	Massive to Blocky Angular	Strong	Roots/Rootlets (20%)	smooth and wavy	Negative for cultural material. Moist from frequently flooded terrain and surrounding wetland area.
	115-160	10YR 4/1	Dark Gray	Clay	Firm	Subangular blocky	Strong	Calcium Carbonate (10%), Very small white gravels (10%)	-	Negative for cultural material. Moist from frequently flooded terrain and surrounding wetland area. Lighter color with appearance of calcium carbonate.

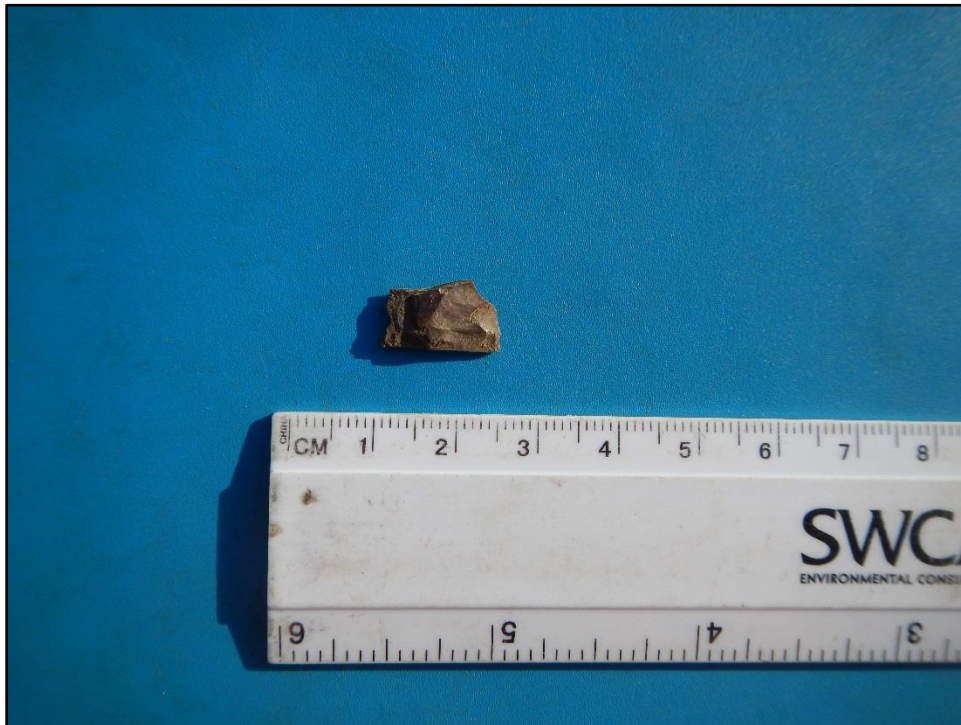
**Figure 19.** Single tertiary reduction flake observed within shovel test MG01 between 20 and 40 cmbs; designated as IF01.

IF01 consists of a single tertiary flake observed within shovel test MG01 located within existing ROW along the northeastern margin of the APE (see Figure 4 and Table 3). The IF consists of a single fine-grained chert tertiary flake fragment recovered between 20 and 40 cmbs (Figure 19). IF01 is situated on a hilltop that severely slopes down toward existing ROW ditch and roadway, and is immediately adjacent to the previously discussed buried AT&T fiber optic line (Figure 20). All shovel tests excavated south of the find were negative for cultural materials.

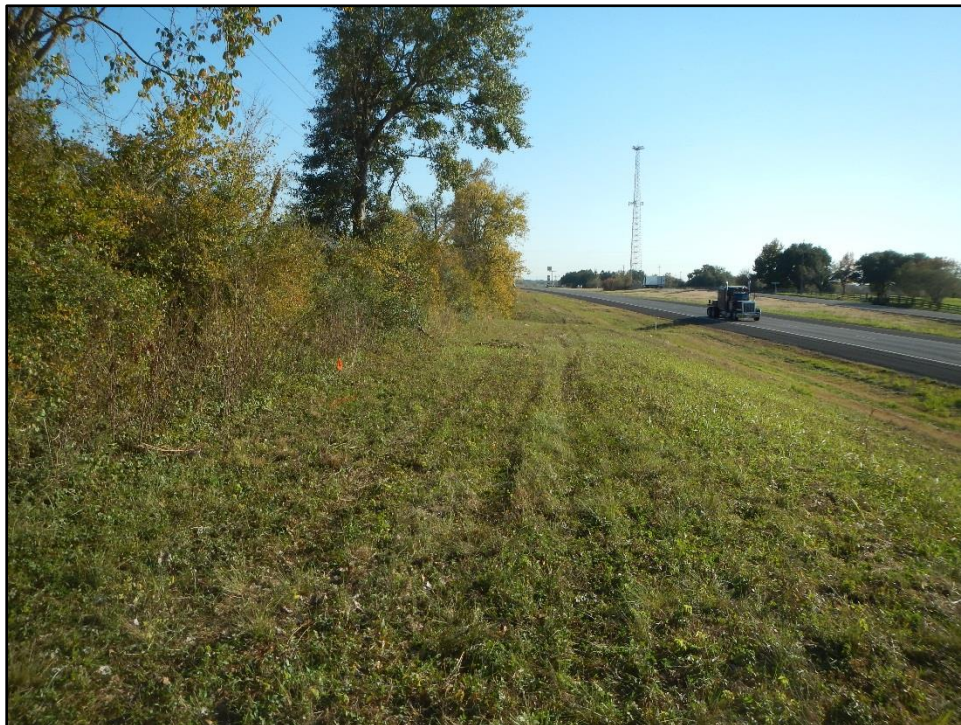
**Figure 20.** Overview from IF01 at shovel test MG01 within existing ROW along northeastern margin of APE severely sloping down toward ditch and roadway, facing southeast.

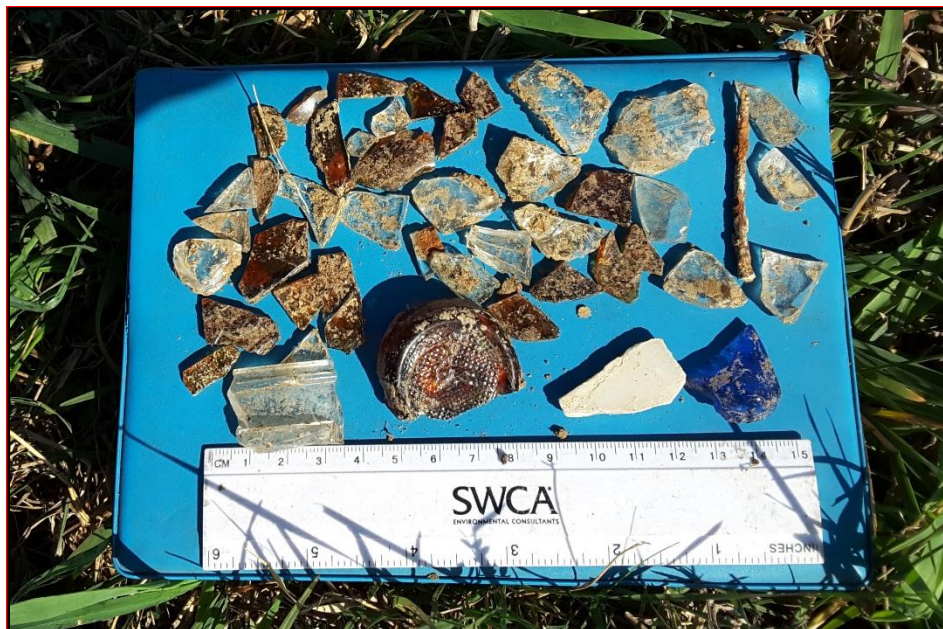
**Figure 21.** Historic glass and wire nails recovered from shovel test MG04 between 0 and 40 cmbs; designated as IF02.

IF02 consists of numerous historic glass fragments and two wire nails observed within shovel test MG04 within proposed ROW in Parcel 11764 (Double H Ranch) (see Figure 4 and Table 3). The cultural materials include colorless, amber, and one cobalt blue glass fragments, as well as two wire nails encountered between 0 and 40 cmbs within dark reddish-brown clay loam atop of mottled strong brown clay (Figure 21). IF02 is situated within Parcel 11789 proposed ROW along the eastern margin of the APE within the southeastern quadrant of the SH 6 and FM 2 intersection. The terrain slopes down from the find towards the bottomlands and stock pond on the property. All shovel tests excavated south of the find within the APE were negative for cultural materials. As previously discussed, a buried waterline is immediately adjacent to the find. The colorless glass and bottle manufacturing methods indicate a twentieth century (post-WW I) date, and the wire nails generally support this chronology. Figure 21 shows one machine-made bottle with a stippled base; stippling post-dates 1940.

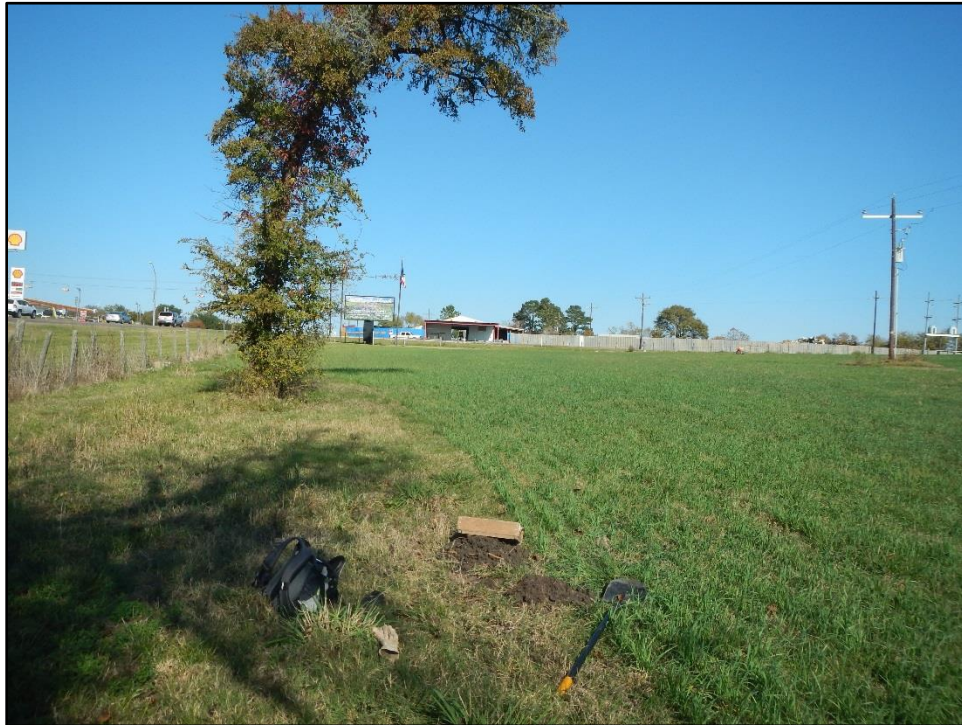
**Figure 22.** Overview of IF02 within shovel test MG04 upslope from shovel test MCC04 in Parcel 11789 (Double H Ranch) within southeastern quadrant of SH 6 and FM 2 intersection, facing northeast.

Although nails indicate architectural elements, a review of historical maps and aerials does not depict a structure was present at this location during the period of time indicated by the material assemblage. The 1914 Navasota and 1958 Courtney USGS maps do not reveal structures within the APE, although the later map shows a structure approximately 100 to 150 feet (30 to 46 m) east of the APE. This is likely the same structure depicted on the 1936 General Highway Map of Grimes County, although the scale of this map precludes an accurate correlation. The high density of material is notable, since the surrounding shovel tests contained no cultural material. The distribution suggests the possibility of a localized dump.
