Marine Archaeological Survey at the Texas Park and Wildlife Department's Rhodes Point Reef Site, Keller and Lavaca Bays, Calhoun County, Texas

*Marine Archaeological Survey
at the Texas Park
and Wildlife Department's
Rhodes Point Reef Site,
Keller and Lavaca Bays,
Calhoun County, Texas*

Texas Antiquities Permit No. 9295

Project No. 20-80001.001

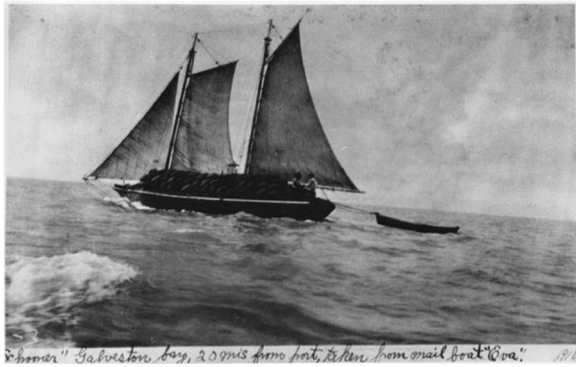
Figure 3-1. Photograph taken in 1910 on Galveston Bay showing a two-masted scow schooner in transit loaded with cargo (photograph courtesy: The Portal to Texas History).

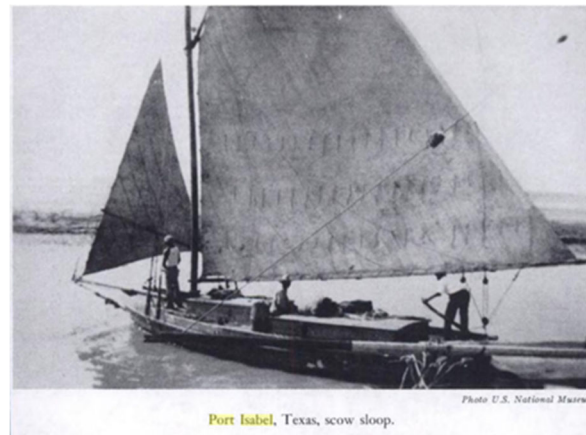
The length of these vessels ranged from 7.92 to 9.75 meters (26 to 32 feet) in length and 3.04 to 3.65 meters (10 to 12) feet in beam, and draft of 1 foot, with the centerboard raised into the hull (Doran 1987:54). These vessels were constructed of local yellow pine and cypress; and near the Mexican border, boat builders used mesquite knees in lieu of cypress crooks. They were built upside down using the frames and the end-transoms as molds, retained chine logs, and were cross planked on the bottom (Chapelle 1951:336). A typical Texas scow sloop operating in coastal Texas is presented in Figure 3-3 which is a historic photograph of a scow sloop in transit.

Figure 3-2. A historic photograph (date unknown) showing a Texas scow sloop underway (as presented in Chapelle 1951:175).

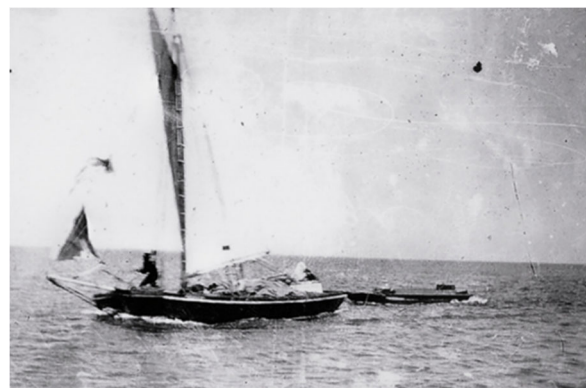
Figure 3-3. A historic photograph (date unknown) showing a Texas scow sloop underway (photograph courtesy: <https://thedolphintalk.com/?p=10537>).

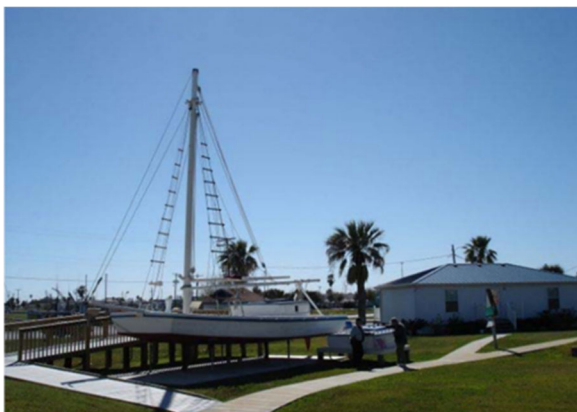
Texas scow sloops were constructed by small-boat builders from the mid-1850s until as late as 1952 (Francaviglia 2010:247–248) and were very popular in the commercial fishing industry. These vessels would fish in pairs with gill nets extended between them which could yield thousands of pounds per netting. Overfishing method nearly decimated the fisheries in coastal Texas, and in 1952, Texas banned the use of gill nets, essentially marking the end of the Texas scow sloop. A replica of a Texas scow sloop, *La Tortuga*, built in 1990, is on display at the Texas Maritime Museum in Rockport, Texas (Figure 3-4).

Figure 3-4. Photograph of *La Tortuga*, a replica Texas scow sloop (photograph courtesy: Dolphin Talk 2020).

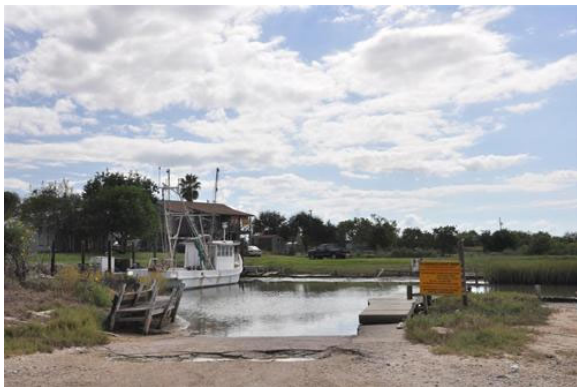
Figure 3-5. Photograph of a trawler docked at a slip in Olivia, Texas (photograph courtesy: Gerald Massey).

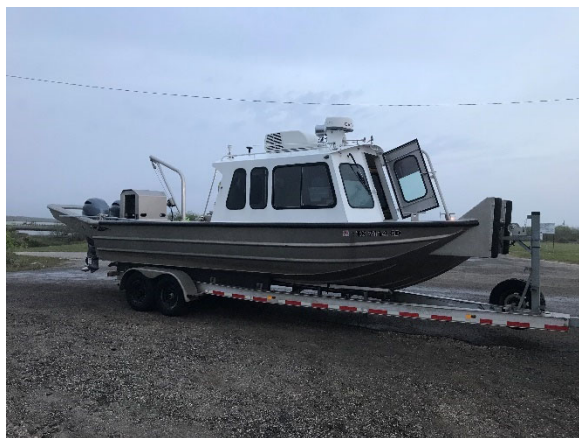
The survey vessel used for the present project was BIO-WEST's 8.2-meter (26-foot) aluminum work vessel (Figure 4-1). The vessel's attributes (ample deck space, shallow draft, high maneuverability, davits, and winches) made it an excellent platform from which to conduct survey while towing numerous pieces of gear. The vessel was propelled by two 130 horsepower (HP) outboard motors and has a top speed of 25 knots to transit to the survey site, while a survey speed of approximately 4 to 5 knots could easily be obtained. The onboard 5-kilowatt power system provided more than enough electricity to power all the remote sensing equipment, computers, navigation

Figure 4-1. BIO-WEST's project survey vessel.

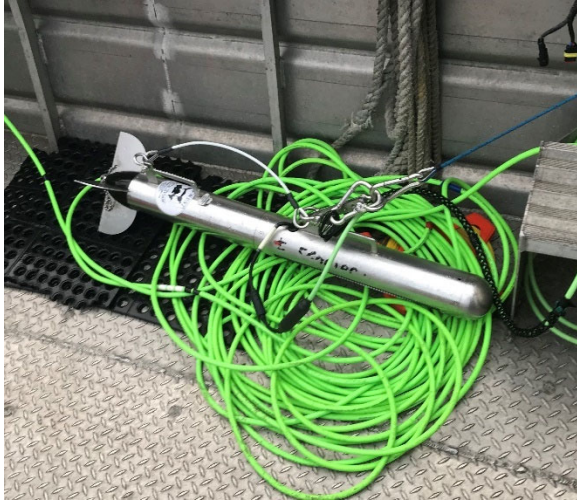
Figure 4-3. EdgeTech 4125 dual frequency side-scan sonar system.

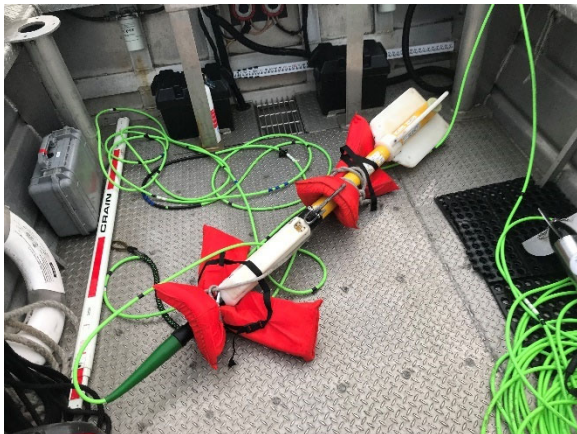
Figure 4-5. Geometrics G-882 Marine Magnetometer with life preservers attached for towing in shallow water.

Magnetic readings were recorded at a rate of 1 per second. The magnetometer could detect, if present, ferrous-based objects indicative of steel pipelines or “metal” debris below the vessel track line. If the sensor passes materials below, on, or projecting above the seafloor containing

ferrous metal masses or magnetic properties large enough, fluctuations created within the earth’s local magnetic field would be recorded. Fluctuation is measured in gammas or nT and proportional relative to the distance of the sensor to the mass of ferrous metal contained in the sensed object. Due to the relative proximity of the bay bed to the sensor, it is considered that any anomaly observed would generally be represented as larger than if the sensor was flown at a traditional survey height above bottom of approximately 6 meters (20 feet).
