Intensive Archeological Survey of US Highway 277

Archeological Survey Report

Project Name: Intensive Archeological Survey of US Highway 277

CSJ Number(s): 0264-06-042

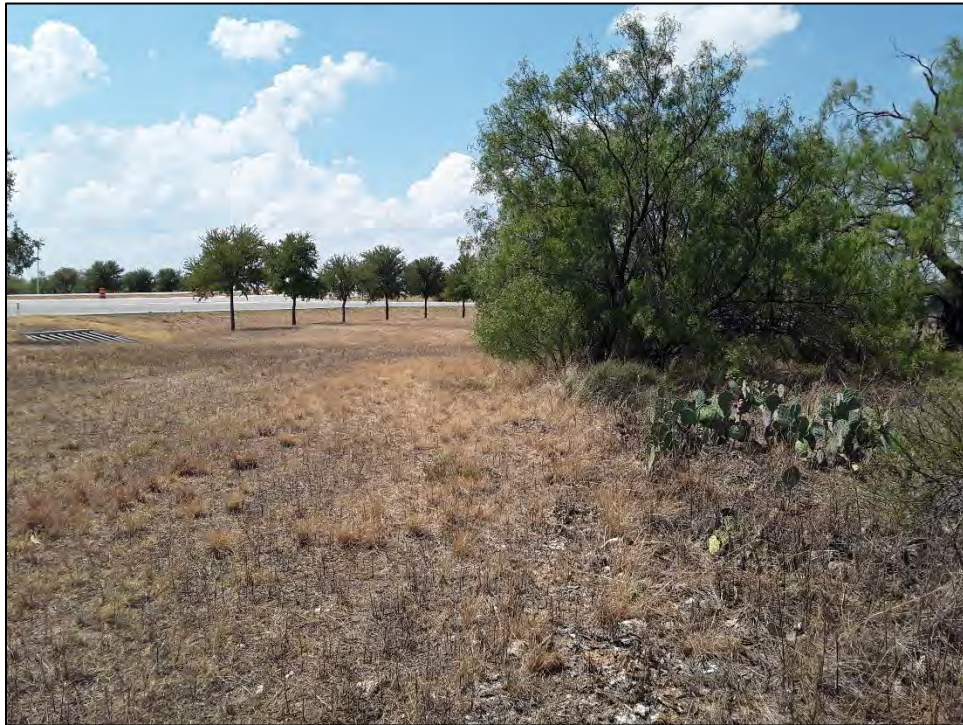
Figure 2. US 67 construction and landscaping disturbance, view facing southwest. Photo Point 01.

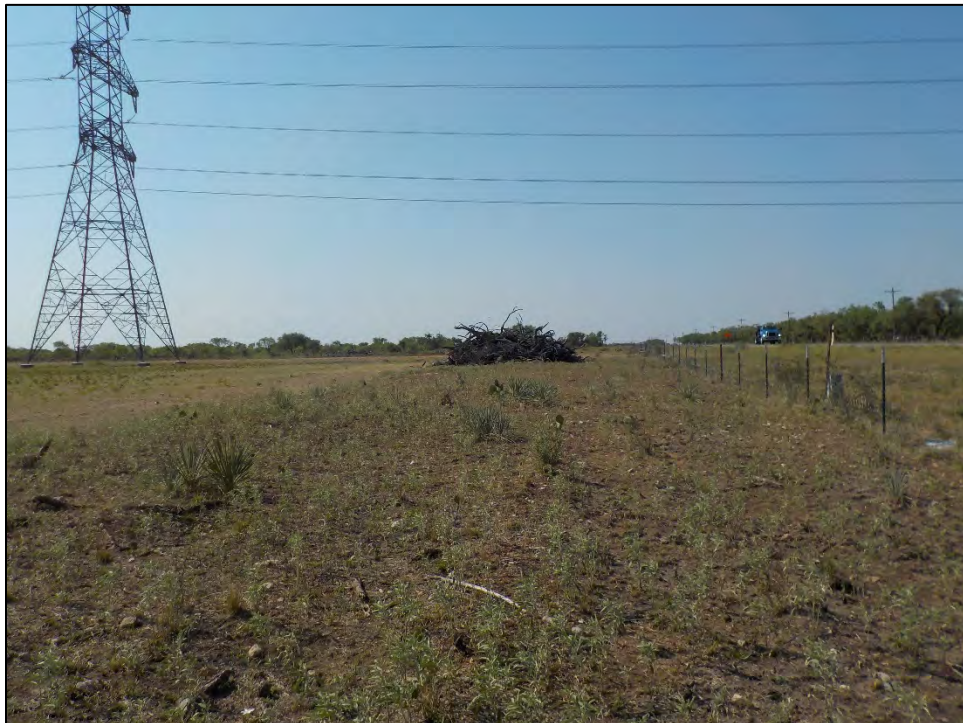
Figure 3. US 277 and transmission line disturbance, view facing south. Photo Point 06.

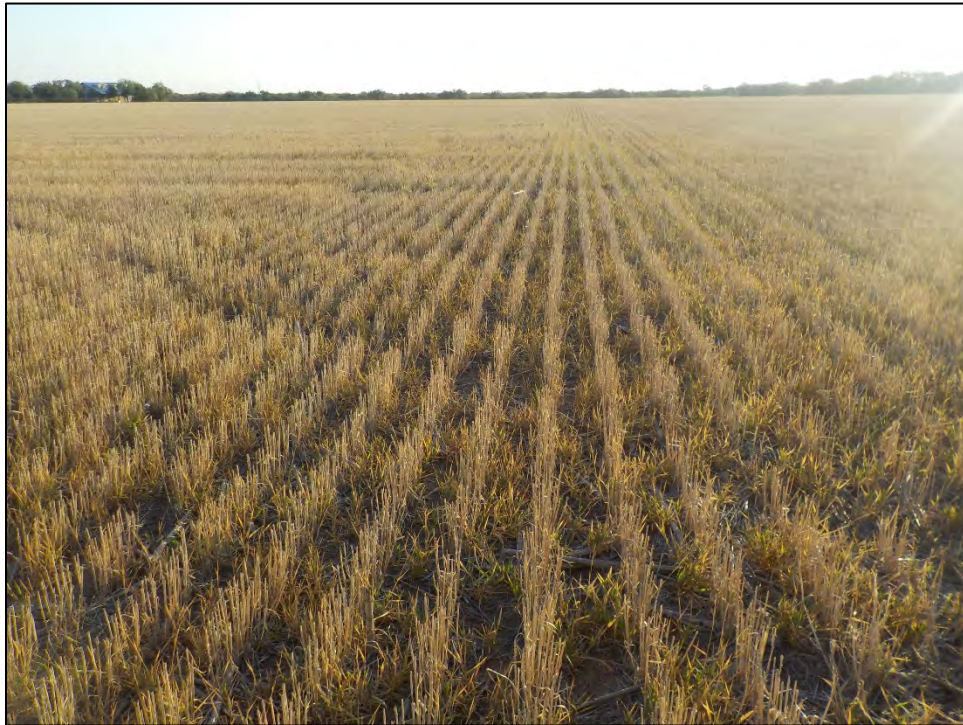
At the time of survey, the northern and southern terminus of the APE was utilized for crop production and the middle section of the APE was utilized for ranching (Figures 7 and 8). In addition, SWCA observed disturbances within the APE due to agricultural practices, ranching practices, stock pond construction, grading for a two-track road, vegetation clearing, construction of a waterline, and pipeline construction.

Figure 7. Plowed field in southern terminus of APE, view facing east. Photo Point 13.

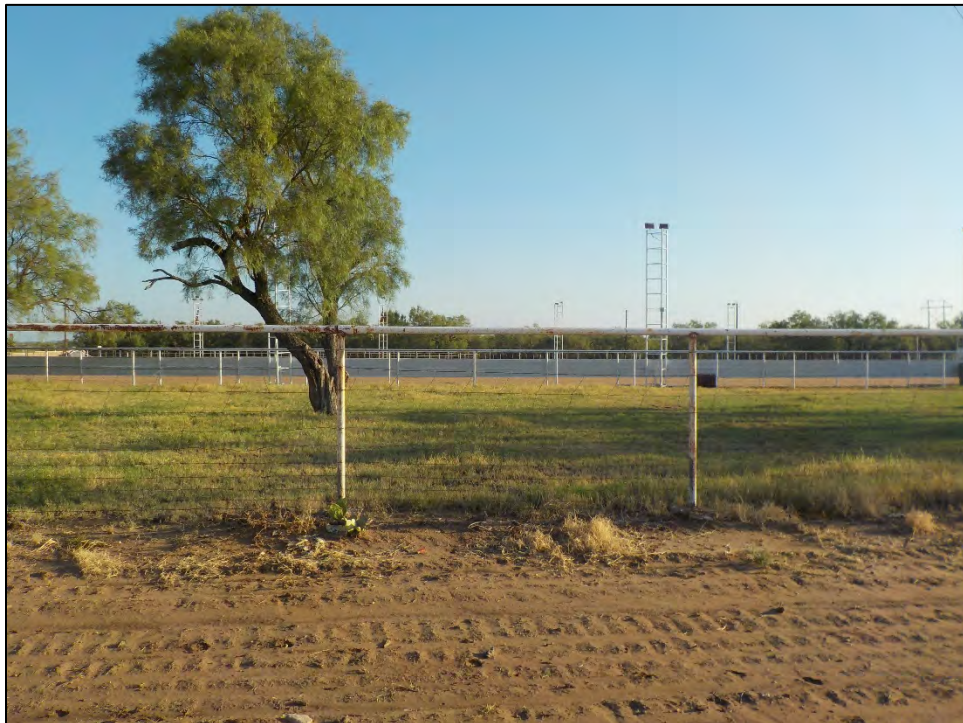
Figure 8. Corral and arena in a ranching complex within the project area, view facing north. Photo Point 14.

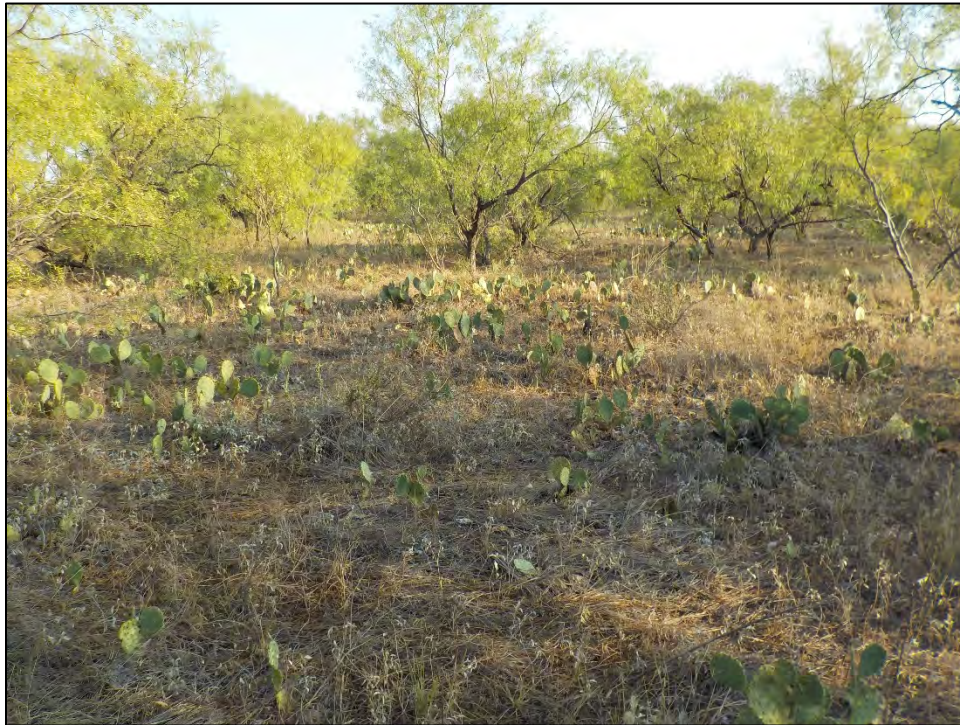
The APE consists of plowed fields in the north and south, with desert scrub growth consisting of prickly pear, tall and short grasses, mesquite, and scrub shrub (Figure 9).

**Figure 9. Typical vegetation within the project area, view facing north.
Photo Point 04.**

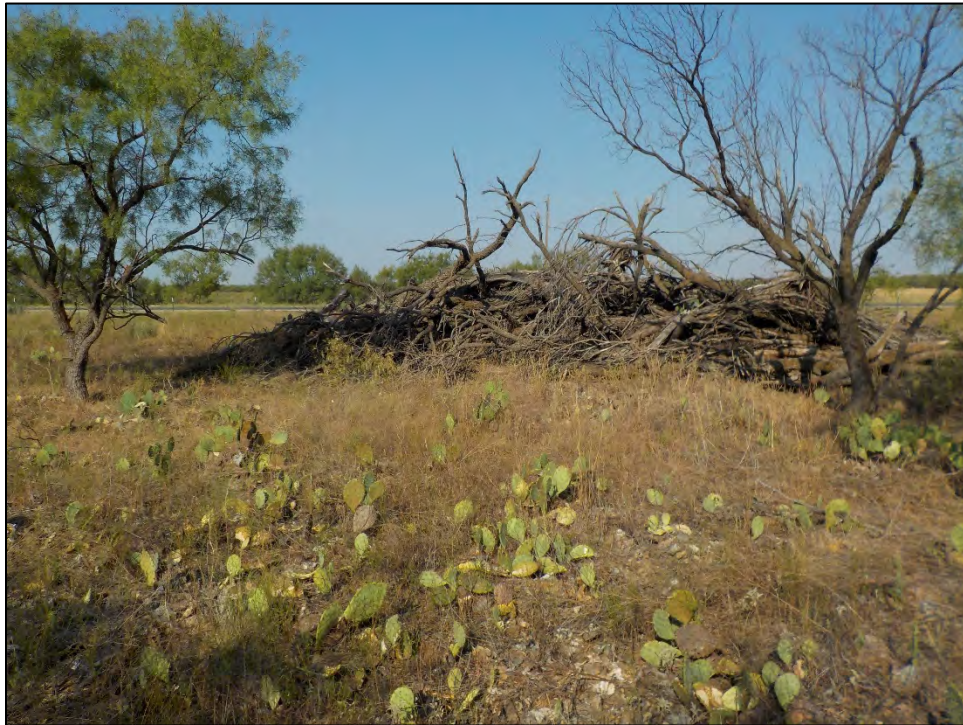
The APE was observed as being extensively modified by agricultural practices, ranching activities, modification of a playa into a stock pond, grading for a two-track road, vegetation clearing, construction of a waterline, and pipeline construction (Figures 11 and 12). The southern and northern terminus of the APE are active agricultural fields and a review of aerials indicates the APE has been an agricultural field for a least half of a century, probably longer (NETR 2020). The result of these activities would likely impact the integrity of any potential cultural resource within the APE.

Figure 11. Vegetation clearing and brush pile disturbance, view facing west-northwest. Photo Point 07.

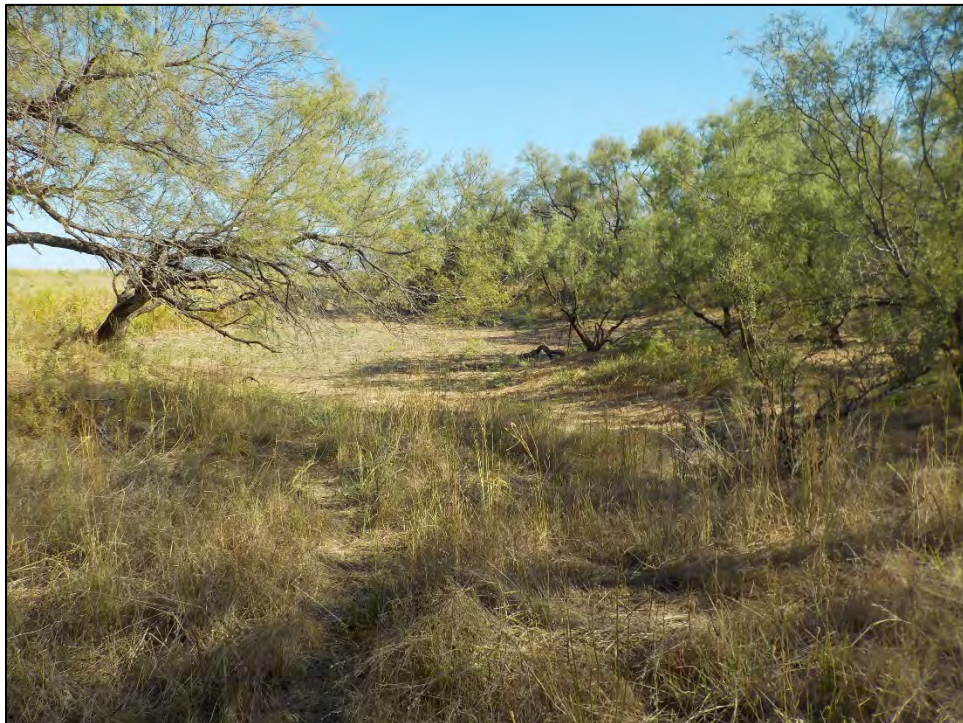
Figure 12. Modified playa overview, view facing north. Photo Point 20.

The intensive survey systematically assessed the entire APE but focused on two relict playa lakes, specifically the leeward sides where dunal formation is expected to have higher preservation potential for buried deposits. Soil data (see Figure 6) indicates two playas intersect the APE, one to the north in the central project area and one farther south. Both have been heavily modified within the APE by the previously mentioned modern disturbances. Trenching on the northern playa is discussed below. The southern playa appears in soil data, but not in the geological data (as does the northern playa - see Figure 5) and is a minor feature with little topographical expression in the APE. In addition, the playa has been modified in order to be utilized as a stock pond. Because of various disturbances and shallow soils, the southern playa was adequately assessed with shovel testing. No cultural materials were identified in either playa or adjacent dunes.

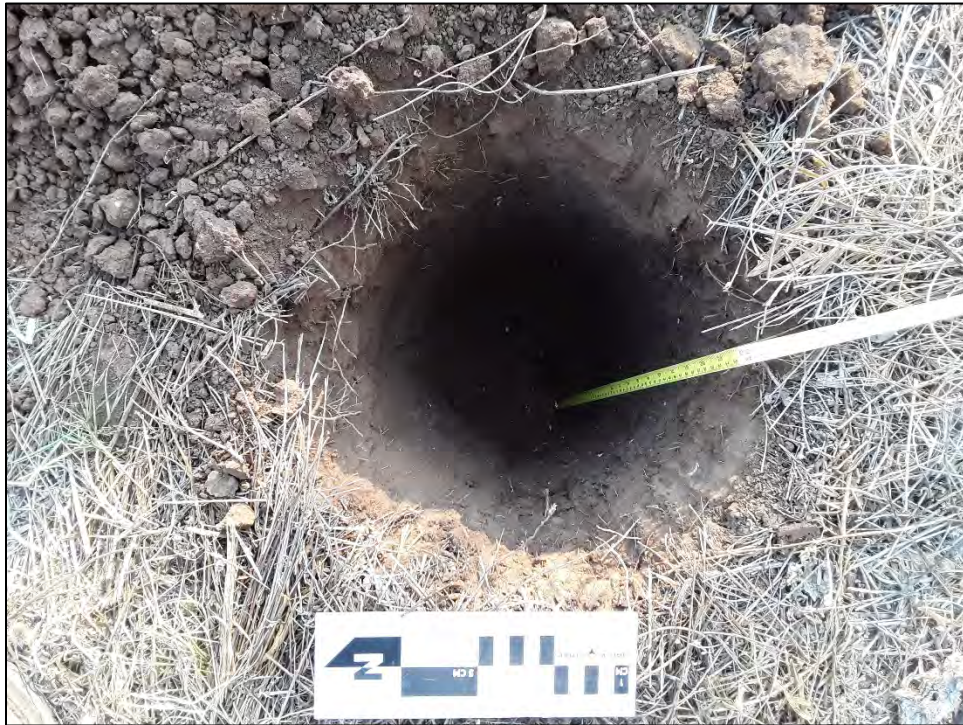
The typical shovel test excavated within the APE was excavated to approximately 40 cm (15.7 inches) and encountered a very compact dark brown (10YR 3/3) to very dark gray (10YR 3/2) clay loam with gravel or calcium carbonate inclusions (Figure 14; Attachment A, Table A-1). The tests terminated at a compact calcareous clay loam; based on the level of calcium carbonate development, the substrate is inferred to be ancient soils. All excavated shovel tests were negative for subsurface cultural materials.

Figure 14. Shovel test SS05, view facing east.

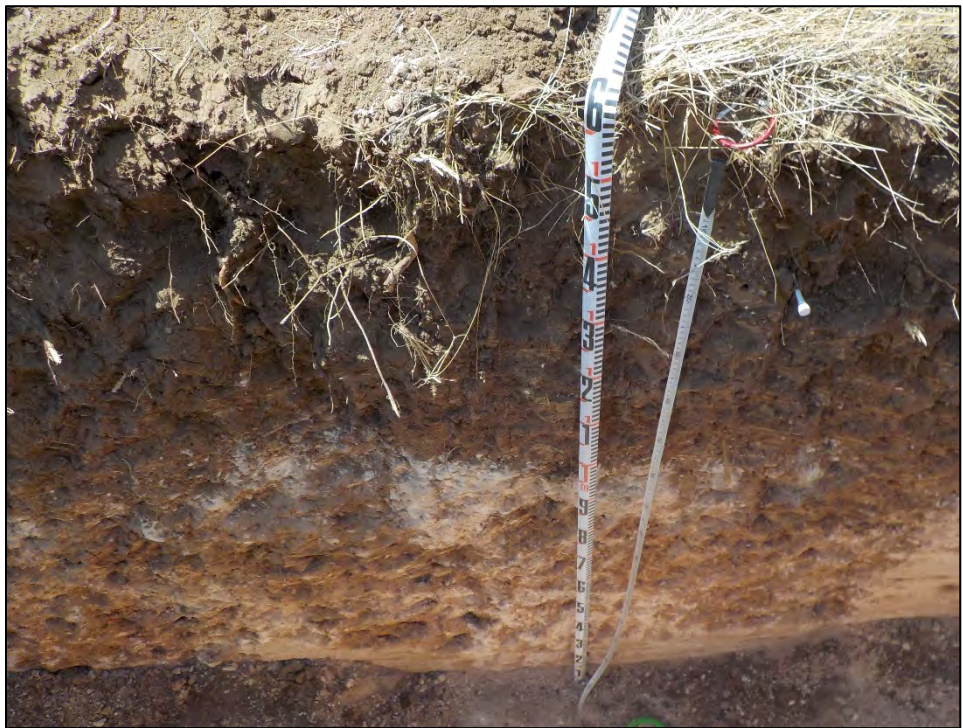
Typically, the natural stratigraphy identified in the BHTs consisted of three strata in profile (Figure 15; Attachment A, Table A-2). Stratum I, 0 to 29 cm (0 to 11.4 inches) below surface, consisted of a dark brown (10YR 3/3) clay loam. Stratum II, 29 to 70 cm (11.4 to 27.6 inches) below surface, consisted of a brown (10YR 4/3) clay loam with 2 to 3 percent white nodules, possible calcium carbonate (CaCO_3). Finally, Stratum III extended from 70 cm (27.6 inches) below surface to the base of the BHT, which varied in depth from 170 to 340 cm (66.9 to 133.9 inches) below surface and consisted of yellowish brown (10YR 5/6) clay loam with 50 to 55 percent CaCO_3 nodules. A column sample was excavated in each of the four BHTs to determine if buried cultural materials were present (Figure 16). All BHTs and column samples were negative for cultural materials.

Figure 15. BHT01 profile, view facing west.

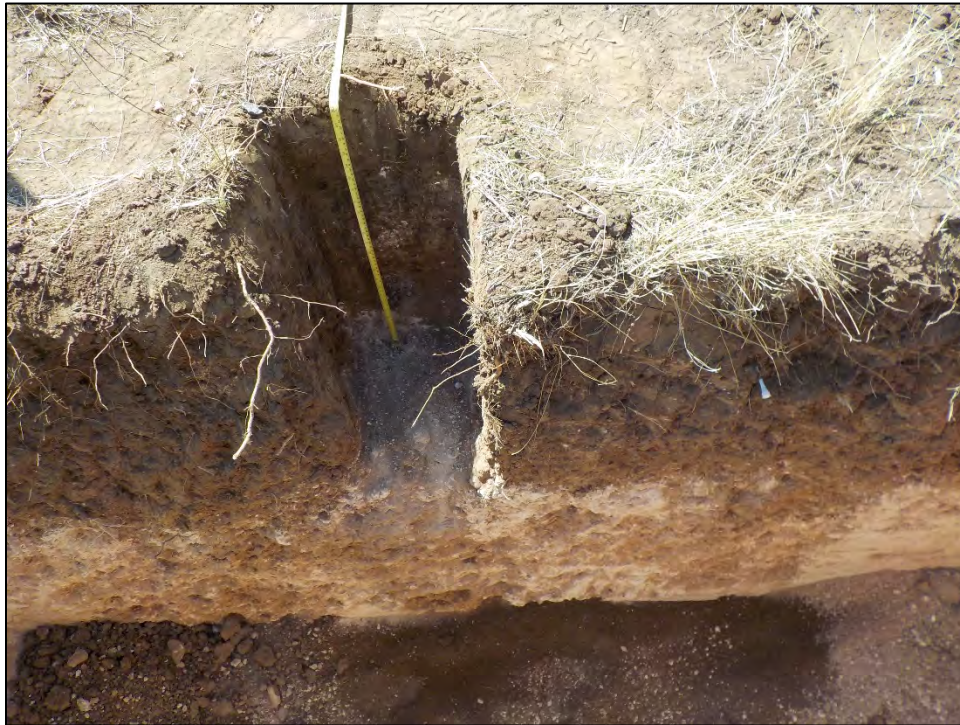
Figure 16. BHT01 column sample overview, view facing west.
