## US287 Realignment

# Archeological Survey Report

**Project Name:** US287 Realignment

**CSJ Number(s):** 0042-09-124

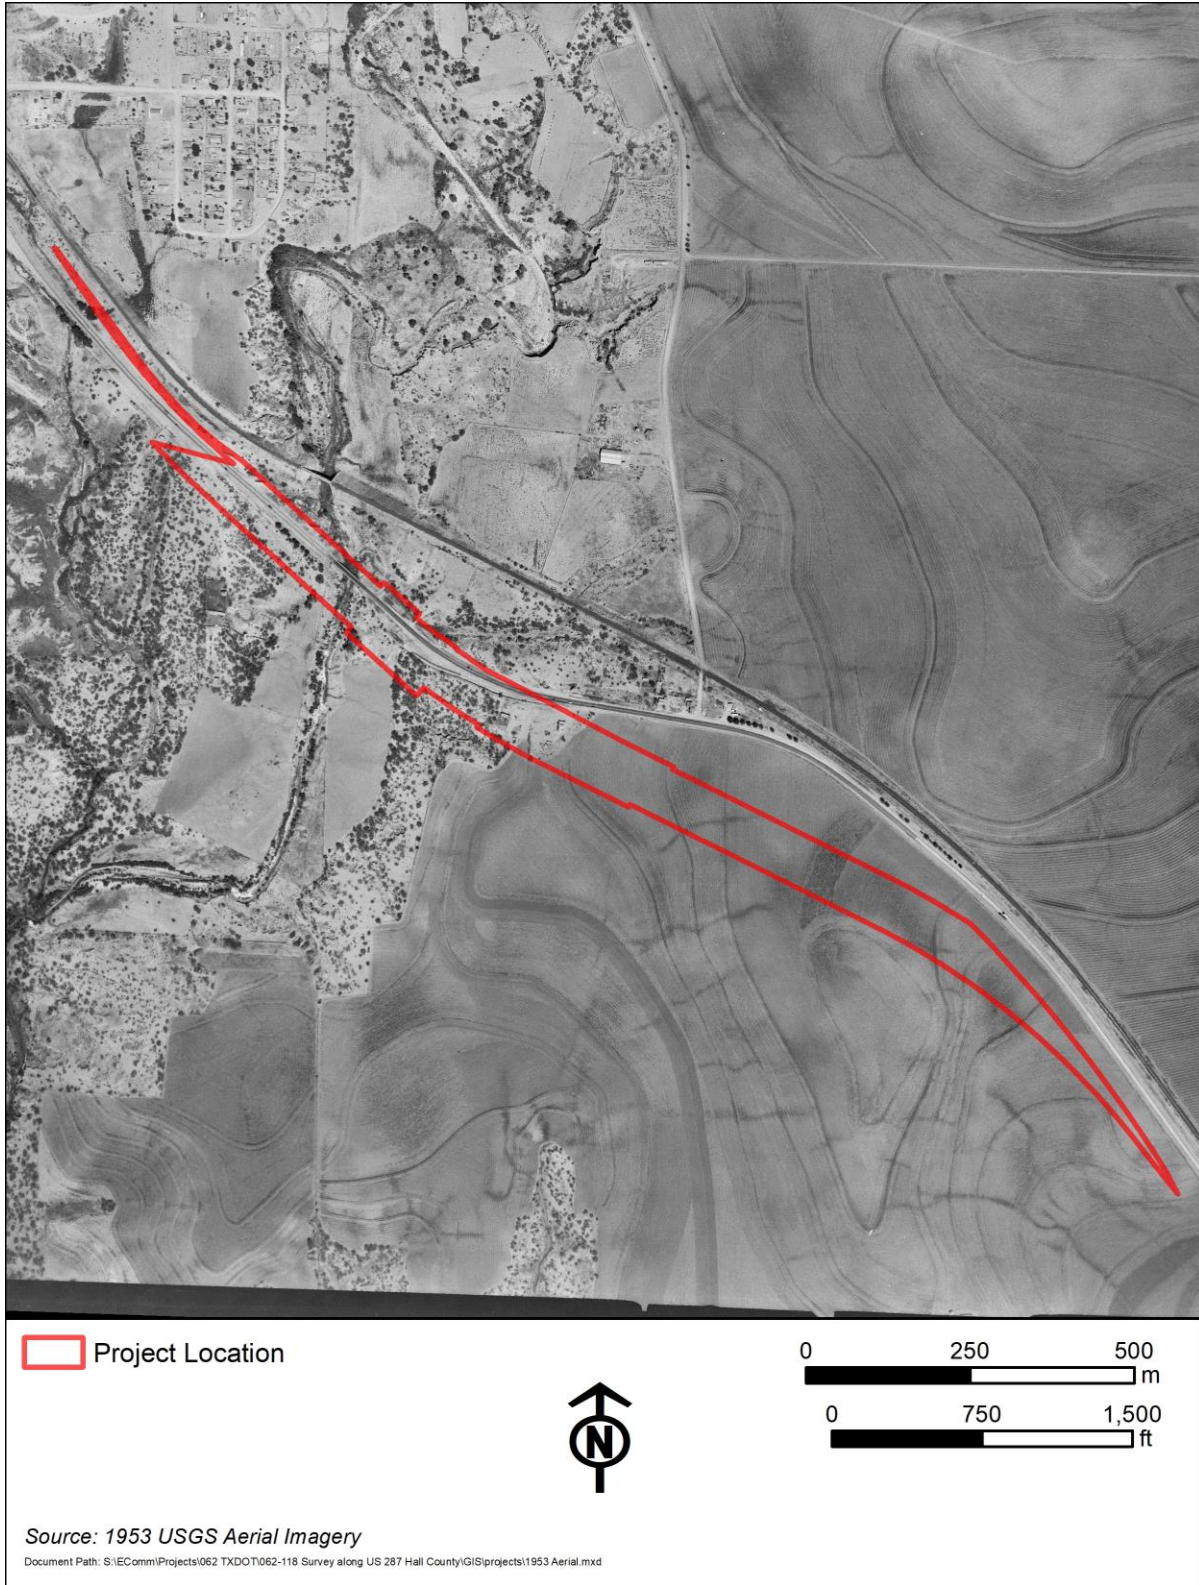
Figure 5: 1953 historic aerial image of the APE.

Historically, the land within and adjacent to the project area has been predominately rural and agricultural with minimal residential development until the mid-part of the twentieth century. A 1953 aerial photo of the project area shows few structures surrounding the US 287 corridor and within the APE (**Figure 5**). The 1963 historic topographic map identifies one structure located within the APE, and few sparse buildings to the north and south with a larger community located northwest of the APE (**Figure 6**).

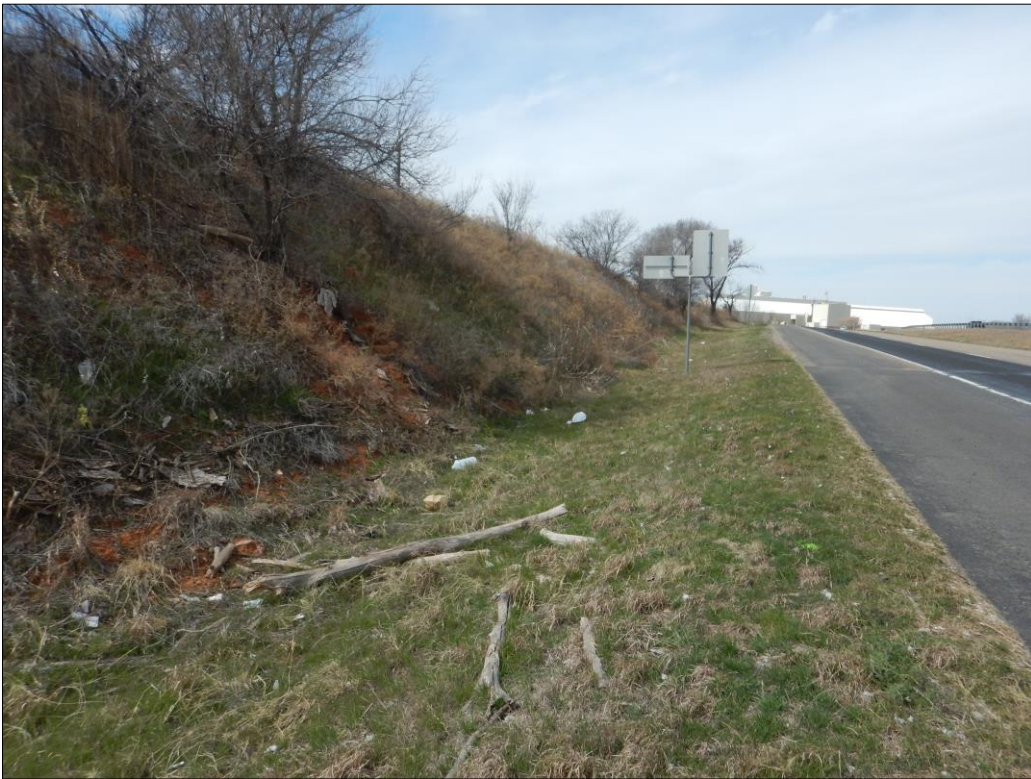
Figure 9: New ROW (left) adjacent to the current ROW (right) along US 287.

Today the land within the APE consists of agricultural cropland (**Figure 7**), storage and staging areas for farm equipment (**Figure 8**), commercial lots, ROW for US 287 (**Figure 9**) and the Burlington Northern Santa Fe Railroad.

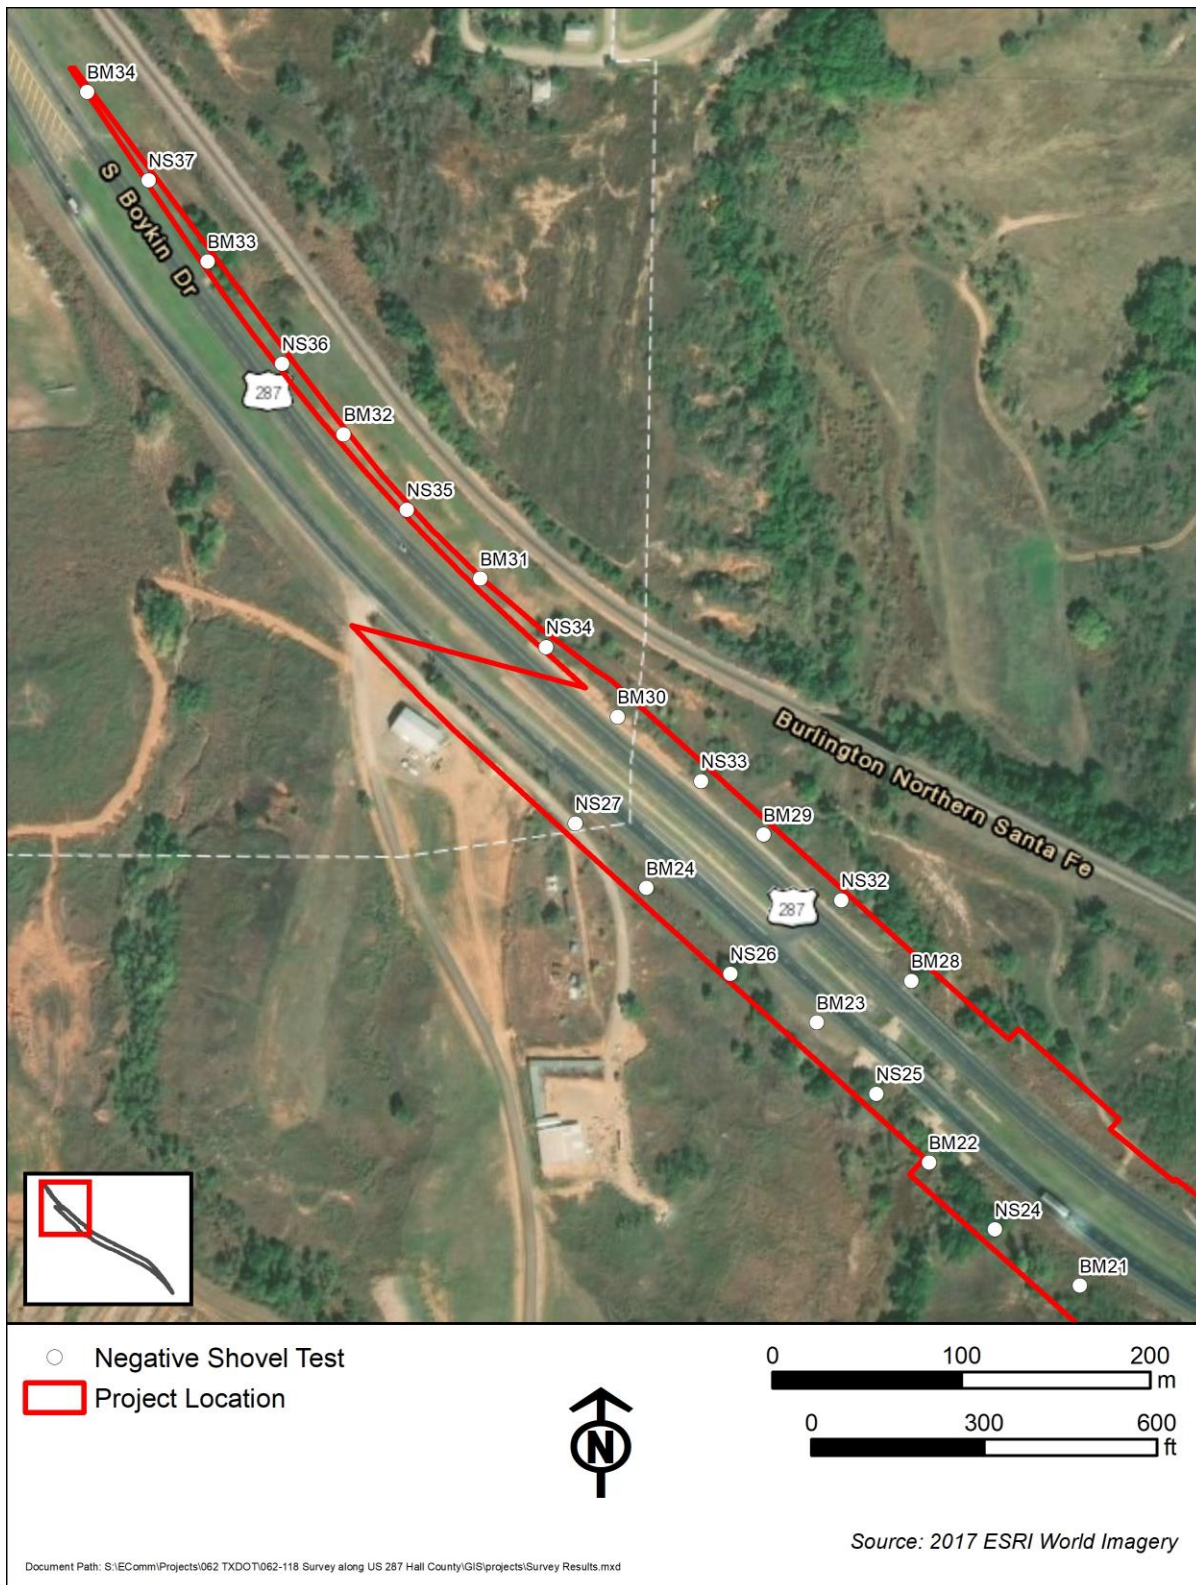
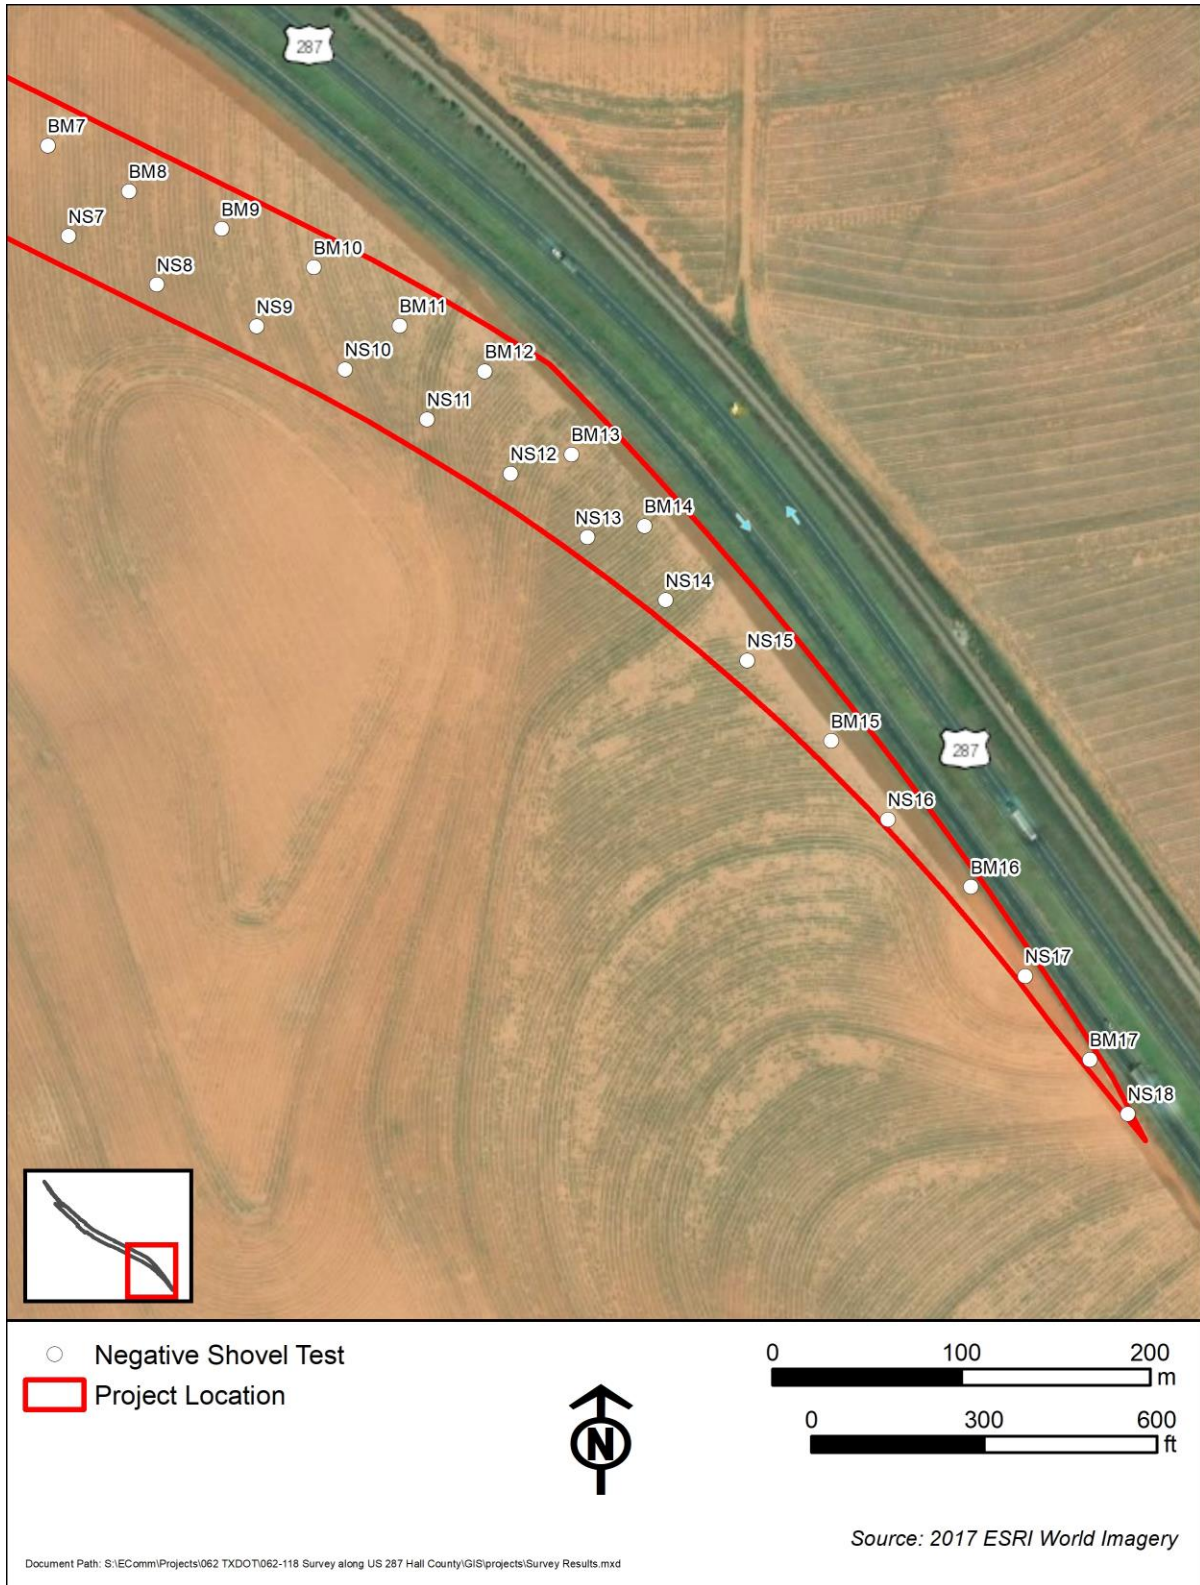
Investigators took photographs of the landscape and various disturbances to document the APE setting. A total of 71 shovel tests were excavated (**Figures 14–16**)

The survey area parallels US 287 as part of future construction improvements to the highway and consists of six parcels identified as needing survey. The APE measures approximately 32 acres of new ROW, based on project schematics provided by TxDOT, and consisted of an intensive pedestrian survey supplemented with shovel testing (**Figures 14–16**).

In total, 71 shovel tests were excavated within the survey area, all of which were negative for cultural material (Attachment A). Shovel tests were terminated upon encountering either disturbed soils, sterile clay, or compact soil. Small to medium gravels were common within shovel tests at the west and east ends of the project terminus. No archeological materials or new archeological sites were observed or recorded as part of this survey

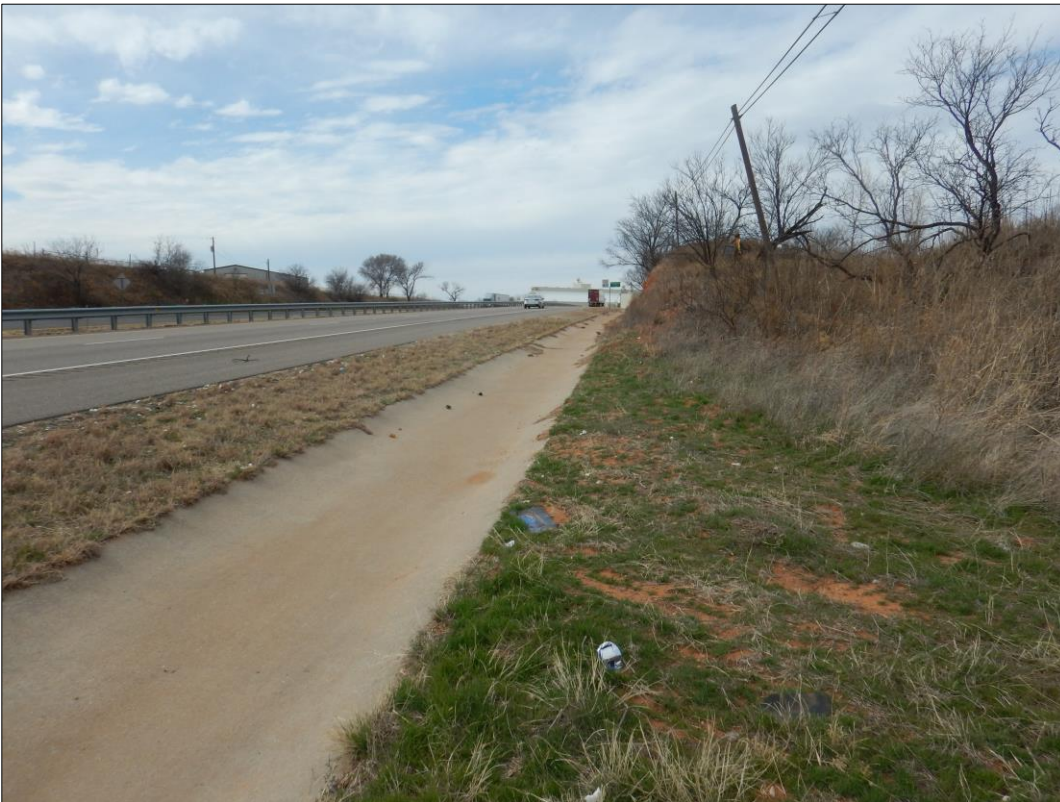
Figure 17: Concrete drainage ditch north of US 287.

The western terminus of the project area is situated between US 287 and the Burlington Northern Santa Fe Railroad ROW and exhibits terraforming, drainage ditch construction (**Figure 17**), asphalt spill-over due to railroad ROW maintenance (**Figure 18**), and disturbed, shallow soils. Approximately 300 m from the western terminus, the APE crosses over to the south side of US 287, towards a commercial complex with a paved asphalt road. The project area continues further east and declines in elevation towards Berkley Creek. Soils within this area were either heavily disturbed due to road terraforming and erosion (**Figure 19**) or inundated, such as those wetland environments noted around Berkley Creek.

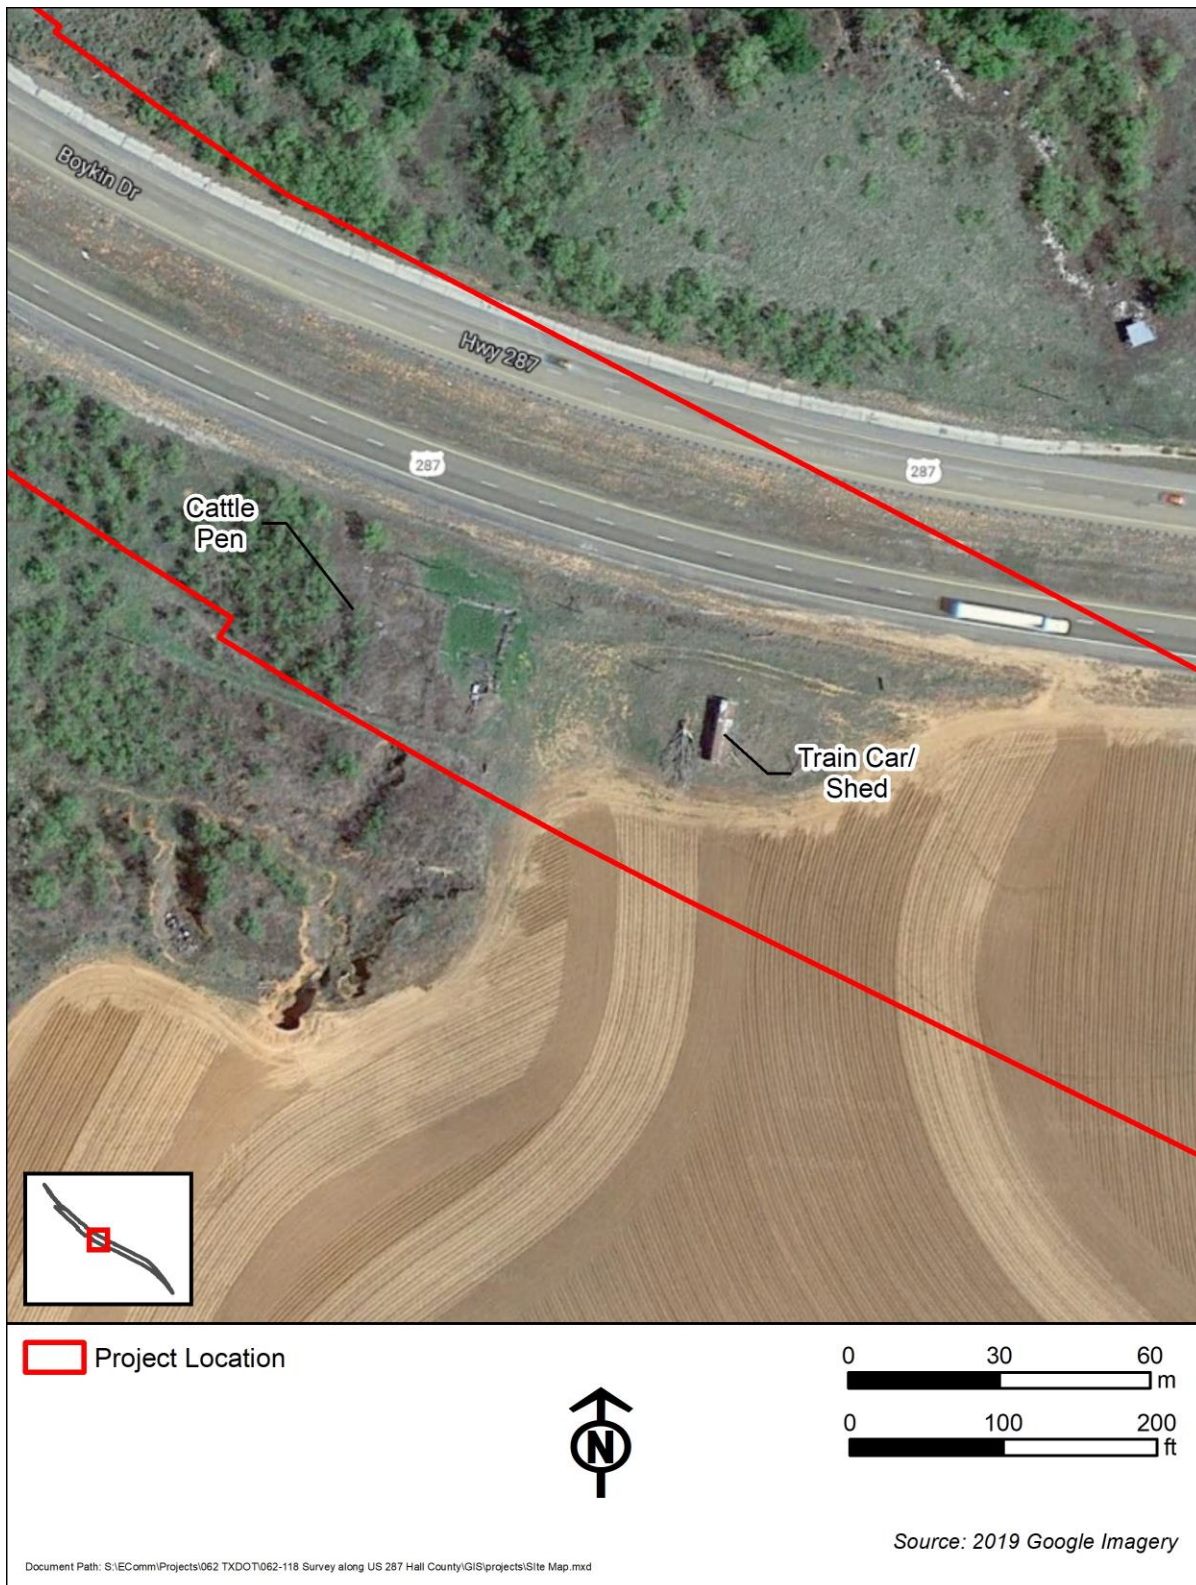
Figure 20: Cattle pen feature and associated railroad train car/shed within the APE.

East of Berkley Creek, on top of an eroding terrace, investigators identified a deteriorating cattle pen and associated railroad train car. The train car was located within the proposed ROW within Parcel 3 owned by Don and Sandra Springer (**Figure 20**). The structures lie at the edge of a plowed agricultural cotton field on a terrace. The cattle pen is approximately 20 m by 15 m and is constructed of old fencing, wood slats, cattle panel and railroad ties (**Figures 21 and 22**). A hose bibb with a red handle is located within the middle of the cattle pen. No surface artifacts were observed through the tall grasses within the cattle pen area or within any nearby shovel tests.

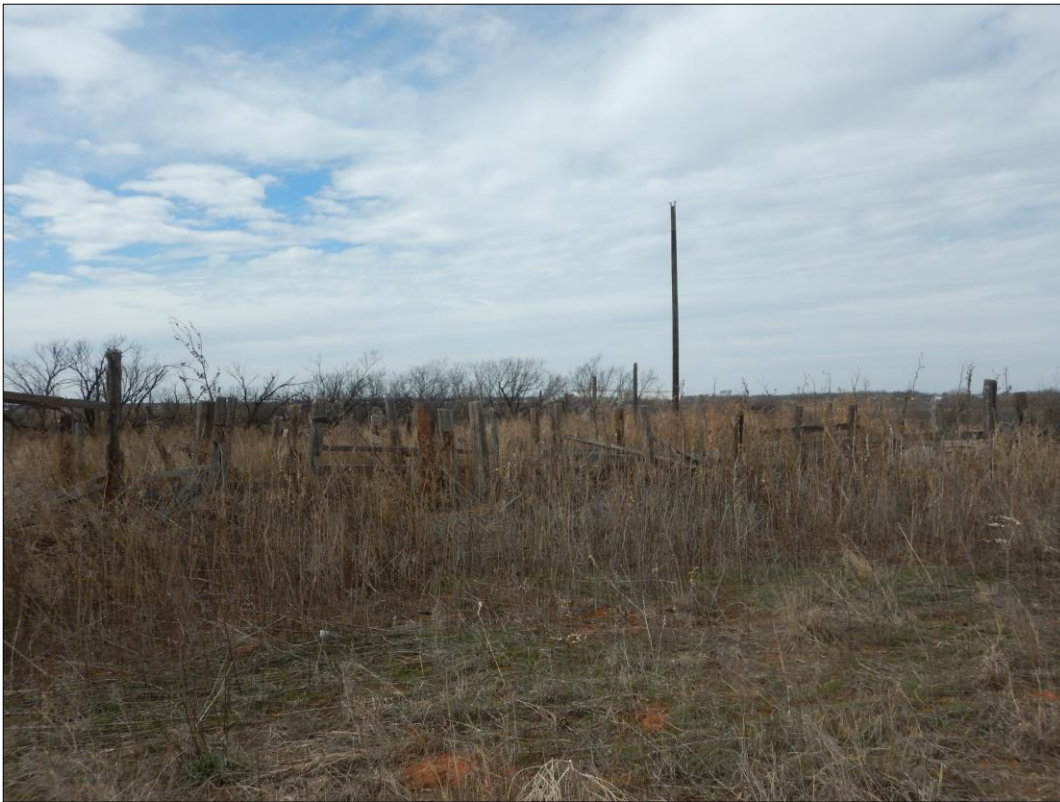
Figure 21: Cattle Pen within the APE.

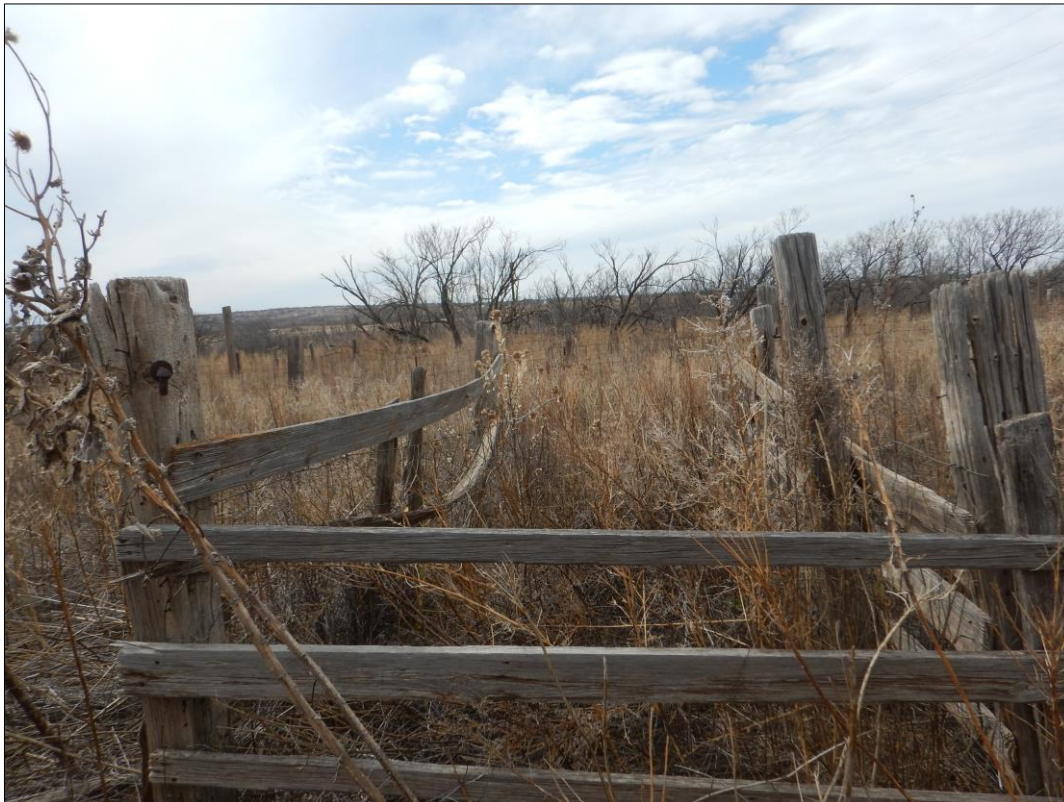
Figure 22: Close-up of cattle pen within the APE.

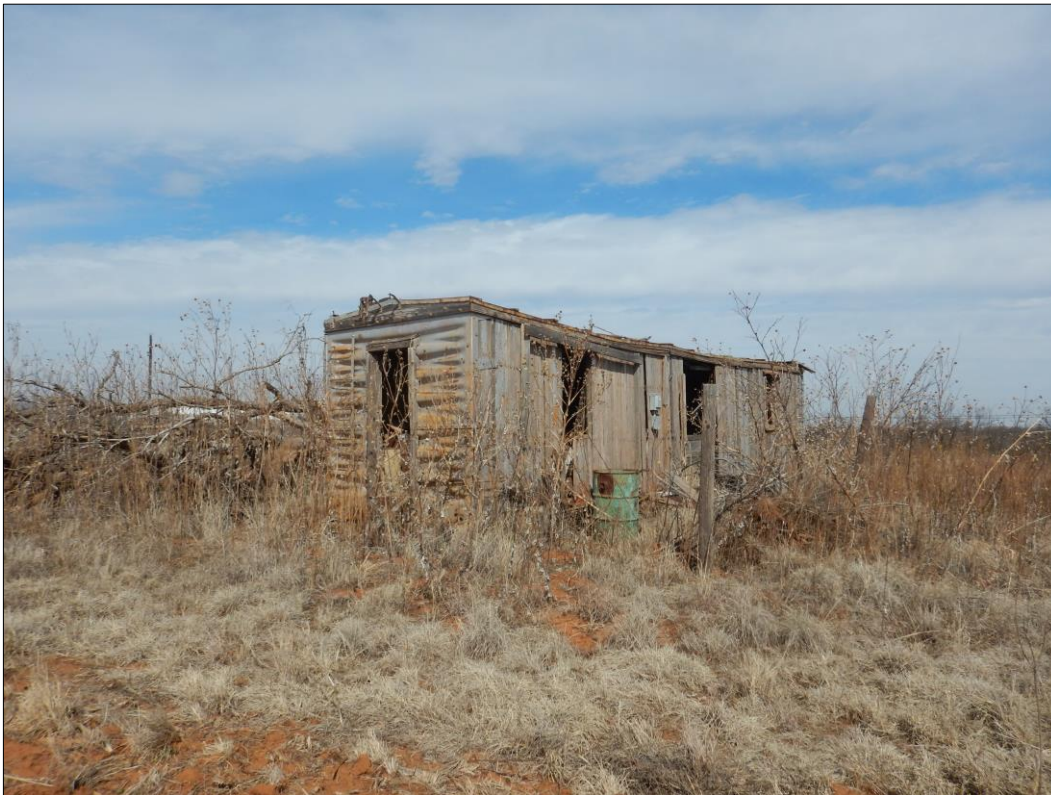
The old railroad train car lies approximately 10–15 m east of the cattle pen and has since been converted into a storage shed. The train car is approximately 6 feet wide and 15 feet long and is oriented north to south with the front of the train car facing east (**Figure 23**). It is constructed of vertical wood slats and metal ties. The inside of the train car contained spare car parts and other farm ephemera (**Figure 24**). The train car was once outfitted with electricity and hooked up to a water source as observed through remaining power lines and a water spigot to the south of the train car.

Figure 23: Railroad train car that has been converted to a storage shed.

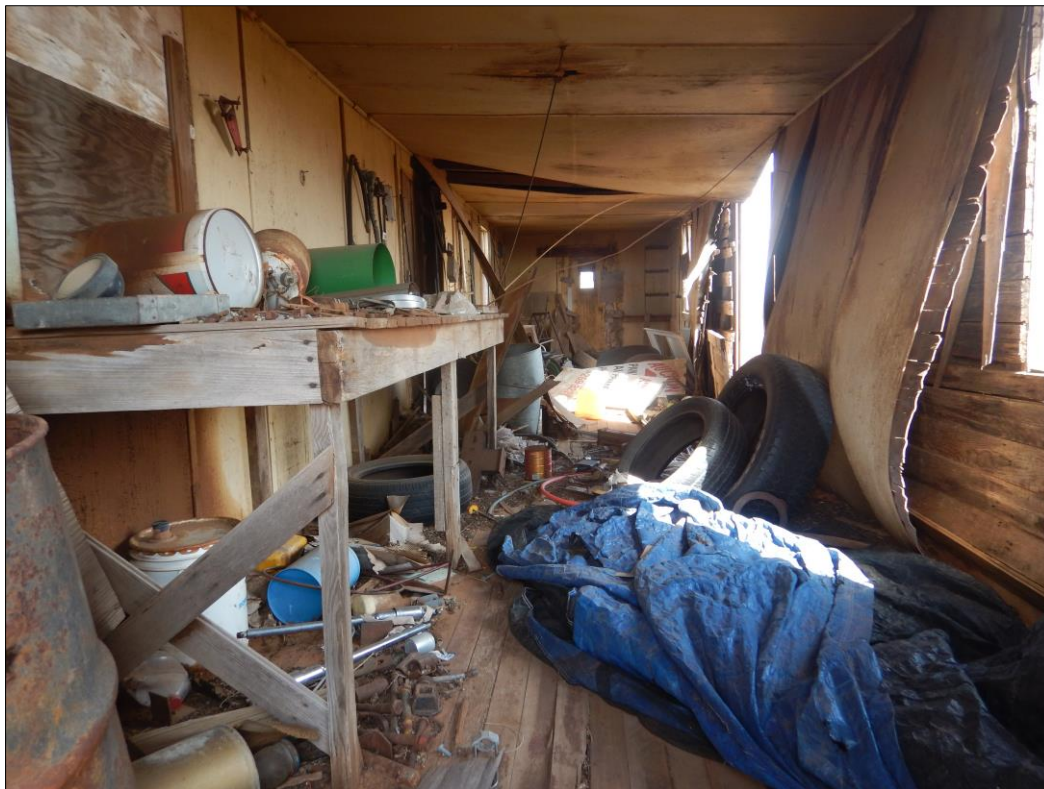
Figure 24: Contents inside railroad train car/shed.

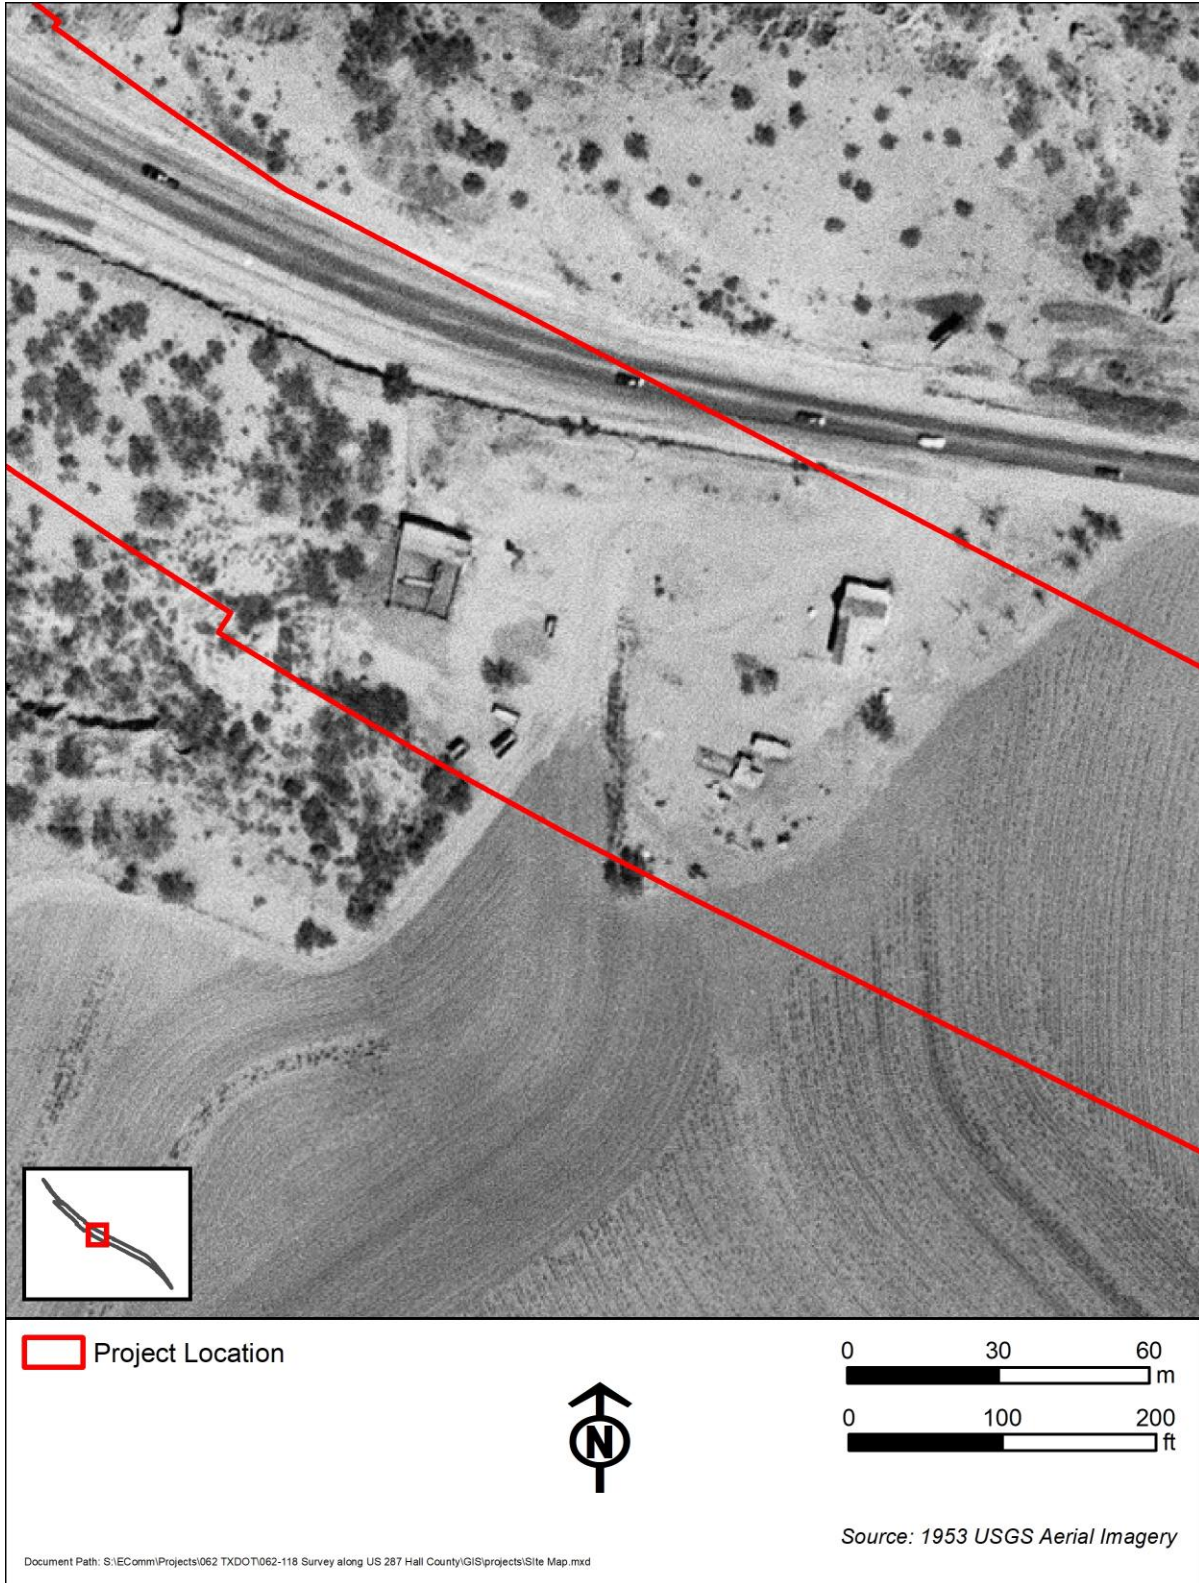
The cattle pen was initially thought to be a potential historic site with an associated railroad train car utilized for farming storage purposes. However, aerial maps from 1953 indicate the cattle pen identified at the time of survey is not the same one identified in the 1953 aerial

(Figure 25). US 287 was once a two-lane highway that expanded to a four-lane highway sometime between 1953 to 1976. The expansion of the highway demolished the standing structure observed within the 1953 aerial map and resulted in the moving of the 1953 cattle pen. Therefore, it was concluded the cattle pen and railroad train car observed at the time of survey is within the same proximity as the once existing historic structure and cattle pen, but not the same existing structures observed in the 1953 aerial. A 1976 aerial exhibits an expanded US 287; as such the cattle pen and train car likely postdate the 1970s (Figure 26). Based on the aerial maps and surface scatter of modern debris surrounding the structures, it is likely these structures are less than 50 years of age and not historic in nature.

Figure 25: 1953 aerial imagery of cattle pen and previous historic structure within the APE.

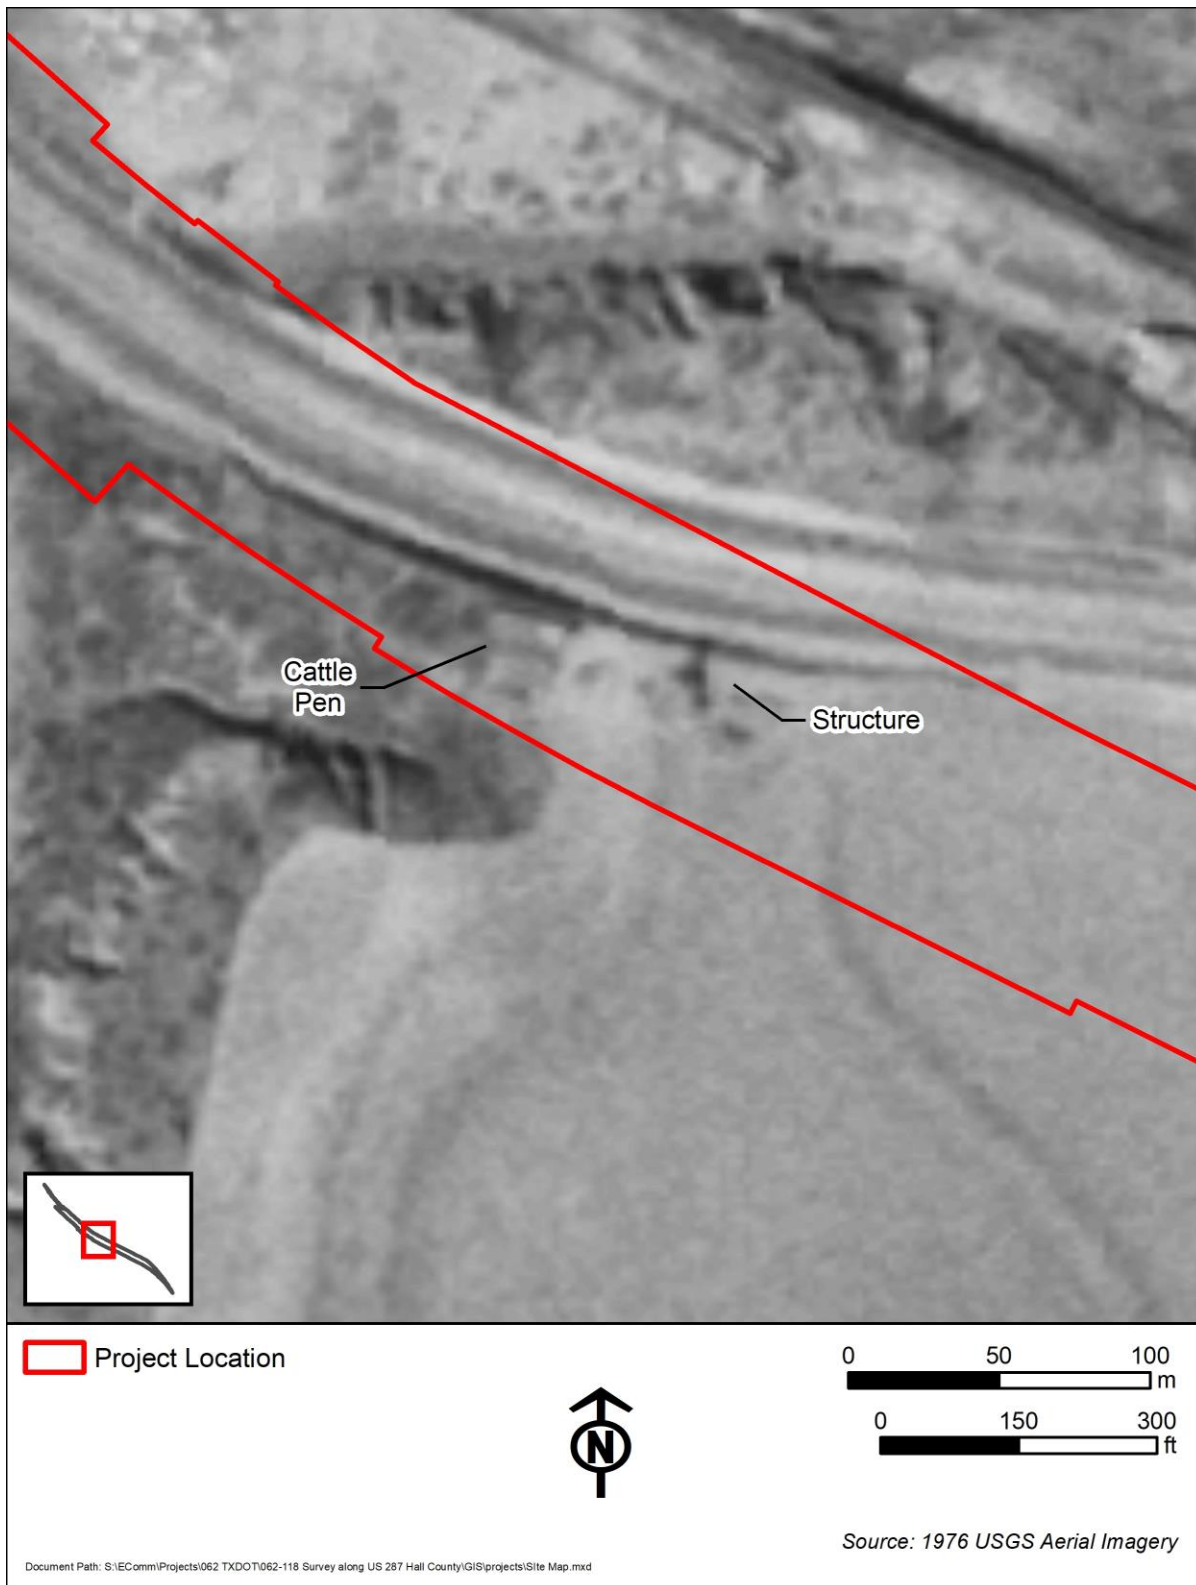
Figure 26: 1976 aerial imagery of cattle pen and possible converted railroad train car within the APE.
