**CULTURAL RESOURCES INVESTIGATION REPORT OF THE
PROPOSED BEAR CREEK SUD WATER SYSTEM IMPROVEMENTS
PROJECT IN LAVON, COLLIN COUNTY, TEXAS**

Texas Antiquities Permit Number 8745

Prepared by:
**Sphere 3 Environmental, Inc.
1501 Bill Owens Parkway
Longview, TX 75604
903/297-4673**

March 2019

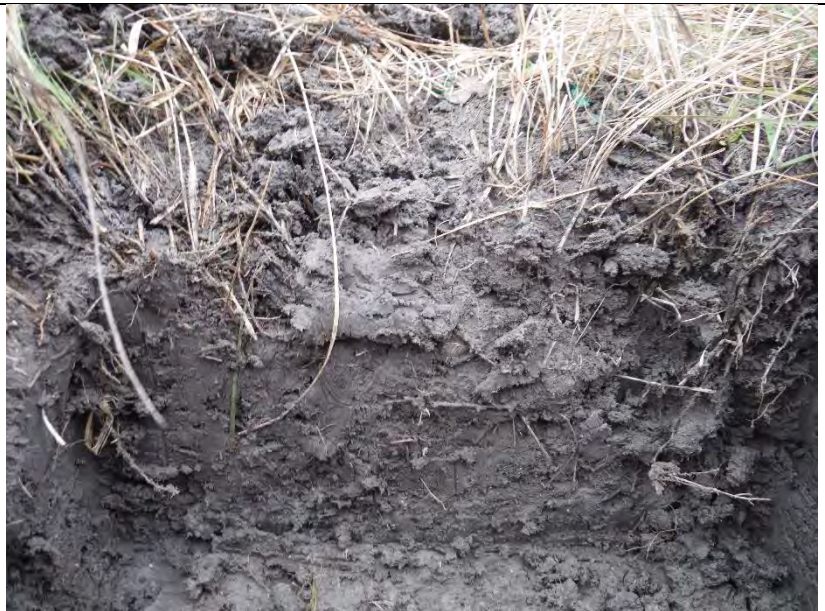
Photograph # 2

Subject: ST M1 soil
profile.
Representative of
Large Facilities
Tract soils.

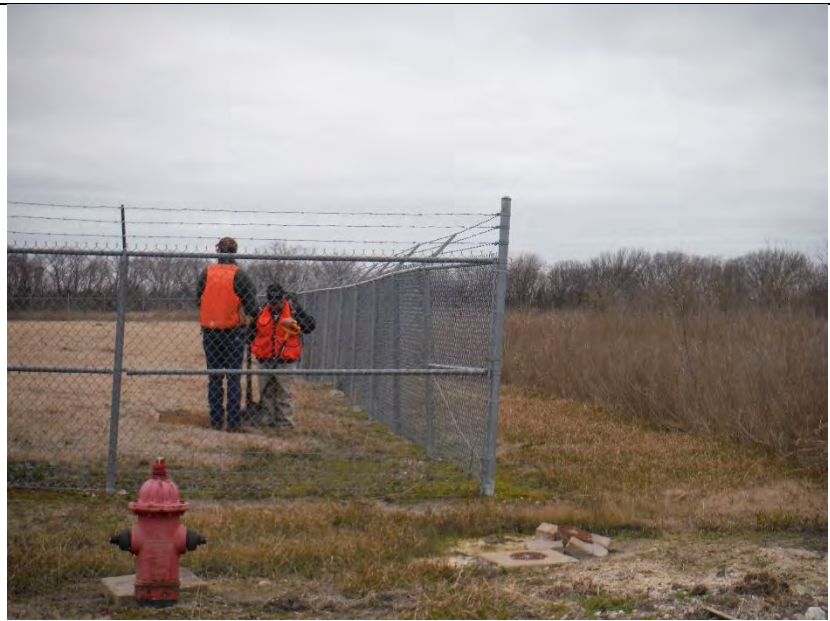
Photograph # 4

Subject: Photo of existing pump station illustrating the raised ground surface from the surrounding area. Facing west toward ST A7 and point at which waterline ties into the existing pump station.

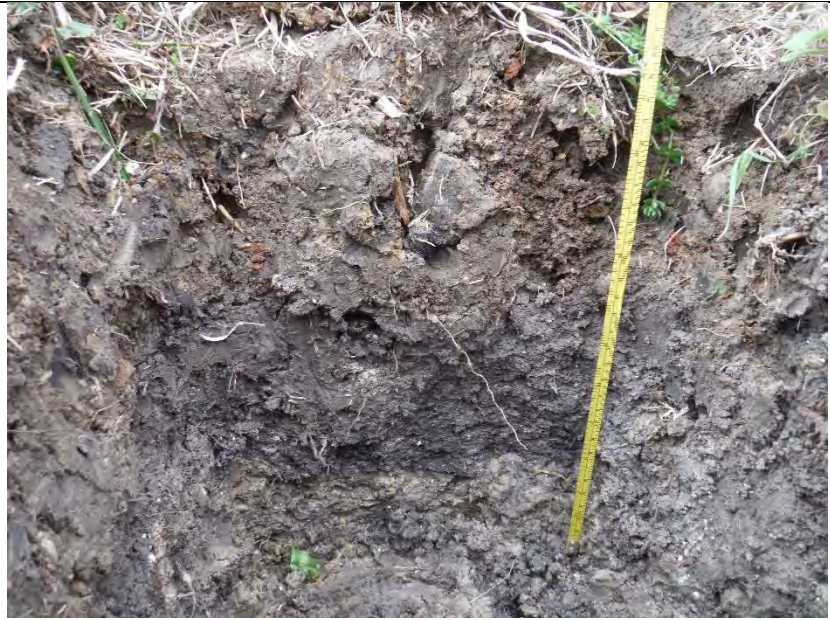
Photograph # 5

Subject: ST A7
profile. Slag and
flecks of brick
rubble visible in top
layer of profile.

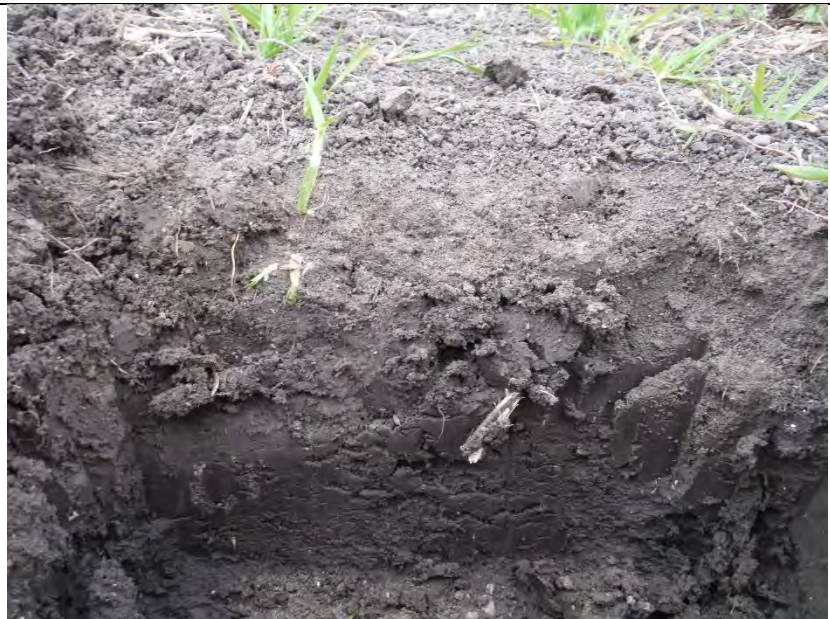
Photograph # 8

Subject: ST
[Removed] profile.
Original positive
shovel test
excavated at
41COL316.
Representative of
soils between Hwy.
78 and Moore Lane.

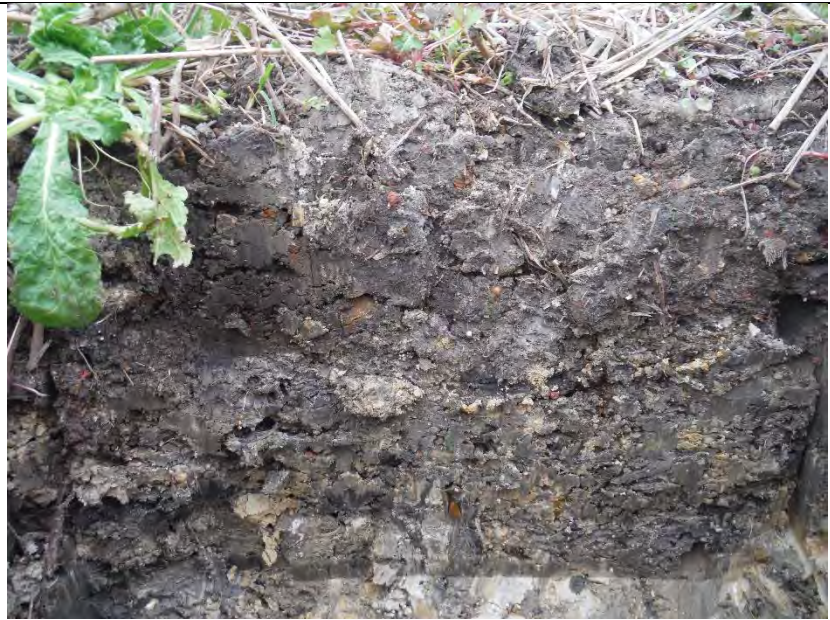
Photograph # 12

Subject: Soil profile
of ST M15.
Representative of
disturbance from
large artificial berm.
Small pieces of
brick visible in
profile.

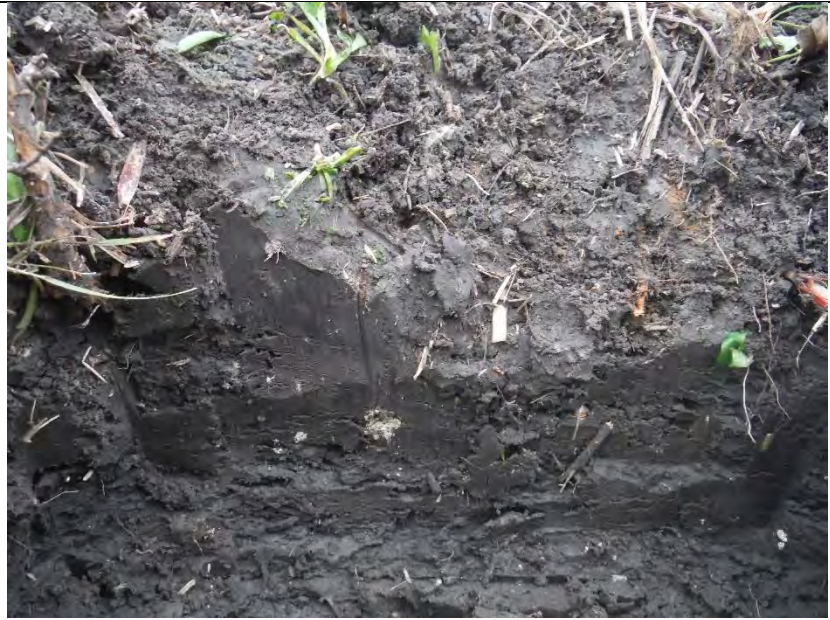
Photograph # 14

Subject: ST M27
soil profile.
Representative of
soils within fallow
field on the west
side of Hwy. 78.

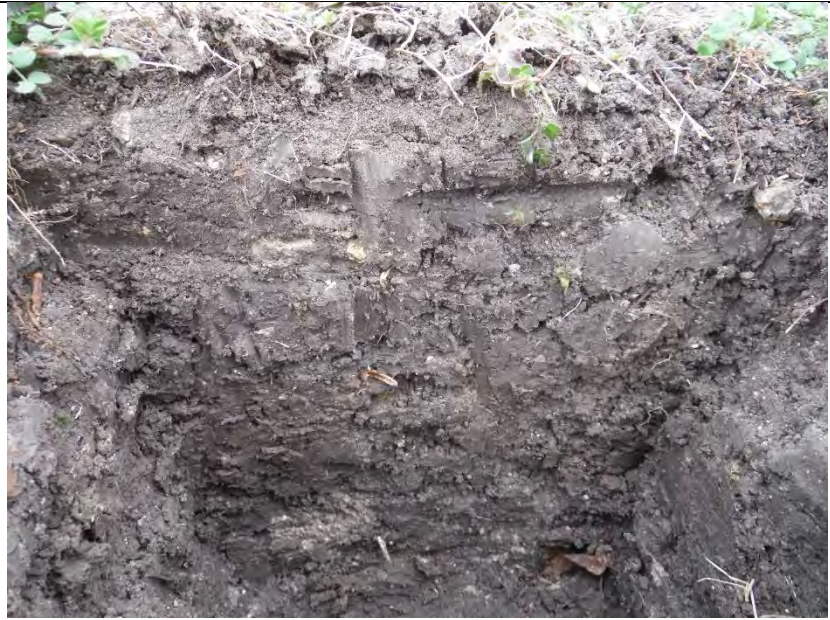
Photograph # 20

Subject: ST A21
soil profile.

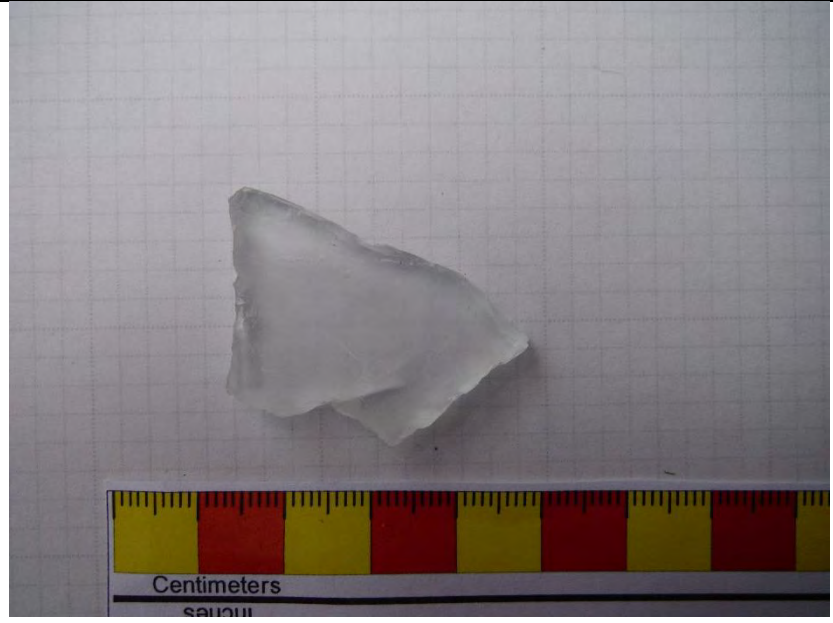
Photograph # 27

Subject: Isolated
Find 1.

Isolated Find #1 consists of a single colorless, translucent bottle glass shard, exhibiting an aquamarine tinge, located in shovel test A15, from 0 to 9 cmbs (0 to 3.4 inbs) (Appendix C: Photograph # 27). It is located along the north side of Highway 78, midway along the southwest waterline ROW segment. It is found on a flat upland terrace. This area is currently an open field situated just east of the main entrance into a large subdivision of recently constructed tract homes (Appendix C: Photograph # 6). This field likely had been extensively plowed and cultivated for agricultural purposes but has not been adversely impacted in this manner for many years. This positive shovel test was delineated only within the APE within the southwest segment of ROW easement. (Appendix A: Figure 3a).
