**CULTURAL RESOURCES MONITORING OF THE SAN ANTONIO  
WATER SYSTEM PARLAND PLACE WATER AND SEWER MAIN  
INSTALLATION PROJECT, SAN ANTONIO, BEXAR COUNTY,  
TEXAS**

**FINAL REPORT (Redacted)**

**Cultural Resources Report No. 18-015**

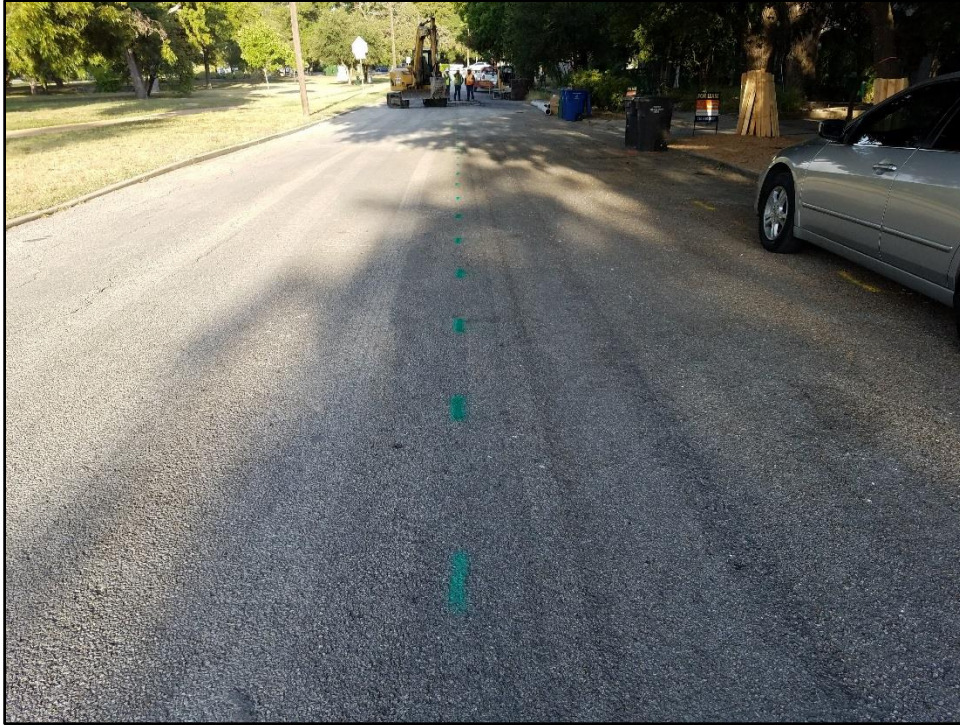
**Figure 5-1. Overview of the APE with new sewer main marked in green, facing west.**

The APE consisted of a city street flanked by residential housing to the north and a city park to the south (**Figure 5-1**). Topography along the western end of the APE was generally level, but increased in elevation by a 5-10 percent slope, roughly mid-way through the monitoring area. Monitoring investigations for the new sewer main installation were conducted from August 27–31, 2018, and investigations for the new water line were completed on October 22–25, 2018. All excavations were conducted by a backhoe, and all spoil matrix (with the exception of asphalt fragments) were deposited on the ground surface adjacent to the trench for use as backfill material.

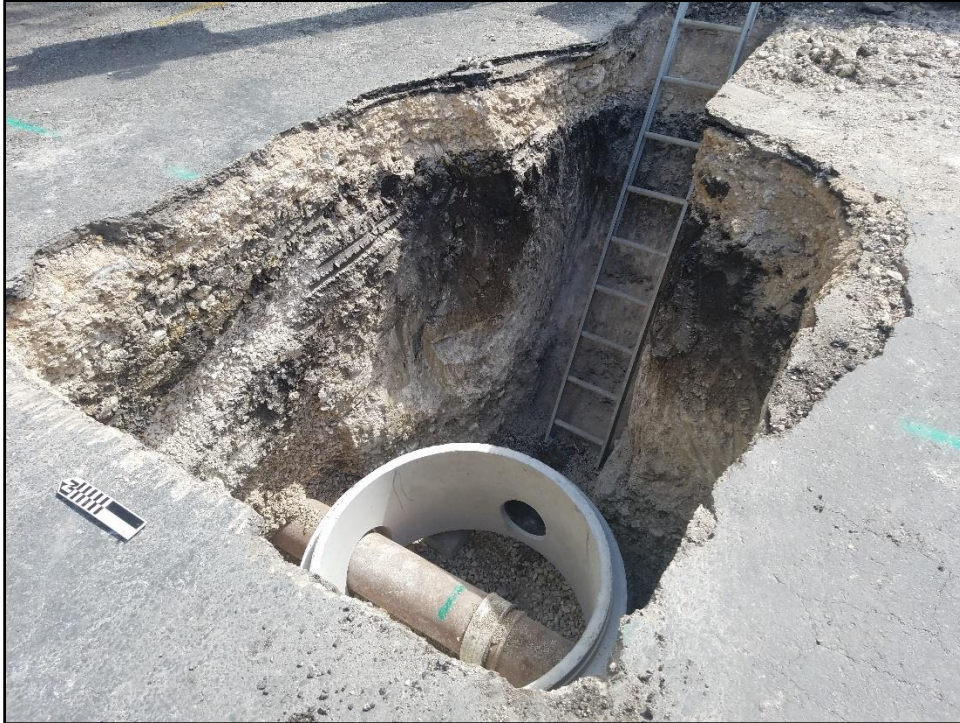
**Figure 5-3. Installation of new sewer manhole at the junction of an existing SAWS sewer main, facing northeast.**

Excavations began with the location of the existing sewer line and the installation of a new manhole at the western end of the APE (**Figure 5-2**). Excavations for the new manhole measured 5 feet by 5 feet (1.5 m by 1.5 m) and were excavated to 8 feet (2.4 m) deep in order to expose the existing SAWS sewer main (**Figure 5-3**). The existing main projected north to south and multiple existing manholes associated with the utility were observed within the immediately vicinity of the Project Area (see **Figure 5-2**). Disturbance from the existing utility was observed within the northern and southern profile walls of excavation box, but no cultural deposits or features were observed throughout the remaining profile.

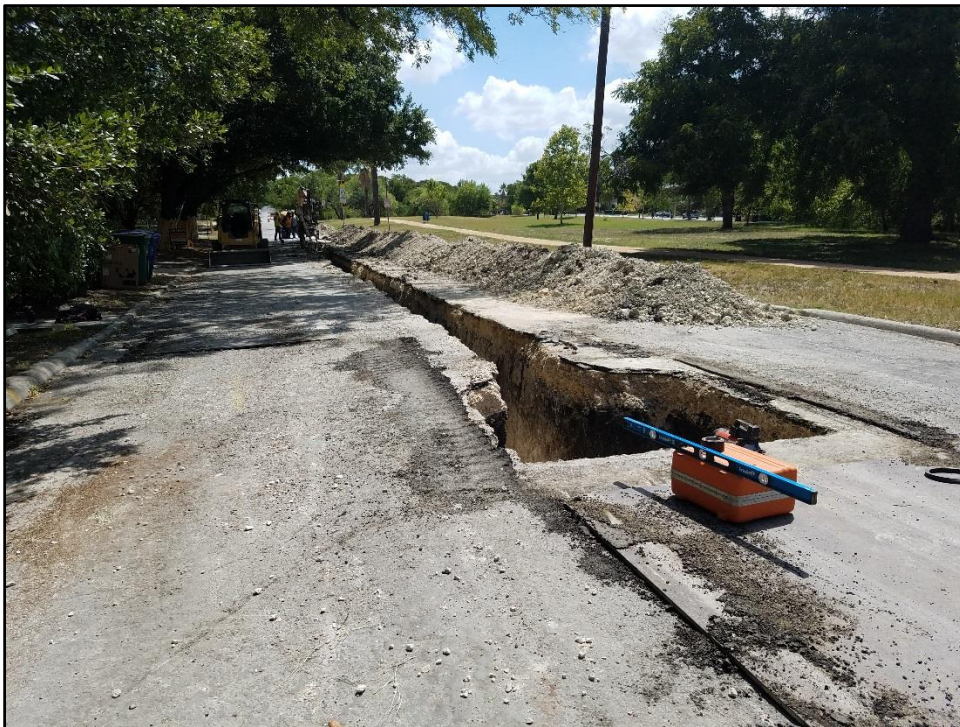
**Figure 5-4. Overview of sewer main installation excavations within the APE, facing southeast.**

Once the new manhole was installed, trenching excavations for the new sewer main projected east, toward Milton Street (**Figure 5-4**). Excavations measured 3 feet (1 m) wide and 8 feet (2.4 m) deep. The average soil profile for the western end of the APE consisted of (**Figure 5-5**):

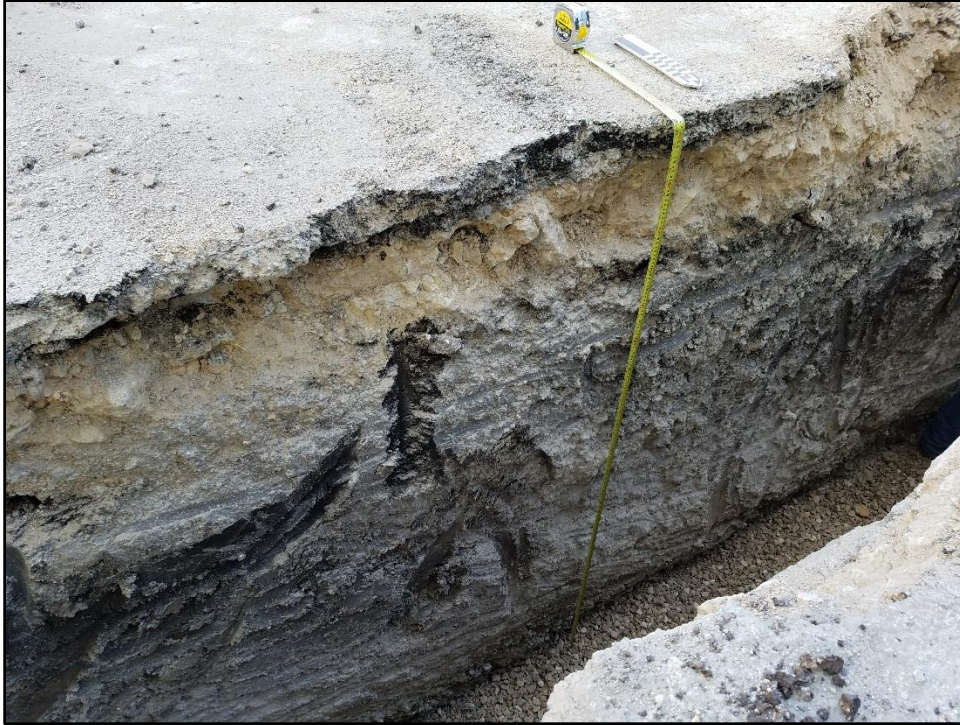
- 0 to 4 inches (0 to 10 cmbs)—asphalt;
- 4 to 12 inches (10 to 30 cmbs)— gravel construction base;
- 12 to 26 inches (30 to 65 cmbs)—10YR 2/2 very dark brown silty clay with less than 2-percent gravel inclusions;
- 26 to 45 inches (65 to 115 cmbs)—10YR 3/2 very dark grayish-brown silty clay with less than 10-percent eroding bedrock/marl;
- 45 to 72 inches (115 to 183 cmbs)—10YR 6/2 light brownish-gray silty clay with 60 to 70 percent eroding bedrock/marl;
- 72 to 91 inches (183 to 230 cmbs)—10YR 7/1 light gray eroding bedrock/marl with 80 to 90-percent friable limestone rock.

**Figure 5-5. Average soil profile at the western end of the APE during sewer main installation excavations, facing southwest.**

Soils appeared to be intact stratigraphic deposits, uniform throughout. As excavations continued east and neared the base of an upland slope, the soil profile transitioned into shallower deposits of eroding bedrock overlain with a layer of dark silty clays with chert gravel inclusions (**Figure 5-6**):

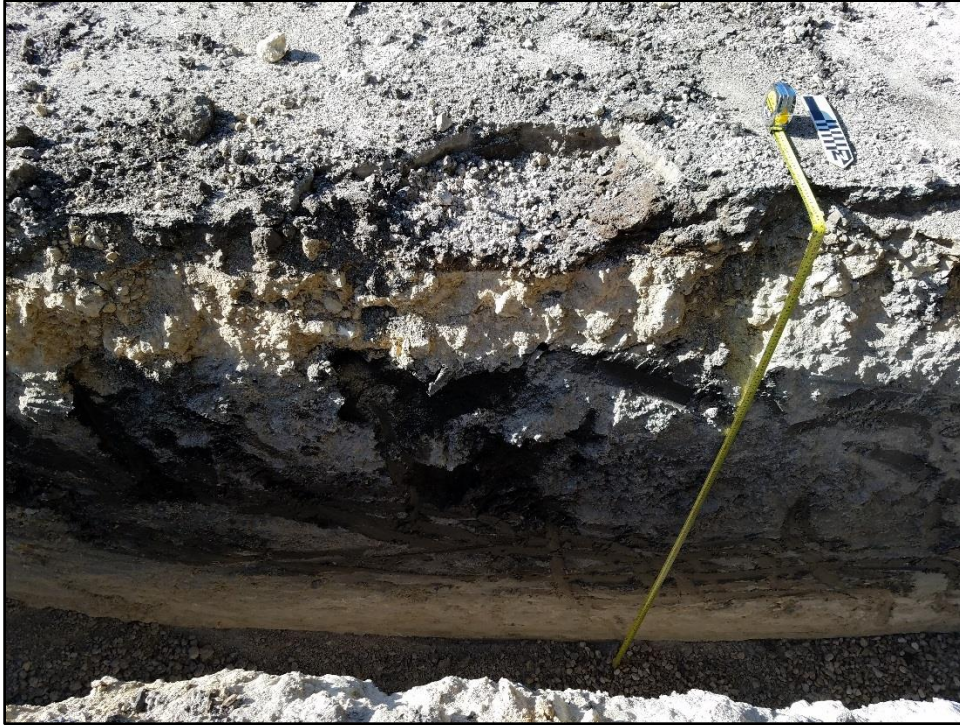
- 0 to 4 inches (0 to 10 cmbs)—asphalt;
- 4 to 12 inches (10 to 30 cmbs)—gravel construction base;
- 12 to 39 inches (30 to 100 cmbs)—10YR 3/2 very dark grayish-brown silty clay with less than 2-percent chert gravel inclusions;
- 39 to 63 inches (100 to 160 cmbs)—10YR 4/1 dark gray clay with 5-percent calcium carbonate nodules and 5 to 10-percent chert gravel inclusions;
- 63 to 67 inches (160 to 170 cmbs)—10YR 6/2 light brownish-gray clay with 60 to 70-percent eroding bedrock/marl;
- 67 inches to 91 inches (170 to 230 cmbs)—10YR 7/1 light gray eroding bedrock/marl, no friable limestone rock observed.

**Figure 5-6. Average soil profile at the center of the APE during sewer main installation excavations, facing south.**

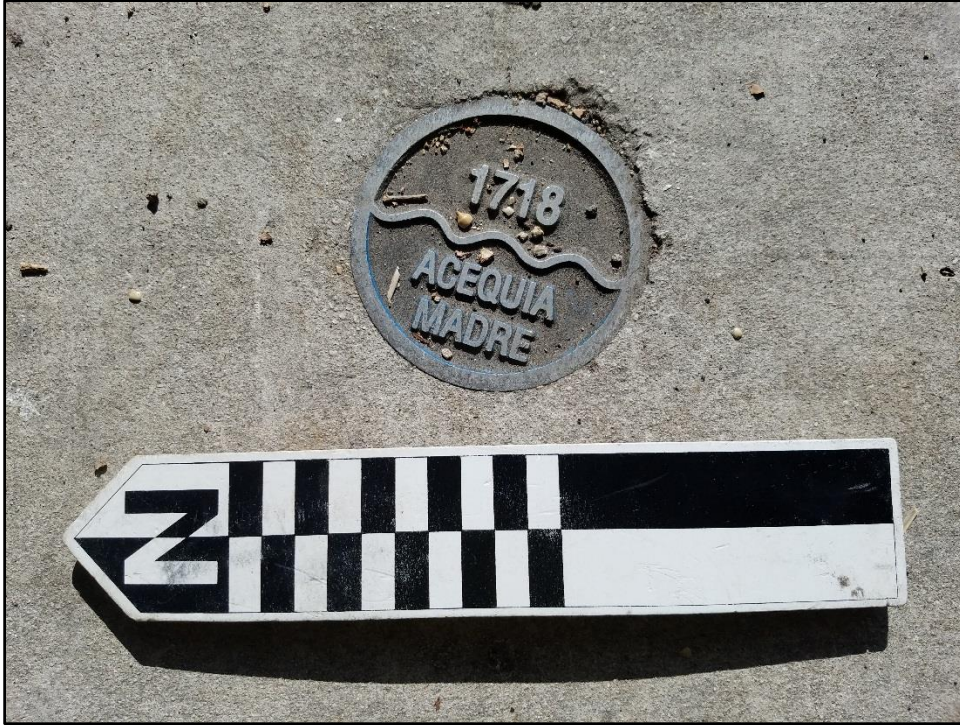
As soils transitioned near the center of the APE, excavations approached the projected alignment of the *acequia*. Field documentation observed a metal medallion set into the sidewalk near the residential dwelling at 135 Parland Place (**Figure 5-7**). The medallion was engraved with “1718/*Acequia Madre*”, with a water line symbol illustrated (**Figure 5-8**). The orientation of the water line (approximately a 220-degree orientation) appeared to correlate with the projection of the *acequia* as depicted on the COSA OHP *Acequia* Maps. However, sewer main excavations within the vicinity of the projection did not identify any evidence of the *Acequia Madre de Valero*.

Figure 5-7. Acequia medallion set in the northern sidewalk of the Parland Place ROW.

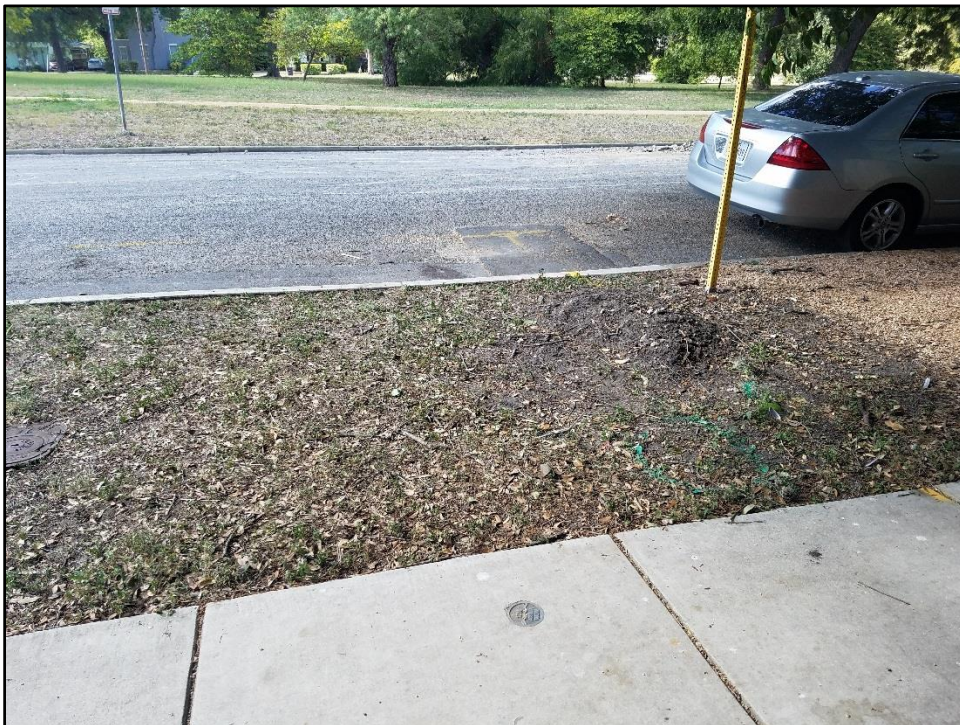
Figure 5-8. Overview of APE at its intersection with the projected alignment of the acequia. Note the medallion set into the sidewalk in foreground, facing south-southwest.

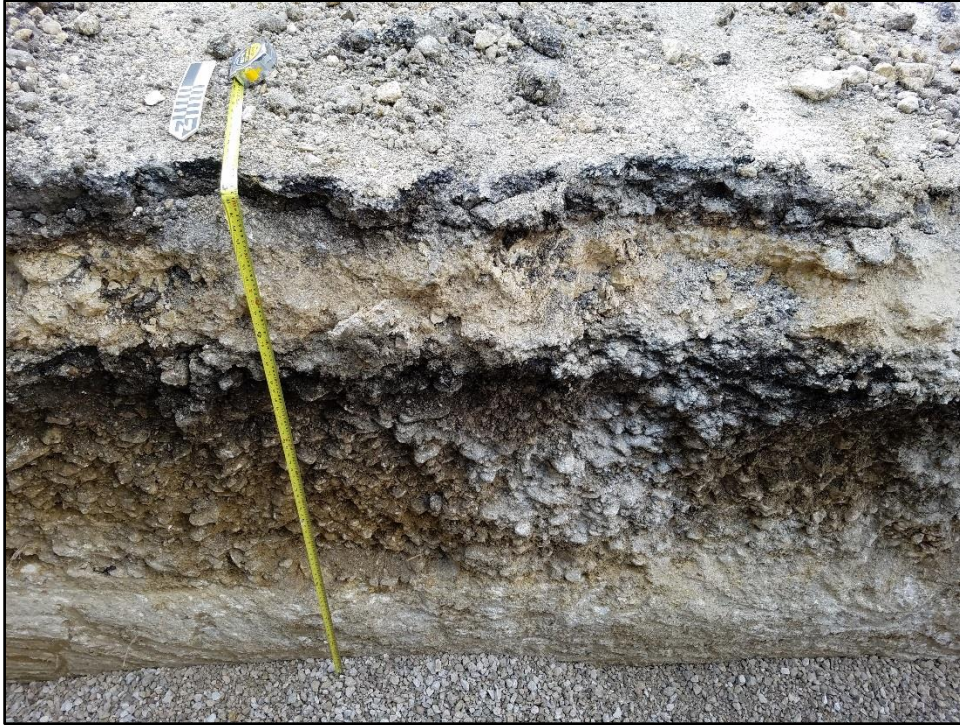
- 0 to 4 inches (0 to 10 cmbs)—asphalt ;
- 4 to 12 inches (10 to 30 cmbs)—yellow gravel construction base;

**Figure 5-9. Average soil profile at the eastern end of the APE during sewer main installation excavations, facing south.**

- 12 to 39 inches (30 to 100 cmbs)—10YR 3/2 very dark grayish-brown clay loam with less than 2-percent calcium carbonate inclusions and 20 to 30 percent chert gravel/cobble inclusions;
- 39 to 51 inches (100 to 130 cmbs)—10YR 4/2 dark grayish-brown clay loam with less than 2-percent calcium carbonate inclusions and 40 to 50 percent chert gravel/cobble inclusions;
- 51 to 63 inches (130 to 160 cmbs)—10YR 3/4 dark yellowish-brown clay loam with 60 to 80 percent chert gravel/cobble inclusions;
- 63 to 65 inches (160 to 165 cmbs)—10YR 5/6 yellowish-brown sandy loam with 80 to 90 percent chert gravel/cobble inclusions;
- 65 to 91 inches (165 to 230 cmbs)—10YR 6/1 gray, 10YR 8/1 white, and 10YR 7/6 yellow mottled clay.

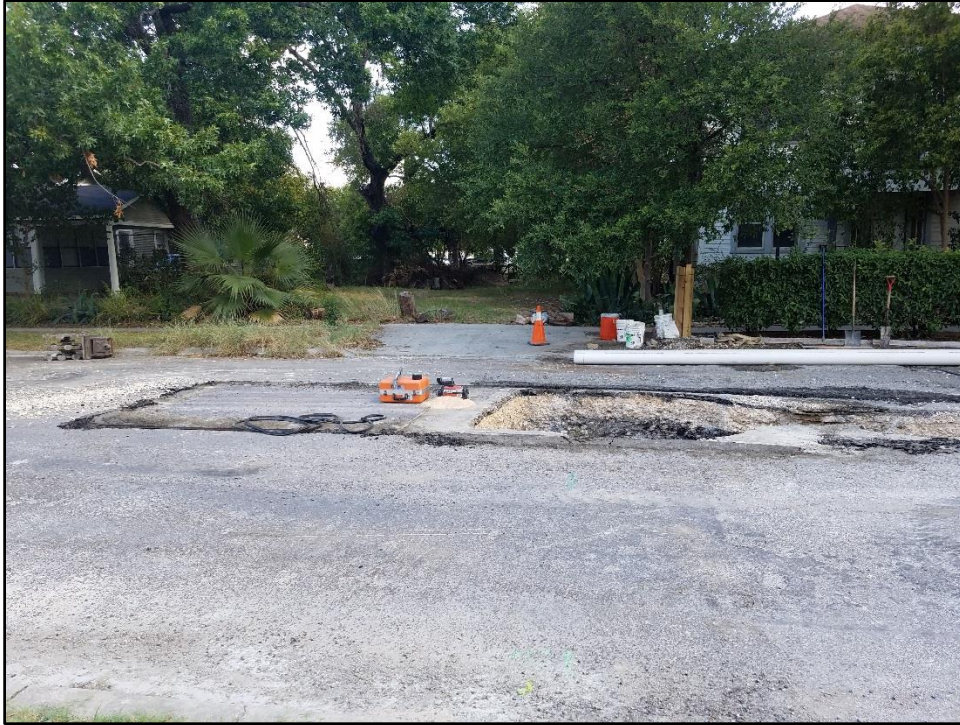
Overall, no cultural deposits or features of any temporal affiliation were observed during the new sewer main installation. Furthermore, no subsurface evidence of the *Acequia Madre de Valero* was observed during trenching excavations. However, field observations of the general Project Area identified a grassy ditch to the northwest of the APE, within an empty residential lot (**Figure 5-10 and 5-11**). The ditch measured between 6.5 to 8 feet (2 and 2.5 m) wide, approximately 12 to 18 (30 to 46 cm) deep, and

**Figure 5-10. Overview of grassy ditch projection in relation to APE and new sewer main manhole installation, facing north.**

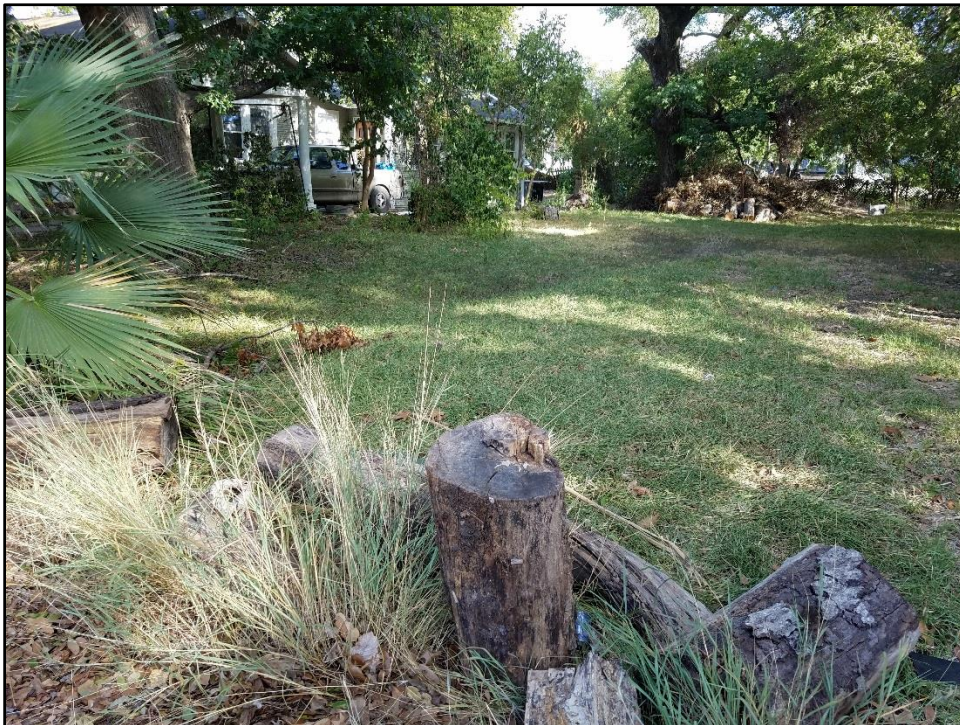
**Figure 5-11. Overview of grassy ditch located within an empty lot to the northwest of the APE, facing northwest.**

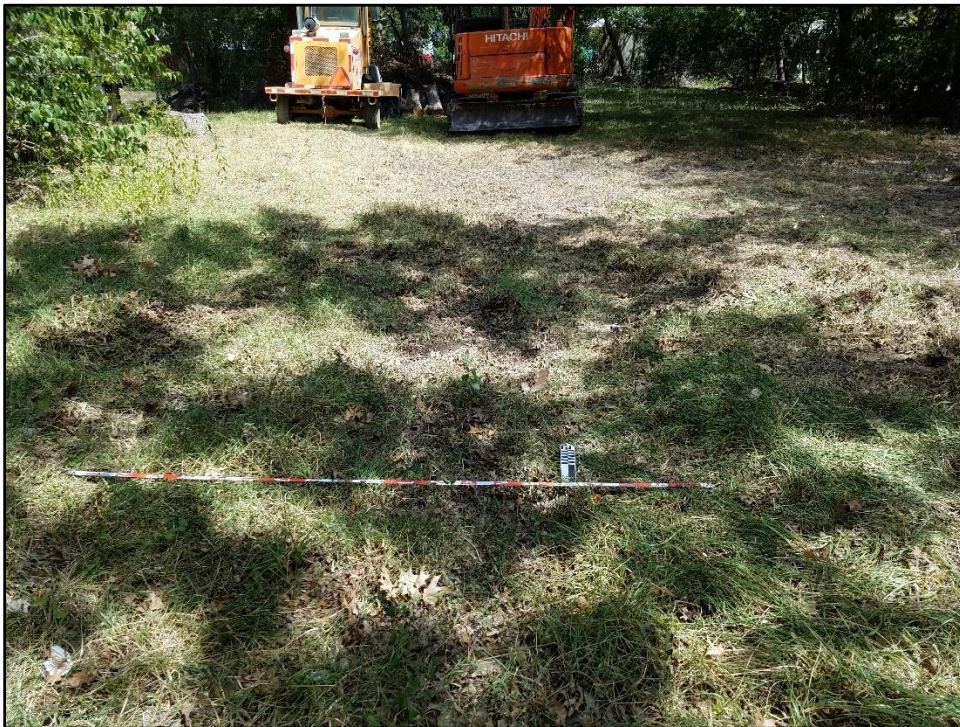
projected at a 186-degree orientation (**Figure 5-12**). A single, small palm tree is located within the ditch at its intersection with the Parland Place ROW. No evidence of the ditch was observed south of the Project Area or within any of the residential lots along the Funstone Place ROW, south of the APE. Observation of the lot to the north of the grassy ditch, along Elmhurst Avenue, also showed evidence of the ditch; however, the northern lot appears to be heavily modified from parking lot construction and building demolition. At the time of the sewer main investigations, it was unclear if the grassy ditch served as an atypical drainage ditch, or if it represented a remnant of the *Acequia Madre de Valero*.

**Figure 5-12. Overview of grassy ditch to the northwest of the APE, facing north.**

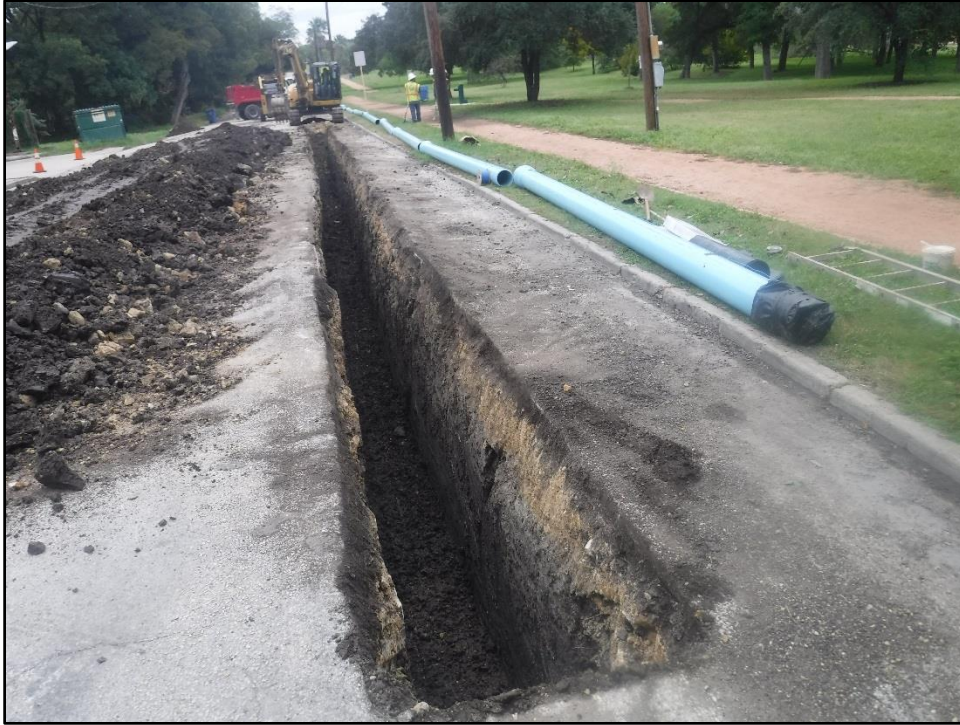
In order to determine if the ditch observed to the north of the Project Area was a remnant of the *Acequia Madre de Valero*, an additional 50-foot (15 m) section of water main excavations immediately west of the APE was also monitored for cultural resources. Water main excavations within the extended APE were monitored from October 22–26, 2018, beginning east of the Broadway Street–Parland Place intersection. Trenching was conducted south of the new sewer main alignment, along the southern Parland Place ROW, and measured 2 feet (61 cm) wide and 5 feet (1.5 m) deep (**Figure 5-13**).

**Figure 5-13. Overview of water main installation excavations along the southern boundary of the Parland Place ROW, facing east-southeast.**

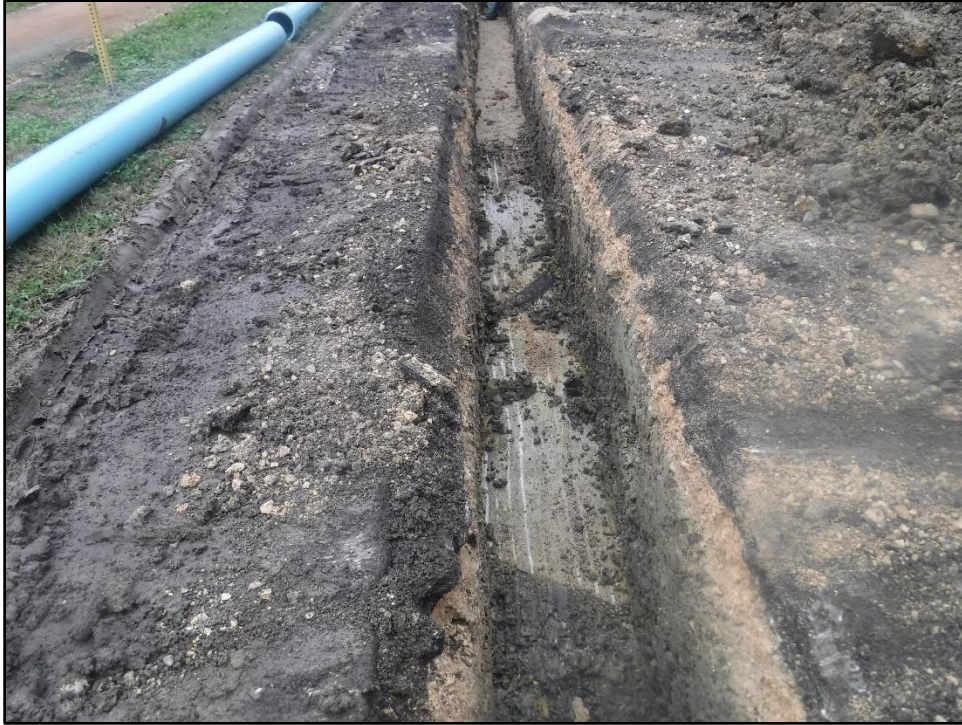
Monitoring investigations observed heavily disturbed soils at the western end of the extended APE, associated with underground utility installations, including existing sewer, water, and storm drain easements. A 33 foot (10 m)-long concrete slab was also observed at 4.5 feet (1.4 m) below surface in the area where the grassy ditch projection would have intersected the new water main excavations (**Figure 5-14**). It is unclear if the concrete slab is the structural remains of a building that may have once occupied the area prior to the construction of the Parland Place ROW (circa 1912–1951), or is associated with an existing underground utility. The fine-grain, grey concrete construction matrix suggests a modern-construction and supports the theory of an existing underground utility.

**Figure 5-14. Modern concrete slab observed within the extended APE monitoring area, facing west.**

Water main excavations were conducted south of the new sewer main alignment, along the southern Parland Place ROW. Soils at the western end of the extended APE were heavily disturbed from the installation of underground utility installations, including existing sewer, water, and storm drain easements. A 33 foot-(10 m) long concrete slab was observed at 4.5 feet (1.4 m) below surface in the area

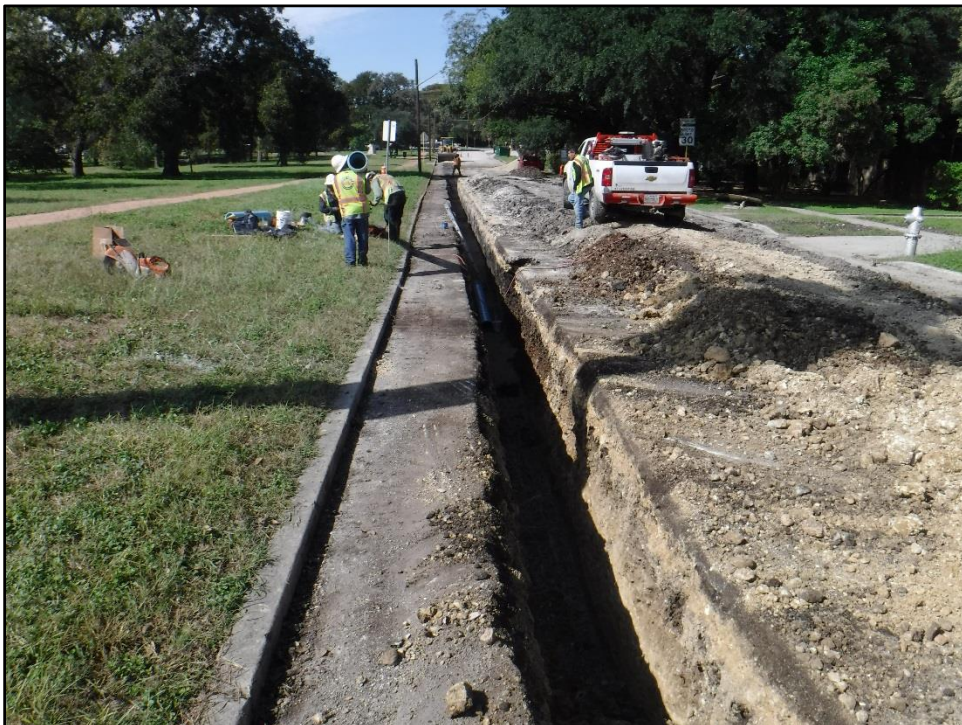
Continued monitoring investigations for the remaining APE observed the same soil stratigraphy as that was observed for the sewer main installation excavations (**Figure 5-15**). Overall, no cultural deposits or features of any temporal affiliation were observed during the new water main installation. Furthermore, no subsurface evidence of the *Acequia Madre de Valero* was observed.

**Figure 5-15. Overview of water main installations within the APE, facing west.**
