# ARCHAEOLOGICAL MONITORING OF THE DEMOLITION OF A HISTORIC CISTERN UNASSOCIATED WITH THE STEGMAN BUILDING, BROWNSVILLE, CAMERON COUNTY, TEXAS

## FINAL LETTER REPORT (Redacted)

Texas Antiquities Committee Permit Number 7649

May 10, 2018

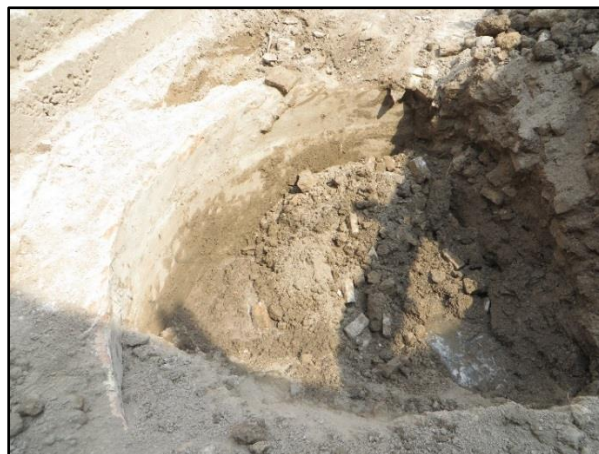
In 1911 during the construction of the Stegman Building, the top portion of the cistern (41CF230) was removed to aid the construction. On May 9<sup>th</sup>, prior to the arrival of the project archaeologist, an additional two-foot segment of the upper lip of the cistern was demolished and the content of the cistern was removed and subsequently refilled. It is our understanding that the removal of matrix was done in order to find the bottom of the feature. **Figure 9** shows the feature as it was encountered when the Project Archaeologist arrived on site.

Figure 9. The cistern located at the Stegman Building.

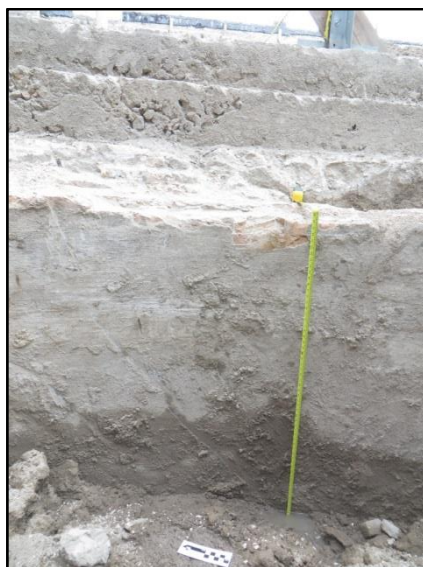
On May 9<sup>th</sup>, the top of the cistern remnant was observed in relation to the existing foundation of the Stegman Building. The missing portion of the cistern indicates that the top course was removed in order to accommodate the new building's foundation (**Figure 10**). This is not unusual, as many cisterns were leveled as new structures were built over them. A mini-excavator was used to remove matrix from the cistern. At 1.4 meters below the existing foundation, water was observed seeping into the bottom of the feature. At 2.1 meters below the foundation, the amount of water prevented further excavation within the feature.

Figure 10. The cistern with top two feet removed, showing current building foundation.

Impacts occurred during the current renovations to the building even before the start of the construction monitoring. Specifically, to accommodate a new concrete slab, the height of the cistern wall remnant was again shortened by an additional two feet. The cistern was cleaned out and new, flowable fill was added. In addition, u-shaped notches were cut into the cistern to accommodate plumbing lines.

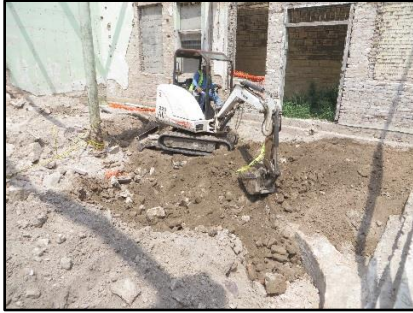
On May 10<sup>th</sup>, the mini-excavator cleared matrix from the eastern side of the cistern (**Figure 11**). The mini-excavator could not reach the bottom of the cistern, however, the manager noted that the bottom of the feature was brick and located approximately 1.85 meters below the current surface. The excavator was able to remove fill to a depth of 1.6 meters (**Figure 12**). The inner diameter of the feature was 4.2 meters wide, while the outer diameter was 4.8 meters wide (**Figure 13**). The cistern wall thickness was approximately 30 cm and exhibited no slope.

Figure 11. Mini-Excavator removing matrix from the feature.

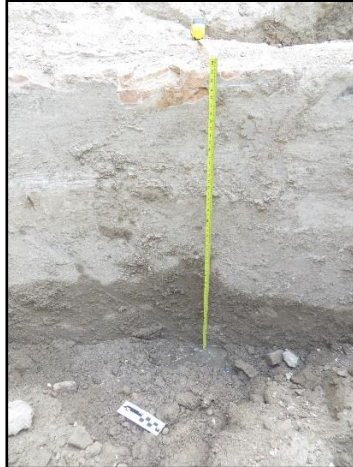
Figure 12. Eastern wall of the feature at 1.6 meters below the surface

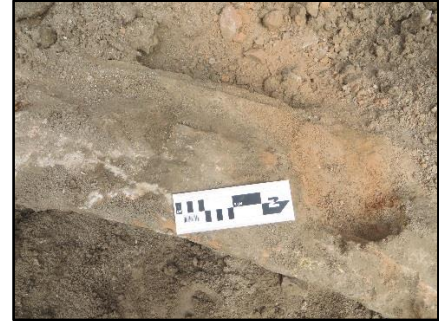
Figure 13. Top of the eastern wall of the cistern, indicating width of brick and mortar.

Since the top of the cistern was removed in the 1910s, it is difficult to determine the type of cistern on the property. The remnant of the cistern that RKEI observed exhibited straight walls with no slope. The cistern has an outer diameter of 4.8 meters (13 feet) and a depth of 1.85 meters (6 feet). The cistern is constructed of local, buff-colored brick, and its walls are least three courses thick (**Figure 14**). The brick is held together with thick mortar and the inside of the feature is mortar-coated.

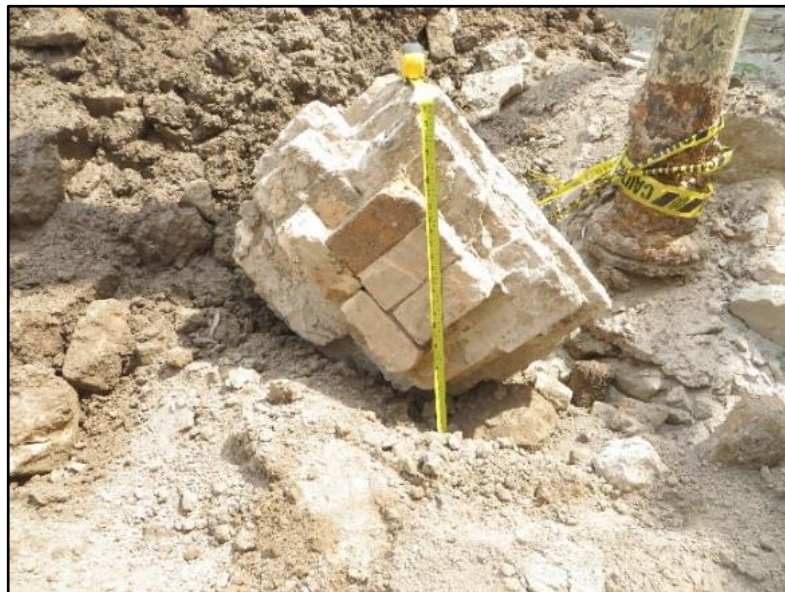
Figure 14. A portion of the removed brick and mortar, 75 cm in length.

The yellow and buff colored, lime based bricks used to construct the features may date to the 1870s. The earliest brick in Brownsville was most likely imported from Matamoros, or locations just north of the river. Matamoros bricks were often yellow in color due to the calcium in local clay deposits (Arreola and Curtis 1993:160-161). Buff colored bricks were popular, locally made bricks. These durable bricks are noted as the preferred construction material of B.G. Stegman for his buildings on Levee Street and Washington Street (*Brownsville Daily Herald* 1911: 10). By 1870, there were four local brick manufacturers in Brownsville, producing 690,000 bricks per year. However, by 1880, the only manufacturer in town was Louis Kowalski (Cook 1998).

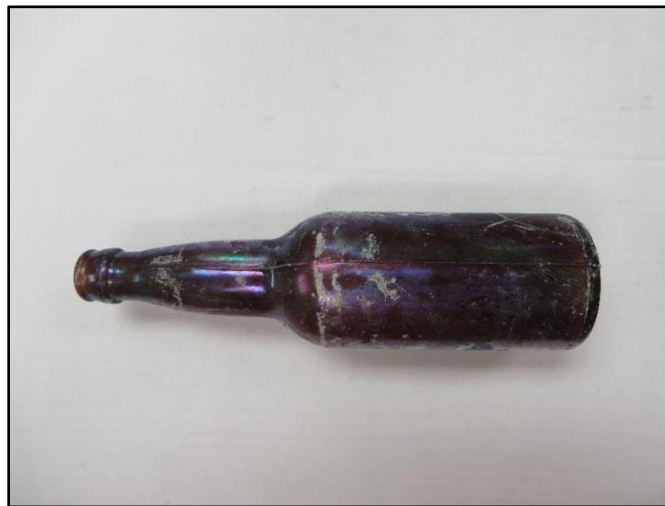
Figure 15. Bottle recovered from fill matrix.

Machine cut bone; white earthenware; hand-painted and sponge decorated earthenwares. Glass artifacts, either through the color of the glass or evidence of manufacture, can serve as temporally diagnostic artifacts. The single bottle recovered from the feature is brown in color and has seams from manufacture (**Figure 15**). The seams, which run from the neck of the bottle through the base, indicate that the bottle was manufactured from a mouth-blown, cup- bottom mold (Toulouse 1969). These bottles were manufactured between the mid- to late 1880s to around 1910. The neck of the bottle shows evidence of a tooled finish, and ends with a crown cap. Tooled finishes on bottles were added to bottles, including beer bottles, began between 1885 and 1890 (Lindsey 2010). Machine manufactured beer and soda bottles were first produced in 1905, but were not popular until 1915. Therefore, the bottle most likely dates from the mid-to late-1880s to 1905-1910.

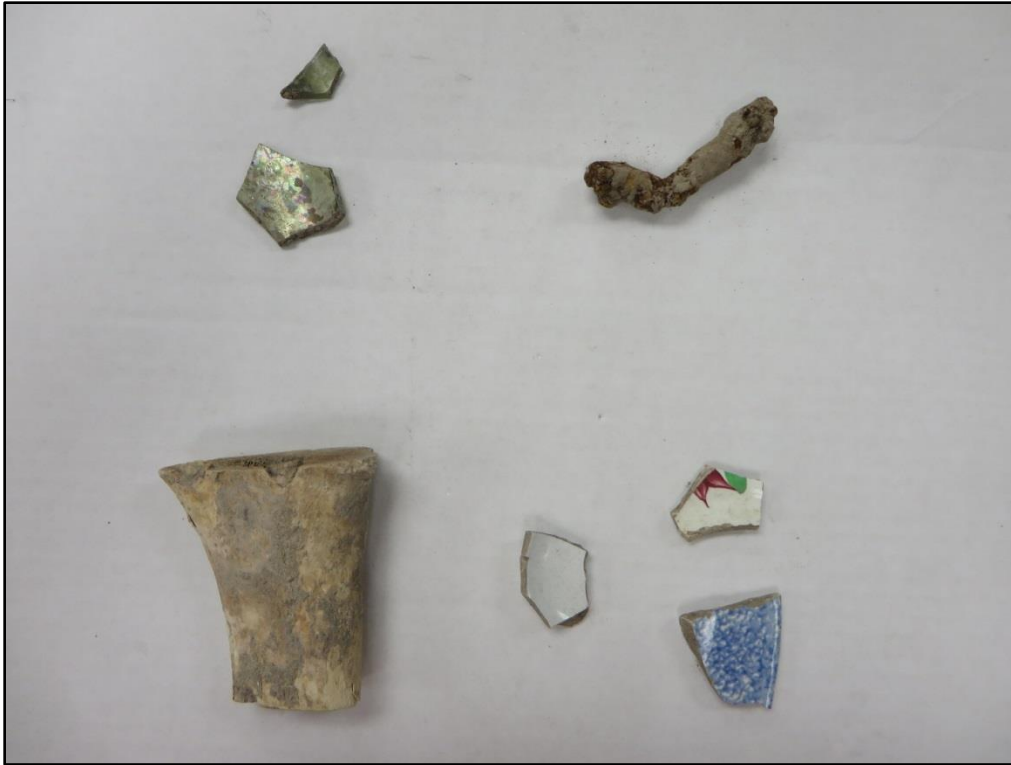
Figure 16. Artifacts recovered from the cistern. Top Row: Olive glass; nail (unknown type); Bottom Row:

Olive- amber to dark olive green glass was popular during the 19<sup>th</sup> and early 20<sup>th</sup> centuries (Figure 16, top row). Its popularity dropped-off after 1900, except for alcohol bottling (SHA 2016). White earthenwares are high-fired, refined clay ceramics, and primarily date to the 19<sup>th</sup> century (Figure 16, top row left). White earthenware and stoneware were difficult to procure until the arrival of the railroad increased their availability across the state (Fox et al. 1997). There were a few producers in Texas as

early as the mid-19<sup>th</sup> century. Hand-painted and sponge decorated white earthenwares were recovered from the matrix within the cistern (Figure 16, bottom row right). Hand-painted wares, including the red and green floral motif found at the site, arrived in South Texas by 1830 (Shelton 2015). Spongewares were popular between 1850 and 1890, however, they were produced until the early 1900s. The distinctive pattern seen on these wares (Figure 16, bottom row right) was produced by dabbing paint onto the vessel using a sponge or cloth (Shelton 2016).

Butchering marks on animal bone provide additional insights into the feature's date. The machine saw-cut bone (Figure 16, bottom row left) from a domestic animal (cow) dates to the early 20<sup>th</sup> Century (Brown and De La O 1997; Christenson 1996).
