# **ARCHAEOLOGICAL MONITORING OF PROPOSED IMPROVEMENTS TO THE CLEVELAND-PARTLOW HOUSE, LIBERTY, LIBERTY COUNTY, TEXAS**

## **Final Report (Redacted)**

### **Cultural Resources Report No. 18-018**

January 30, 2019

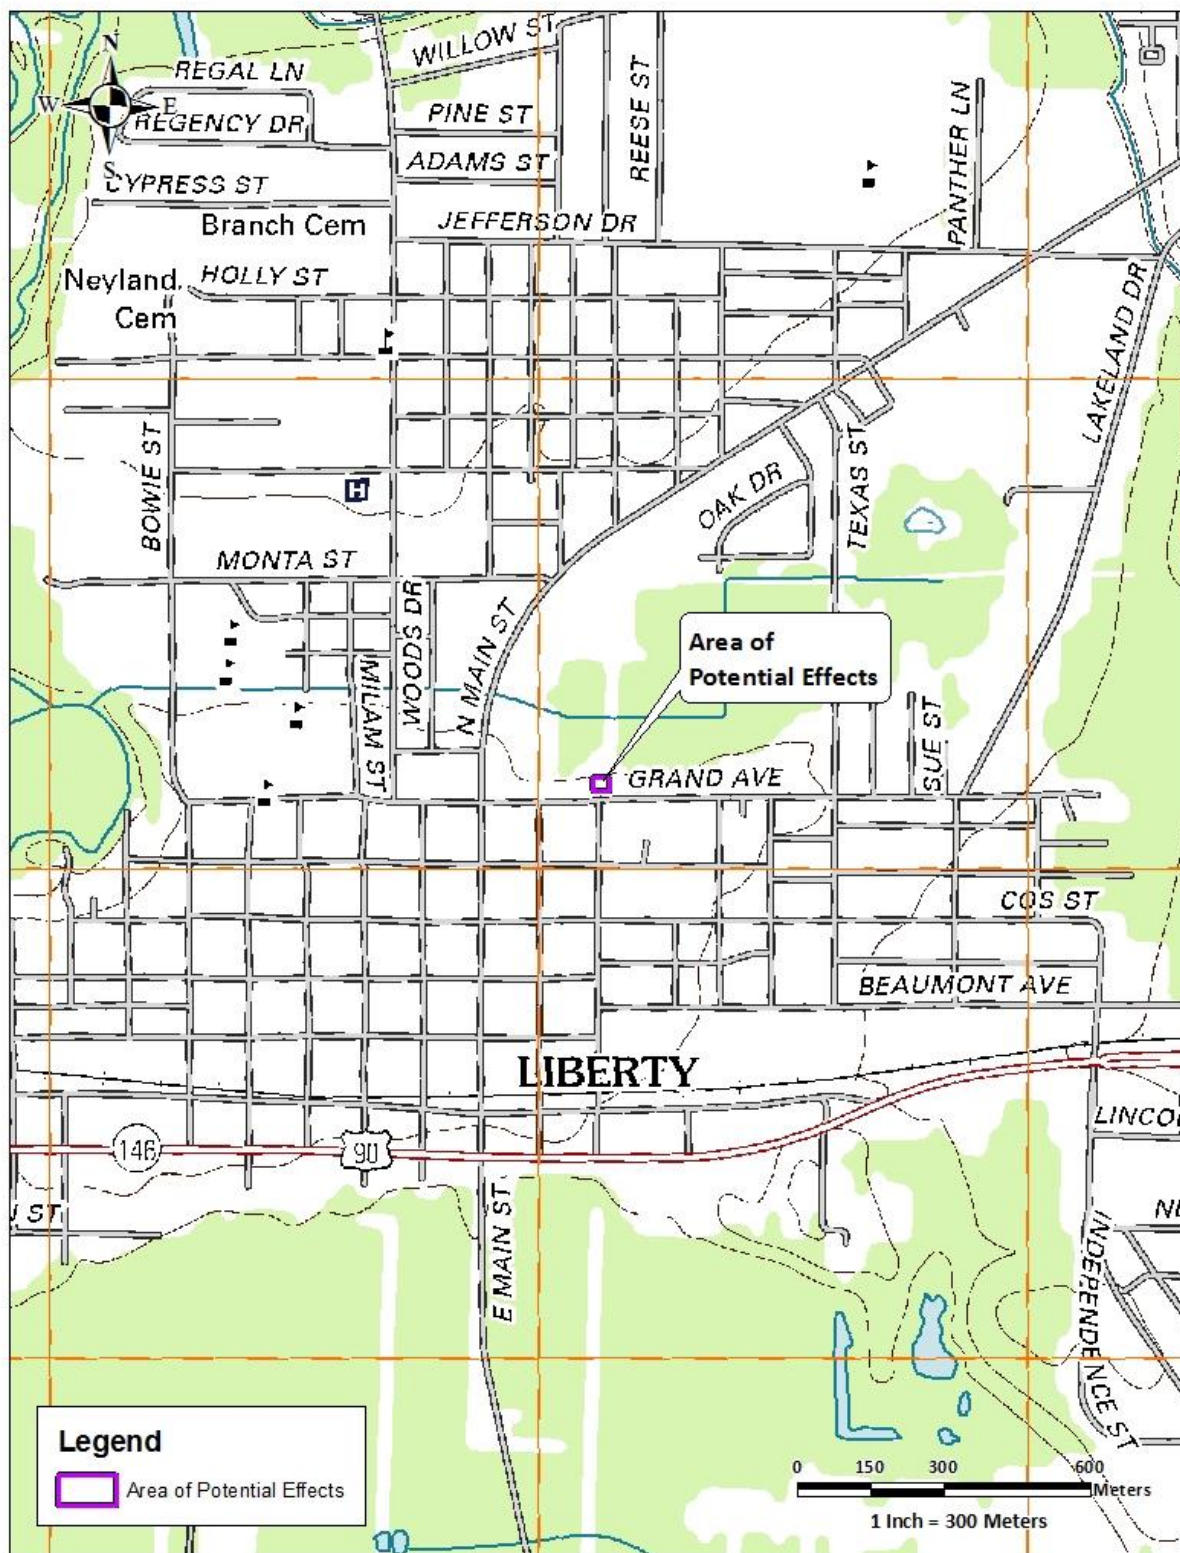
Figure 1-2. The APE on the Liberty, TX (3094-221) USGS 7.5 Minute Quadrangle Map.

The Cleveland-Partlow House is located in an urban setting in the town of Liberty, Texas. The project area is depicted on the Liberty, TX (3094-221) USGS 7.5 Minute Topographic Map (Figure 1-2). The project area encompassed roughly 0.14-acre around the main house. The focus of the first portion of monitoring was on approximately 210 feet (64 meters) of trench excavations around the perimeter of the house. There is a flat area adjacent to the driveway, extending from the driveway to the cistern and addition on the northern side of the home. No trenching was placed in this area. The second phase monitored the excavation of piers, each approximately 4-X-4 ft. (1.2-X1.2 m), and excavated to a depth of approximately 12 inches (0.3 m). Pier excavations were concentrated on the western and southern sides of the house. For archaeological purposes, the Areas of Potential Effect (APE) is the area around the perimeter of the main house, within approximately 39 ft. (12 meters) from the house foundation.

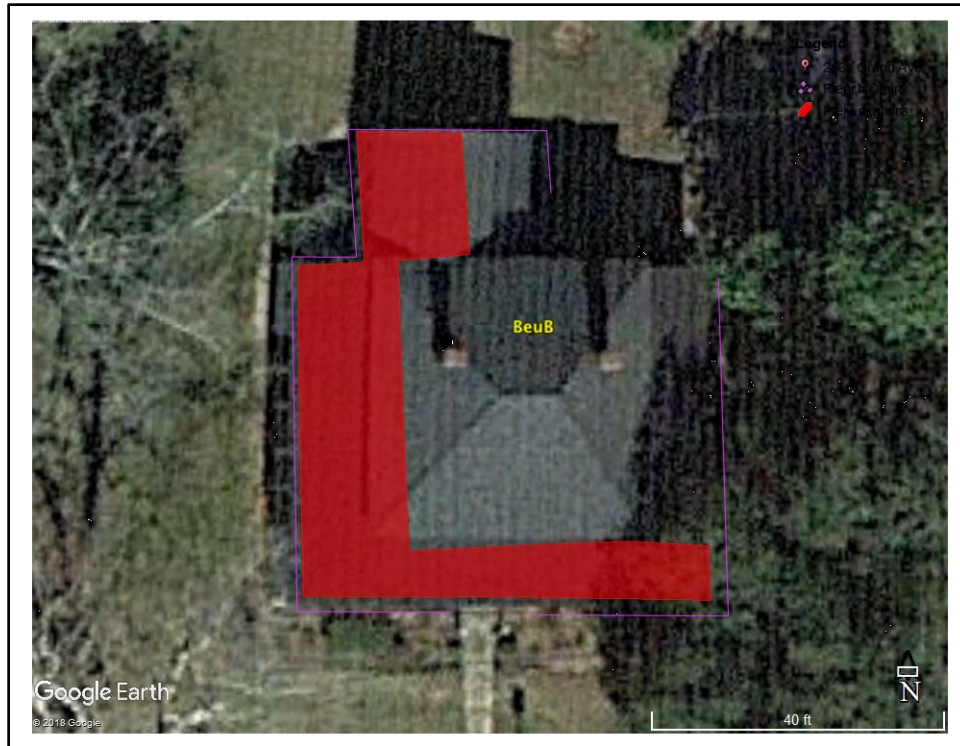
**Figure 5-1. Area inspected during the cultural resource monitoring.**

In August and September of 2018, **RKEI** monitored the excavations of a new drainage feature and piers at the Cleveland-Partlow house (**Figure 5-1**). All excavations were done by hand, without the aid of machinery. All matrix produced during excavations were then screened for archaeological deposits. The drains and piers were excavated in order to alleviate drainage issues associated with storm water flow under the home. Currently, water is flowing from the southern (front) side of the house towards the north, leading to soil loss on the northwestern side of the house (**Figures 5-2 and 5-3**). The new drainage feature was placed around the perimeter of the house to encourage water flow away from the structure. The northeast corner of the home was not excavated, as this area is flat and contains a cistern (**Figure 5-4**). A total of eleven pits were excavated to accommodate new piers under the home. New piers are located along the southern and western edges of the house, with a majority of the new piers located along the western side of the home.

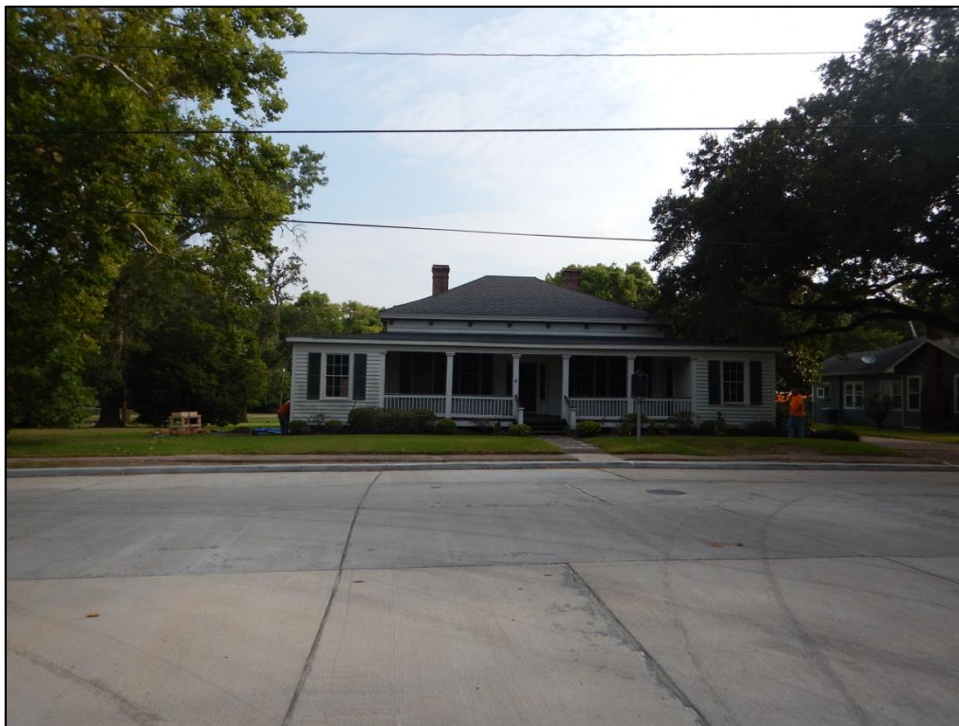
**Figure 5-2. Overview of project area, facing north.**

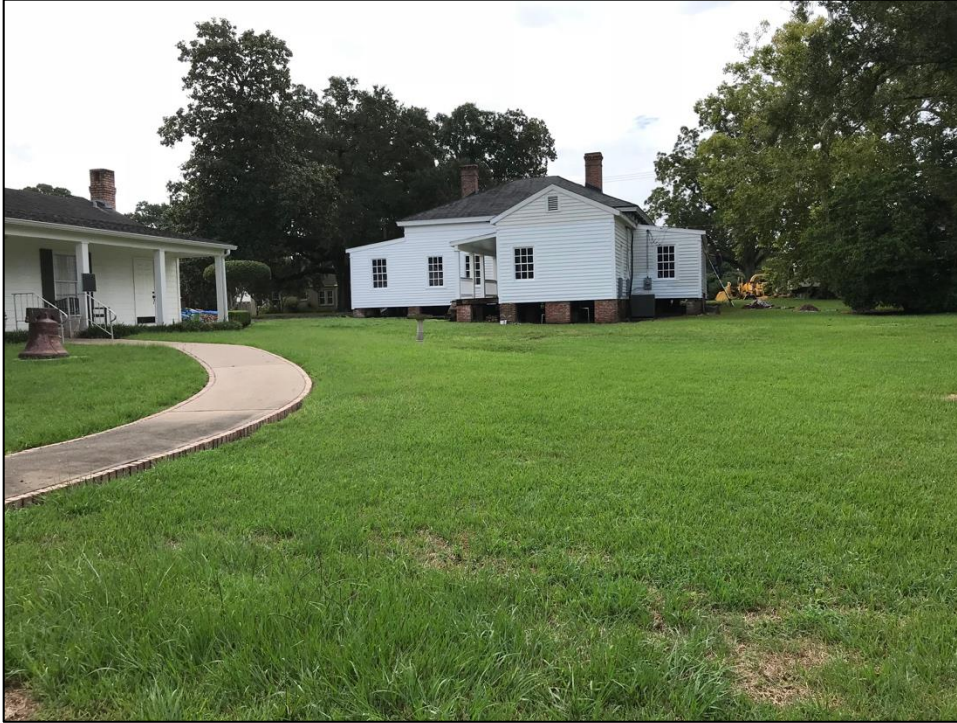
**Figure 5-3. Overview of project area showing rear elevation, facing south.**

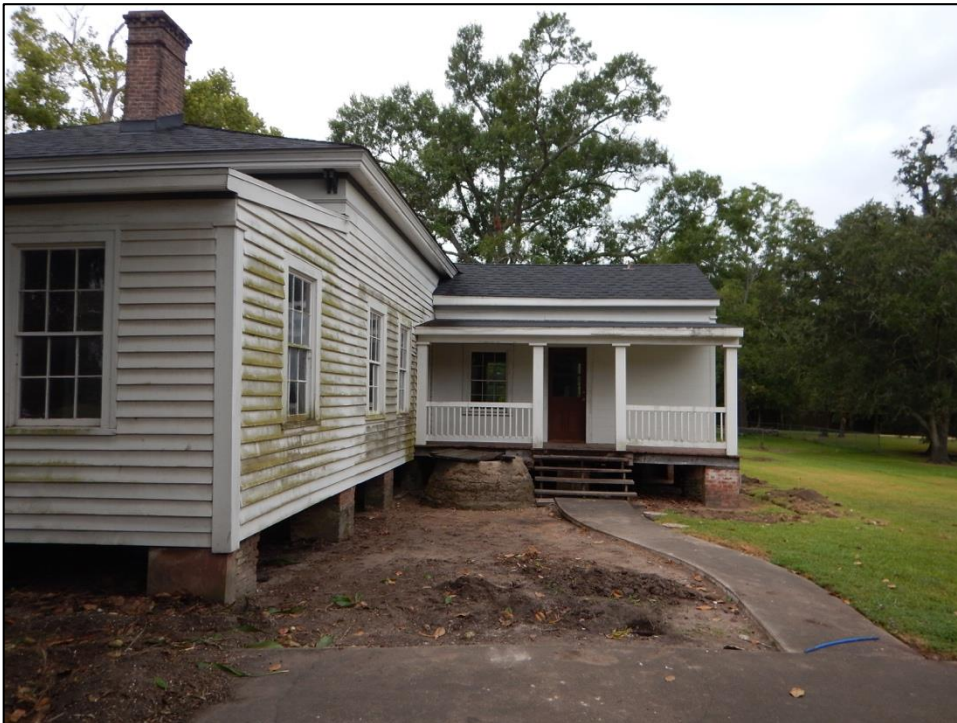
**Figure 5-4. Overview of project area showing the driveway, cistern, and addition on the north side of the house, facing west.**

The north trench was excavated along the rear of the house, extending to an existing cement sidewalk (**Figure 5-4**). The cultural material identified during hand excavations in this area was sparse and was limited to architectural items (wire nails, glass) and terracotta pot fragments. The trench in this location was relatively shallow, when compared to trenching along the southern and western sides of the structure. A cement pad was encountered near the western corner of the addition (**Figure 5-5**). It is likely that this pad and pipe are modern features relating to supplying water to the house.

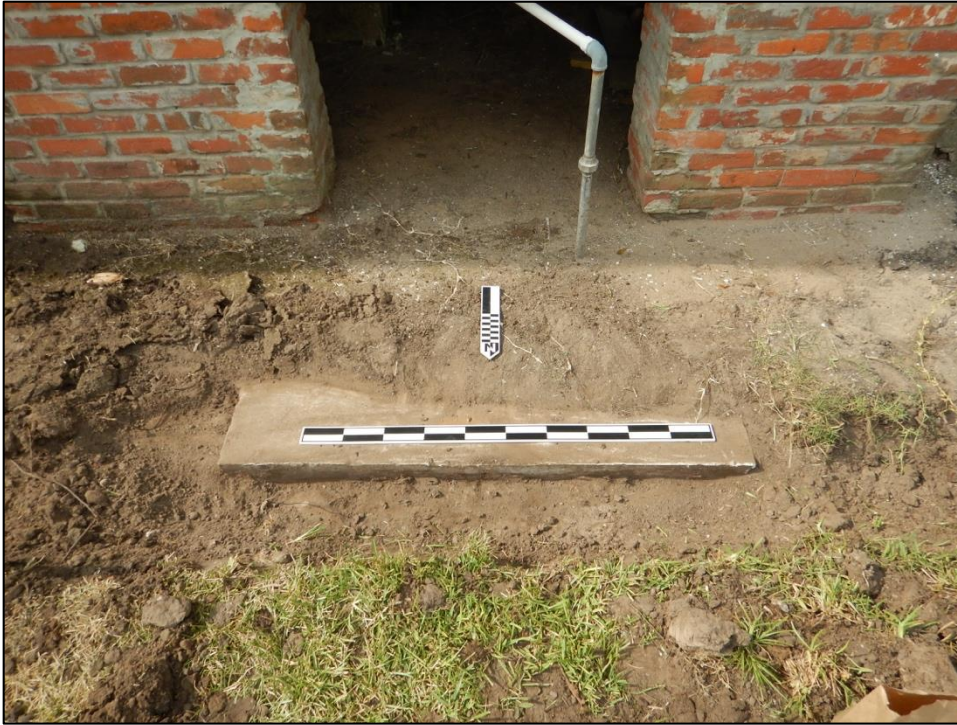
**Figure 5-5 Cement pad encountered on the western side of the north trench, facing south.**

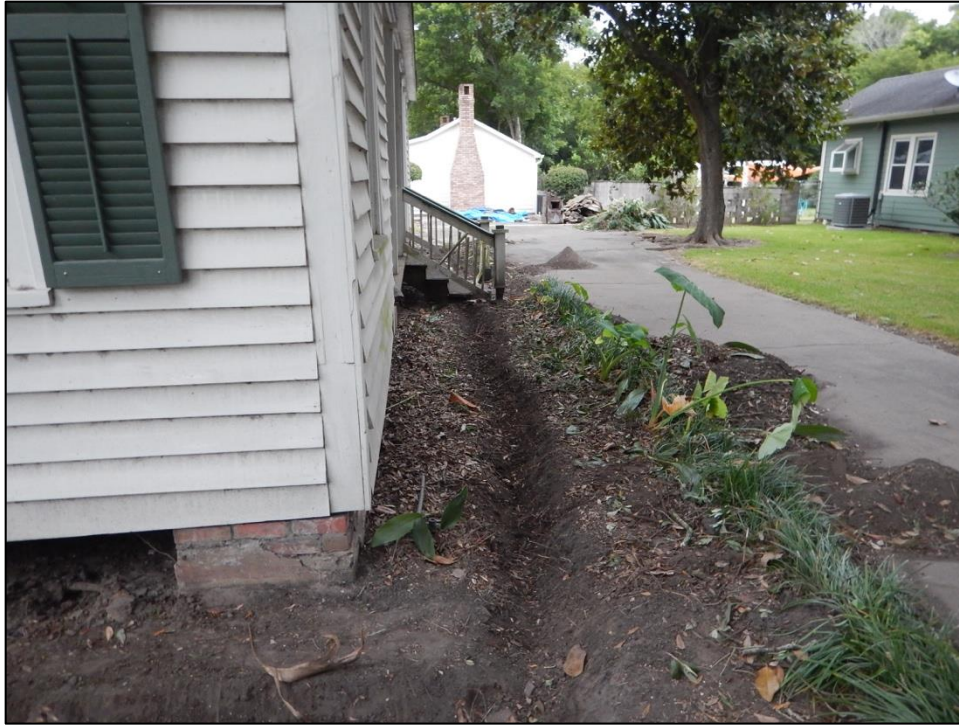
Trenching along the eastern side of the house was located between the house and a cement driveway (**Figure 5-6**). The trench terminated at the northeastern corner of the house, where a flat area is located between the driveway, cistern, and house addition. When compared to the materials produced during excavations along the western side of the house, this trench did not exhibit the same density of cultural materials. Less cultural materials were encountered on the eastern side of the house. This may be attributed to disturbances caused by the construction of the driveway and gardening activities.

**Figure 5-6. Trench along the eastern side of the house, facing north.**

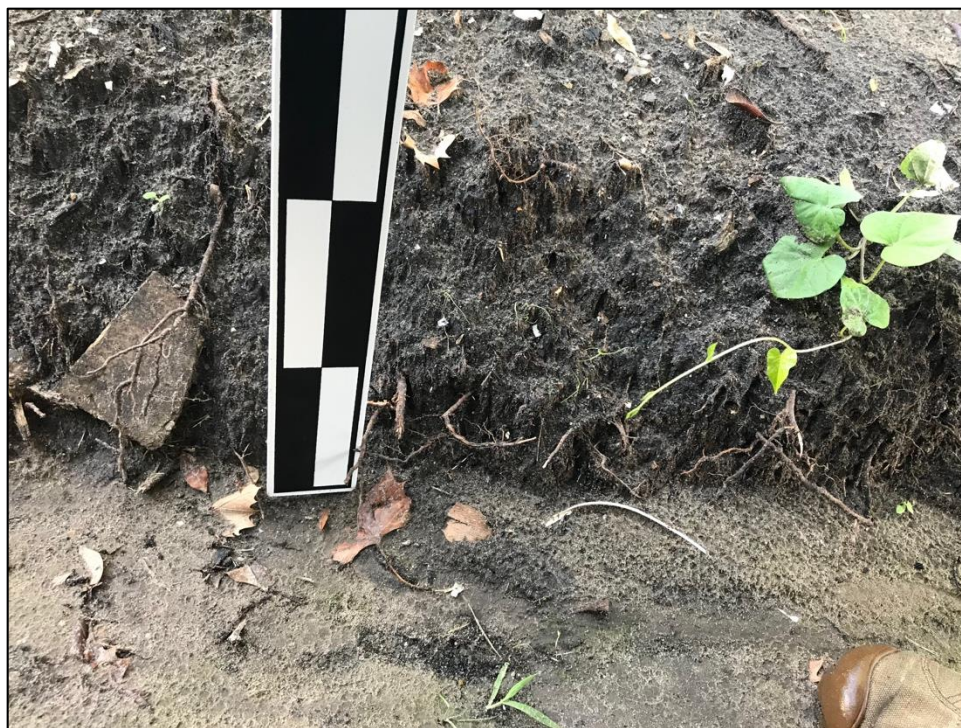
Hand excavations of the drain along the southern side of the house revealed a method used by gardeners to keep nutrients in the flower beds. As seen in **Figure 5-7**, the fine sandy loam in this location has been mixed with ash and is gray in color, turning brown with depth. The trench in this location extends east to west from the central stairs to the entrance of the home. The eastern side (**Figure 5-8**) encountered fine sandy loam soils, with a bit of ash intermixed at the surface. Near the southeast corner, a cement pipe was encountered approximately 10 cmbs (3.9 inches) (**Figure 5-9**).

**Figure 5-7. Profile of soil in the southern trench, looking south. Note ash in fine sandy loam.**

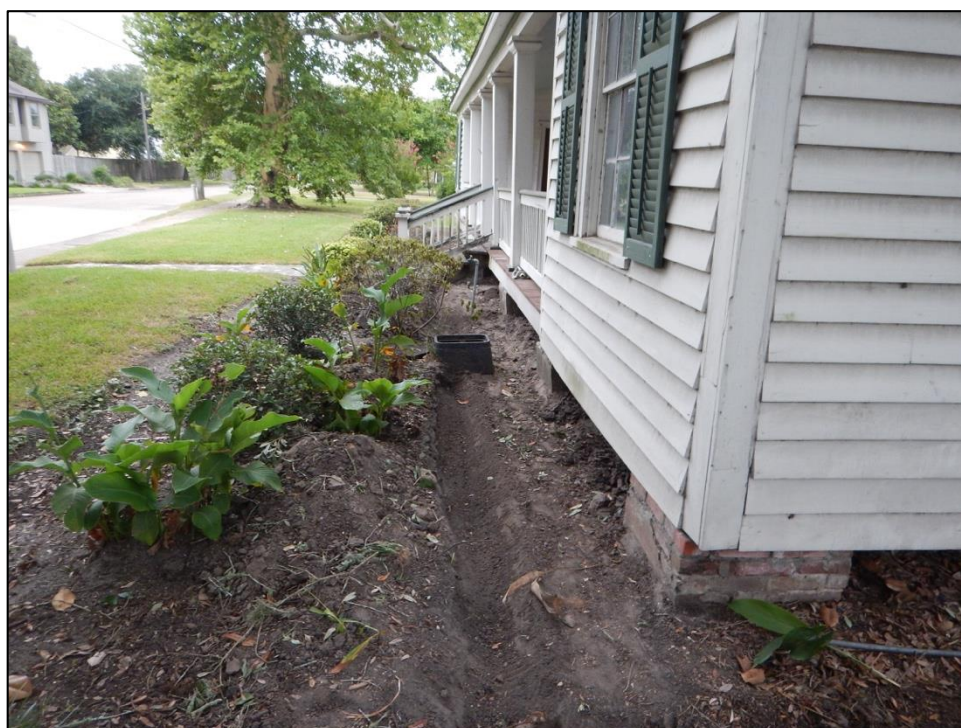
**Figure 5-8. Trench along the southern side of the house, facing west.**

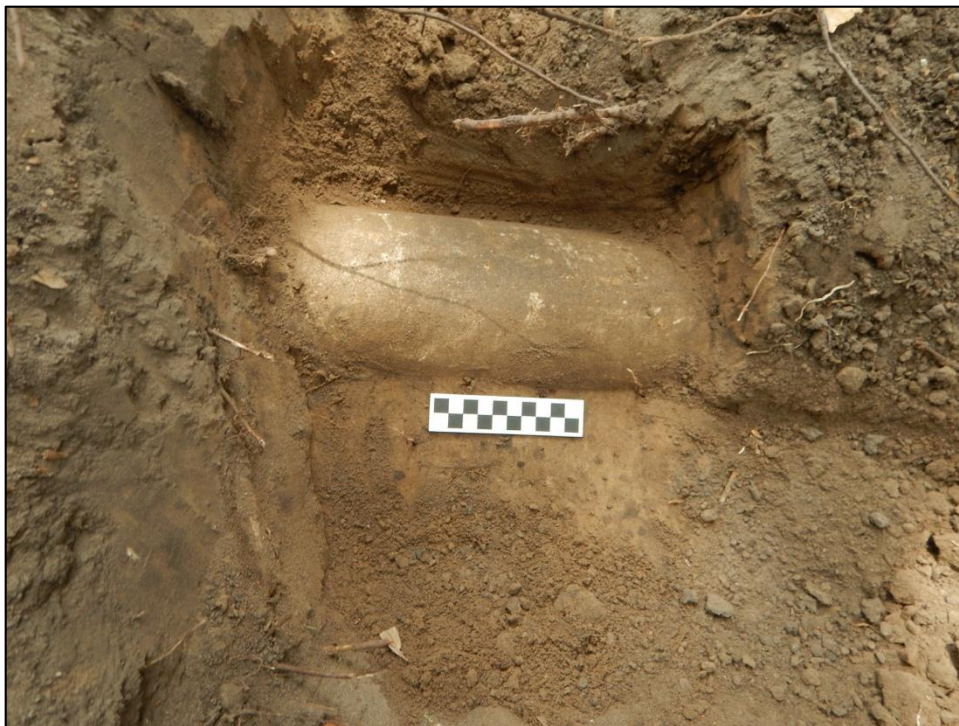
**Figure 5-9. Pipe exposed during trenching located at the southeast corner of the house.**

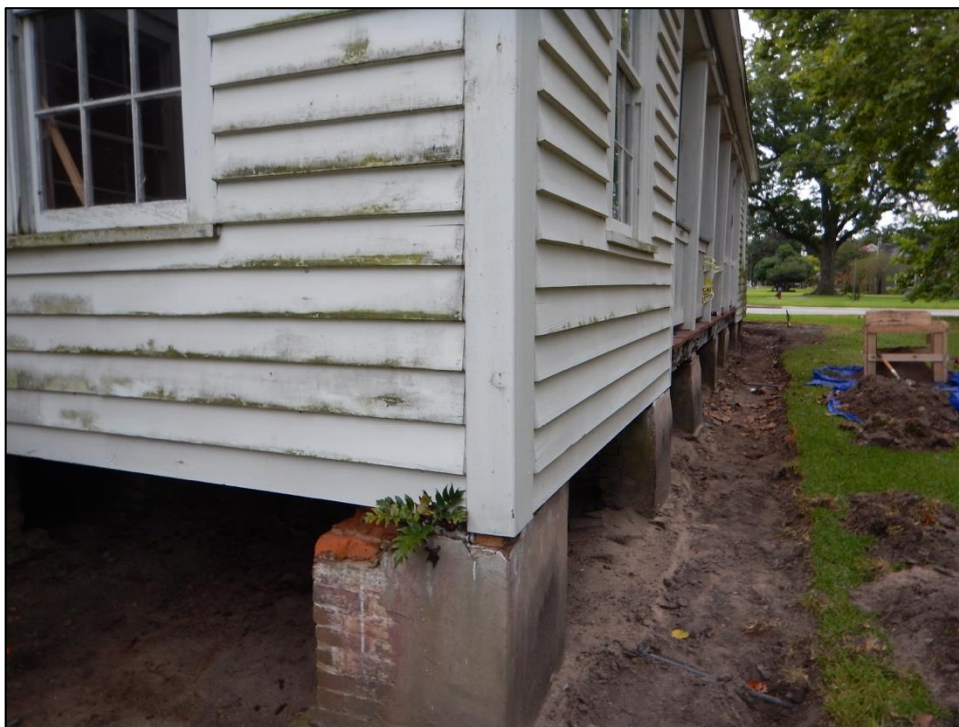
**Figure 5-10. The western trench, facing south.**

The western side of the house has been impacted by water flow. However, heavy concentrations of cultural material were found during excavations in this location. The locus seems to be in the vicinity of the porch (**Figure 5-10**). The materials are mostly architectural in nature, including wire nails, chimney glass, pieces of brick, and window glass. The trench was excavated to a depth of 12 to 15 cmbs and encountered a fine sandy loam (**Figure 5-11**).

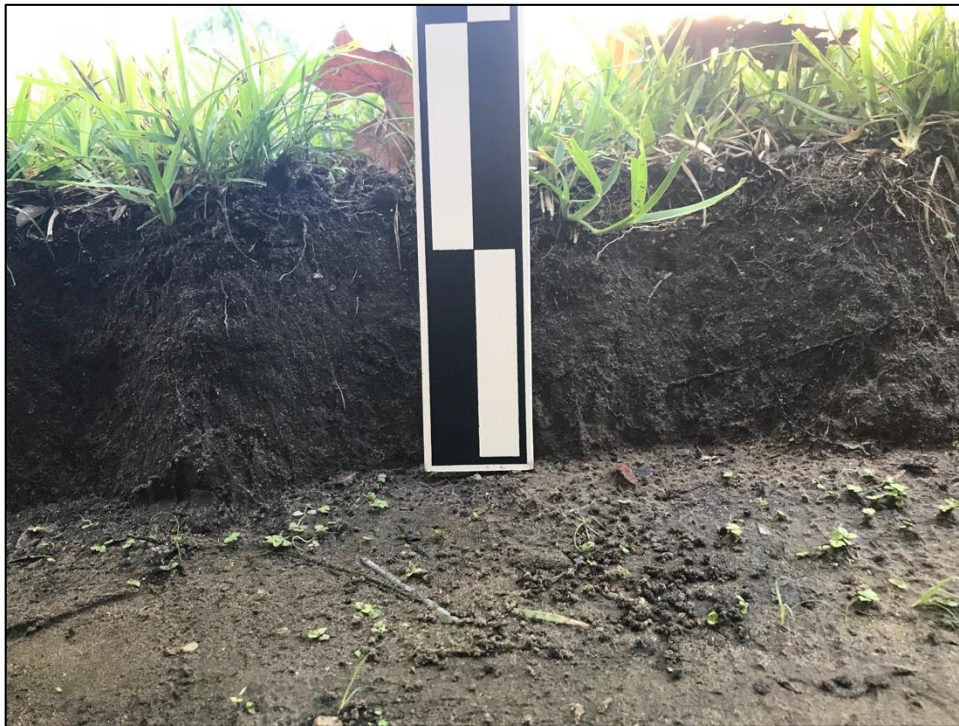
**Figure 5-11. Profile of soil in the western trench, looking west.**

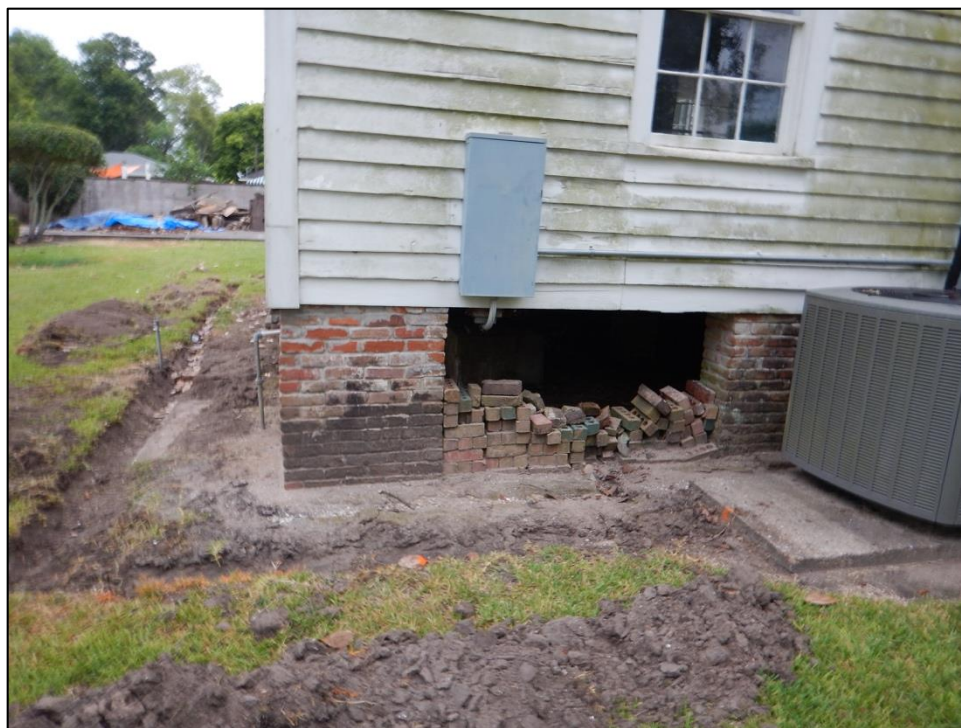
**Figure 5-12. Northern section of the western and northern trenches. Note stacked brick between piers.**

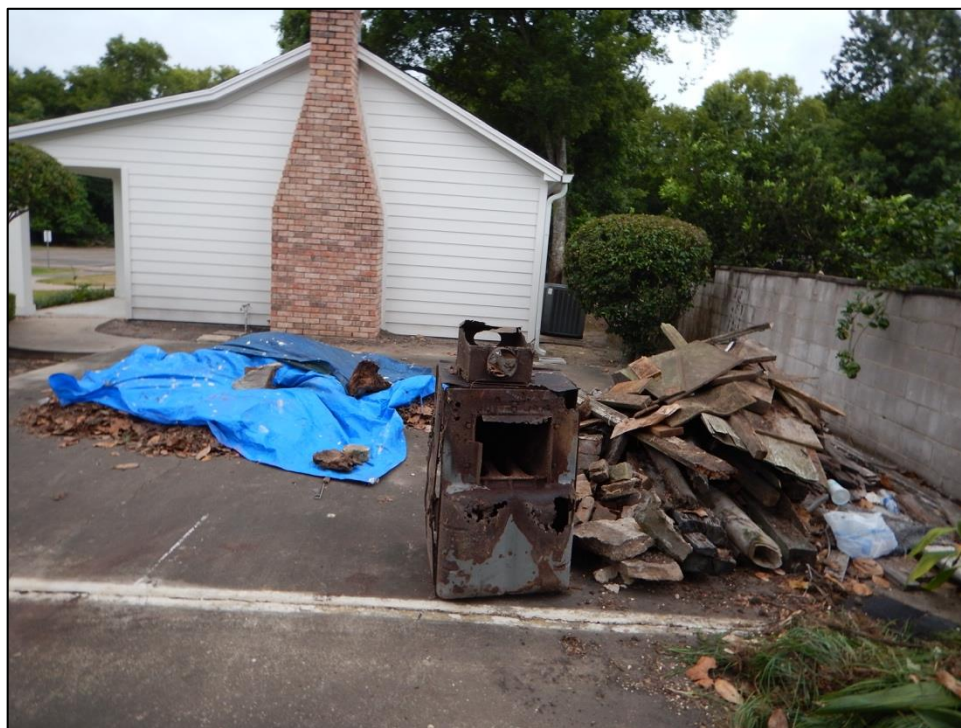
**Figure 5-13. Items removed from crawl space during clean-up activities prior to the excavation of piers. Note the old furnace in the foreground.**

In addition to materials identified in the trenches, materials associated with the house were stored in this area. After hand-excavations were complete, the crew cleared debris and materials from under the house. Any bricks that were found were stacked between two existing piers. These bricks were candidates to replace heavily weathered brick in existing piers (**Figure 5-12**). Other materials removed from under the house includes an old furnace, a tree stump, and miscellaneous building materials (wood, windows, tiles, shingles, etc.).

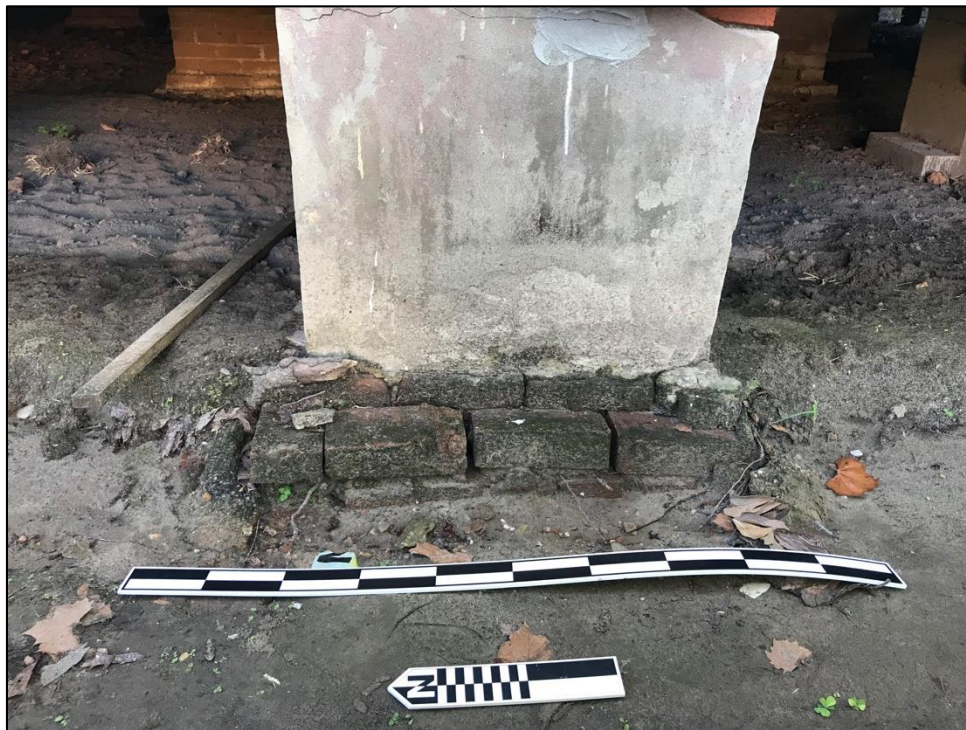
A total of eleven piers were excavated along the southern and western sides of the structure, including piers under the northern addition of the house. The existing piers are constructed of orange-red brick, and the outer piers have been covered in water-proofing coating (**Figure 5-14**). Prior to the start of excavating new pier locations, temporary piers were placed beneath the house as a safety measure (**Figure 5-15**). As the pits were excavated, the matrix was placed into a bin and brought outside to be screened. The backdirt from all excavations was used to fill in any low spots beneath the house.

**Figure 5-14. Typical pier on the western side of the house, showing brick footing exposed by trench.**

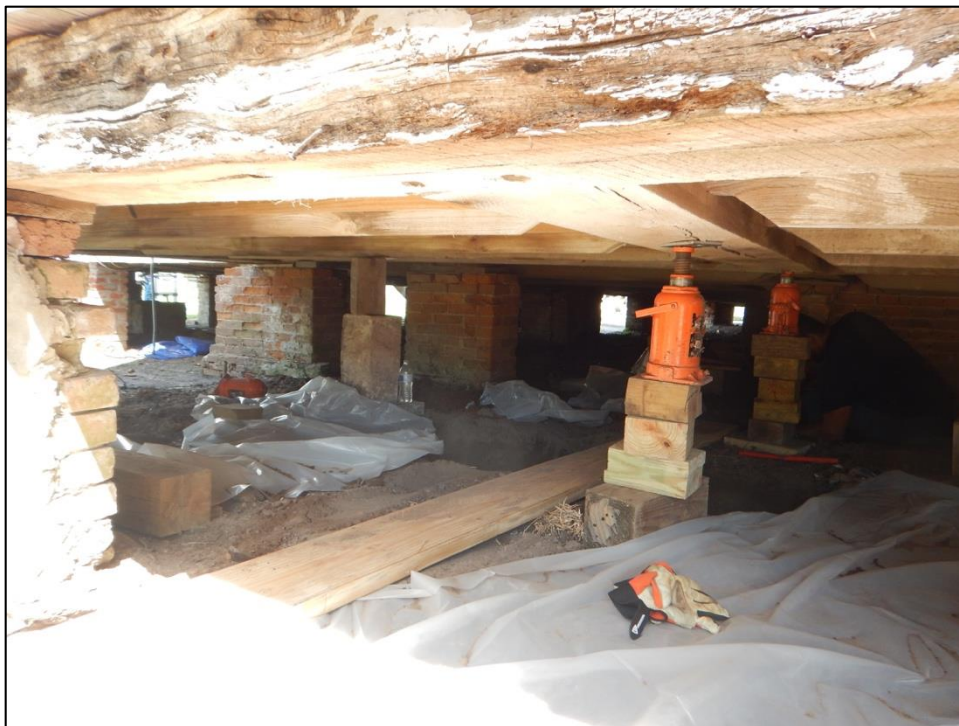
**Figure 5-15. Temporary piers and plastic located in the crawl space as piers were excavated.**

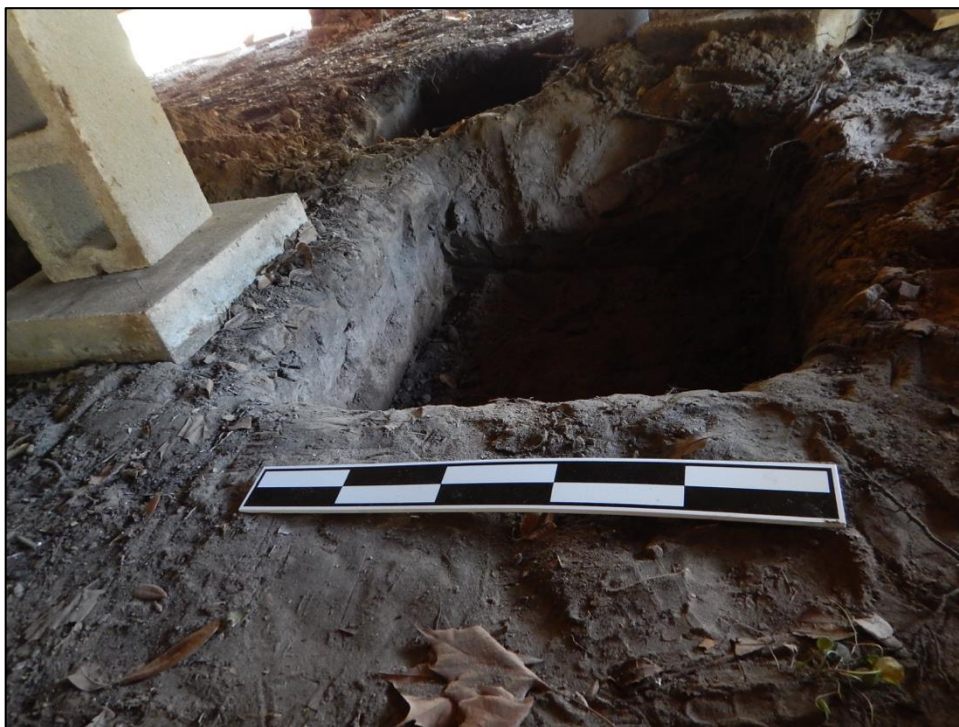
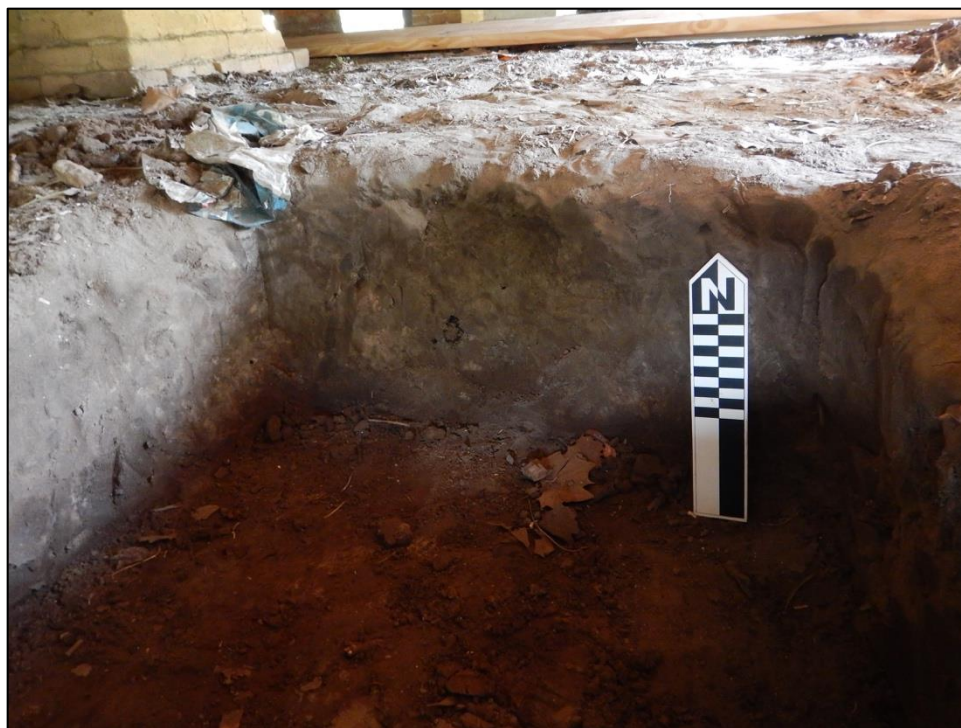
Each pier pit was approximately 60 cm by 60 cm and excavations terminated at a depth of 30 cmbs (**Figures 5-16 and 5-17**). The soils were a brown to brown gray fine sandy loam. The soil loss at the northwestern corner of the structure is evident in the soil strata found in the pits. This is best illustrated by a pier excavated near the well under the addition. The brown to grayish brown fine sandy loam quickly transitions to saturated reddish brown fine sandy loam intermixed with a sandy clay (**Figures 5-18 and 5-19**). Although the house is situated on a downslope, the transition to soils that exhibit the characteristics of the base of a Belrose complex deposit indicates the level of disturbance and soil loss in this location.

**Figure 5-16. Hand excavated pier located near an existing pier, on the western side of the house.**

**Figure 5-17. Profile of the south wall of a pier under the house.**

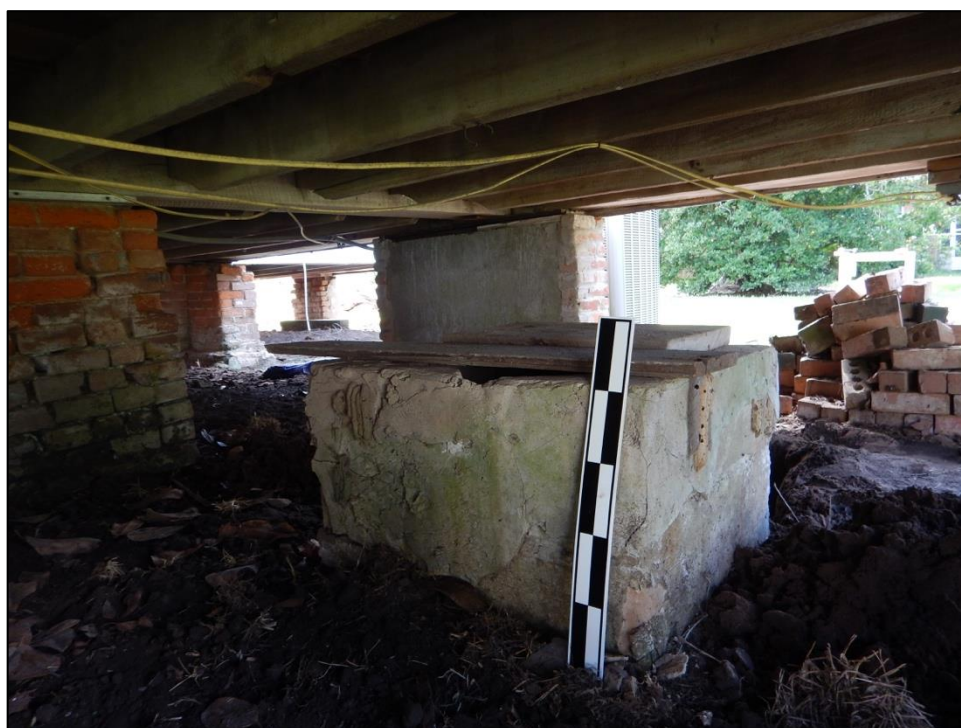
**Figure 5-18. Well under the addition of the house, facing west.**

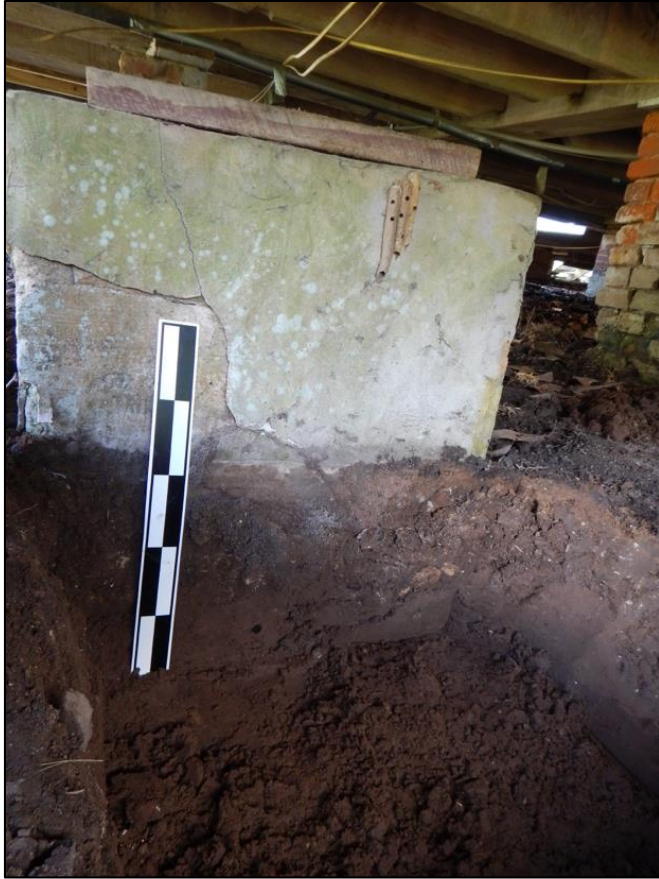
**Figure 5-19. Pier excavated adjacent to the well. Soils were saturated.**

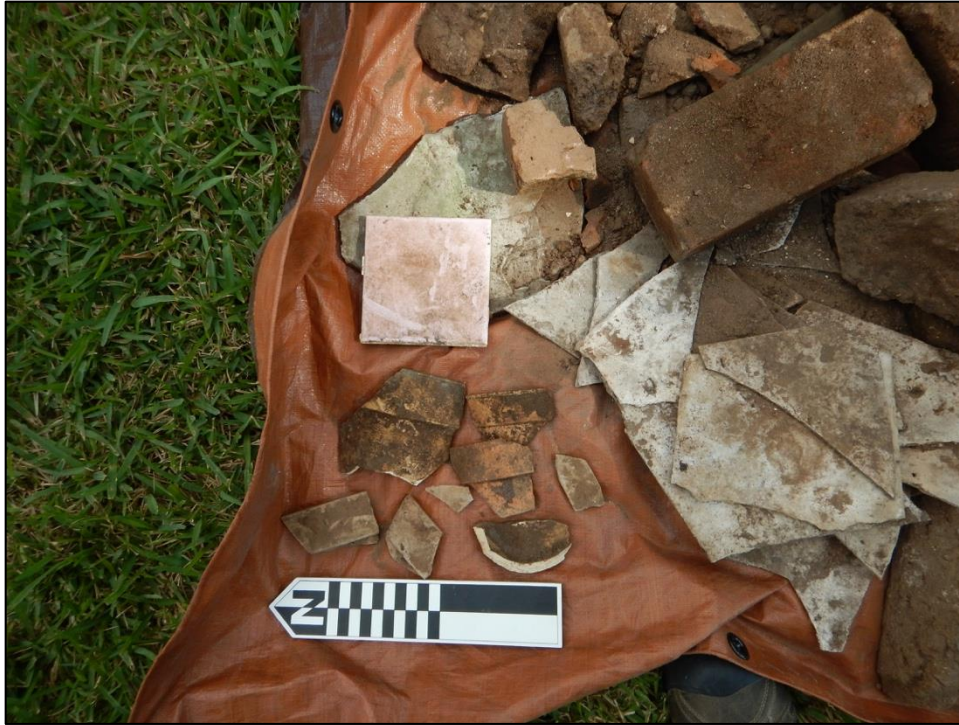
Architectural materials were found shallowly buried along the western side of the house, near the porch (**Figure 5-20**). These materials include brick and brick fragments, mortar, cement, shingles, limestone fragments, a pink tile, and pieces of terracotta pots.

**Figure 5-20. Sample of architectural materials, tiles, and terracotta pots recovered from the surface or shallowly buried from the first four piers excavated.**

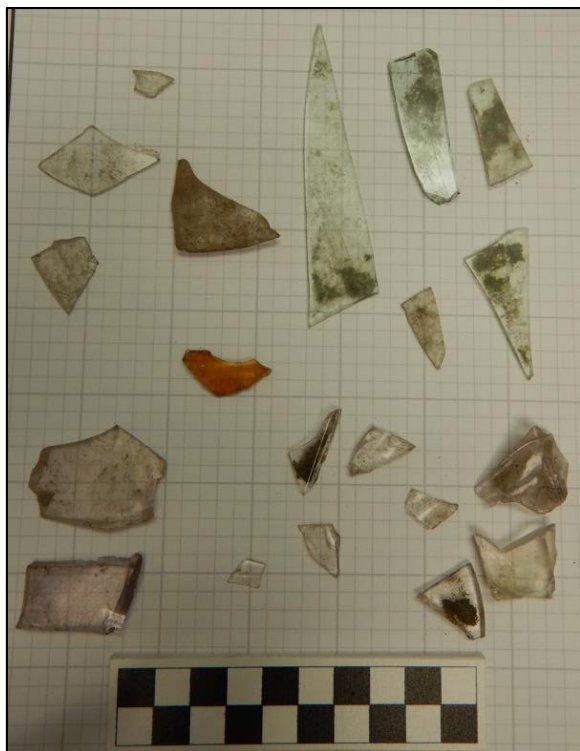
Figure 5-21. A selection of glass fragments encountered during the excavation of trenches.

Diagnostic artifacts were recovered during hand-excavations at the Cleveland-Partlow House. The items represent personal, architectural, and food-related items used over the course of the home's history. **Figures 5-21 and 5-22** are samples of the metal and glass artifacts identified during the course of field investigations. The glass fragments represent containers (colorless and amber glass), windows, and lamp glass. In addition, two pieces were recovered that have a lavender hue, indicating the use of manganese to create clear glass. Manganese glass, also known as purple or amethyst glass, was common in bottle production between 1880 and 1914 (Kendrick 1966). Manganese use in glass production dropped off with the advent of World War I, when manganese supplies from Germany were cut off (Kendrick 1966)

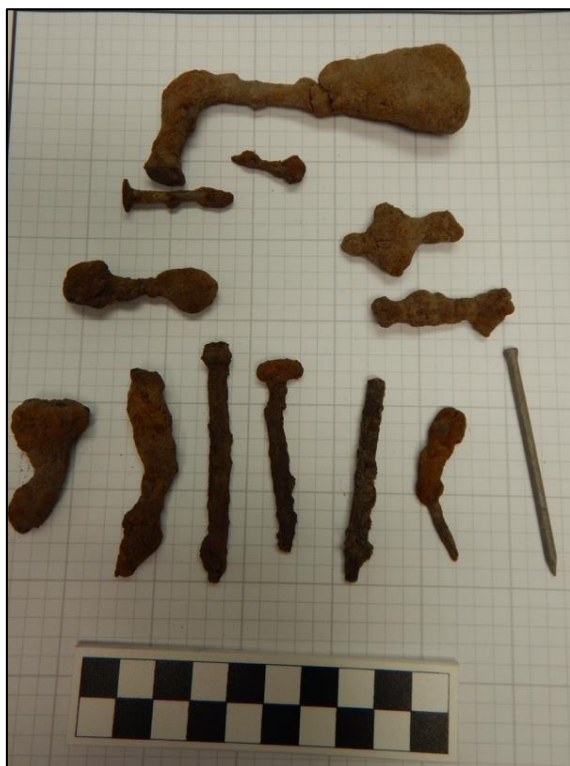
Figure 5-22. A selection of metal nails encountered during the excavation of trenches.

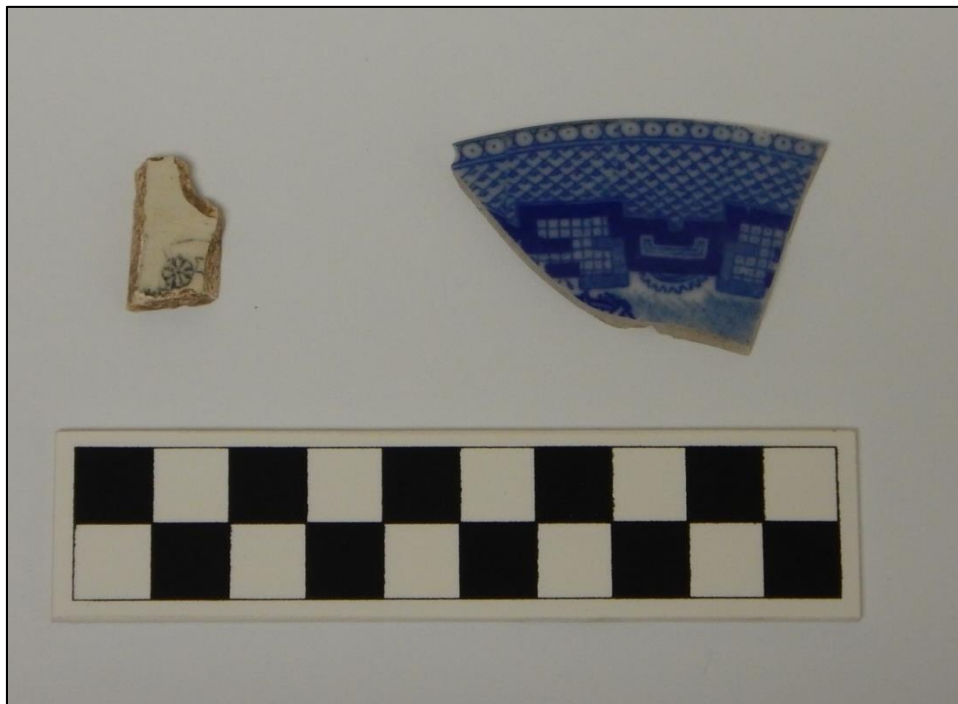
**Figure 5-23. A white earthenware sherd with part of a maker's mark and a piece of Old Blue Willow pattern ceramic.**

The ceramics recovered during excavations reflect some of the more popular white earthenware patterns of the 20<sup>th</sup> century. This includes the Old Blue Willow pattern (**Figure 5-23**), a popular Japanese-style pattern that was produced by several manufacturers based out of England and Japan. As no maker's mark was on the plate, it is difficult to identify the exact maker and date of this particular transferware. However, in comparing with plates advertised for sale at auction houses and antiques dealers, this may be a piece manufactured in Japan between the 1920's to 1950's.

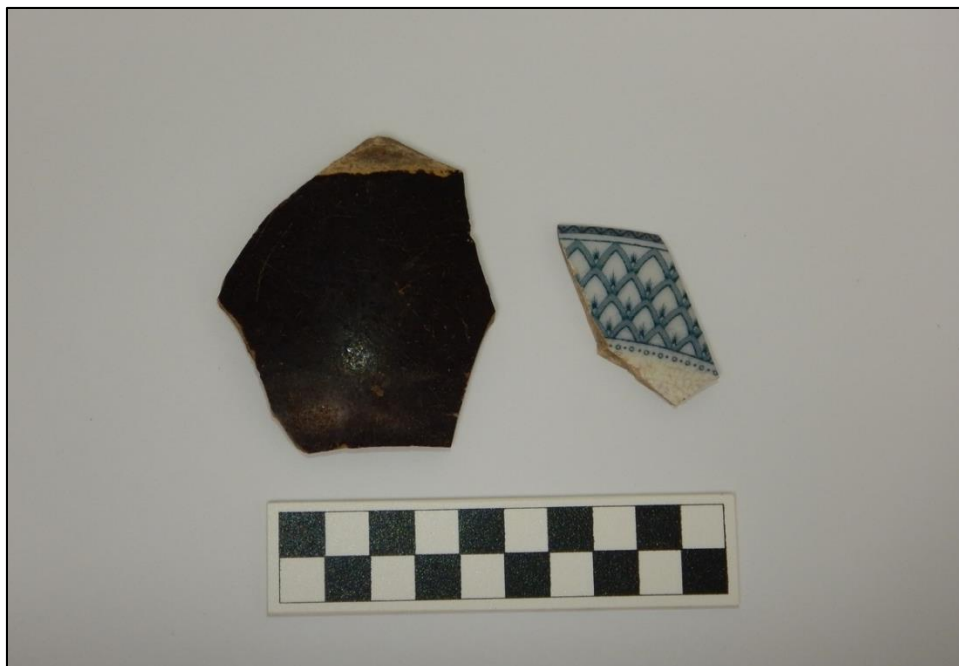
**Figure 5-24. A piece of teal transferware and brown with cream stoneware.**

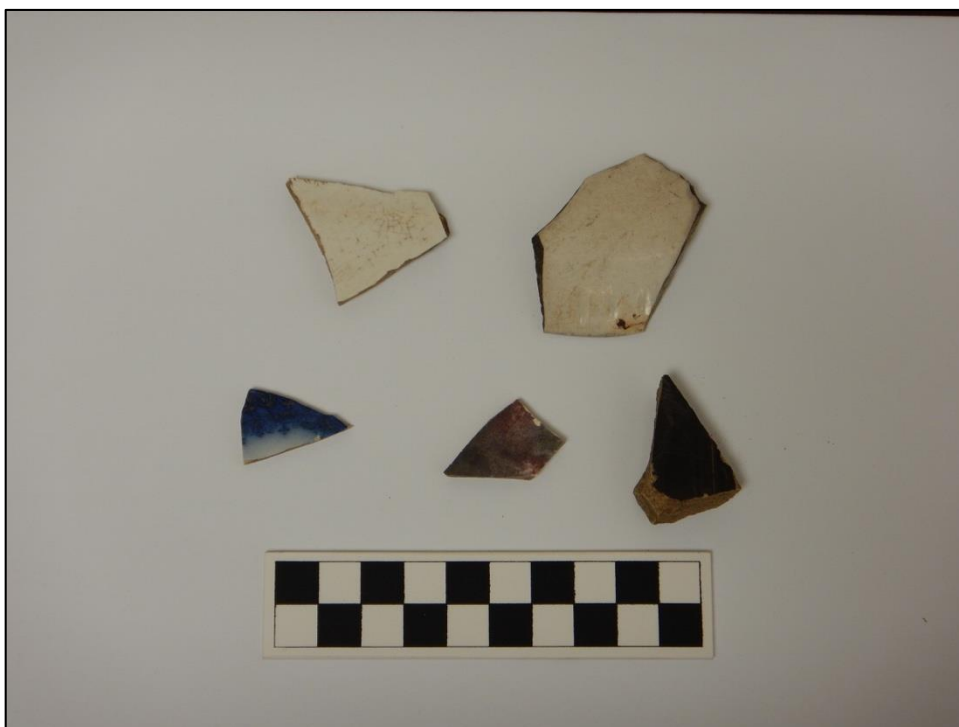
**Figure 5-25. A selection of ceramics encountered during trench excavations. Includes a fragment of flow blue, hand-painted white earthenware and brown stoneware.**

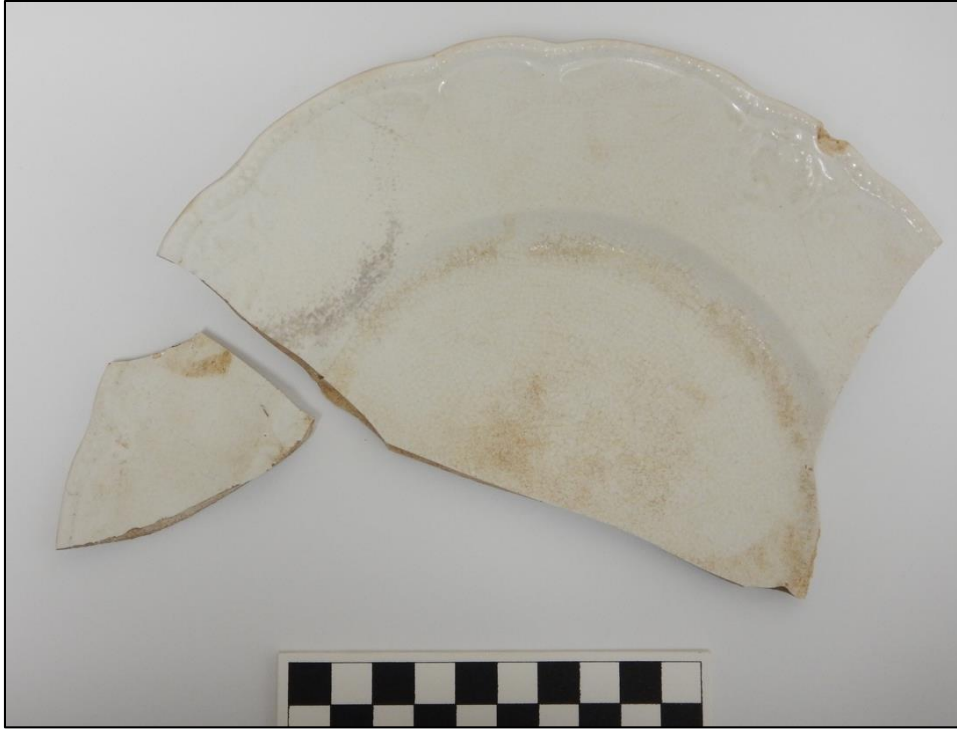
**Figure 5-26. Two pieces of a white earthenware plate produced by Albert Meakin (c. 1891-1897)**
