# **ARCHAEOLOGICAL MONITORING OF PROPOSED IMPROVEMENTS TO THE CLEVELAND-PARTLOW HOUSE, LIBERTY, LIBERTY COUNTY, TEXAS**

## **Final Report (Redacted)**

### **Cultural Resources Report No. 18-018**

January 30, 2019

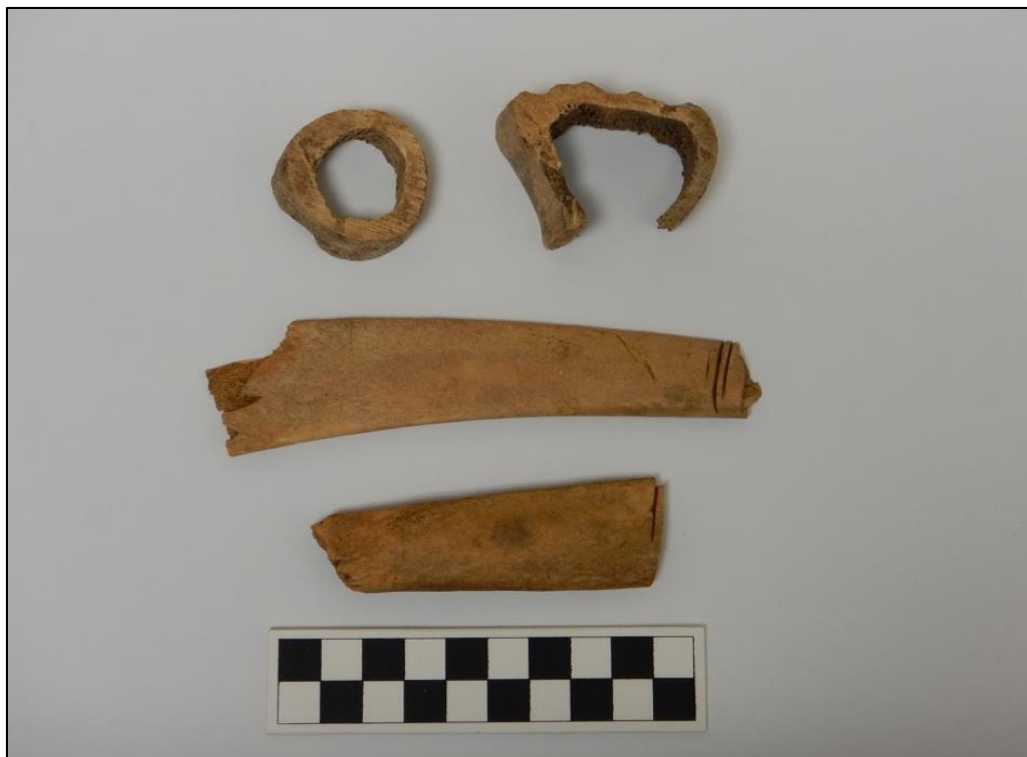
**Figure 5-27. A selection of butchered and processed faunal bone found during pier excavations.**

Faunal bone was recovered during excavations of the piers (**Figure 5-26**). Although some of the bone was not modified, several pieces showed evidence of being butchered. The long bones show evidence of saw cuts. Hand-sawing was used for butchering in the 19<sup>th</sup> century, and machine saws were used by the 20<sup>th</sup> century. The rib bones have surface marks in the distinct “v” shape of a knife. This is further evidence of processing an animal. While these animals may not have been butchered at the house, this does show the types of meat that was being consumed at the house in the 19<sup>th</sup> and 20<sup>th</sup> centuries.

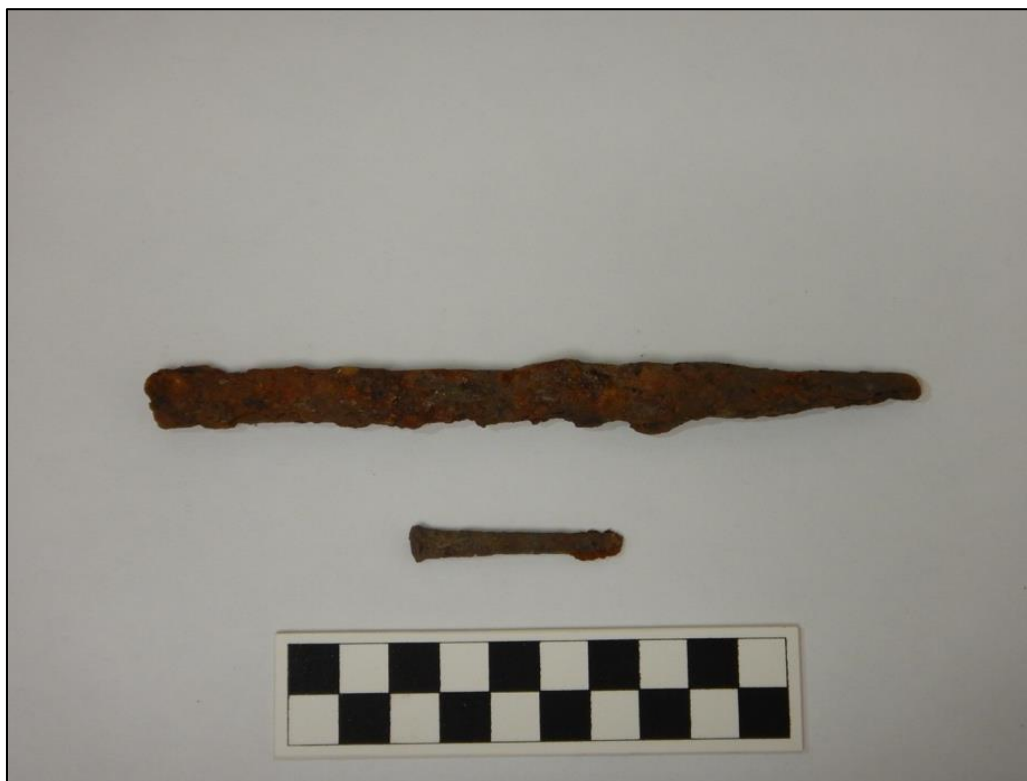
**Figure 5-28. A spike used to hold wood supports in place under the house and one square nail.**

Of all the metal nails identified in the screened matrix, only one was found to be a square nail. As the house has been renovated several times during the course of its history, it is likely that most of the square nails have been removed. The spike most likely was used as a fastener to the bottom wooden supports of the house, or the large beams that supported the porch on the western side of the house. These two items correlate to the initial construction of the house in the 1860's and reflect the history of the house.

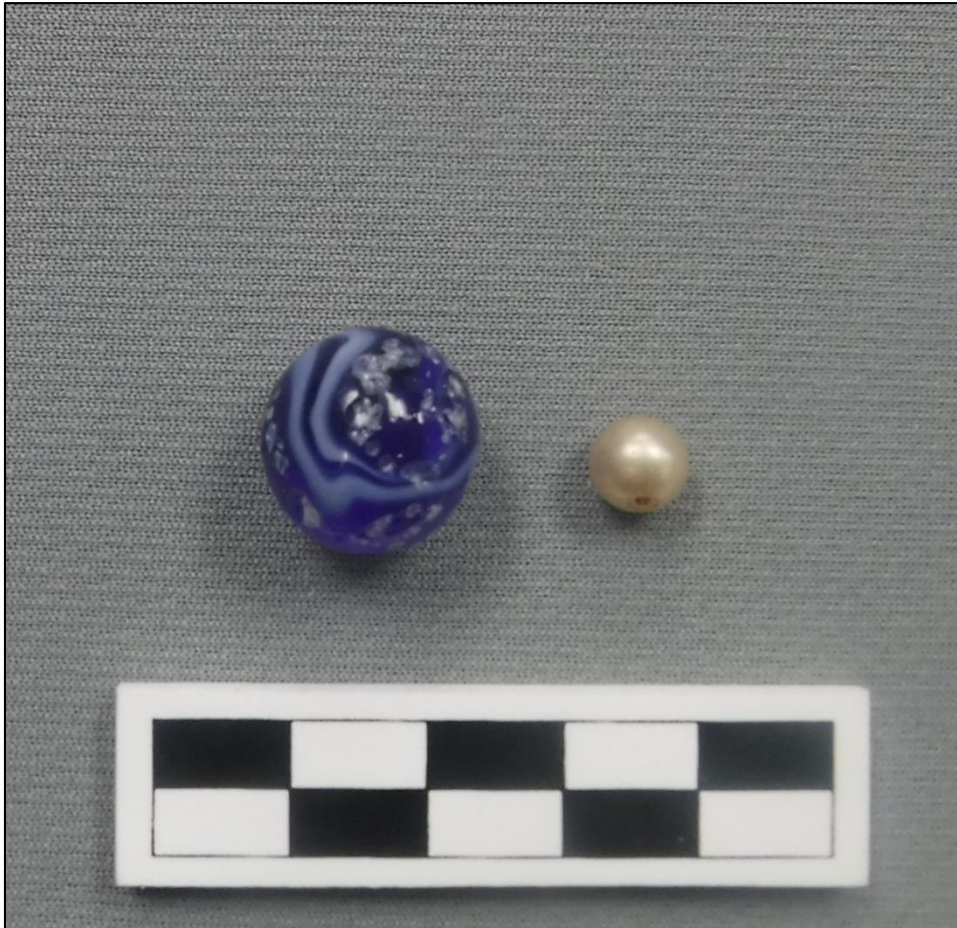
**Figure 5-29. Glass marble and faux pearl recovered during monitoring.**

Three personal items were recovered during the monitoring of the trench along the western portion of the house. These included a button, a faux pearl, and a glass marble (**Figure 5-29**). It is difficult to date these items as they span a long period of manufacture and use, but are consistent with the late 1800s to early 1900s occupation of the site.
