Archaeological Investigations of the Monterrey Park Improvements, San Antonio, Bexar County, Texas

Texas Antiquities Permit No. 8798

Prepared by:
Center for Archaeological Research
The University of Texas at San Antonio
One UTSA Circle
San Antonio, Texas 78249
Technical Report, No. 81

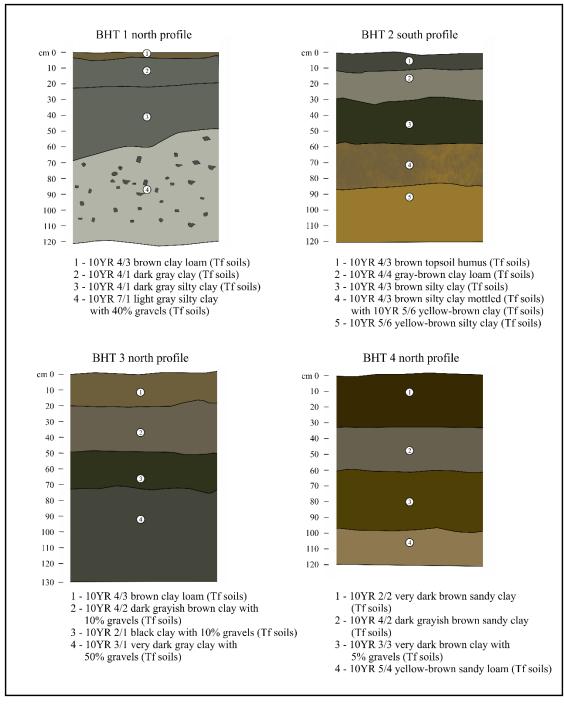
Figure 4-2. Soil profiles from BHT 1 (top left), BHT 2 (top right), BHT 3 (bottom left), and BHT 4 (bottom right).

As seen in Figure 4-1, four backhoe trenches were excavated along the west bank of Zarzamora Creek. The soil profiles were slightly different in each backhoe trench; therefore, a 1-m representative profile for each trench is displayed in Figure 4-2.

Backhoe Trench 1 was excavated 70 m south of the Fortuna Street bridge that crosses over Zarzamora Creek. The profile of the north wall of BHT 1 revealed four stratigraphic layers (Figure 4-2, top left) representative of the Tinn and Frio soil complex (Tf). The first soil horizon observed was a thin brown clay layer that was 1-2 cmbs. Soil horizon 2 was a dark gray clay that extended to 22 cmbs. The third soil horizon was a dark gray silty clay that extended from 50-70 cmbs. The deepest and final soil horizon (71-120 cmbs) observed in BHT 1 was a light gray silty clay matrix that consisted of 40 percent gravels.

Backhoe Trench 2 was excavated 35 m south of BHT 1. Five soil horizons were observed in the south profile of BHT 2 (Figure 4-2, top right), all representing the Tinn and Frio soil complex. The uppermost soil horizon observed was a very dark top soil humus layer and extended 0-11 cmbs. The second soil horizon was a gray-brown clay loam that reached 12-32 cmbs. The third soil horizon consisted of a black silty clay that was 32-59 cmbs. The fourth soil horizon observed in BHT 2 was a black silty clay mottled with a yellow-brown clay that ranged in depth from 59-100. The deepest soil horizon observed in BHT 2 was 100-120 cmbs and consisted of a yellow-brown silty clay.

Backhoe Trench 3 was excavated 46 m south of BHT 2, and four Tinn and Frio soil horizons were observed in the north profile of the trench (Figure 4-2, bottom left). The upper soil horizon was a brown clay loam that extended from 0-21 cmbs. The second soil horizon observed in the profile of BHT 3 reached a maximum depth of 52 cmbs and consisted of a gray-brown clay matrix with gravels (10 percent). The third soil horizon extended from 53-71 cmbs. The matrix was a black clay and gravels made up 10 percent of the soil. This soil horizon varied in depth from 72-77 cmbs. A very dark gray clay with a high percentage of gravels present (50 percent) made up the remainder of the backhoe trench profile that terminated at 130 cmbs.

The final trench excavated was BHT 4 (Figure 4-2, bottom right). It was located 50 m southwest of BHT 3 and four Tinn and Frio soil horizons were observed in the north profile of the trench. The first soil horizon was a very dark brown sandy clay that reached a maximum depth of 35 cmbs. The second soil horizon consisted of a dark brown sandy clay extended to a depth of 61-65 cmbs. The third soil horizon observed was dark brown clay mixed with gravels (5 percent). The third soil horizon reached a maximum depth of 102 cmbs. The fourth and deepest soil horizon observed in the profile consisted of yellow-brown sandy loam that terminated at the bottom of the excavated trench at 120 cmbs.
