Re: **ADDENDUM LETTER: PHASE I ENVIRONMENTAL SITE ASSESSMENT AND SUBSEQUENT CULTURAL RESOURCES SURVEY**

CULTURAL RESOURCES SURVEY FOR A 9.1-ACRE TRACT AT GRANBURY, HOOD COUNTY, TEXAS

Technical Report No 208

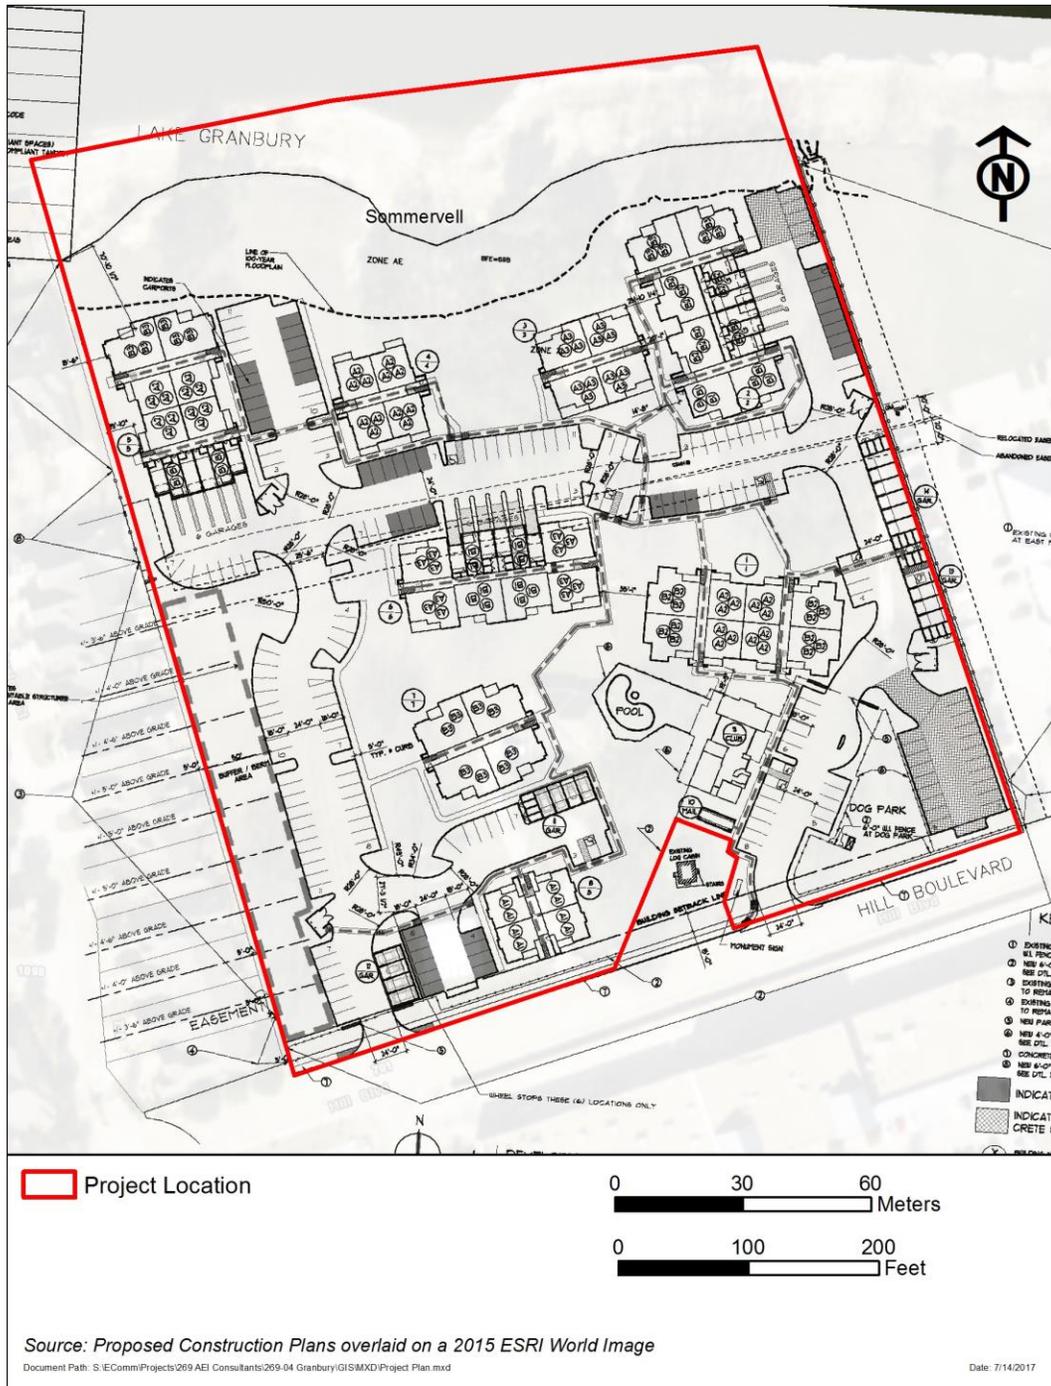
Figure 3. Proposed Construction Plans

Current design plans call for the development of residential houses with associated garages and parking areas, utility lines, sidewalk, stone walls, and a pool within the 9.1-acre tract referred to as the APE (**Figure 3**). Although the exact depth of ground disturbing activities has not yet been determined, subsurface investigations within the APE were assessed to culturally sterile soil. As the project will require compliance with Section 106, an assessment of indirect effects will be required per Section 106 guidelines. Thus, any structure of historic age encountered within the footprint of proposed construction or within 300 feet (approximately 100 m) of the APE, was photographed and assessed for potential eligibility for listing on the National Historic Register of Historic Places (NRHP).

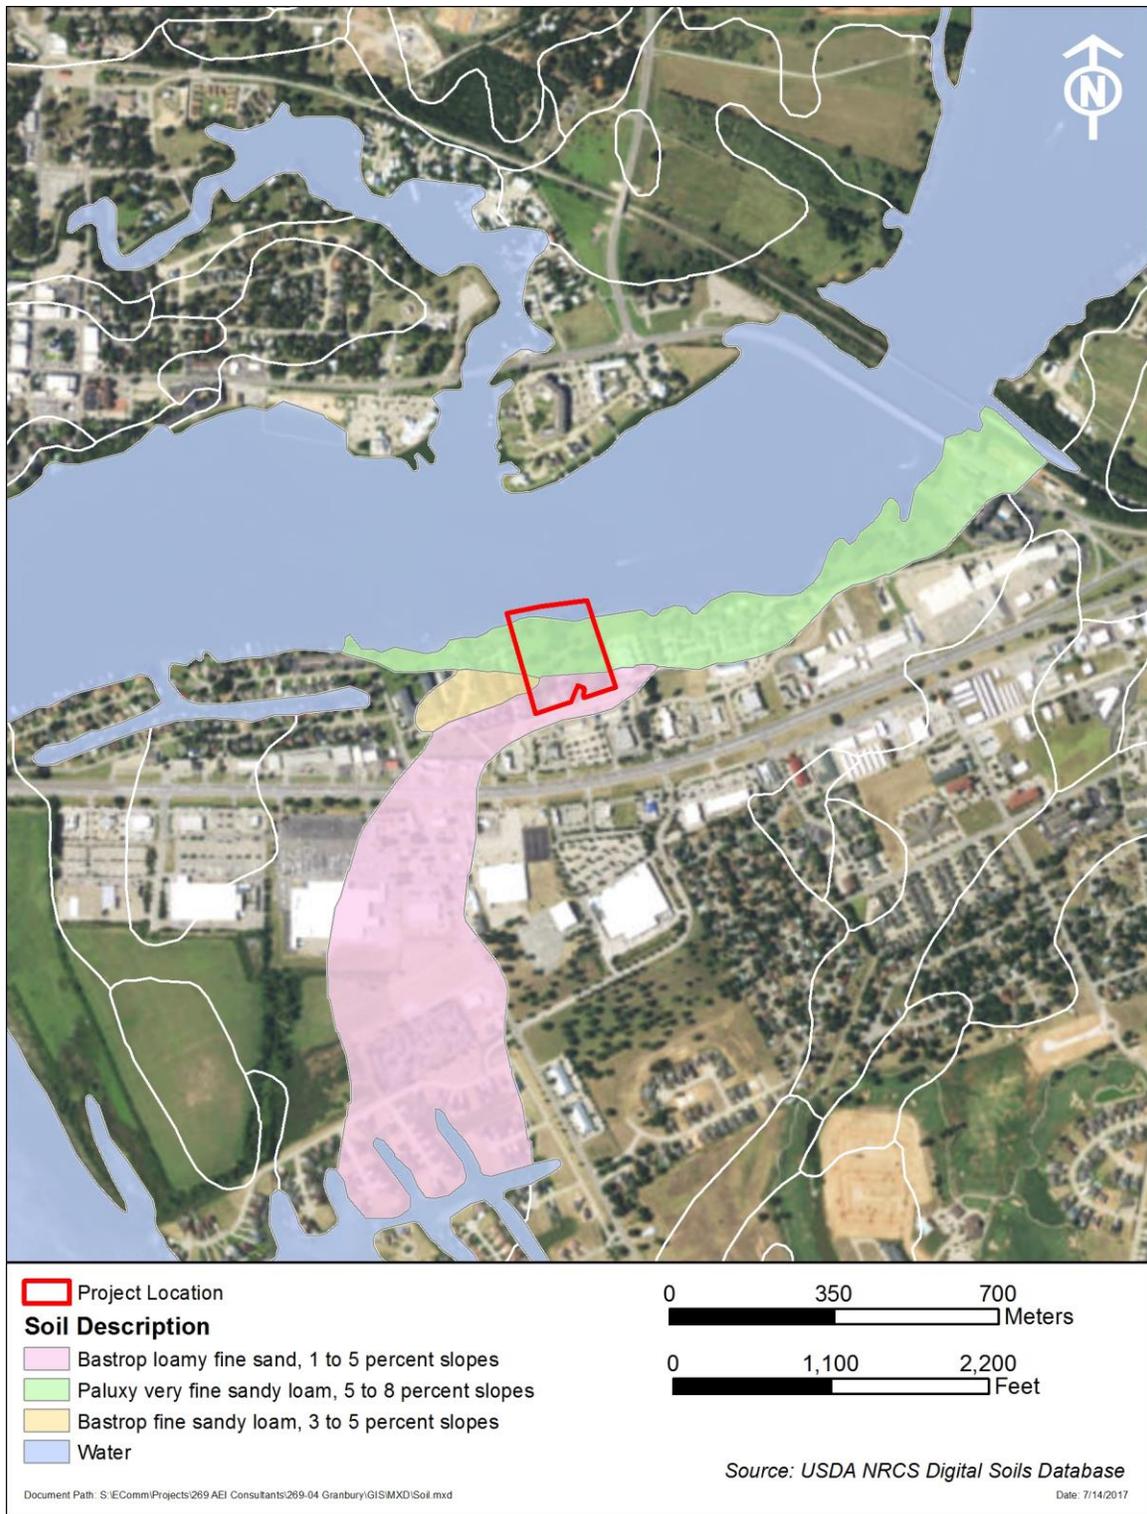
Figure 4. Soil Types within the APE.

Three soil series are located within the APE (**Figure 4**). **Table 1** provides a brief description of the three soils and their percentages within the APE. According to the *Soil Survey of Hood and Somervell Counties, Texas* (Coburn 1978) and U.S. Department of Agriculture Natural Resources Conservation Service web soil survey data for Hood County (USDA NRCS 2017), the three soil types that dominate the APE are Paluxy very fine sandy loam, 5–8 percent slopes, Bastrop loamy fine sand, 1–5 percent slopes, and Bastrop fine sandy loam, 3–5 percent slopes.

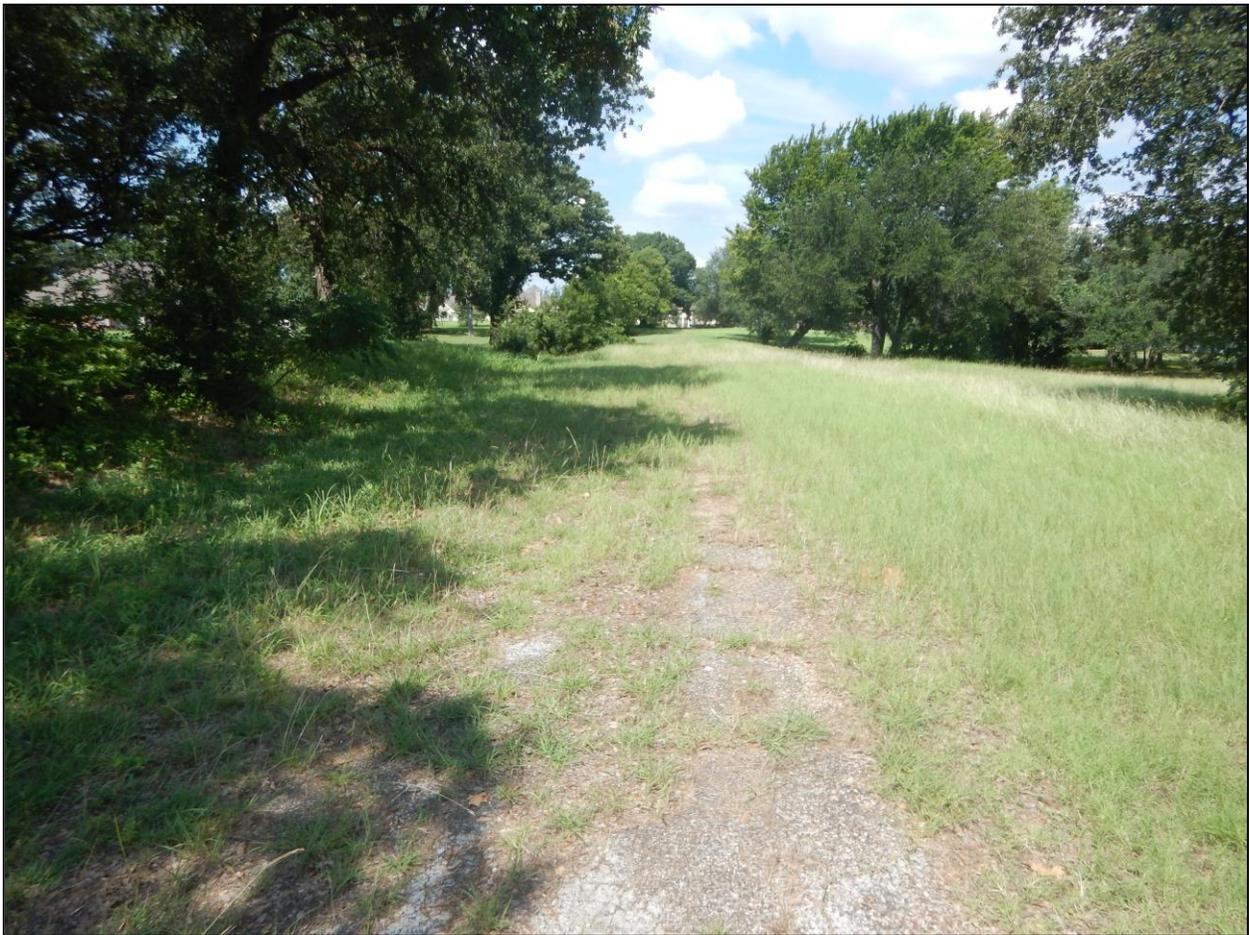
Figure 7. Historic-aged Road within the APE.

Several disturbances were observed during the site delineation that have reduced the site's overall integrity. These disturbances included the construction of a historic-aged road along the southern extent of the site and erosion from the sloping landform and periodic flooding from the lake. Site 41HD94 was a newly recorded prehistoric site with an ephemeral scatter of prehistoric lithic materials from an undetermined age. The site is located within the northeastern portion of the APE and abuts Grandbury Lake. The majority of site 41HD94 is located within a continually eroding area where surface water flows downhill into the lake and cycles of periodic flooding from the lake continually erode the banks. While artifacts were observed along the surface and subsurface, these materials occur in low densities and were general in nature.

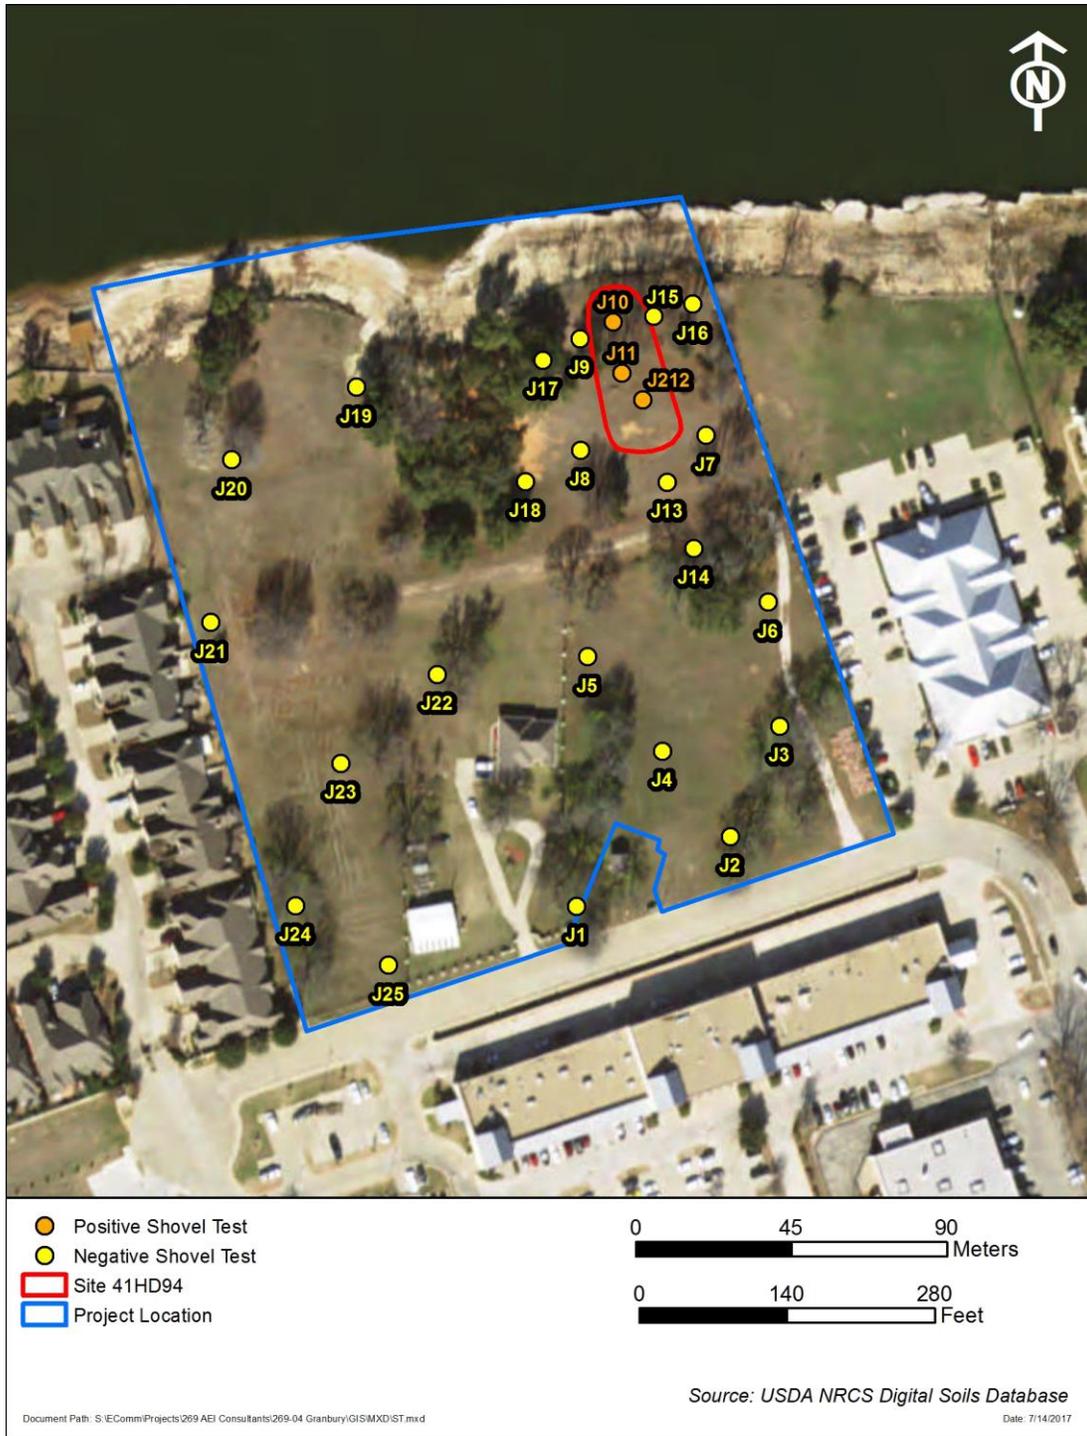
Figure 8. Shovel Test Locations within the APE.

During the pedestrian survey, a total of 25 shovel tests were excavated, of which 22 tested negative and three tested positive for cultural material (**Figure 8**). Although the minimum requirements stipulated by the THC and CTA Archeological Survey Standards for Texas was 19 for the acreage of the APE, six additional shovel tests were excavated during the delineation of an archeological site. Shovel tests excavated within the APE were terminated at an average depth of 55 centimeters below the surface (cmbs) upon encountering a compact clay soil. Shovel tests excavated within the southern half of the APE generally contained deeper soils than the shovel tests within the northern half. Excavating shovel tests within the APE revealed three predominant soil types across the APE which was relatively consistent with the data received from the soil survey. The southern and central portions of the APE were dominated by a sandy loam and sandy clay loam pertaining to the Bastrop loamy fine sand, 1–5 percent slopes. The soils contained a dark red brown (2.5YR 3/3) sandy loam upper layer that overlaid a dark red (2.5YR3/6) sandy loamy clay to sandy clay at approximately 30–50 cmbs. The *Soil Survey of Hood and Somerville Counties, Texas* (Coburn 1978) and the USDA NRCS Digital Soils Database (2017) indicated the central and northern portions of the APE's landscape were comprised of a Paluxy very fine sandy loam, 5–8 percent slopes. However, excavated soils within those portions were more similar to the Bastrop loamy fine sand found within southern portion of the APE. Only two shovel tests located in close proximity to the lake within the northwestern portion of the APE contained very fine sandy soils pertaining to the Paluxy very fine sandy loam soil series.

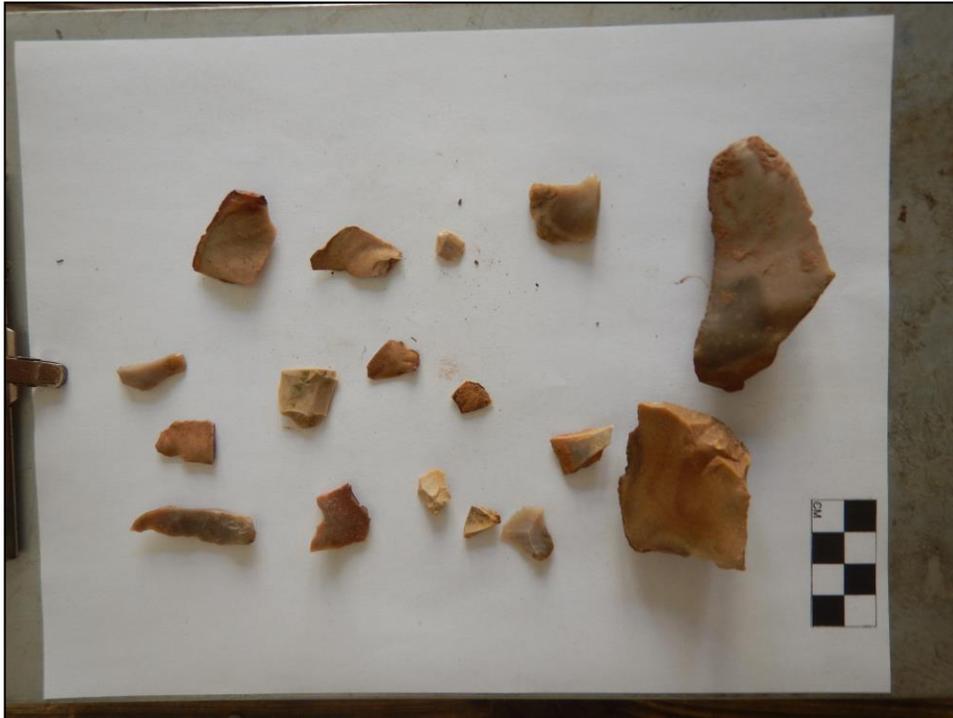
Figure 9. Lithic Debitage Observed within Site 41HD94.

The archeologist manually excavated 12 of the 25 shovel tests within a close proximity to the site area. Groundcover was limited due to short grasses throughout the site, as well as senescent foliage covering the ground within the northern forested portion of the site. The few areas devoid of vegetation were examined and contained a few surface artifacts along the surface. While delineating the site, shovel tests were placed ten meters from the nearest surface artifact or positive shovel test. Three of the 12 shovel test excavated tested positive for cultural materials. The lithic assemblage observed resembled middle and late stage reduction sequences in an area that contained low quality chert sources. A total of 19 artifacts were recorded for the site (**Figure 9**). Five flakes were found within three shovel tests and 13 flakes, a burin spawl, and a quartzite hammerstone were found along the surface. The hammerstone contained evidence of use from peck marks on both faces and light peck marks on one lateral edge (**Figure 10**). The light peck mark patterns on the faces and one lateral edge suggest that the hammerstone was likely used for cracking nuts rather than reducing raw lithic materials, which would have had peck marks on the ends, or grinding, which would have resulted in fewer peck marks and a smoother, potentially polished, surface.

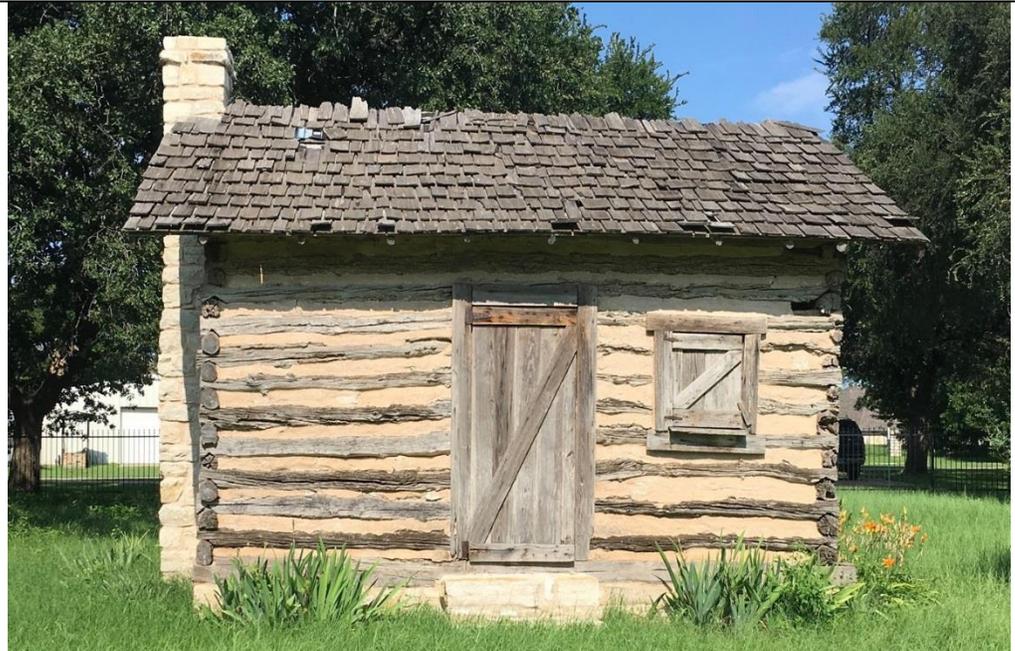
Photo No. 002	Date: June 27, 2017
Direction Photo Taken: Northwest	
Description: Oblique view of the cabin. Modern construction visible in the background.

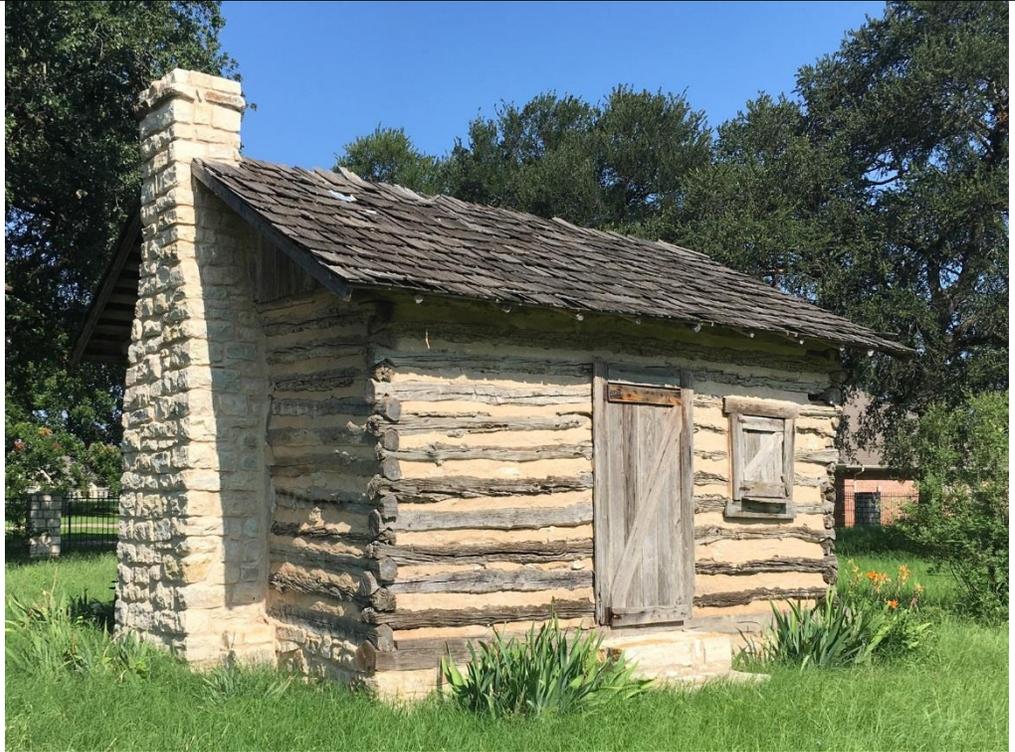
Photo No. 003	Date: June 27, 2017
Direction Photo Taken: North	
Description: South façade of the cabin; view towards Lake Granbury. Stone chimney likely rebuilt when cabin was relocated to this location. Modern construction visible in the background.

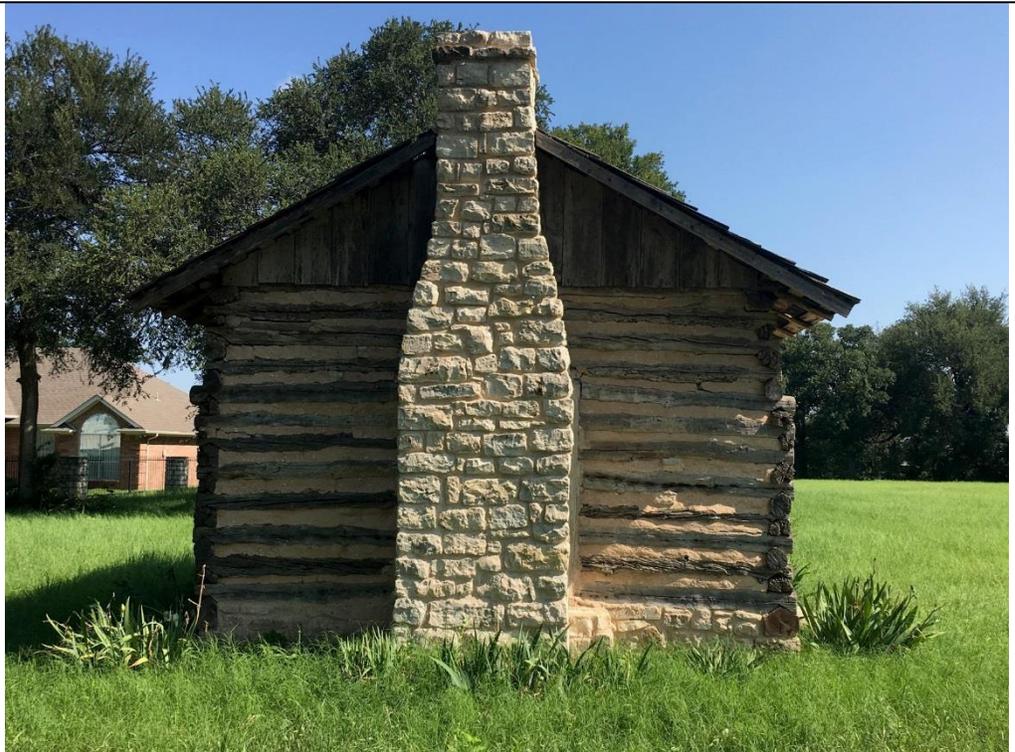
Photo No. 004	Date: June 27, 2017
Direction Photo Taken: Northeast	
Description: Oblique view of the cabin. Modern construction visible in the background.

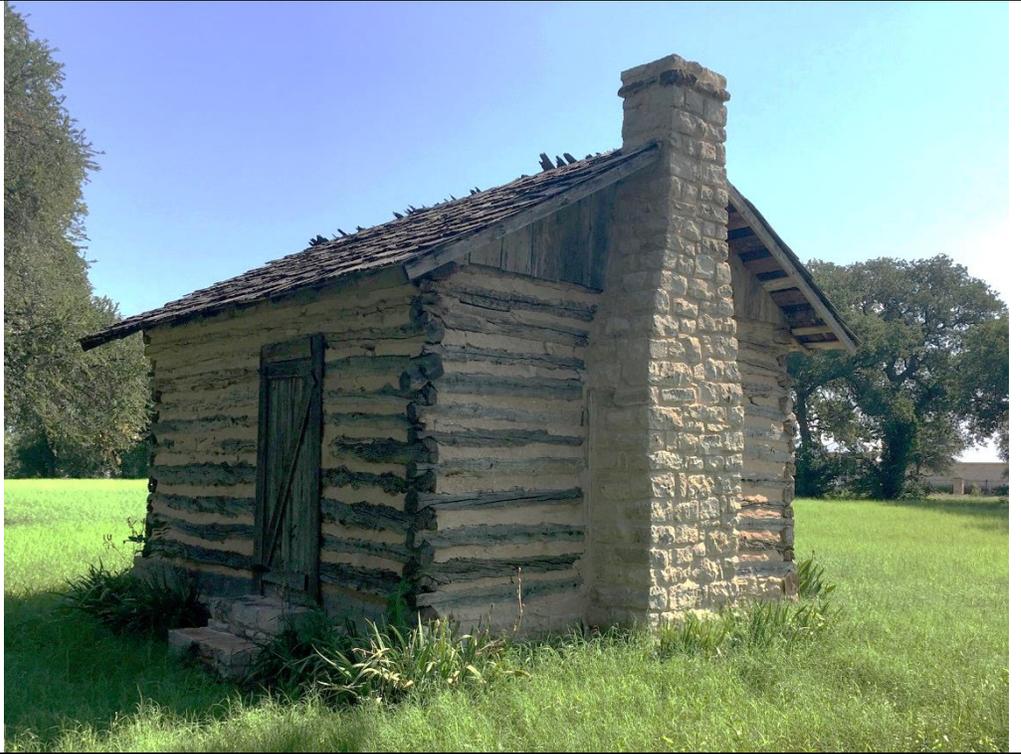
Photo No. 005	Date: June 27, 2017
Direction Photo Taken: East	
Description: West façade of the cabin. Modern construction visible in the background.

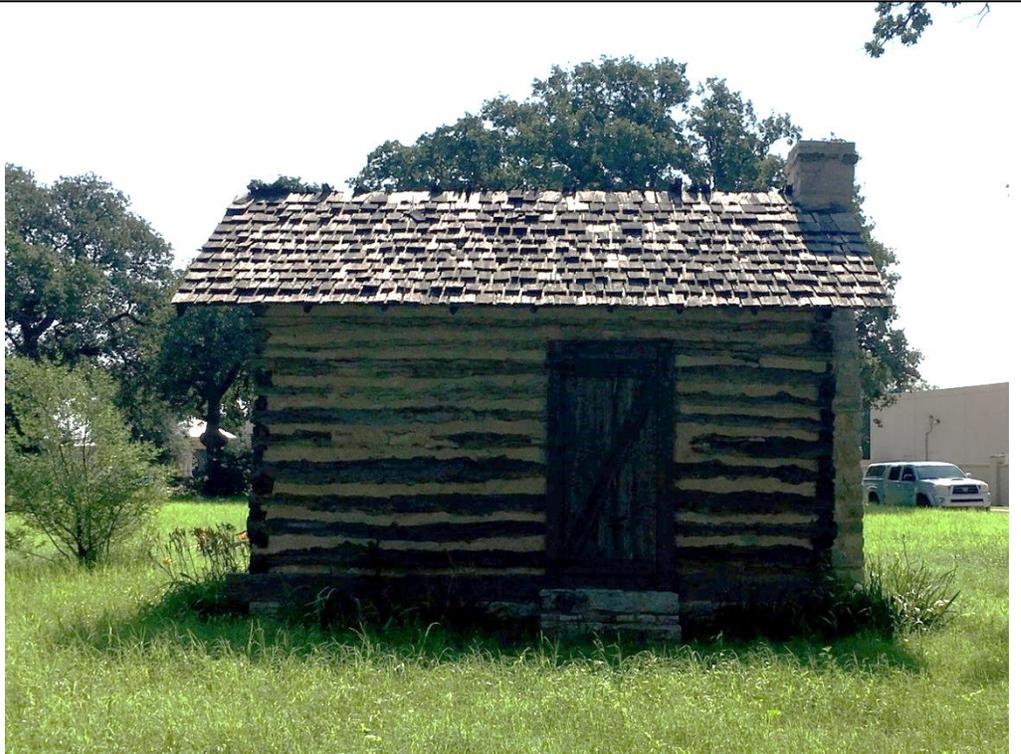
Photo No. 006	Date: June 27, 2017
Direction Photo Taken: Southeast	
Description: Oblique view of the cabin. Modern construction visible in the background.

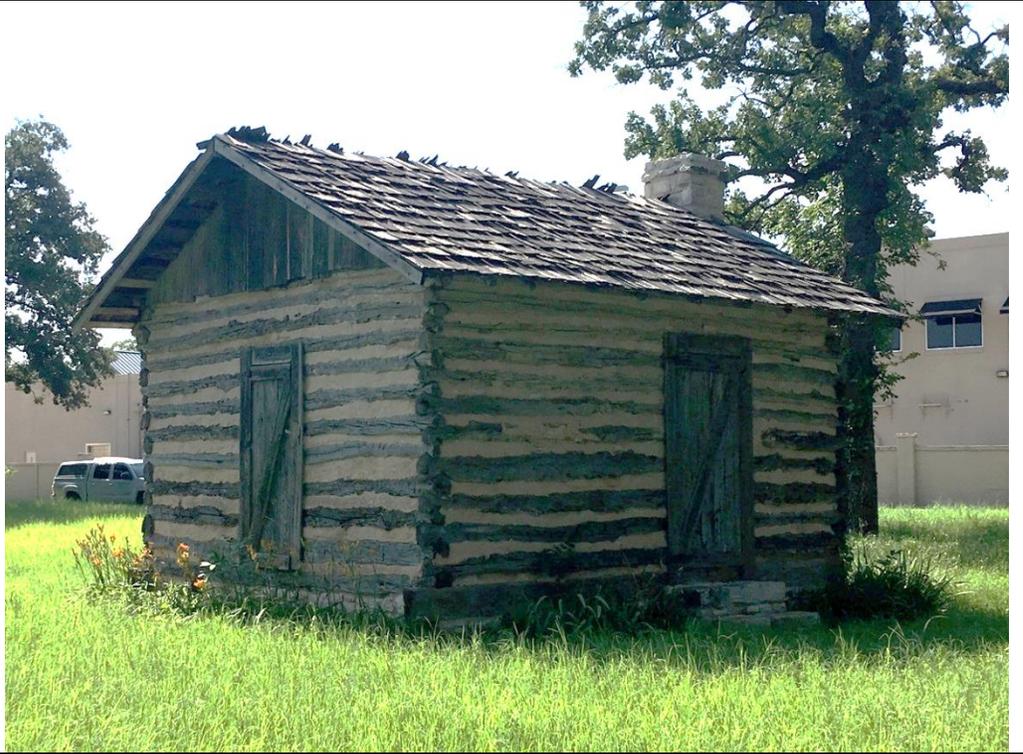
Photo No. 007	Date: June 27, 2017
Direction Photo Taken: South	
Description: North façade of the cabin. Modern construction visible in the background.

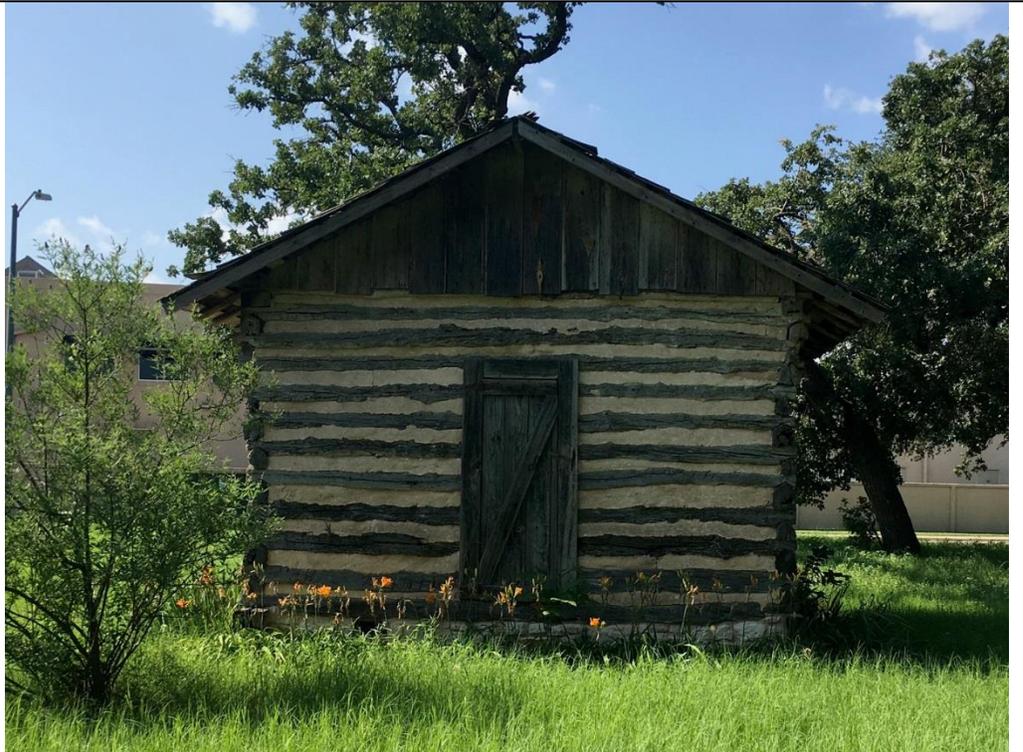
Photo No. 008	Date: June 27, 2017

Direction Photo Taken: Southwest		
Description: Oblique view of the cabin. Modern construction visible in the background.

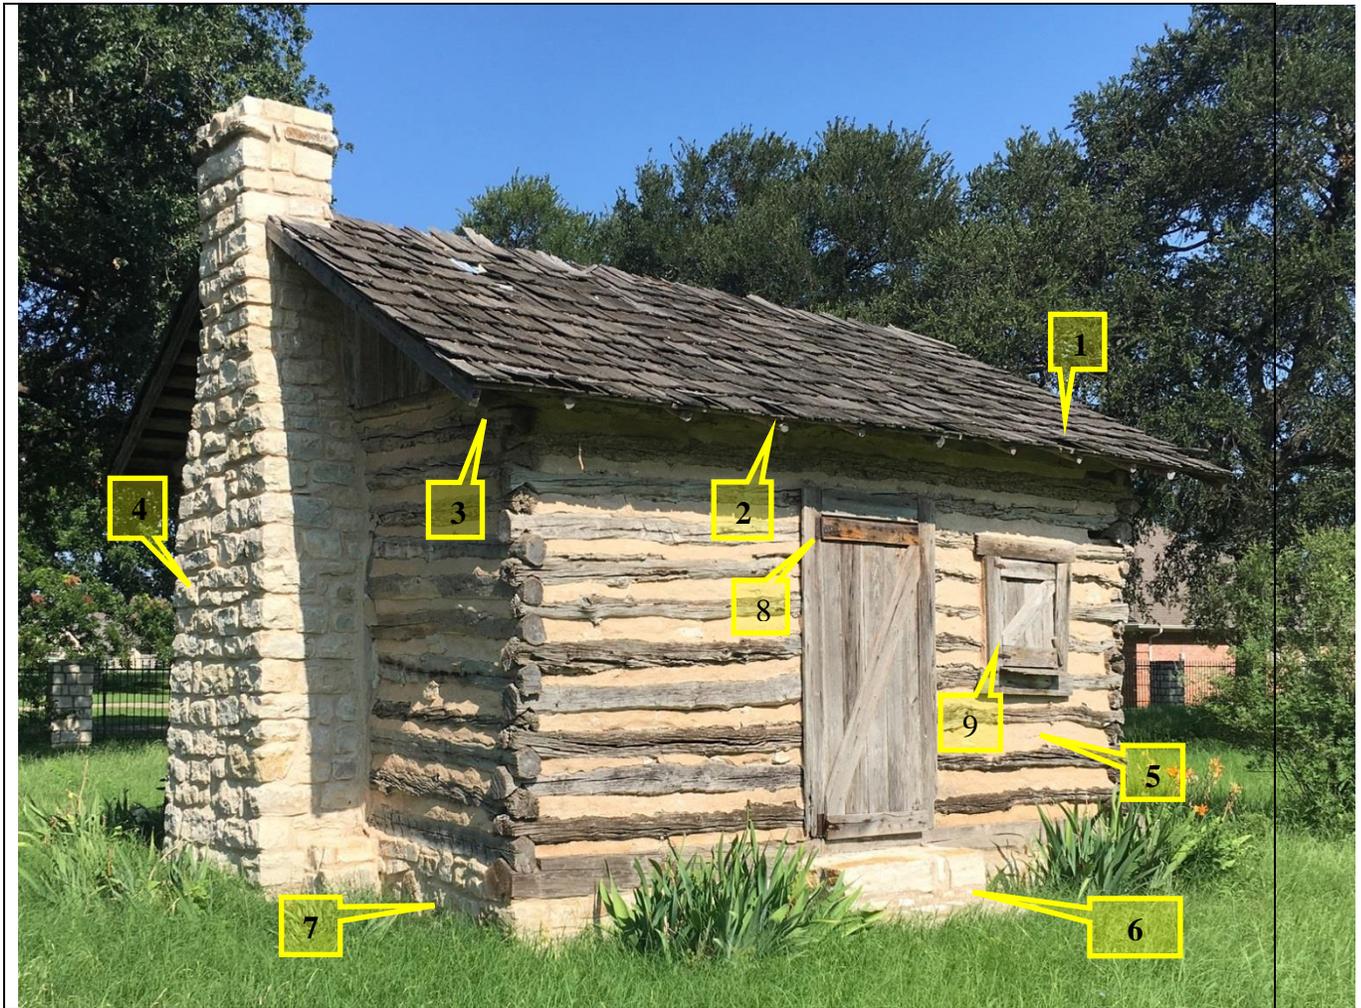
1. Replacement wood shingle roof.
2. Replacement roofing members.
3. Overhang bigger than original design (see 1970 photographs of the cabin below).
4. Chimney rebuilt when moved in 2013 (It is possible that the stone was recycled from original cabin).
5. Replacement mortar is thicker in places than the original design (see 1970s photograph below).
6. Modern steps constructed when cabin was moved.
7. Modern foundation constructed during cabin relocation.
8. Modern hardware replacement.
9. Modern door and window opening framing.

Based on comparison to historic photographs found in newspaper articles and in the History of Hood County documents, the cabin appears to have new roofing materials. In a 1974 photograph, the roof is a corrugated metal sheathing, while the current material is wood shingle. In a description referenced by the Hood County Texas Genealogical Society, the rock cabin that was built by Y. J. Rylee around the same time had hand hewn shingles for the roof. It is likely that the same material would have been used for the cabins as well.

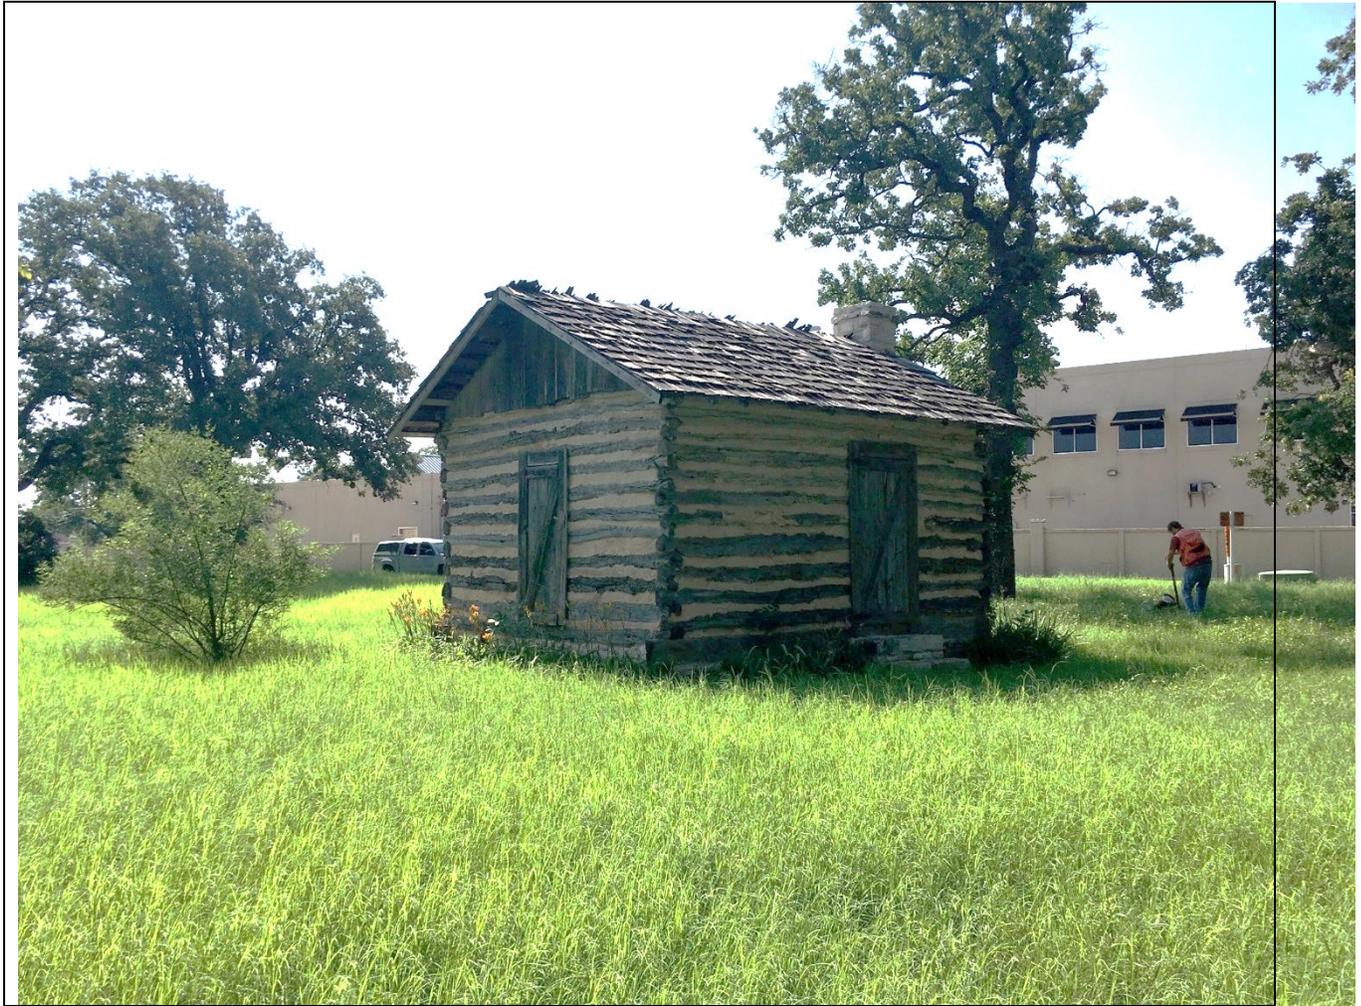
Photo No. 001	Date: June 27, 2017
Direction Photo Taken: Northwest	
Source: AmaTerra Environmental, Inc.

1. Replacement wood shingle roof.
2. Replacement roofing members.
3. Overhang bigger than original design (see 1970 photographs of the cabin below).
4. Chimney rebuilt when moved in 2013 (It is possible that the stone was recycled from original cabin).
5. Replacement mortar is thicker in places than the original design (see 1970s photograph below).
6. Modern steps constructed when cabin was moved.
7. Modern foundation constructed during cabin relocation.

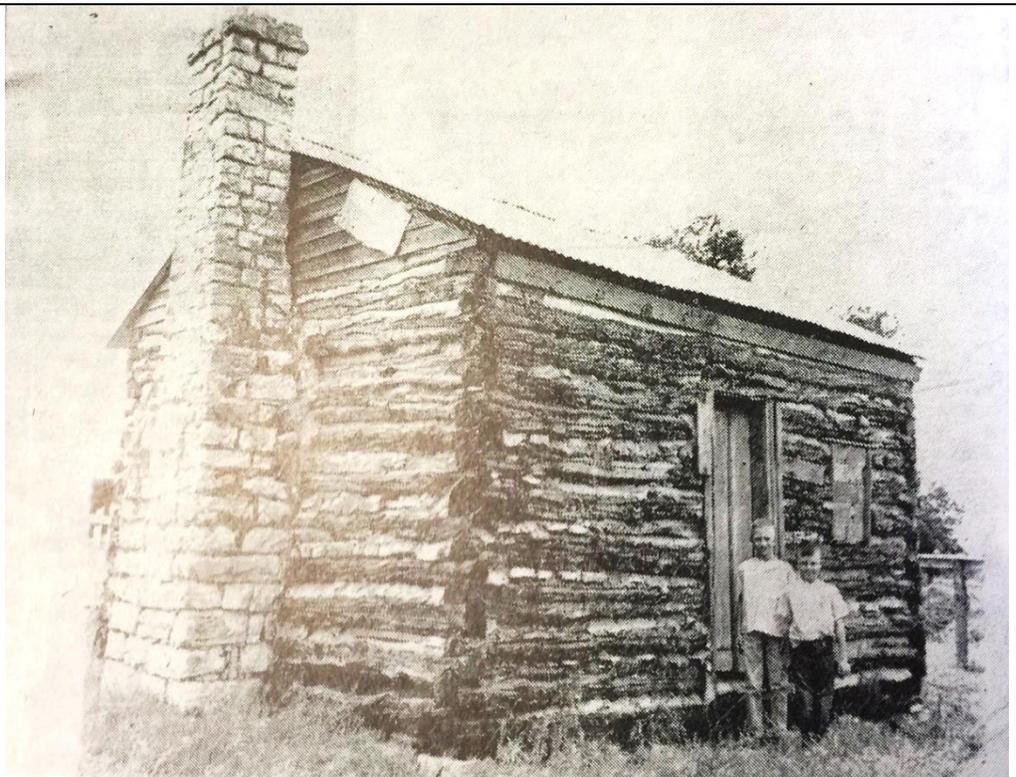
Photo No. N/A	Date: c. 1965
Direction Photo Taken: Northwest	
Source: Hood County History in Picture and Story: 1970.

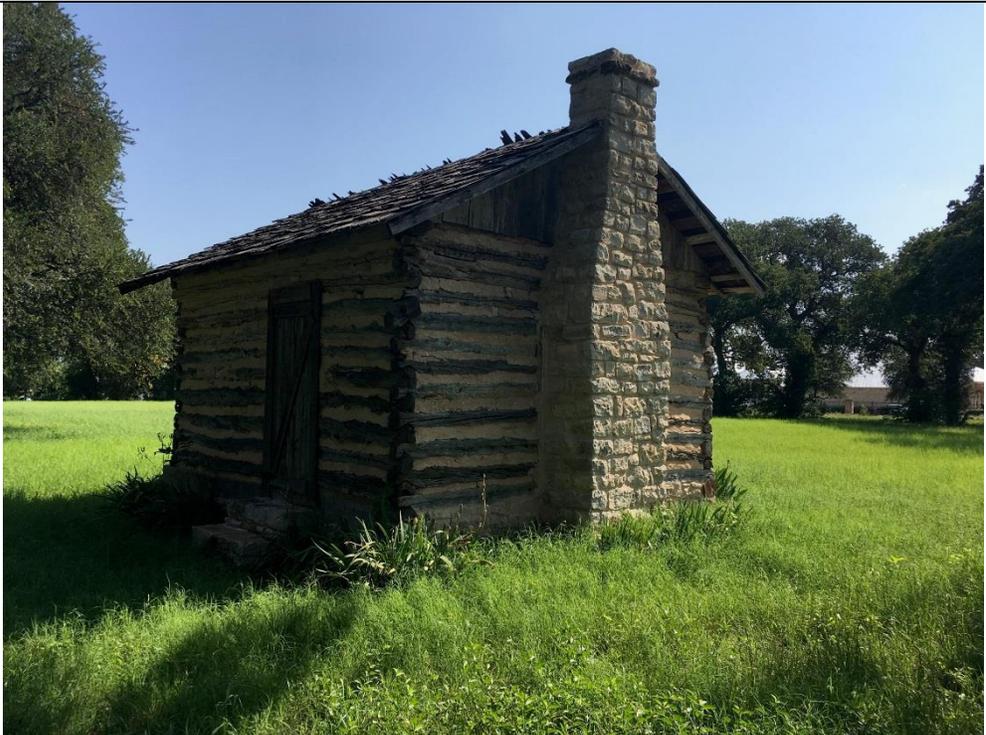
Photo No. N/A	Date: June 27, 2016

Direction Photo Taken: Northeast		
Source: AmaTerra Environmental, Inc.

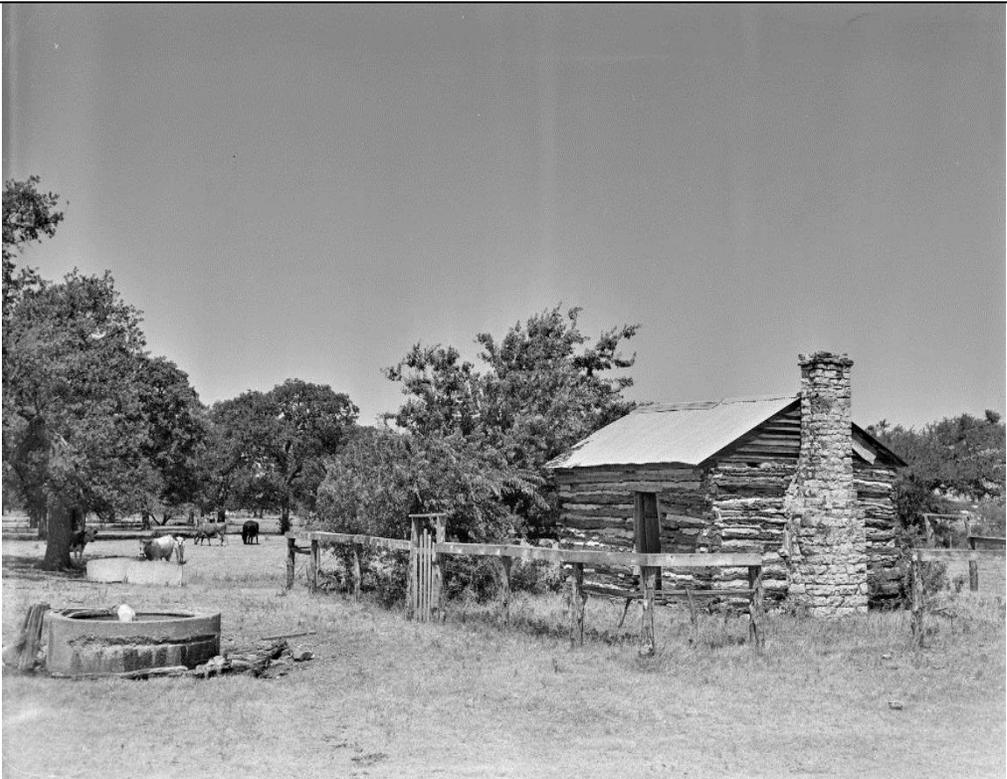
Photo No. N/A	Date: c. 1974

Direction Photo Taken: Northeast		
Source: Ferry Master's Cabin in Granbury, Texas, 1974.
