## **Cultural Resources Survey for the Beck Branch Bank Stabilization Project, City of Richardson, Collin County, Texas**

CULTURAL RESOURCES REPORT

Prepared for:  
Texas Historical Commission  
Texas Antiquities Permit #8911

On Behalf of:  
Nathan D. Maier Consulting Engineers, Inc.  
and  
The City of Richardson

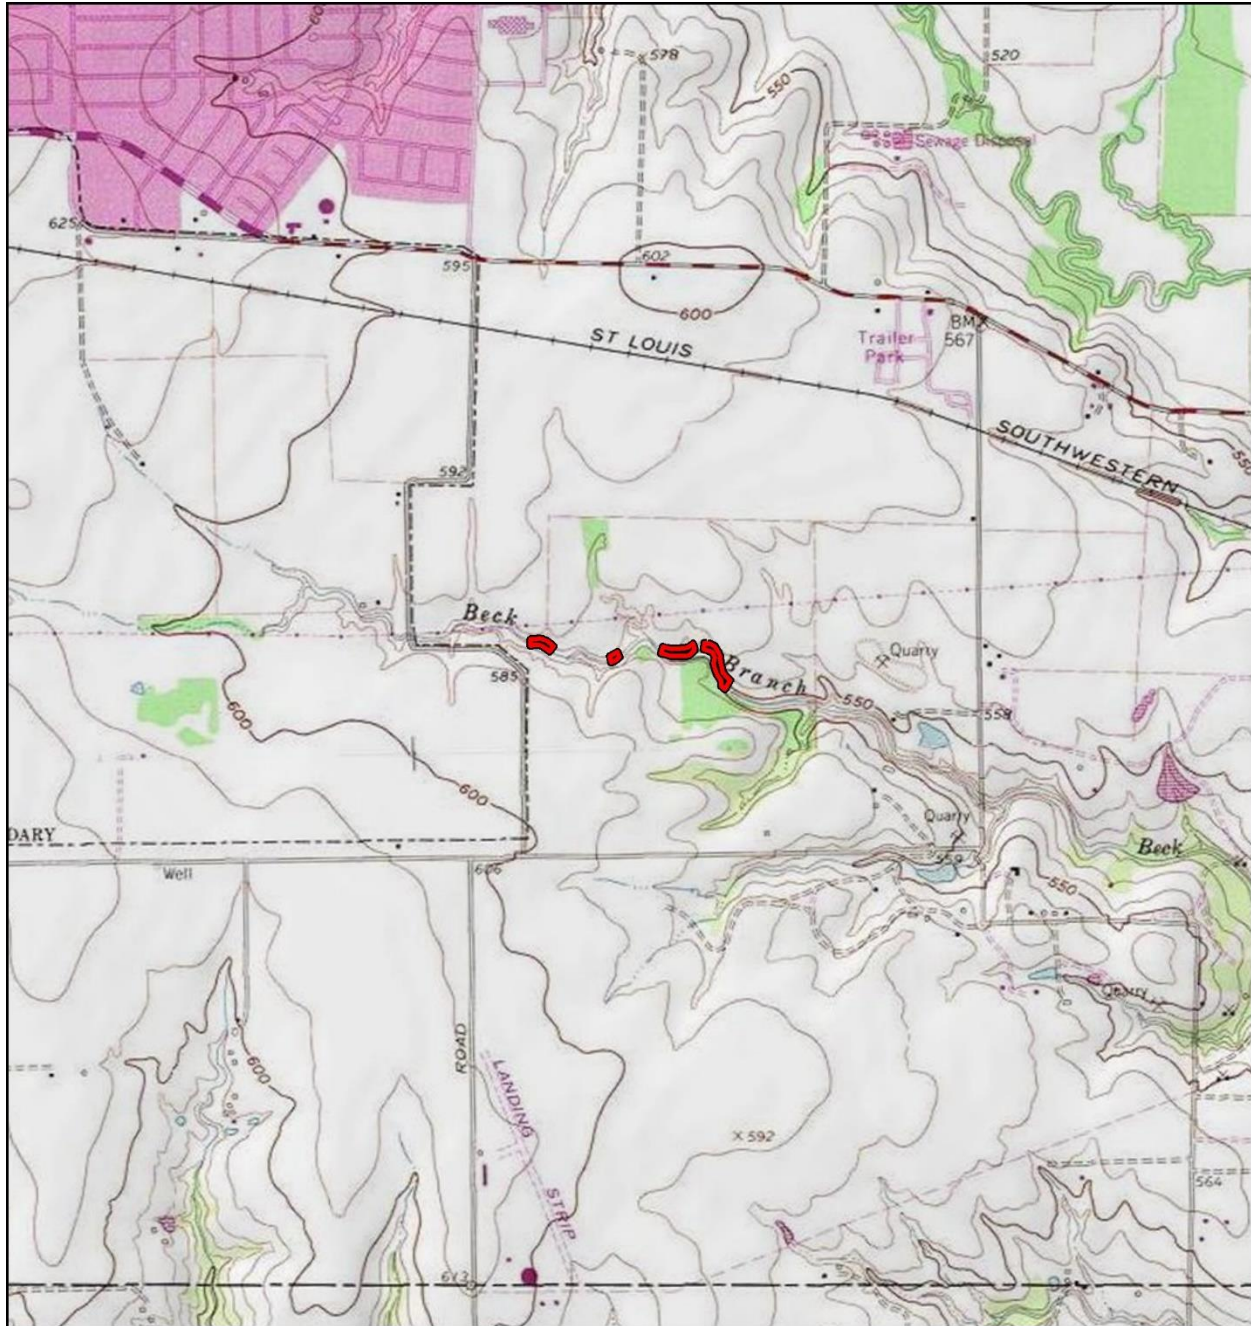
<p><b>Figure 1.2</b> Topographic Setting</p>	<p>

0 2,000 4,000 ft</p>
<p>County: Collin State: Texas Date map created: 6/24/2019 Source: USGS Topographic Map 7.5-min quadrangle(s): Plano (1974); Garland (1974) IES Project Ref: 04.051.046</p>

The Plano 7.5-minute USGS topographic quadrangle map illustrates that the APE is located along the channel of Beck Branch and the adjacent upland shoulder slopes (see **Figure 1.2**). The project area is in the upper reaches of the watershed, which generally flows in a west-to-east orientation through the APE. The stream has incised into the underlying bedrock along the entire course within the project area. The APE occupies an elevation range of 650 to 670 ft above mean sea level (amsl).

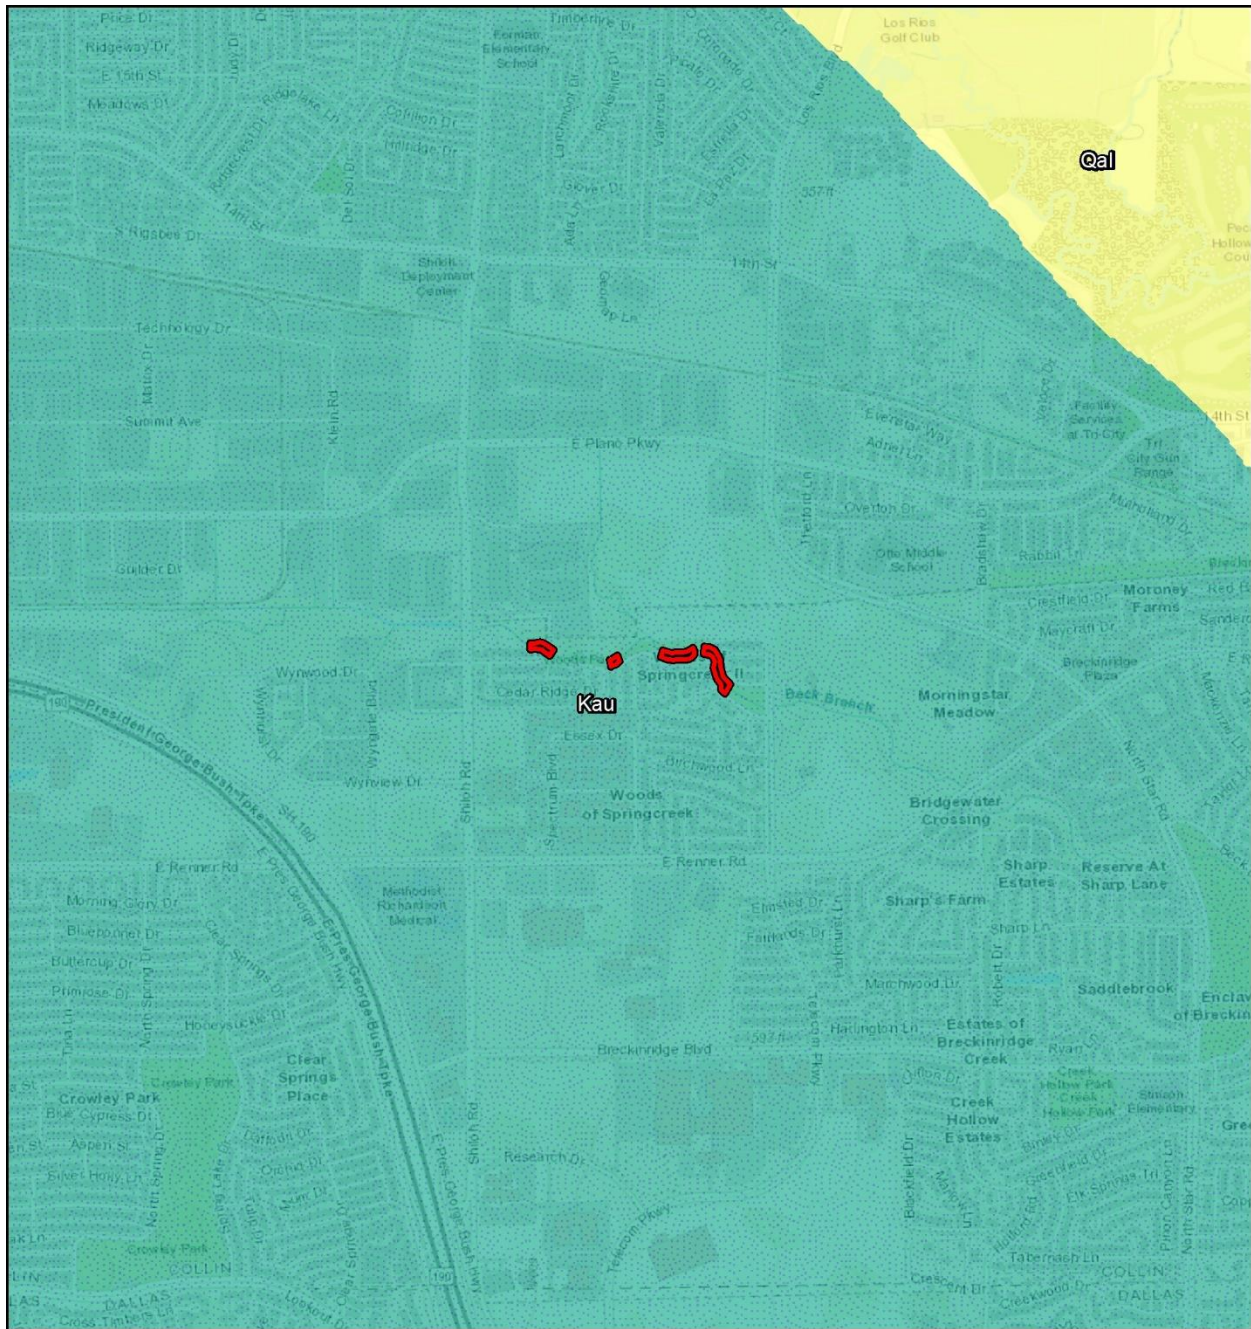
The project area is located within the Northern Blackland Prairie subregion of the Texas Blackland Prairie ecoregion (Griffith et al. 2007). The Northern Blackland Prairie is distinguished from surrounding regions by gently rolling hills and black, fine-textured soils and that primarily support prairie vegetation. Historical vegetation included little bluestem, big bluestem, yellow Indiangrass, and tall dropseed. Most of the prairie has been converted to cropland, non-native pasture, and expanding urban uses around the Dallas-Fort Worth metroplex. Vertisols dominate the Blackland Prairie ecoregion and consist of high clay content soils with significant shrink and swell potential. Soils within the APE are underlain by the Cretaceous-age Austin Chalk Formation (Kau), which is characterized by massive chalky limestone deposits with thin marl interbeds that has weathered upwards, forming the deep vertisols that mantle the Blackland Prairie region (McGowen et al. 1987; **Figure 2.1**).

preserved contexts. Despite the recommendations of the TxDOT PALM, the APE is within a dissected upland area within *situ* soil development, extensive erosion, and is located nearly 1 mi away from soils that have developed within Quaternary-age alluvial sediments (Qal; see **Figure 2.1**).

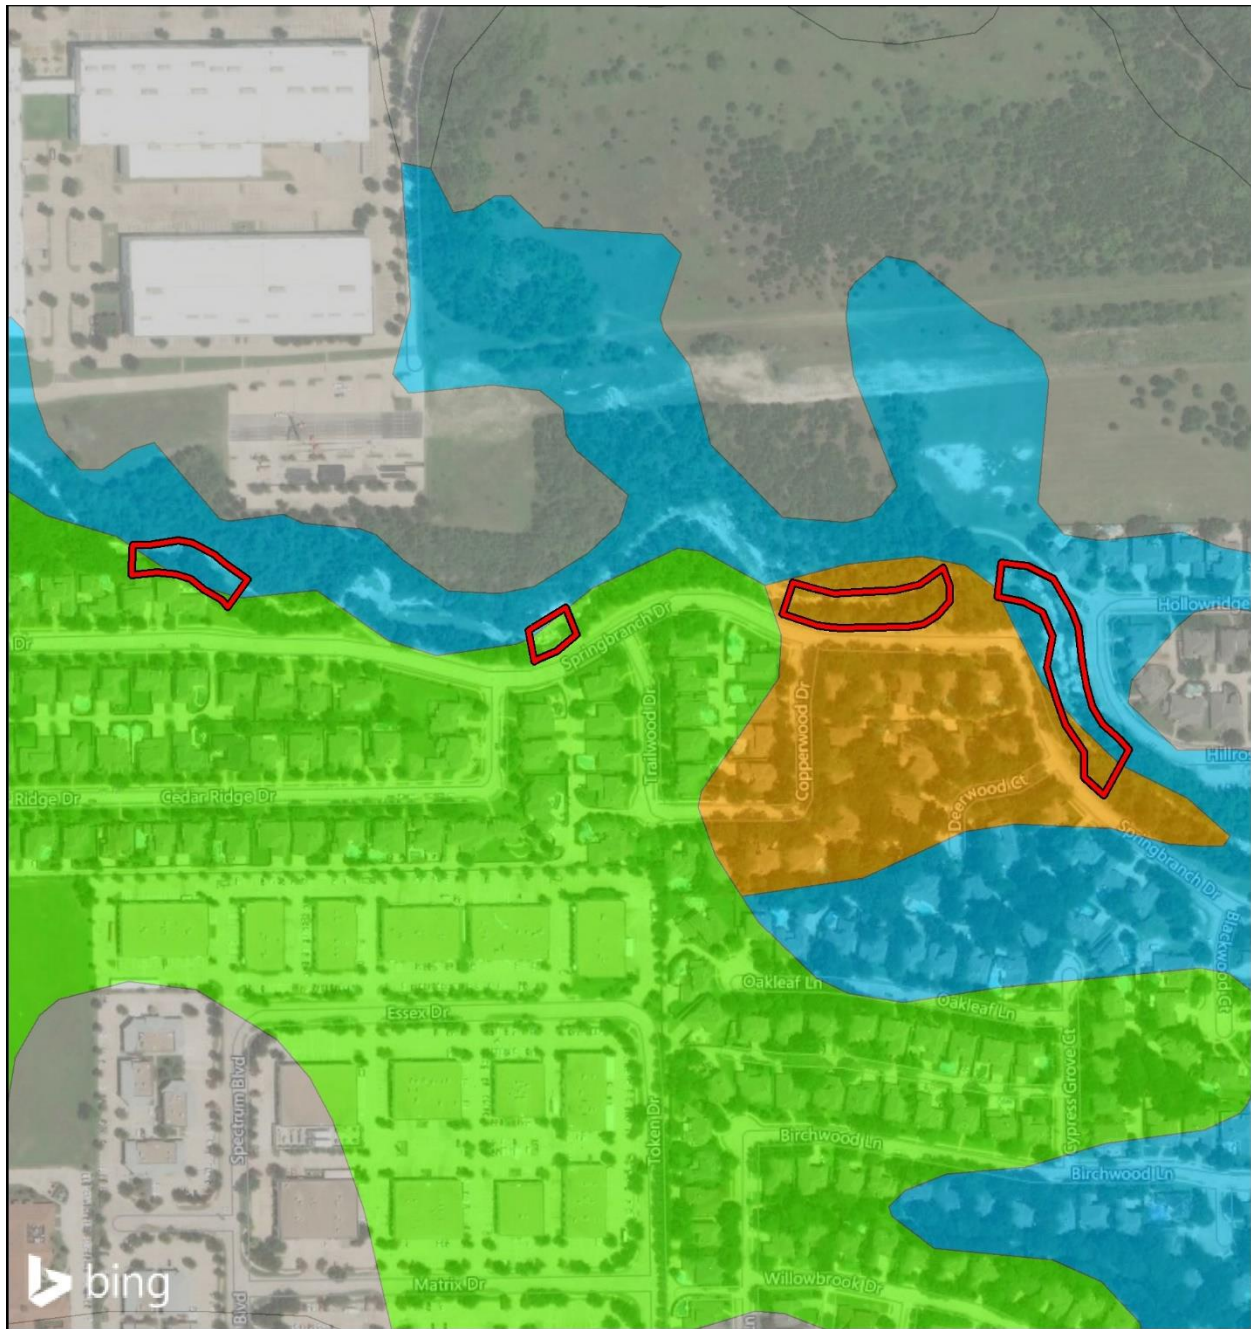
**Figure 2.2**  
Soil Map Units Located Within  
and Adjacent to the APE

HoB - Houston Black clay, 1 to 3 percent slopes
-

EdB - Eddy gravelly clay loam, 1 to 3 percent slopes
-

EdD2 - Eddy gravelly clay loam, 3 to 8 percent slopes, eroded
-

As shown by the *Soil Survey of Collin County, Texas*, there are three soil map units within the APE (Hanson and Wheeler 1969; **Table 2.1**; **Figure 2.2**). The entire APE contains soils typical of *in situ* soil development and erosion within upland settings in the Northern Blackland Prairie region. Soil data was viewed from the U.S. Department of Agriculture (USDA) Natural Resources Conservation Service (NRCS) Web Soil Survey (Web Soil Survey 2019).

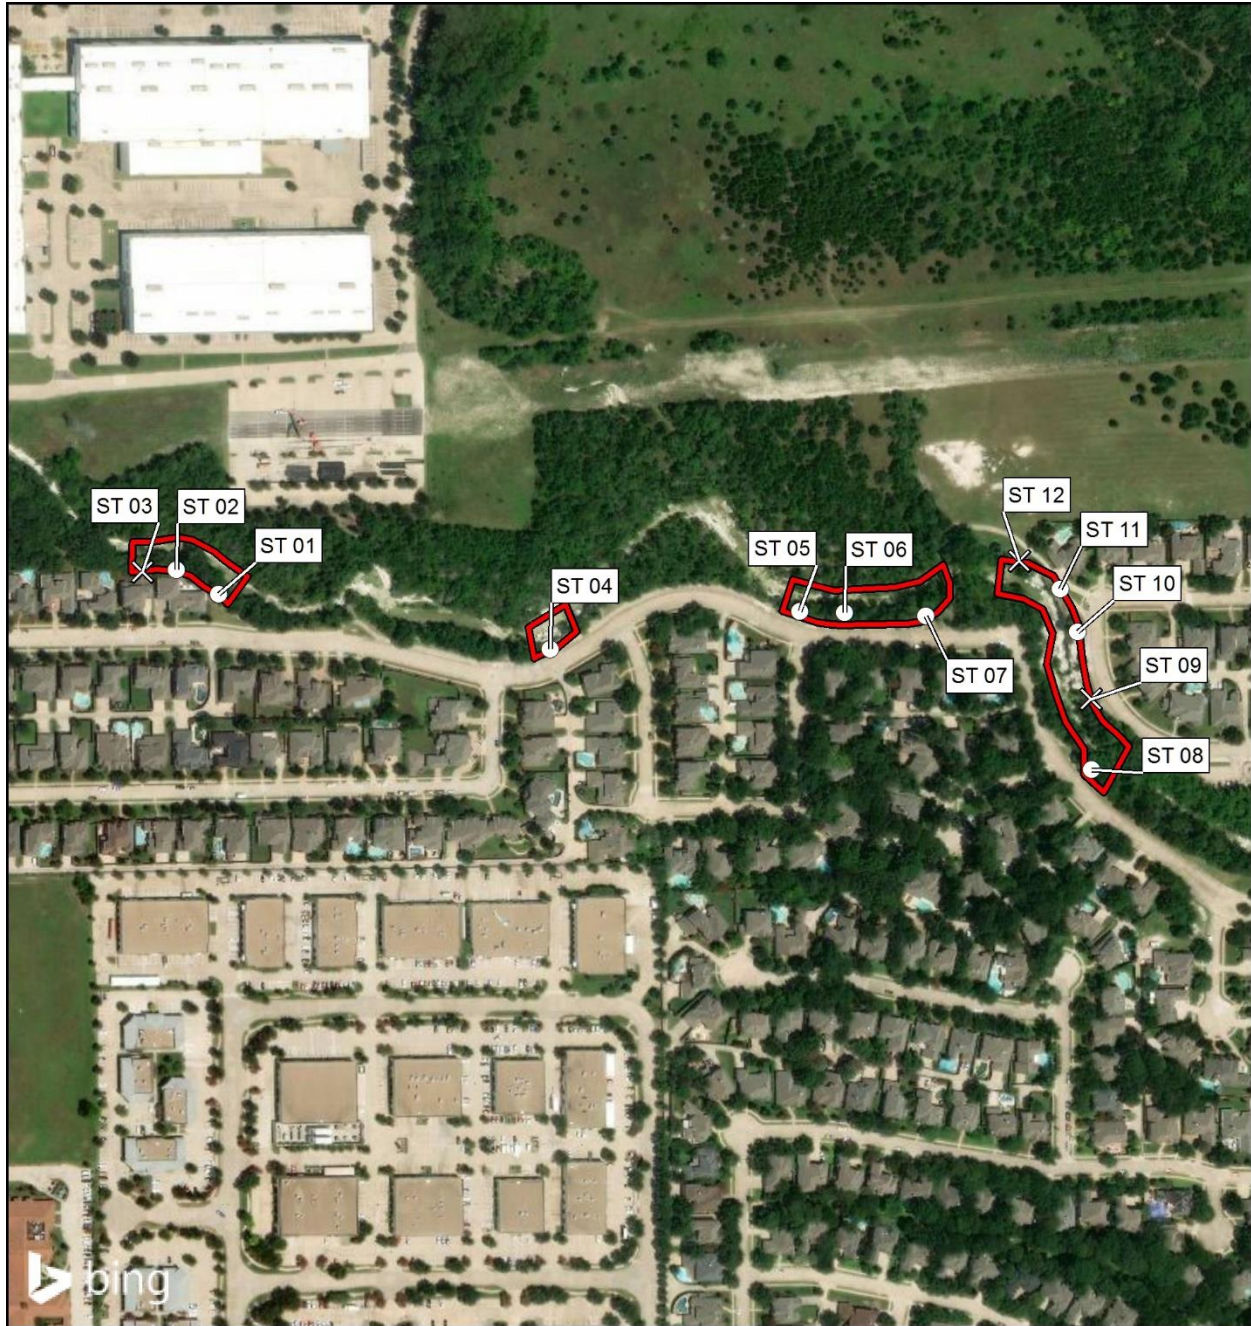
Figure 5.1  
Shovel Test Location Map

- Area of Potential Effects - Direct
- Negative Shovel Test
- X Surface Inspection Location

Shovel tests were conducted within portions of the direct APE with the potential to contain intact buried cultural deposits within the shallow subsurface. During the intensive survey, nine negative shovel tests were excavated within the APE. An additional three locations were recorded, but not excavated due to extensive soil erosion or steep slopes (**Figure 5.1**). Previously disturbed areas identified through background review were visually assessed and photographed during pedestrian transect survey.

Soils exposed within shovel tests generally revealed a profile that transitioned from very dark grayish brown (10YR 2/1 and 2/2) clay loam with small gravel inclusions to a medium grayish brown (10YR 3/2 and 4/1) clay loam or clay that contained larger gravel and chalky limestone or shale regolith. Shovel Test (ST) 11 contained visibly mottled soils of medium grayish brown (10YR 4/2) and reddish brown (10YR 4/4) clay with frequent gravel likely resulting from installation of an adjacent retaining wall and sidewalk. No cultural materials were encountered within shovel tests.

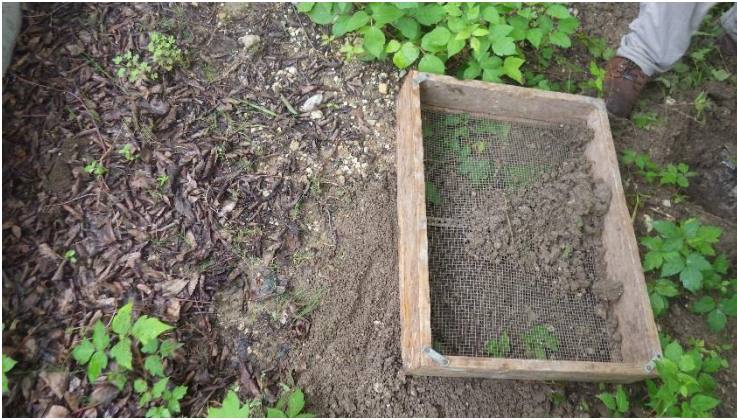
Photograph 5 - Screened soil from ST 01.

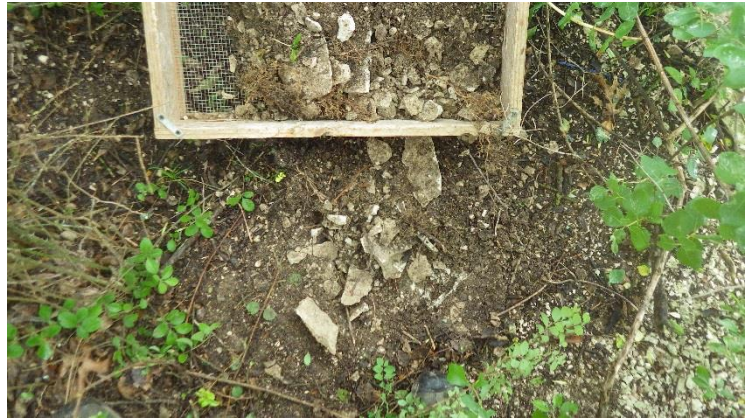
Photograph 10 – Gravel and bedrock at ST 05.

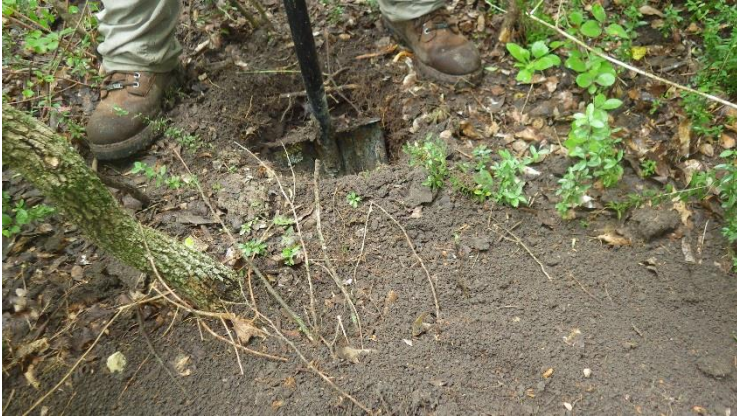
Photograph 11 – Excavation of ST 06, view to the southeast.

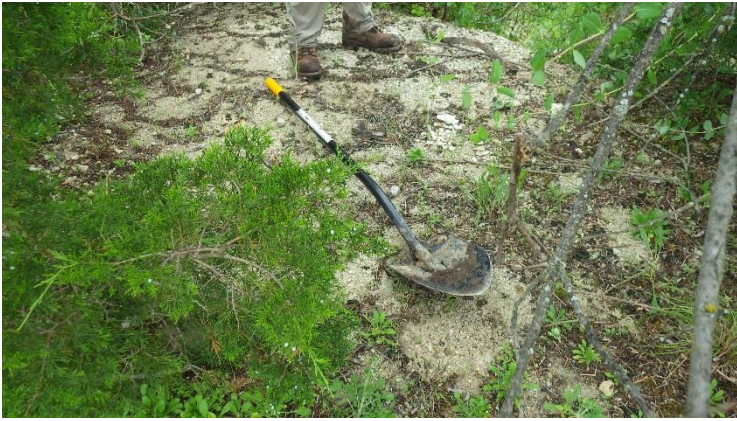
Photograph 17 – Exposed bedrock, view to the south.

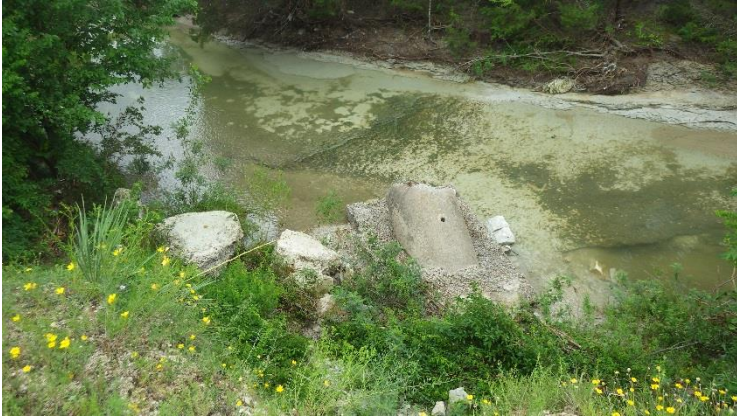
Photograph 25 – Debris in channel from bank erosion, view to the southwest.
