10TH STREET SUBSTATION EXCAVATION OF THE  
ACEQUIA MADRE (41 BX 8), SAN ANTONIO, BEXAR COUNTY, TEXAS

Texas Antiquities Committee Permit No. 441  
Dr. Thomas R. Hester, Principal Investigator

Center for Archaeological Research  
The University of Texas at San Antonio®  
Archaeological Survey Report, No. 153

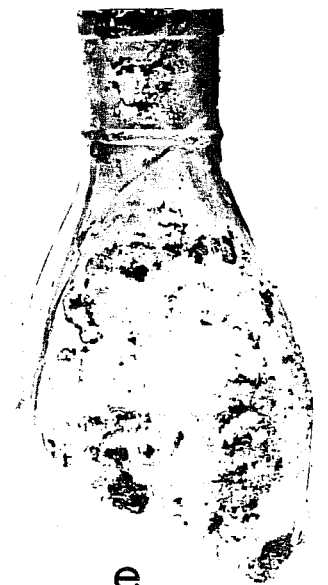
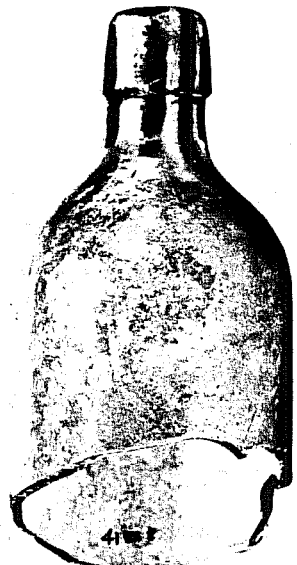
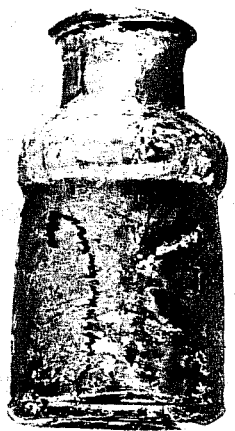
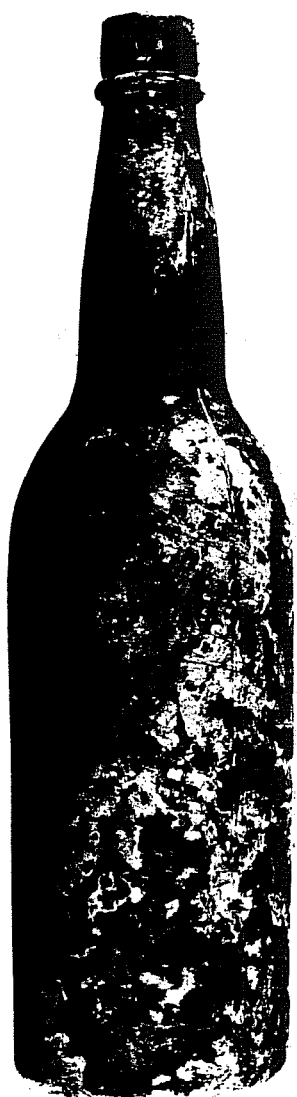
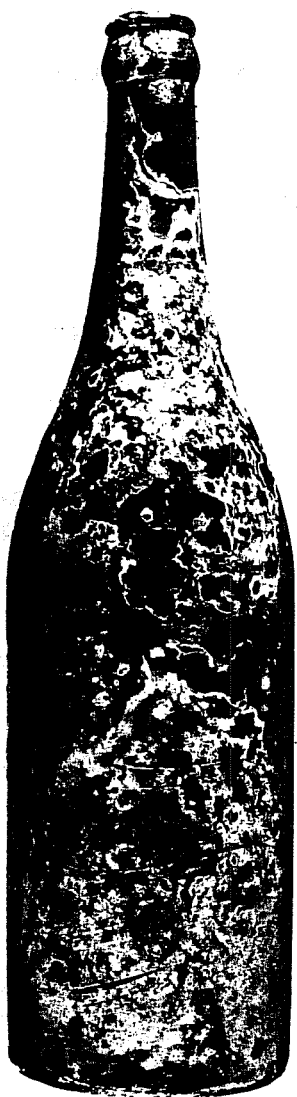
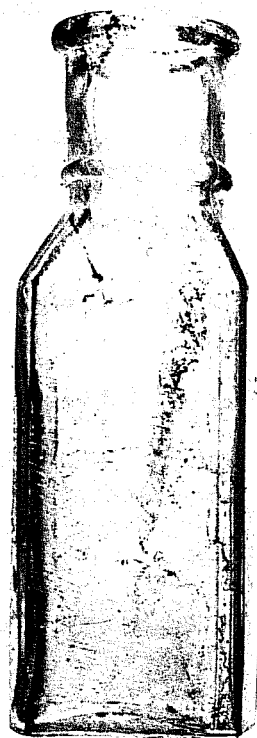
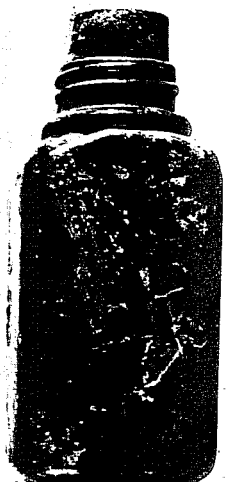
**Figure 4. Selected Glass Artifacts from the Acequia Madre at the 10th Street Substation.**

- a, goblet base;
- b, telephone pole insulator;
- c,d, molded bottles;
- e, clear bottle;
- f, short neck bottle with molded lip;
- g, condiment bottle;
- h, long neck bottle, produced in two-piece mold;
- i, long neck bottle, produced in turn mold;
- j, clear milk or cream bottle;
- k, brown square bottle with screw cap.

- 1 entire clear taper-sided condiment bottle 5-3/8 inches high  
(Fig. 4,g).
- 1 entire extruding shoulder clear bottle with sides tapering to square  
base 3-3/4 inches high (Fig. 4,e).

- 1 entire clear milk or cream bottle, square with truncated corners  
6-3/4 inches high (probably post 1880s; Fig. 4,j).
- 1 brown-shouldered long neck bottle produced in two-piece mold, seam  
extends only to base of lip, 11-1/2 inches high, bottom marked "C M  
Co./F 28" (probably 1880-1900; Fig. 4,h).

- 1 entire brown-shouldered long neck bottle, machine made in turn mold  
with crown cap, 11-1/2 inches high (probably 1892-1900; Fig. 4,i).
- 1 broken aqua-shouldered short neck bottle with molded lip, produced in  
two-piece mold (probably 1880-1900; Fig. 4,f).

- 1 brown square bottle with screw cap, 4-1/2 inches high, marked  
"P M/F S Co." on bottom (Fig. 4,k).
- 1 fragment round cobalt blue bottle.
- 1 fragment square aqua bottle produced in two-piece mold.

- 2 neck fragments of small molded bottles, 1 clear, 1 aqua (Fig. 4,c,d).
- 1 fragment ointment jar.
- 2 fragments lamp chimney.
- 2 fragments of pressed glass tumbler.

- 2 goblet base fragments, clear (Fig. 4,a).
- 1 fragment aqua telephone pole insulator (Fig. 4,b).
