## The Sam Houston Home, 41WA46, Huntsville, Walker County, Texas: 1980-1981 Archeological Investigations and Monitoring

Jody C. Pevey  
*Prewitt and Associates, Inc.*

Archeological investigations at the Sam Houston Home, "The Woodlands," in Huntsville, Walker County, Texas, were conducted by Prewitt and Associates, Inc. from November 1980 through January 1981. Sponsored by the Sam Houston State University, Huntsville, Texas, the work was done in conjunction with restoration of Sam Houston's home, "The Woodlands," and an associated structure commonly known as Houston's "Law Office" (Fig. 1). Restoration work is being done by Cox Construction Company of Fredericksburg, Texas, in conformance with restoration plans developed by Bell, Klein and Hoffman, restoration architects, of Austin, Texas. The archeological work accomplished under the present contract agreement conforms to the provisions of State of Texas Antiquities Permit No. 258; the Principal Investigator was Elton R. Prewitt and fieldwork was supervised by Jody Pevey, Project Archeologist.

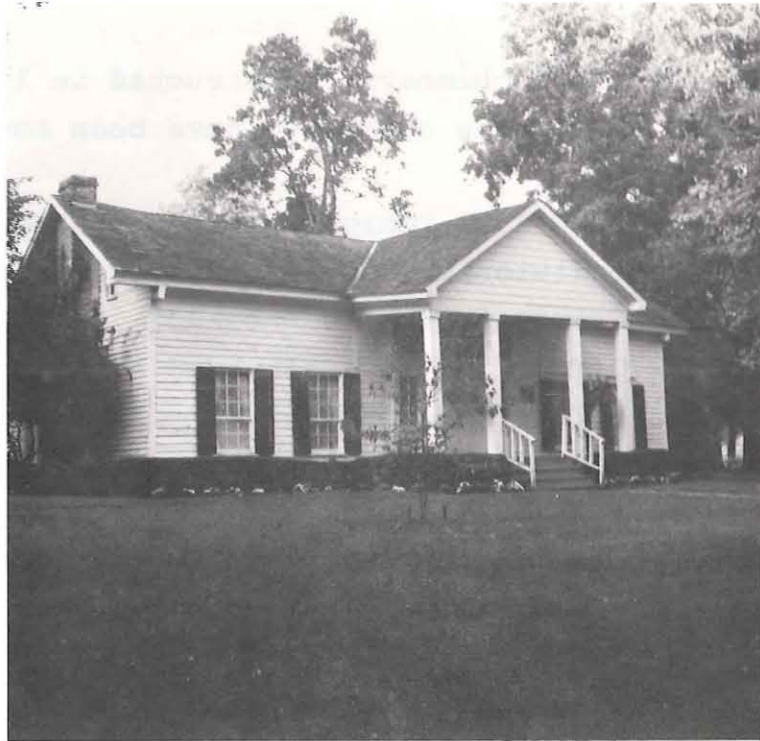
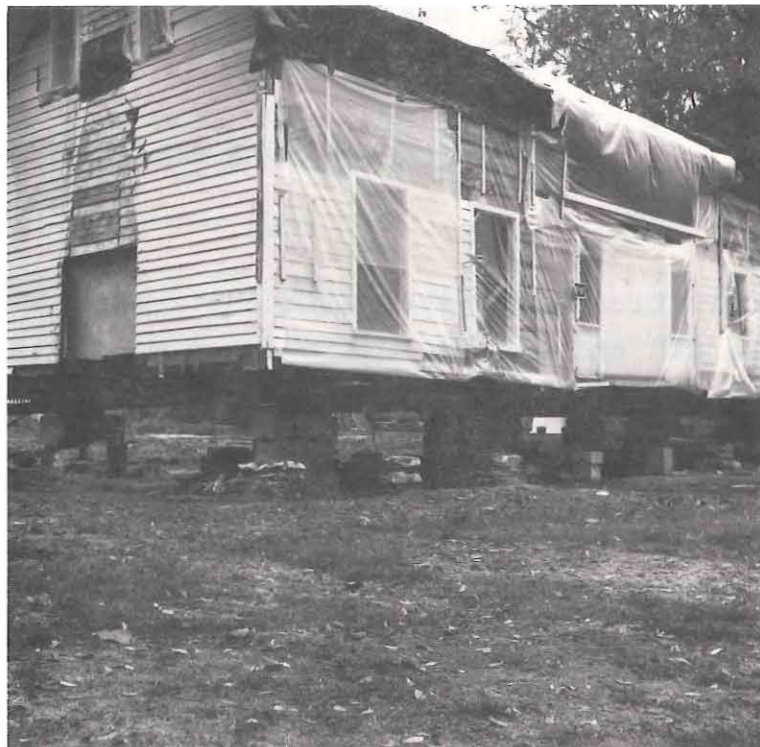
Figure 2

Figure 2. General Site Photographs

- a.* Sam Houston Home, October 1979, looking southwest, before restoration activities.
- b.* Sam Houston Home, November 1980, looking southwest, in-progress restoration activities.

(1) the house proper has been raised and placed on pine supports which coincide indirectly with the exposed 1929 cement foundation piers (Fig. 2a and b);

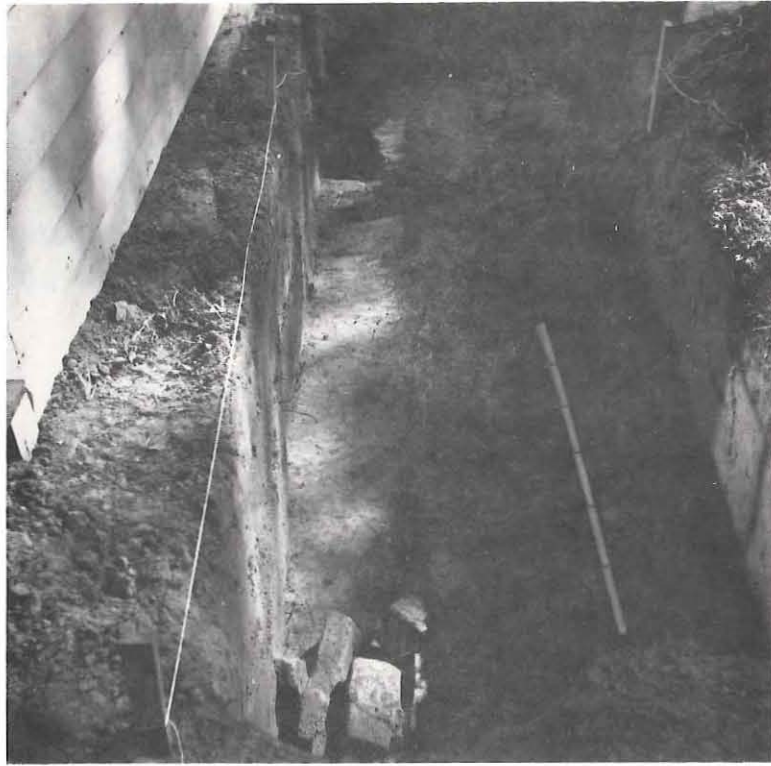
Figure 4

Figure 4. General Excavation Photographs

- a. Test Pits 29, 26 and 22 looking east showing mid-nineteenth century exterior brick foundation piers (Features 17 and 13) and laid brick coursework (Feature 19). Structure in left of photograph is the south wall of rear porch.
- b. Test Pit 48 looking north showing interior brick foundation pier (Feature 3) appearing in foreground. Post molds (Features 6 and 8), prominent square post mold (Feature 7), and miscellaneous pit (Feature 5) showing in Test Pit 50. Sandstone foundation pier in lower right-hand corner dates to the 1929 renovations.

The brick foundation piers recorded during the present and previous investigations can be divided into exterior (Features 12, 13, 15, 16, 17 and 19) (Fig. 4a) and interior (Features 3 and 4) (Fig. 4b) supports based on their location relative to the reconstruction of the rear porch (*see* Fig. 3). Four exterior piers, one at each corner of the porch (Features 12 and 13) and two located between these corners (one [Feature 17]

A total of six post molds, two rectangular in plan (Features 7 and 8) and four cylindrical in plan (Features 1, 2, 6 and 11) were recorded in Test Pits 48, 49, 50 and 52; all were located directly beneath the rear additions (Fig. 4b). No evidence of specific alignments or arrangements of the features were noted which might provide indications of their purpose. The only potentially diagnostic materials recovered from the feature matrix were wood fragments from Feature 2 and a fragment of barbed wire dating to around the turn of the century from Feature 1.

A pit encountered in Test Pit 50 was recorded as Feature 5 and was partially excavated (Fig. 4b).
