Archaeological Monitoring and Testing Associated with the Restoration at Mission Francisco de la Espada (41BX4), San Antonio, Bexar County, Texas

by
Antonia L. Figueroa
and
Leonard Kemp

Prepared by:
Center for Archaeological Research
The University of Texas at San Antonio
One UTSA Circle
San Antonio, Texas 78249
Archaeological Report, No. 448

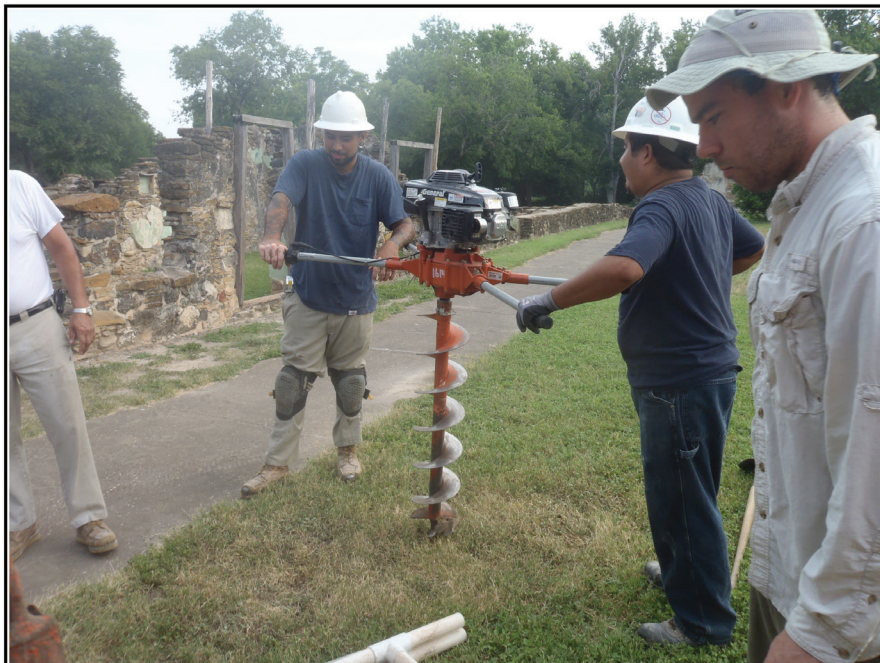
Figure 3-1. Gas powered auger used to excavate bollard and auger holes.

Based on the assessment of the bollard data and previous excavations, 16 tests were excavated in the APE. Nine auger holes were dug with a mechanical auger (Figure 3-1) by personnel with Pugh Constructors. Auger holes were approximately 18 cm (7 in.) in diameter. Excavations were terminated at 20 cmbs (7.9 in.) and were dug in 10-cm (3.9-in.) levels. The depth and location of these tests was based on the depth of gravel in the APE, the depth of the Spanish Colonial foundation and surface encountered in 1998 by Cargill et al. (2004), Fox (1981), and Smith (1980a, 1980b), and the depth of impact associated with the construction. CAR staff screened excavations and collected all artifacts and sediment samples from each test by level. A form for every excavation was also completed. Data collected from each test included the final excavation depth, a tally of all materials recovered from each 10-cm (3.9-in.) level, and a brief soil description (texture, consistency, Munsell color, and inclusions).

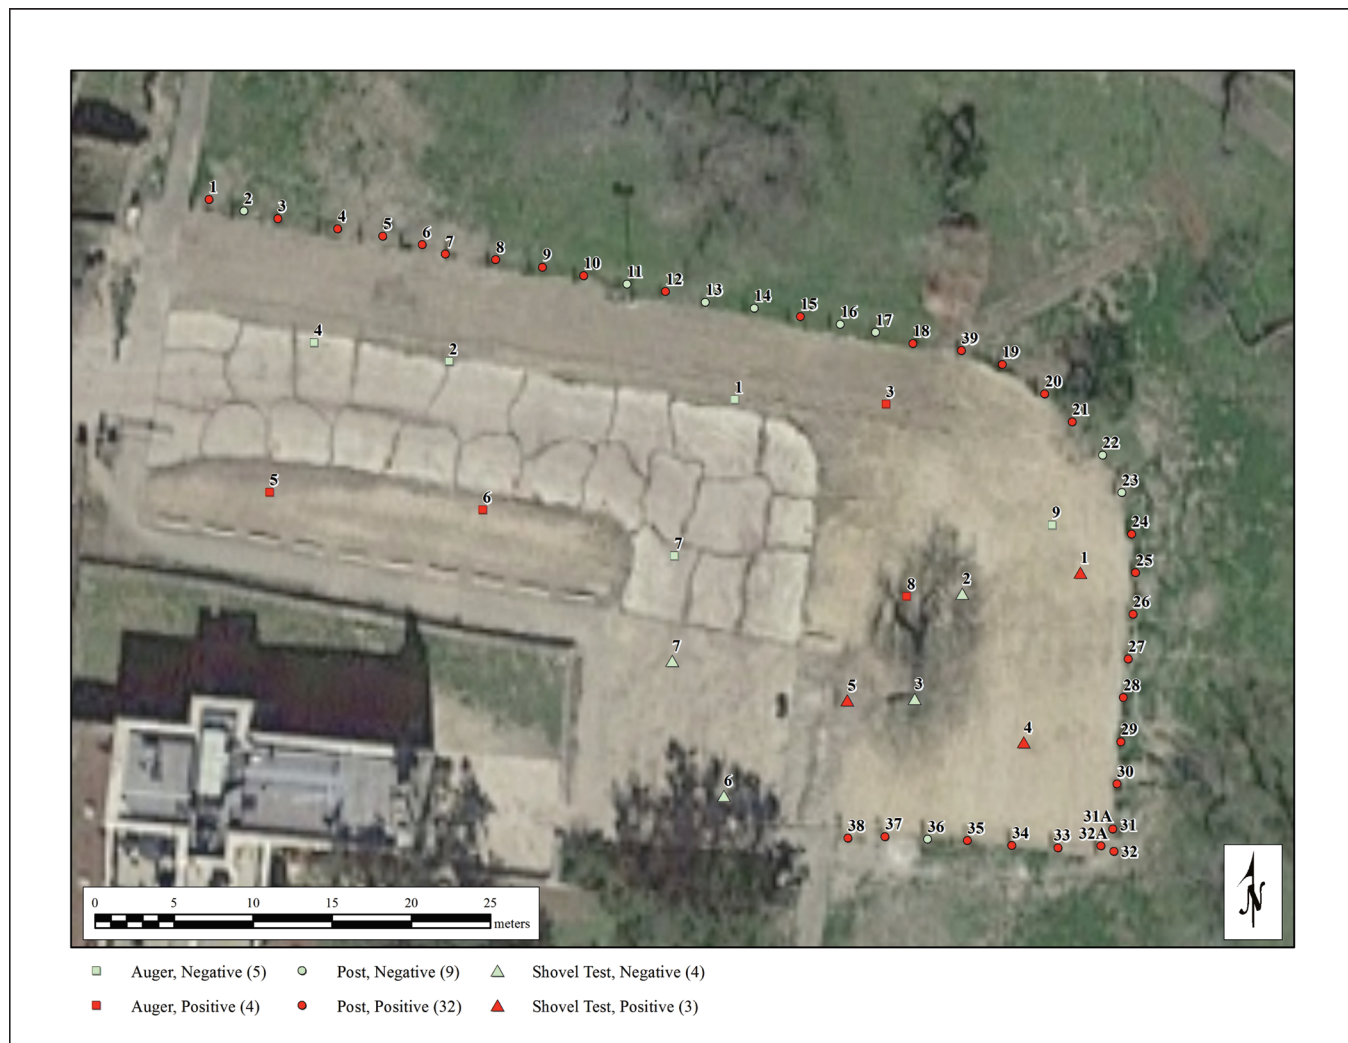
Figure 4-1. Bollards, auger tests, and shovel tests in Area 1 of the APE.

On June 24 and June 30, 2014, the excavation for and installation of 39 bollards around the perimeter of the parking lot were conducted (Figure 4-1). Although only 39 bollards were installed, 41 postholes were excavated. The two extra excavations were a result of a shift in the layout of the bollards. Excavations commenced on the north side of the parking lot starting with bollards 1-21 and 39. Soils from this part of the parking lot consisted of clay loam to silty loam that

During grading of the parking lot, a concentration of faunal material along with Goliad wares were found southwest of positive auger hole 3 and south of positive post holes 18-21 and 39 (see Figure 4-1). The depth of these materials was approximately 20 cmbs (7.9 in.) and included faunal material, such as bovine (436.79 g), *odocoileus virginianus* (6.96 g), and artiodactyla (2.99 g). Two pieces of Goliad ware were also found in this concentration.

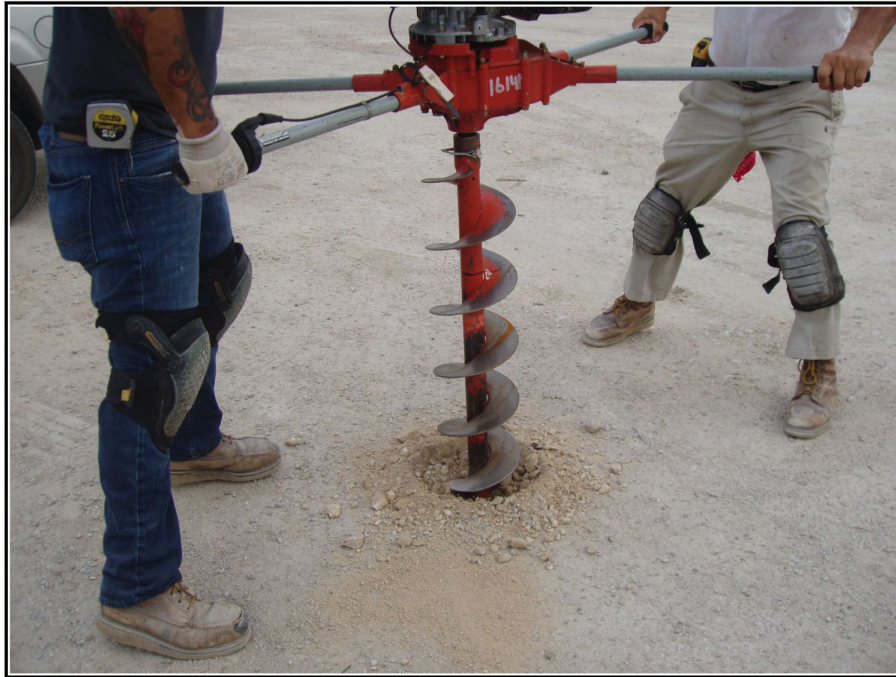
Figure 4-2. Gravel encountered in auger tests.

(7.9 in.), and shovel tests were dug to 30 cmbs (11.8 in.). Excavations for auger holes were distributed throughout the parking lot. Soil from the auger tests contained heavy gravel mixed with a light brownish gray silty sand (Figure 4-2). Four of the nine auger tests were positive for cultural material. Artifacts from auger tests (Table 4-3) included bone (2.4 g), glass (n=9), and metal (n=1). The cultural material appears to be associated with gravel that was placed for the parking lot.

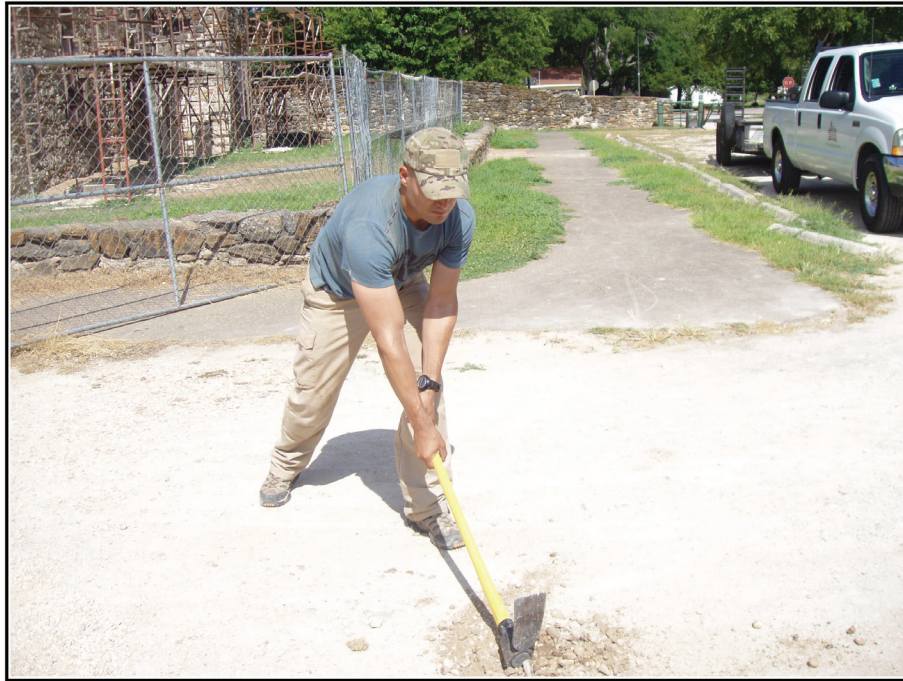
Figure 4-3. Excavation of Shovel Test 7 in parking lot.

Seven shovel tests were concentrated in the southwestern portion of the parking lot. The parking area contained compact sediments, and it was necessary to use a pick ax (Figure 4-3). Levels 1 (0-10 cm; 0-3.9 in.) and 2 (10-20 cm; 3.9-7.9 in.) of the shovel tests consisted of heavy gravel, similar to that of the auger test excavations. Level 3 (20-30 cm; 7.9-11.8 in.) was a dark grayish brown (10YR 4/2) clay loam. Three of the seven shovel tests were positive for cultural material (Table 4-3). Material from the shovel tests include bone (9.6 g), glass (n=1), and shell (n=1).

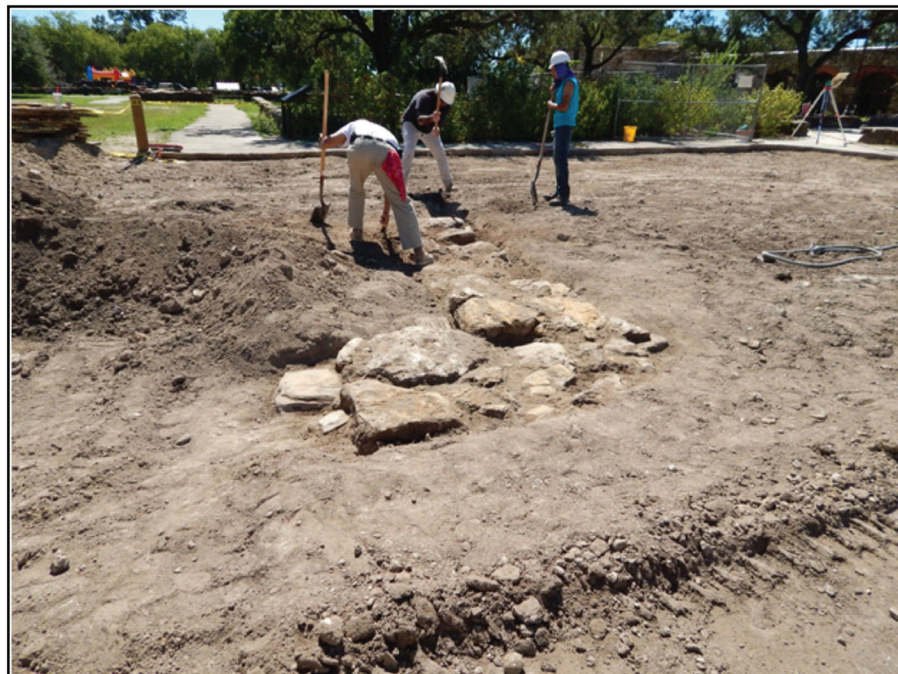
Figure 4-4. Feature 1 encountered during grading of parking lot (facing south).

Grading of the parking lot was conducted from October 4-17, 2014. This effort required the removal of up to 15.24 cm (6 in.) of deposits, consisting primarily of gravel, and the replacement of that gravel with new top soil. During the grading on October 4, 2014, Feature 1, a stone alignment, was encountered and exposed (Figure 4-4). The stone alignment was located in the southeast portion of the parking lot just below the gravel layer, less than 20 cmbs (7.9 in.).

Figure 4-5 shows the alignment after flagstones were placed adjacent to the feature. It runs roughly southwest-to-northeast and is 12 m (39.4 ft.) in length (Figure 4-4) and 1.5 m (4.9 ft.) in width. However, at the northern end, the feature is 3 m (9.8 ft.) in width. The wall is in the same location as the one found by Smith (1980a; see Figure 4-6). The treatment of Feature 1, the Spanish Colonial wall, was determined in consultation with the THC, NPS, and Pugh Constructors. The

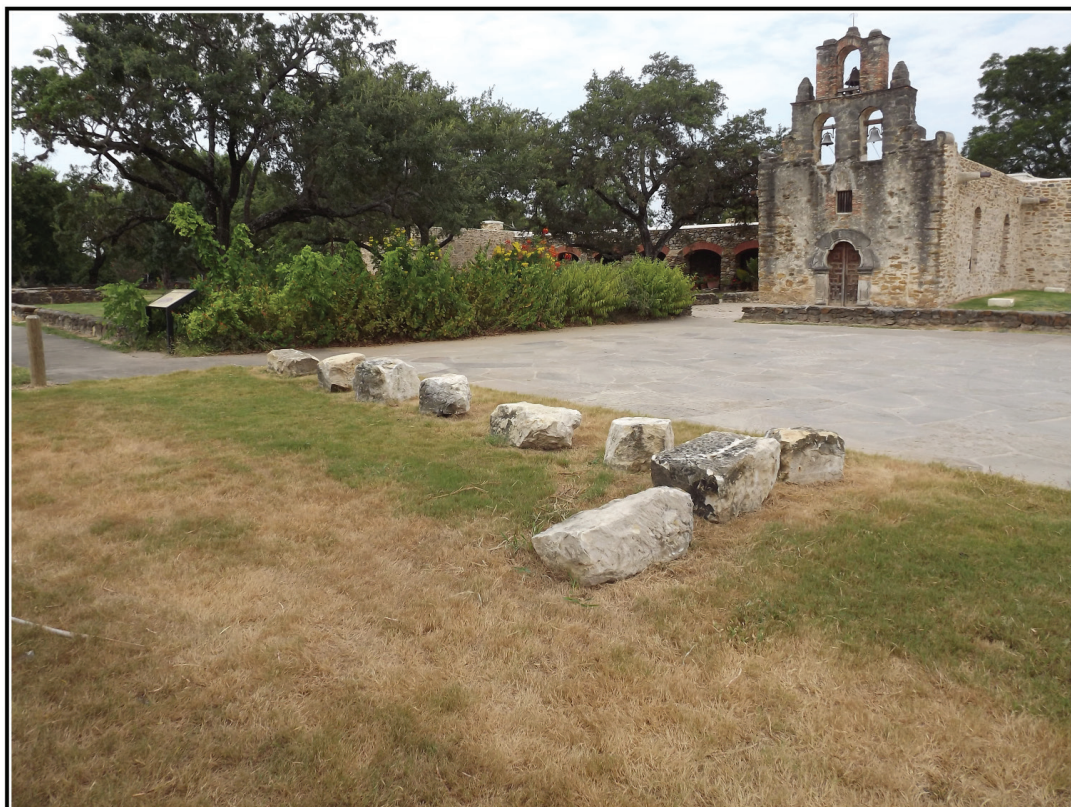
Figure 4-7. Treatment of Feature 1 area (facing southwest).

wall was covered with protective landscape cloth, topped with 5-7.6 cm (2-3 in.) of sand, geogrid, soil/limestone base, and sod. Large irregular stones were placed to demarcate the wall (Figure 4-7).

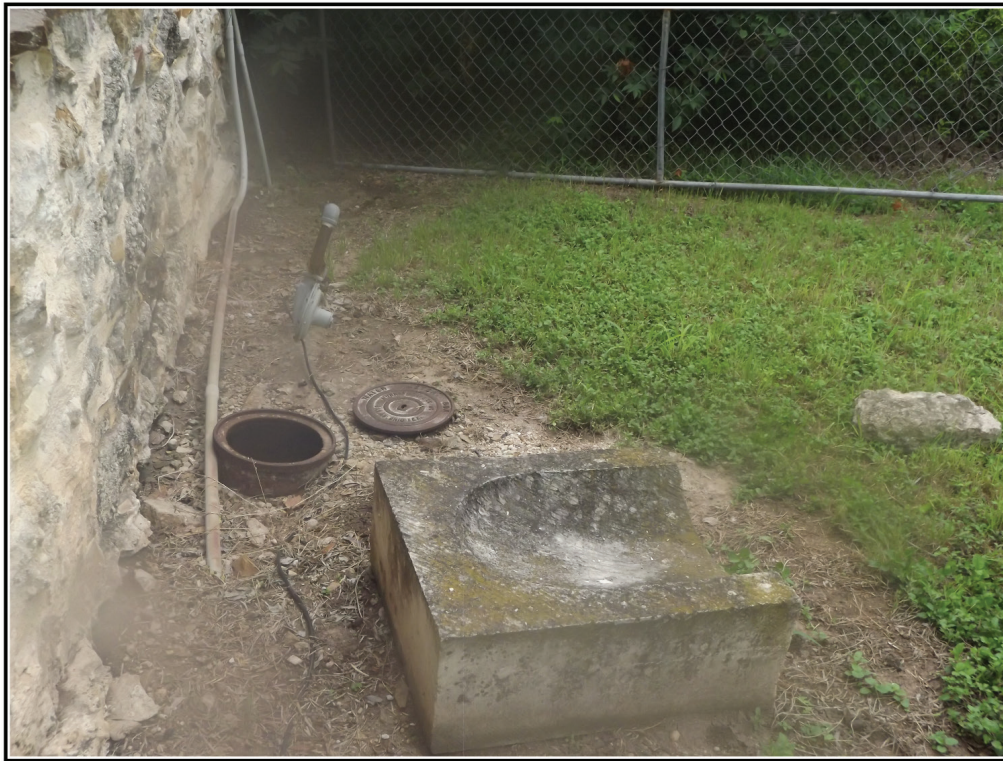
Figure 4-8. Water valve box prior to excavation and replacement.

On June 12, 2014, CAR monitored the excavation and installation of a water valve box. Figure 4-8 shows the water valve box west of the Priests' Quarters/Convento. During

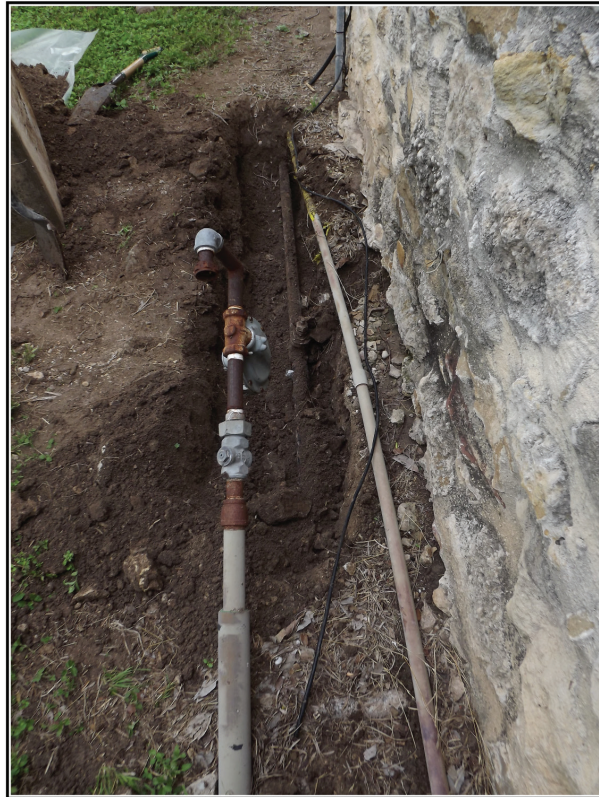
Figure 4-9. Excavation for the water valve box replacement.

After the removal of the water valve box, a larger area was excavated to locate the couplet to the water pipe for the installation of a new box. Initially, the excavation measured 0.61-x-0.91 m (2-x-3 ft.) wide, but it was further extended to 2.4-x-0.91 m (8-x-3 ft.). Figure 4-9 illustrates the excavation conducted for the water valve replacement. The depth of the excavation was 45-50 cm (17.7-19.7 in.). Soil from the excavation was visually inspected, but only a few brick fragments and sandstone were observed. No features or significant cultural material were encountered during the excavations. The area had been disturbed by the installation of existing utility lines.

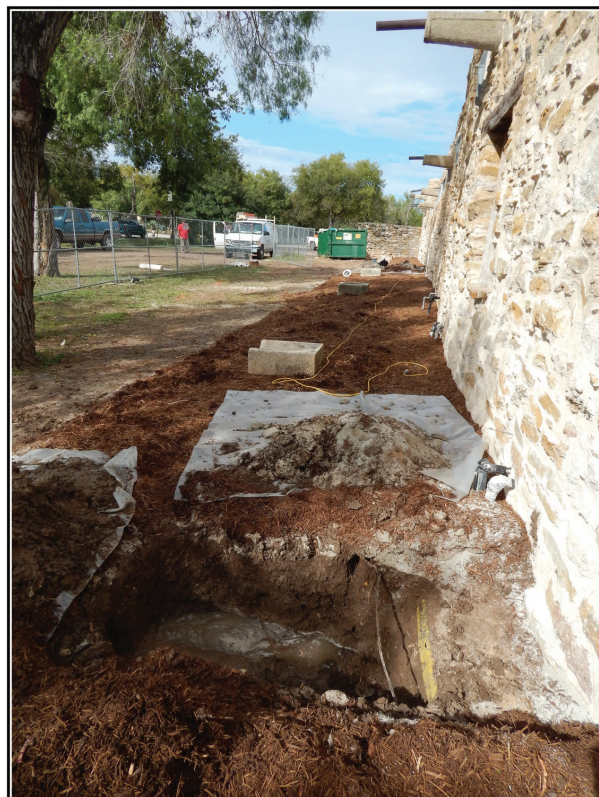
Figure 4-10. Excavations associated with sewage blockage.

On November 7, 10, and 11, 2014, additional excavations were conducted to search for a blockage in the pipes. Five areas were excavated along the west wall of the Priests' Quarters/Convento to locate the blockage (Figure 4-10). These areas had been previously disturbed due to the original placement of the sewer lines. A mixture of modern material and a few historic and Spanish Colonial artifacts (glass and unglazed ceramics) were observed but not collected.

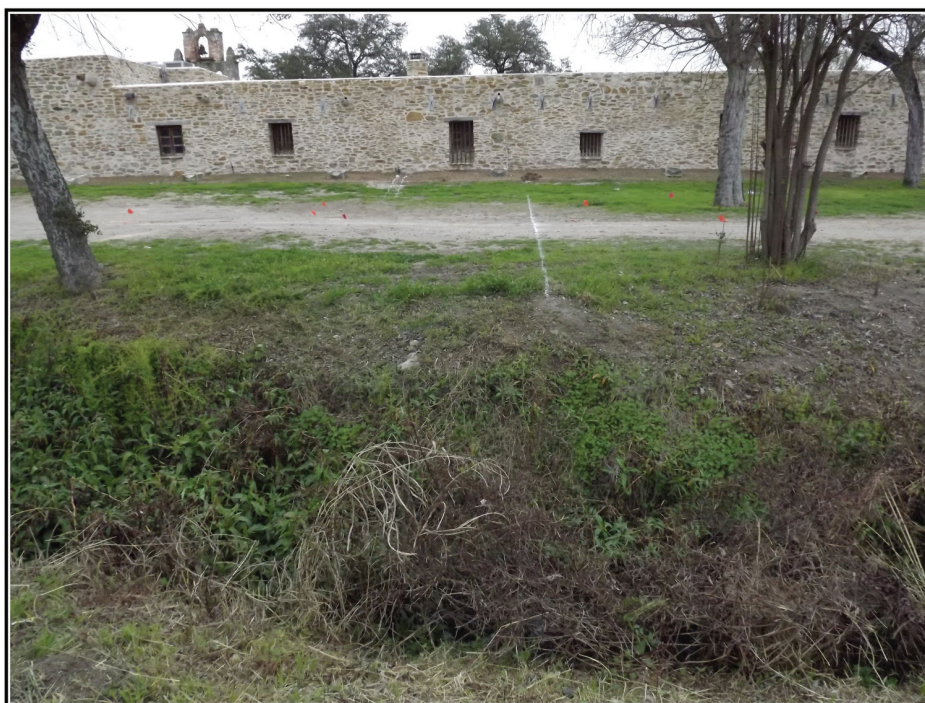
Figure 4-12. The east-to-west main line for sewer lateral.

CAR archaeologists L. Kemp and A. McBride monitored the excavation of trenches for the Espada Sewer Lateral on March 11-13 and 16, 2015. All trenches were marked by the Guarantee Plumbing and Air Conditioning crew prior to excavation. Figures 4-12 through 4-14 show the marked

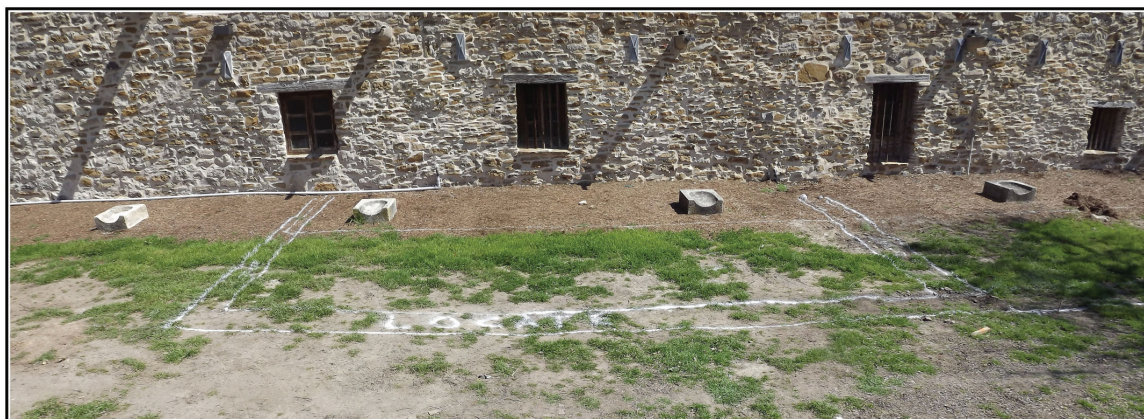
Figure 4-13. Marked areas, north by the sacristy.

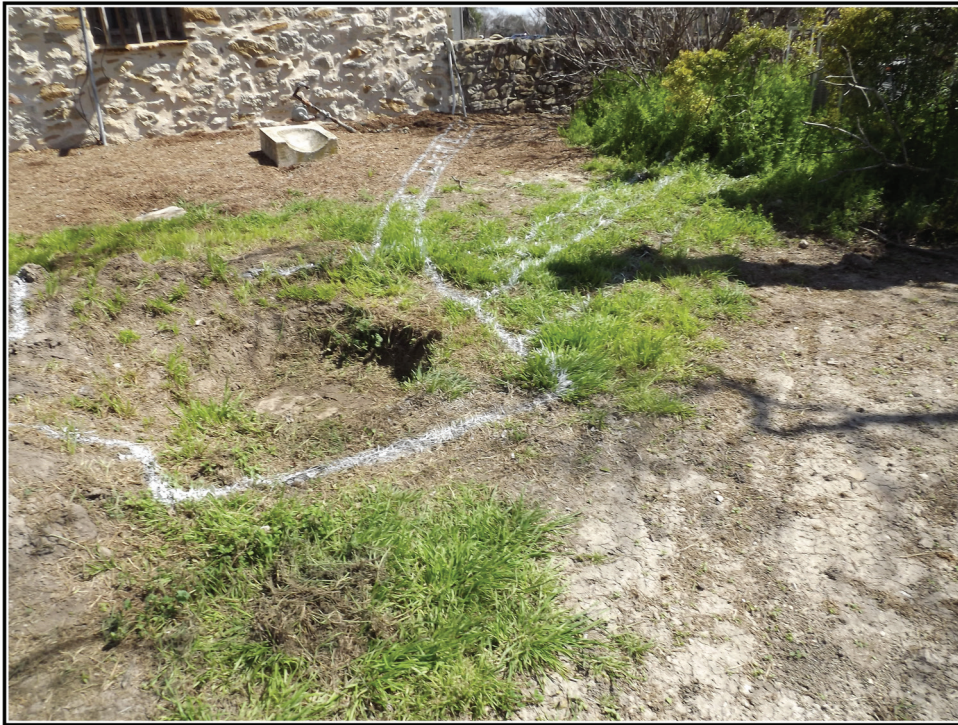
Figure 4-14. Areas excavated for electrical lines for the sump pump.

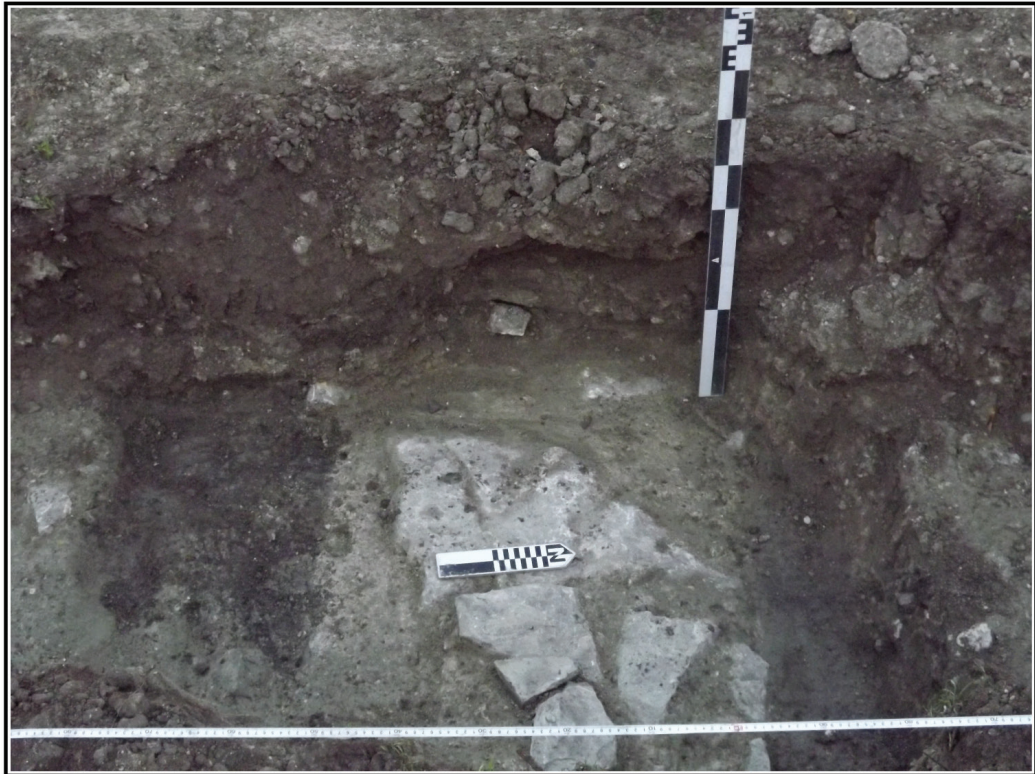
Figure 4-15. Feature 2 showing wall mortar, in situ artifact, and delineation.

In the main north-to-south trench, a limestone wall or foundation, Feature 2, was uncovered 3-4 m (9.8-13.1 ft.) south of the beginning of the trench and previously excavated STs 16 and 17 (Figure 4-15). The center of the feature was recorded using a Trimble GPS unit. Unfortunately, a course of two large, cut limestone blocks were removed from the feature. Another course of limestone lay underneath this course. The discovery of this feature prompted a cessation of work in this area pending further investigation. Both THC and NPS, as well as other parties including Pugh Constructors and Ford, Powell and Carson Architects, were notified of the discovery. The wall feature and the northern portion of the trench was cleaned and documented with photographs, profiles, and plan view drawings. In addition, the feature and trenches were documented with a total data station on March 12. The feature, minus the removed stones, measured 0.80 m (2.6 ft.) north-to-south and 1.2 m (3.9 ft.) east-to-west at a depth of 55 cmbs (21.7 in.). The feature is constructed of limestone block and cobbles with a lime-based mortar. The wall is delineated on either side by a charcoal flecked brown (10YR 4/3) silty clay loam. The wall runs east-to-west, and the area north and south of it was probed for subsurface floor or

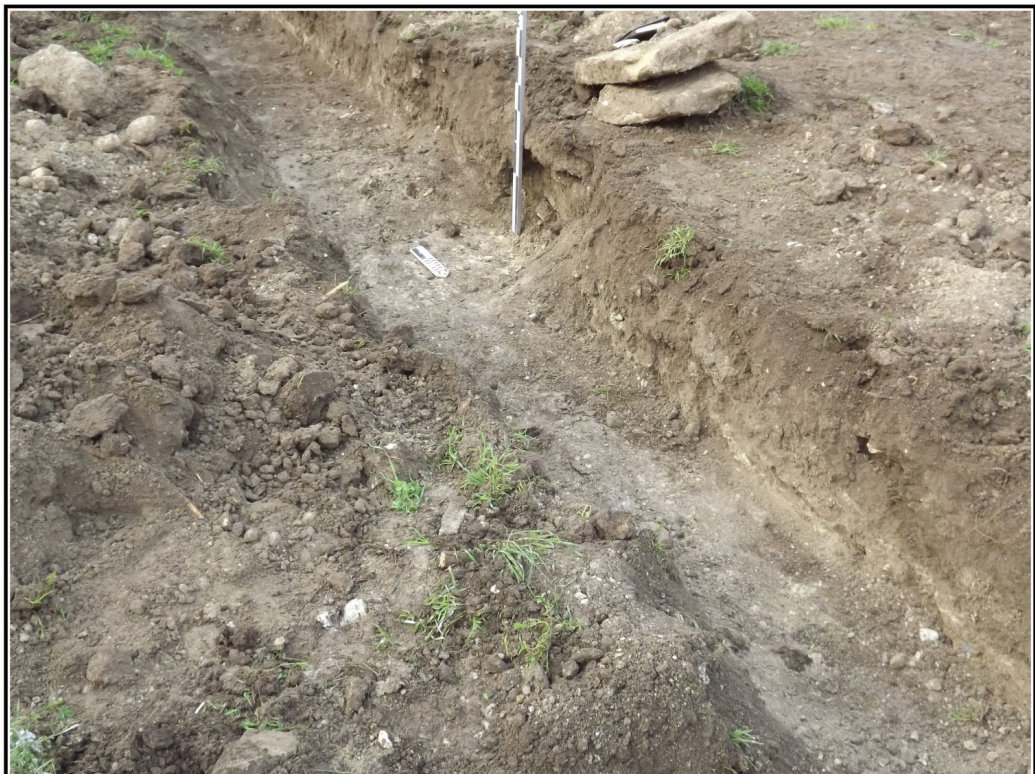
Figure 4-16. West wall profile prior to cleaning, showing plaster floor, Feature 3 (facing northwest).

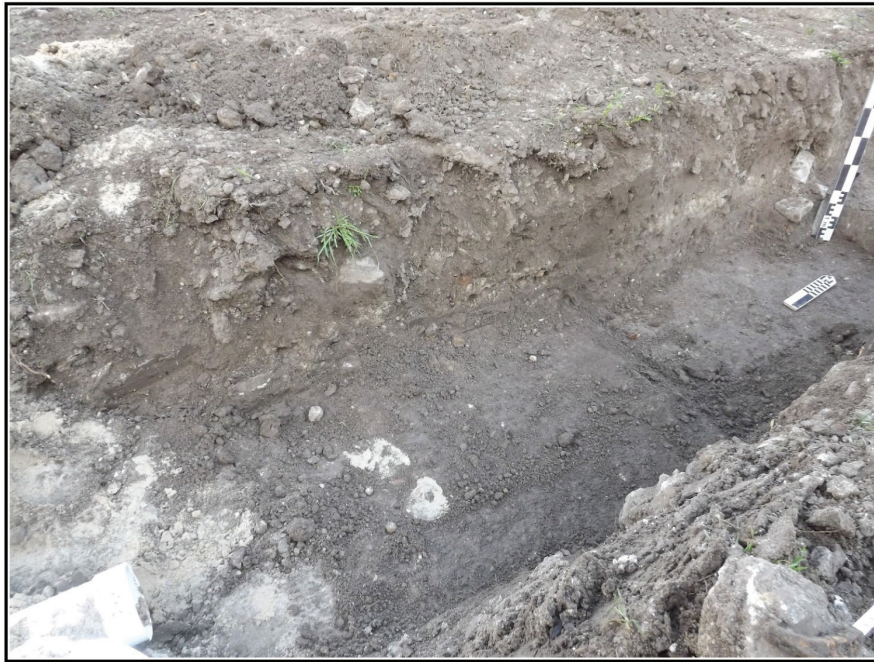
Figure 4-17. View of west wall and the termination of Feature 3, plaster floor; note pit-like feature and limestone cobbles on the trench floor.

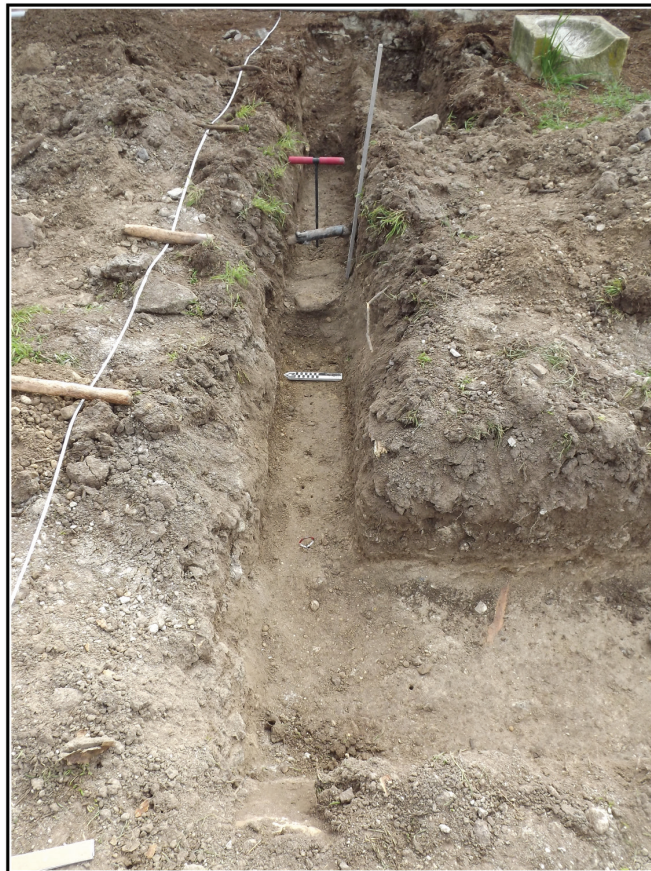
Figure 4-18. View of trench coming from the sacristy showing in situ flagstone, Feature 4, underneath the gas line and probed area of subsurface floor or wall.

Two flagstones (Feature 4) were found 40 cmbs (15.7 in.) beneath a nonfunctional gas line, and a line of plaster was observed in the north wall of the eastern most portion of the trench (Figure 4-18). This trench was probed starting at the flagstone east and west, indicating subsurface stone 20 cm (7.9 in.) east and 1 m (3.28 ft.) west of the flagstone at 10-15 cm (3.9-5.9 in.) below the trench depth.

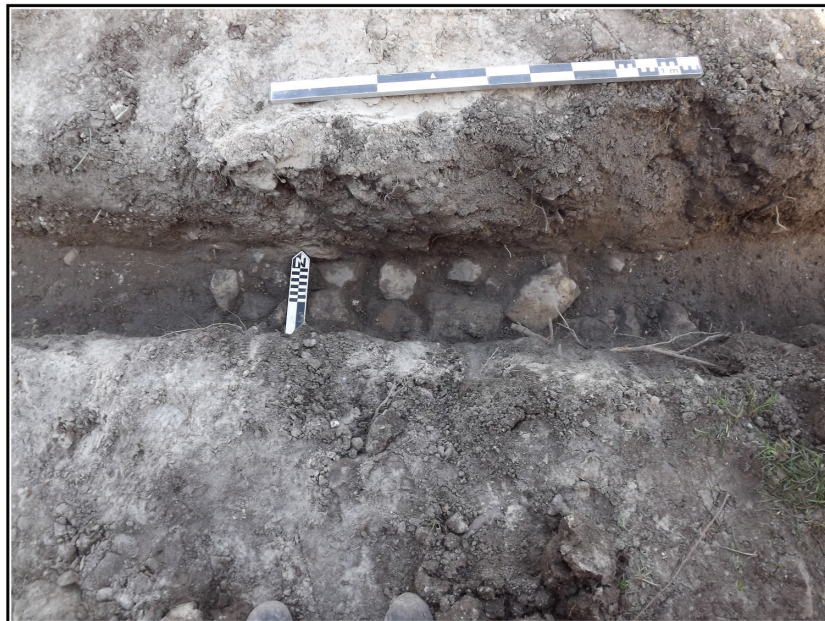
Figure 4-19. View of cobblestone, Feature 5.

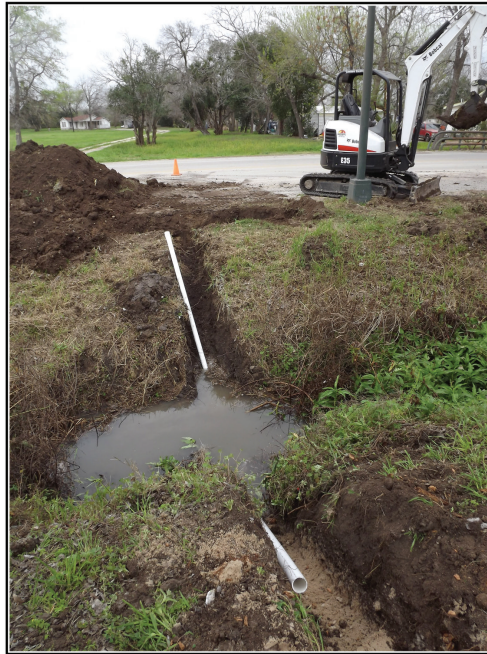
Figure 4-20. View of excavated trench crossing the acequia.

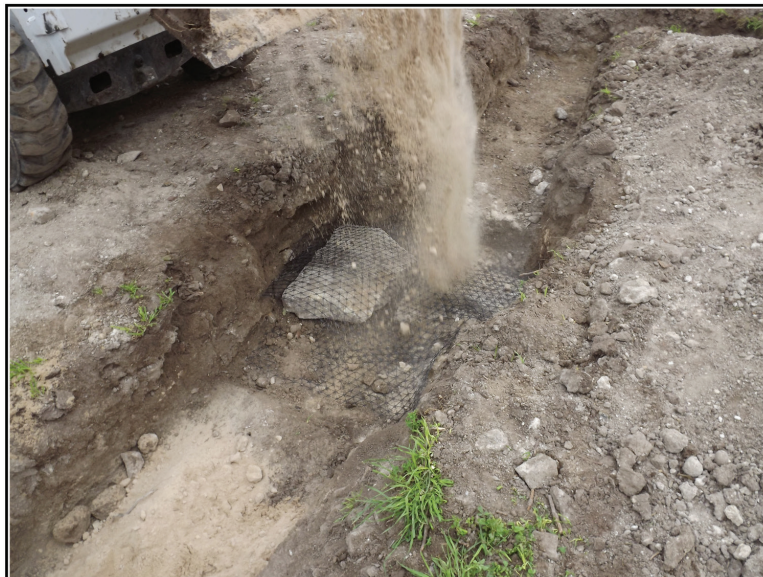
Figure 4-21. Backfilling with sand of wall feature; note plastic webbing.

Following this excavation, the CAR placed webbed plastic netting and sand over the flagstones, wall, and cobblestone features to indicate their presence should any future construction take place in this area (Figure 4-21). On March 16, CAR staff monitored the trenches containing features as they were backfilled with sand and excavated soil.

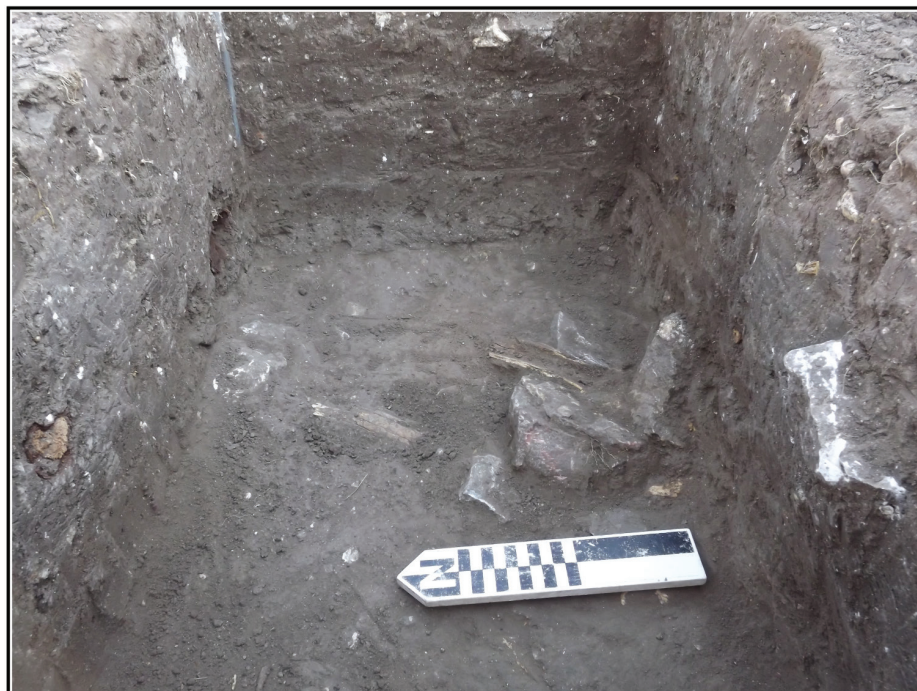
Figure 4-22. Feature 6 in Test Unit 1.

Feature 5 consisted of a cobble wall with no artifacts in association. Similar cobble surfaces have been encountered by Smith (Ivey et al. 1990) and interpreted as the blacksmith shop. Feature 6 was found during shovel testing and further investigated in excavation of Test Unit 1. Feature 6 was defined as an intact midden and is the only feature with associated artifacts. This feature was interpreted as a Spanish

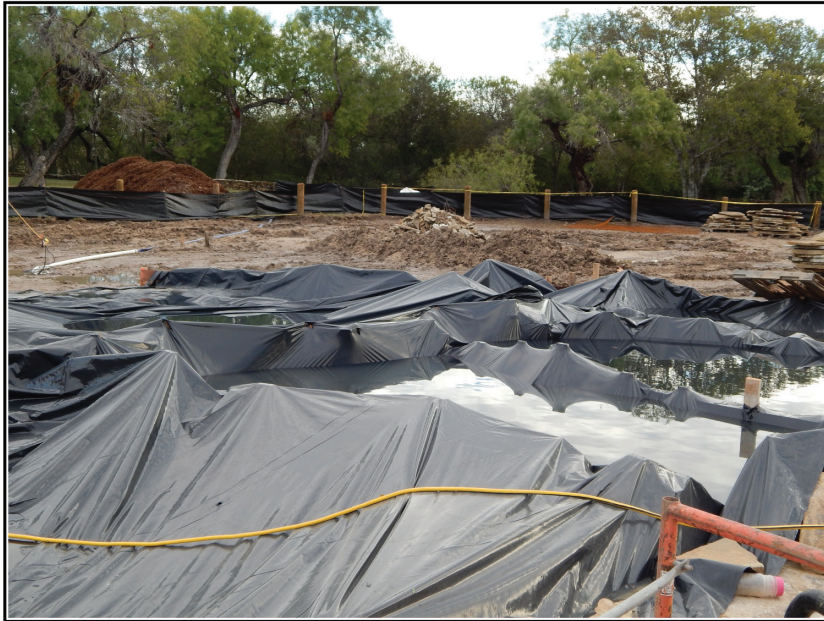
Figure 4-23. Water collected in the parking lot after heavy rains.

Two additional areas that were included in archaeological monitoring were in front of the church (Area 3) and in the mission plaza (Area 4), north of the parking lot. Heavy rains in early November of 2014 caused large amounts of water to collect in the parking lot as seen in Figure 4-23. To drain water off the parking lot area, a small trench 30.5-cm (12-in.) wide and 20.3-cm (8-in.) deep was excavated by hand and monitored by CAR staff (Figure 4-24). Two ceramic sherds were encountered and noted, but they were not collected.

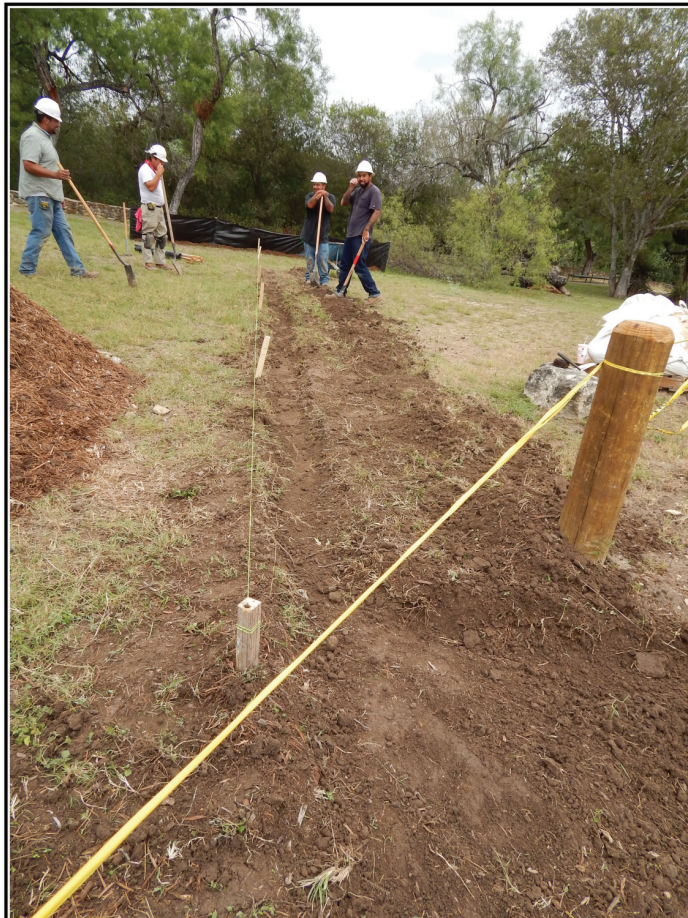
Figure 4-24. Trench excavated for drainage of rainwater collected in parking lot area.

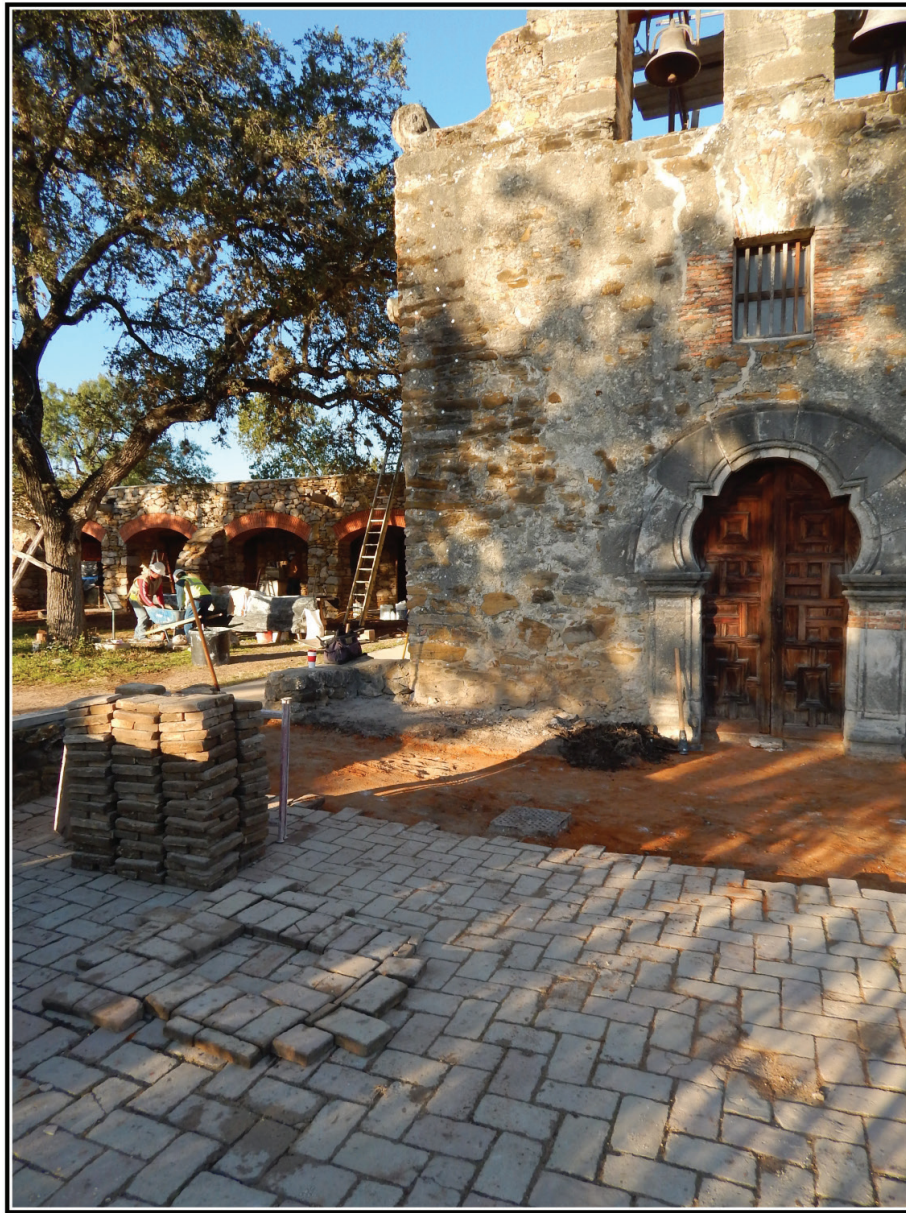
Figure 4-25. The removal of fill underneath pavers in front of the church.

On November 19, 2014, fill from underneath the pavers in front of the church was removed to waterproof the area (Figure 4-25). A CAR staff member monitored the activity. No features or cultural material were encountered during this time.
