Archaeological Investigations Associated With The 1886 Hidalgo County Courthouse And Jail, Hidalgo County, Texas

**ARCHAEOLOGICAL INVESTIGATIONS ASSOCIATED
WITH THE 1886 HIDALGO COUNTY COURTHOUSE AND JAIL
HIDALGO, HIDALGO COUNTY, TEXAS**

**Prepared for:
EGV Architects, Inc.
220 S. Bridge St.
Hidalgo, TX 78557**

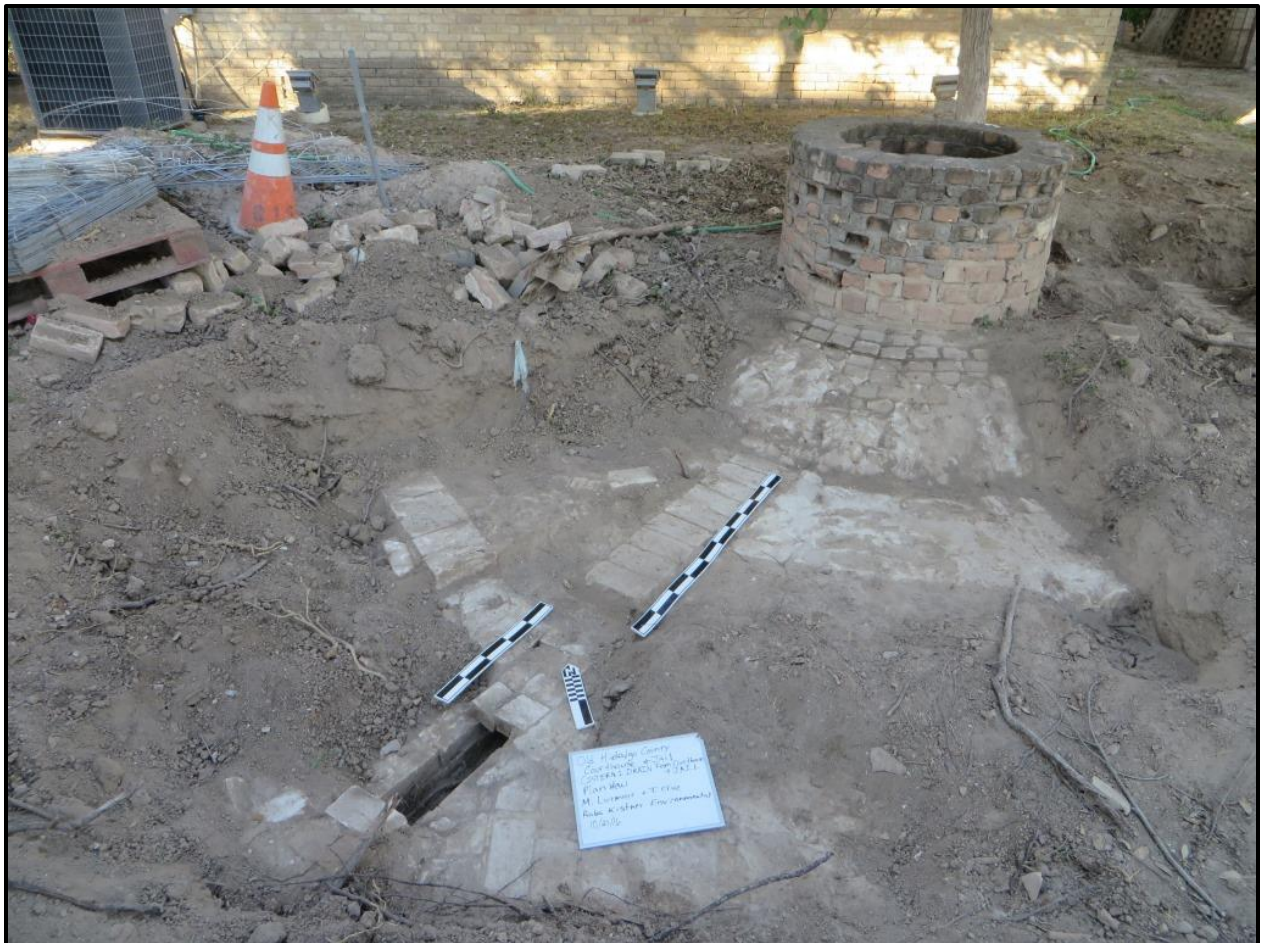
Figure 4-2. Cistern 1 after exposure of the edge of the cistern.

Since the very top of Cistern 1 was visible above the ground surface, RKEI wanted to try to find the edges of the cistern to determine its maximum diameter (**Figure 4-2**). After exposing the cistern, it was determined that the feature represented an example of a Bell Cistern (**Figure 4-3**) (Denton 2011). This cistern style dated from the 1880s-1900s and held between 3,000-20,000 gallons of storm water depending on their date of construction (Denton 2011:6). The top of Cistern 1 had a diameter of 1.22-m and extended 86-centimeter (cm) above the neck of the cistern. The diameter of the main body of the cistern was approximately 4.04-m. The depth was not able to be determined since there was soil up to neck of the inlet (**Figure 4-4**).

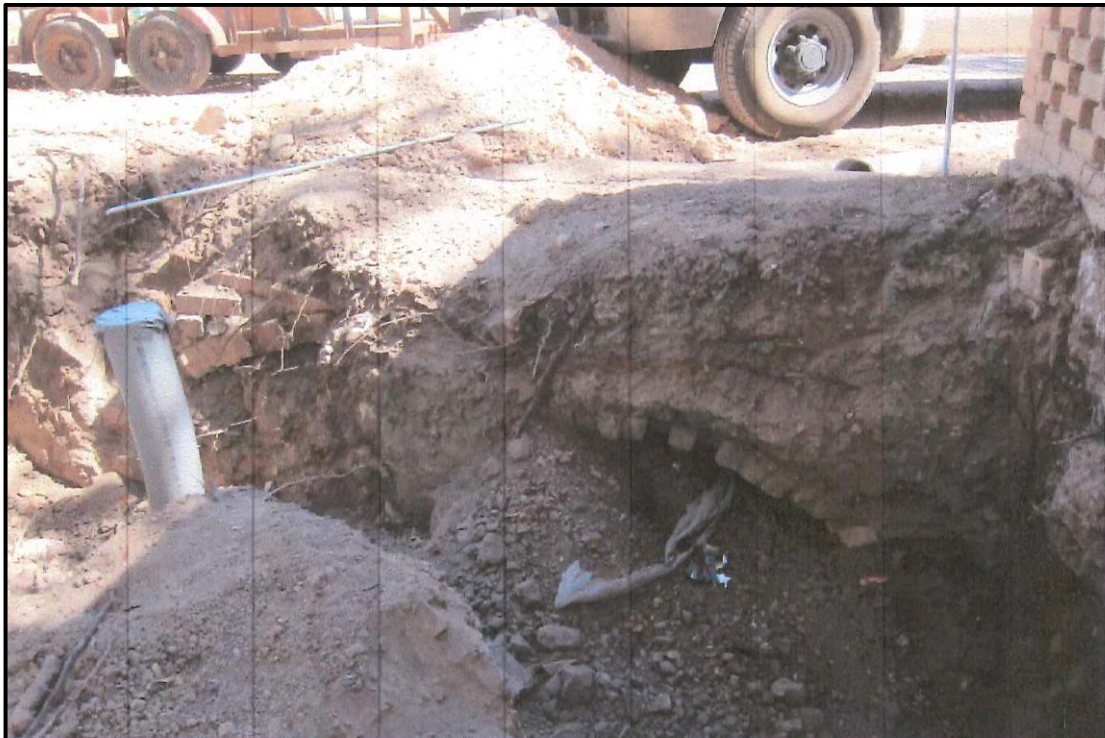
Figure 4-5. Original excavations of Cistern 2 in February, 2016. Note the two arches of the cistern and the parking lot in the background.

During the original excavations in February 2016, EGV Architects exposed Cistern 2 directly under the parking lot, approximately 4 m to the east of the Jail, during the installation of electrical PVC pipes (**Figure 4-5**). Half of the cistern was removed prior to these excavations. During the re-exposure of the cistern, RKEI archaeologists observed that approximately one meter of the top of the cistern was exposed underneath the parking lot. A 1-inch metal pipe was also noted running across the top of the cistern (**Figure 4-6**). The metal pipe contained an electrical line that powered the lights in the parking lot. Cistern 2 had a diameter of approximately 2.78 m, measured 1 m wide and approximately 55 cm of the profile was exposed within the trench (**Figure 4-7 and 4-8**). Cistern 2 was photographed and profiled after exposure (**Figure 4-9**).

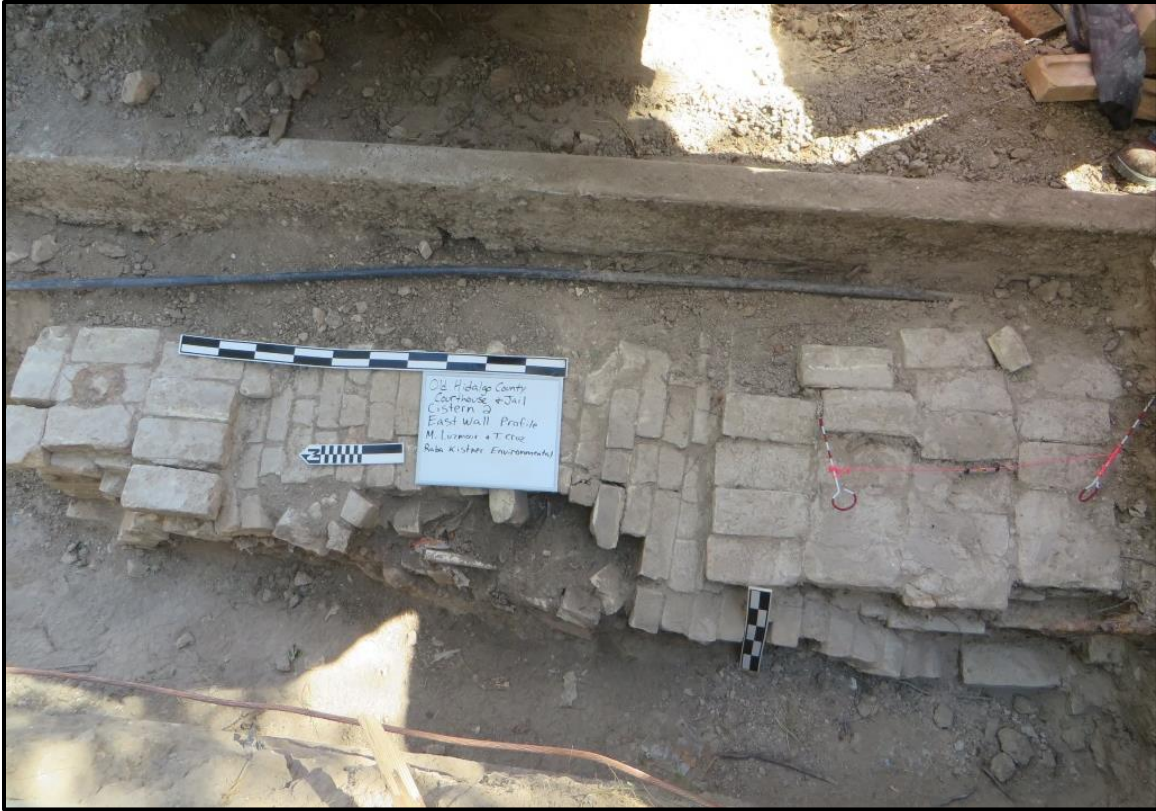
Figure 4-6. Plan view of Cistern 2 after re-exposure. Note metal pipe running along the top.

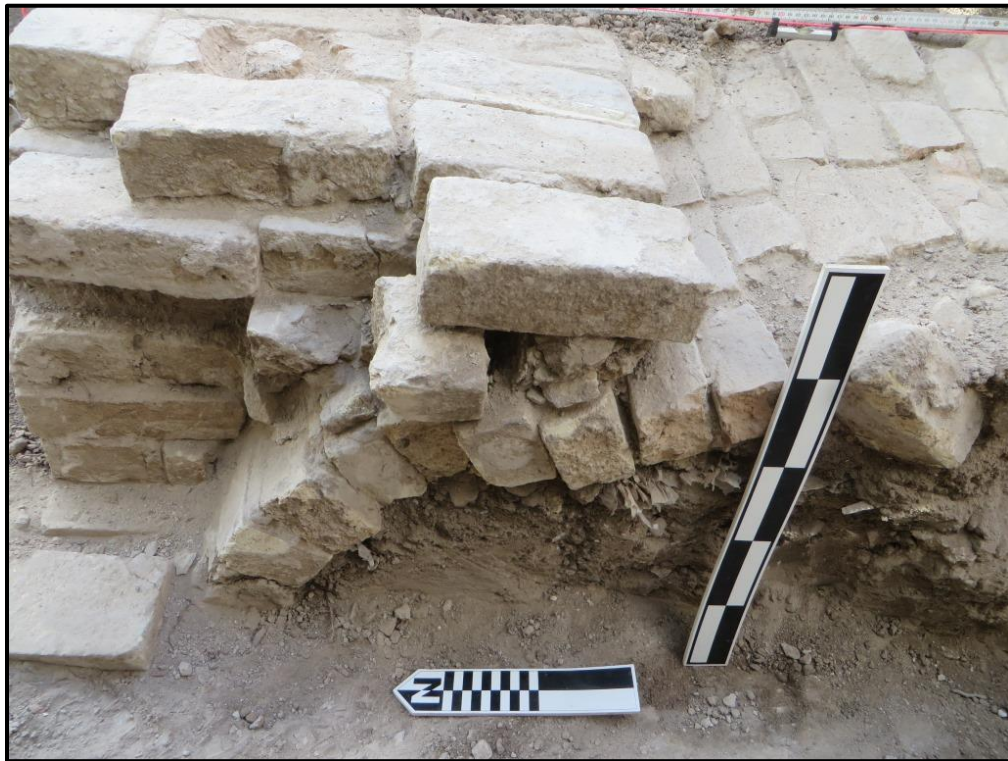
Figure 4-7. Profile view of the northern arch of Cistern 2.

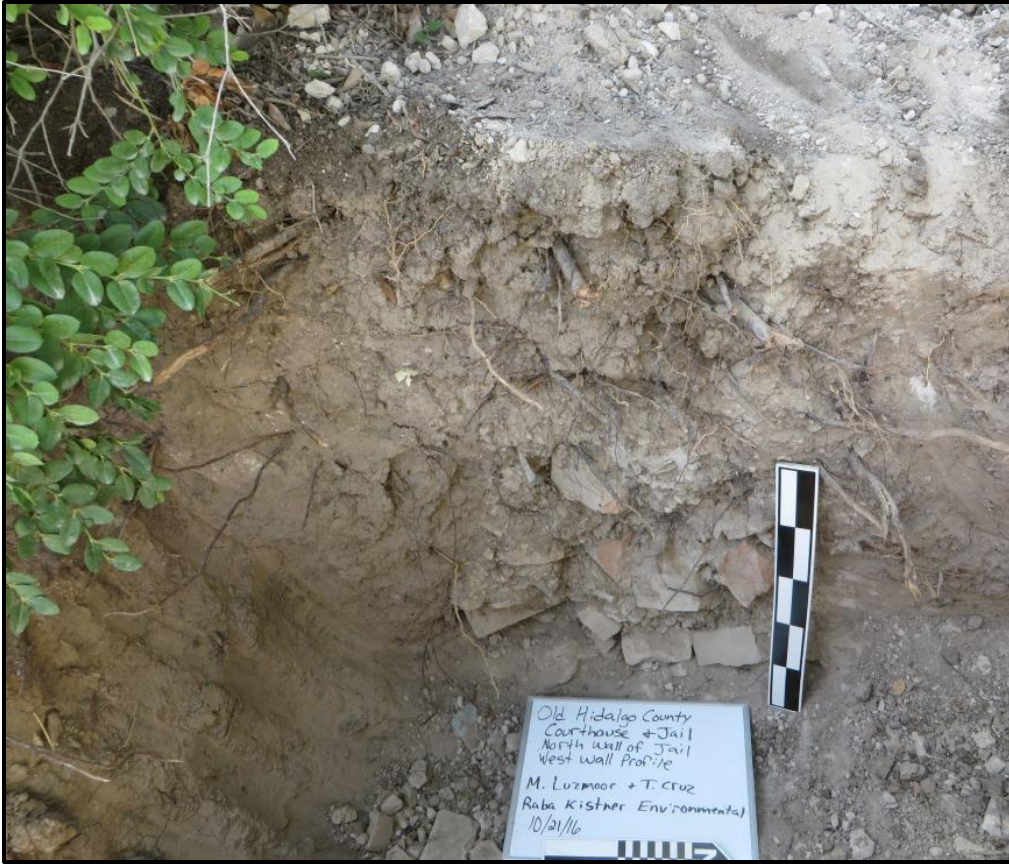
Figure 4-13. Northern section of the original wall surrounding the 1886 Jail. Note the disturbed nature of the profile.

It appears that the northern edge of the wall was removed after the Jail was relocated to Edinburg. Within an exploratory trench along the northern edge of the Jail, RKEI exposed an area in which the original wall had been heavily disturbed and replaced with rubble/trash (Figure 4-13).

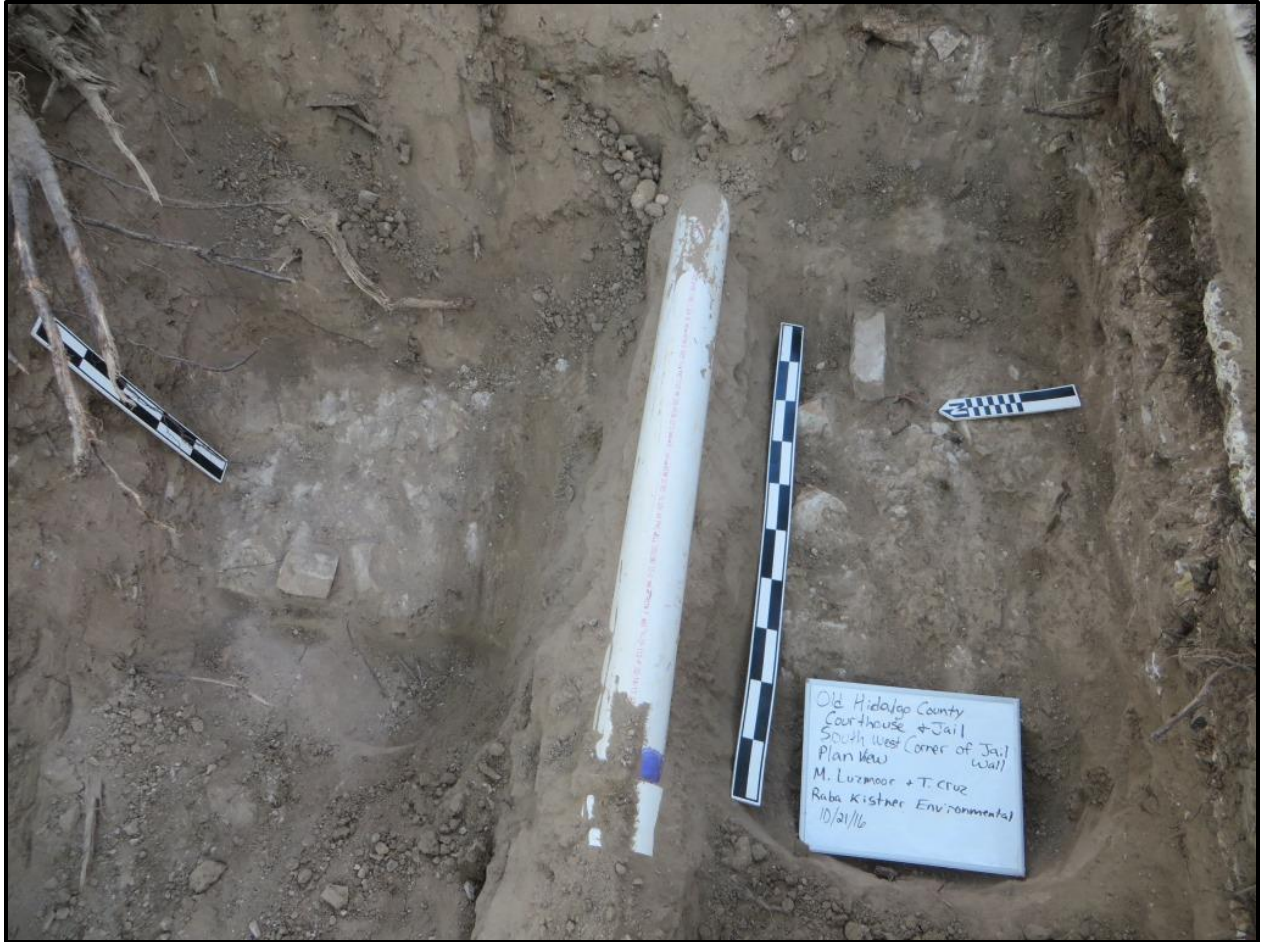
Figure 4-14. Southwest corner of original wall. Note the four inch PVC pipe just north of the corner.

Along the southwestern edge of the wall, the 4-inch PVC sewer pipe noted during the original excavations in February was encountered (Figure 4-14). According to the contractor, they did not

encounter evidence that they were disturbing an intact foundation. It also appears that the southwest corner also had its bricks removed, similar to the northern wall.

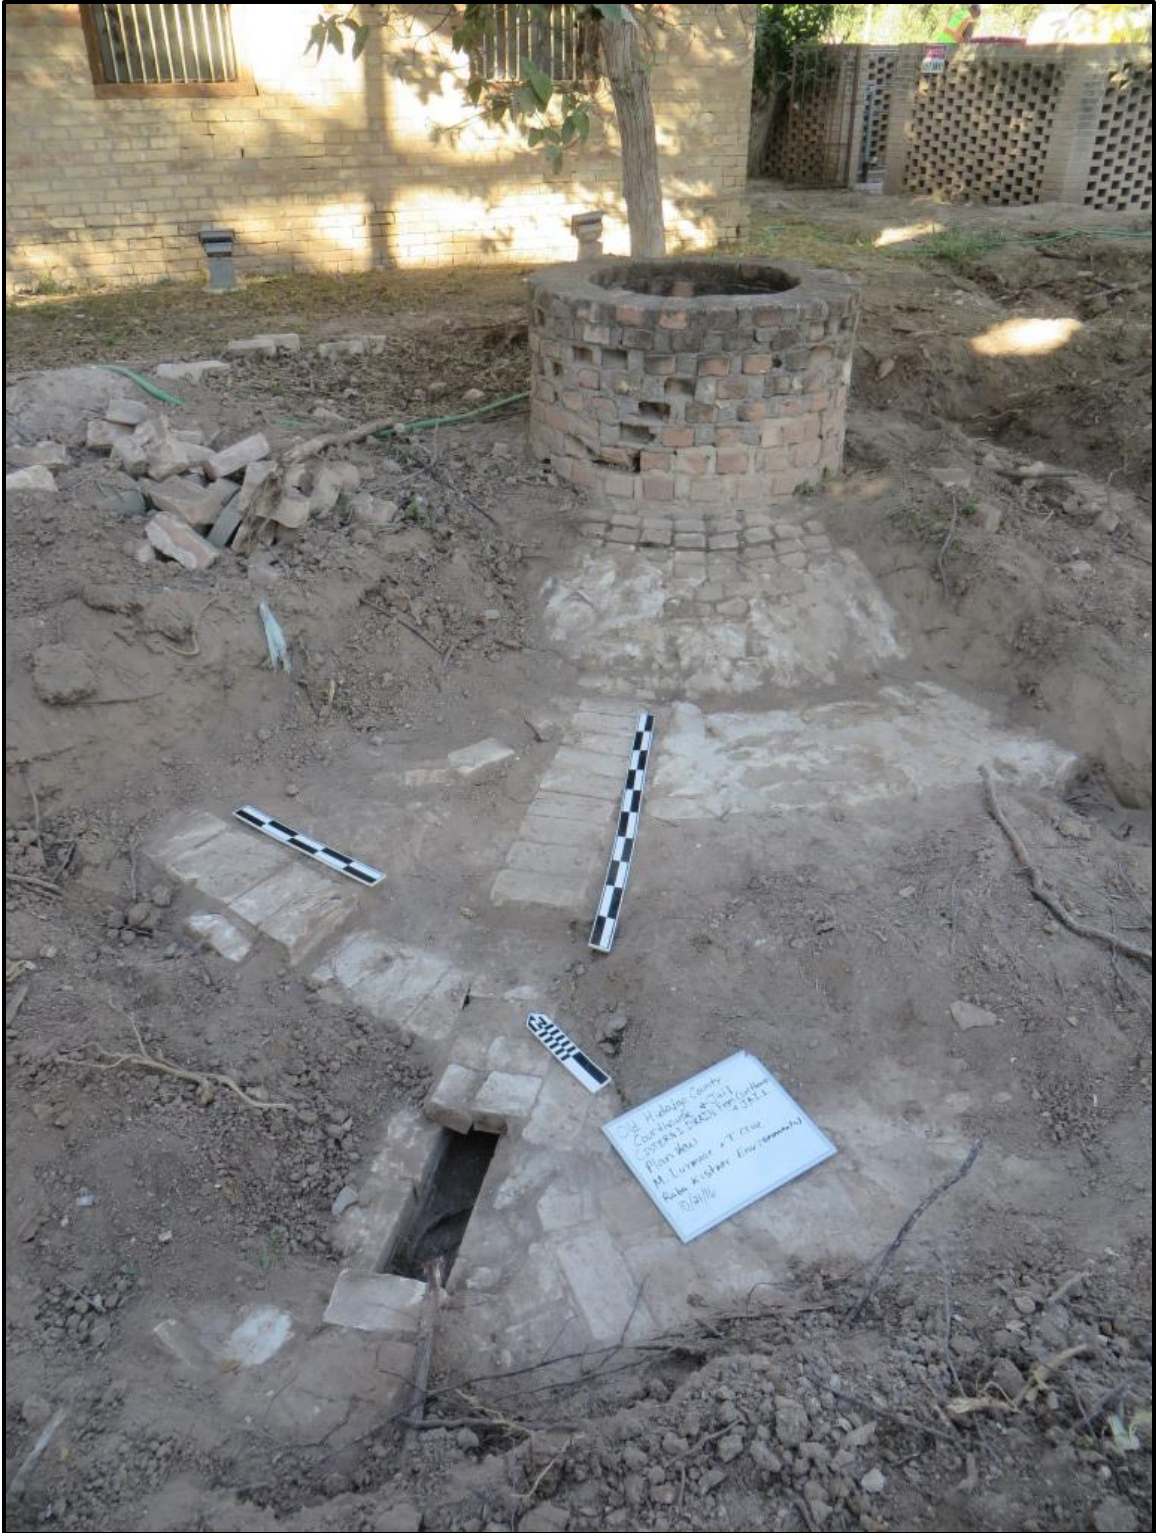
Figure 4-15. Cistern 1 with both drains. One goes northwest to the southwest corner of the Jail, one travels southwest to the northeast corner of the Courthouse.

Previous excavations along the northeast corner of the Courthouse also revealed a brick lined drain that flowed from the northeast corner of the Courthouse into Cistern 1 (**Figure 4-1**). After re-exposing this drain, **RKEI** uncovered a second drain that flowed from the southwest corner of the Jail into the drain from the Courthouse (**Figure 4-15**). These drains were relatively small, approximately 29 cm tall and 33 cm wide, with an inside diameter of approximately 15 cm.
