Archaeological Investigations in Front of the Spanish Governor's Palace in Plaza de Armas, San Antonio, Bexar County, Texas

**ARCHAEOLOGICAL INVESTIGATIONS IN FRONT OF THE
SPANISH GOVERNOR'S PALACE IN PLAZA DE ARMAS, SAN
ANTONIO, BEXAR COUNTY, TEXAS**

FINAL REPORT (Non-Redacted)

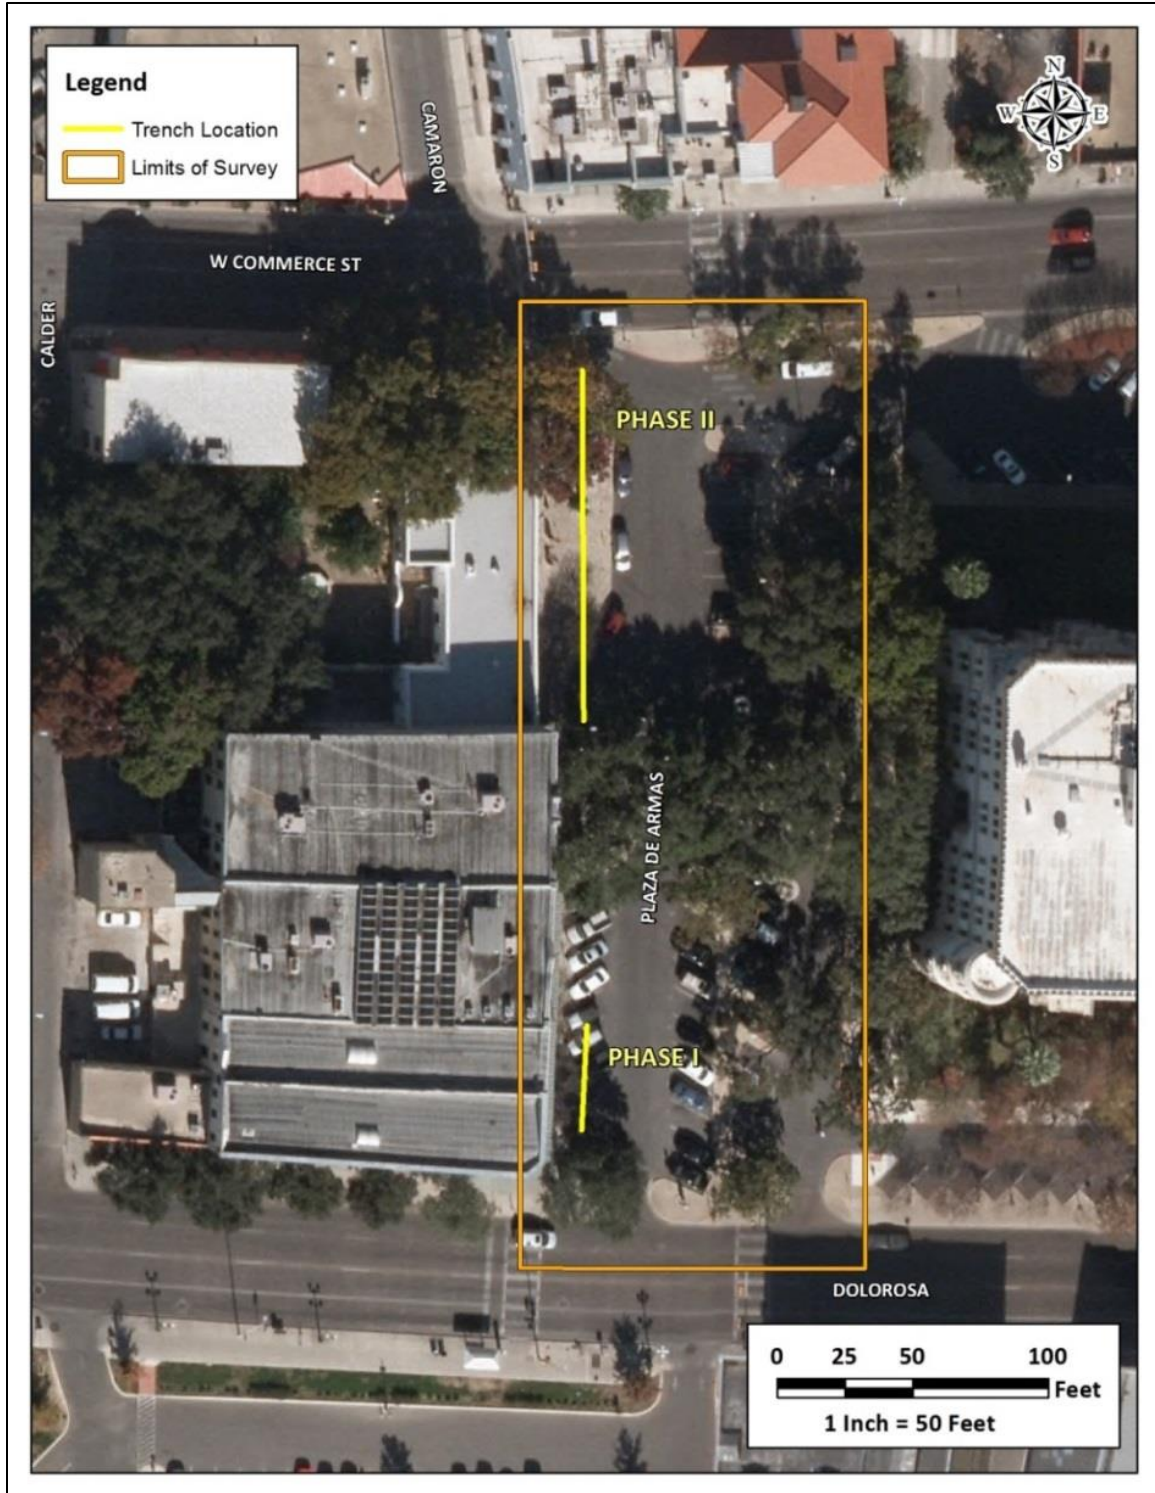
Figure 4-1. Location of the Phase I and Phase II trenches.

To minimize disruption to the general public and nearby establishments, the trenching associated with the installation of the two segments of water main was carried out during two distinct mobilization periods (Phase I and II; **Figure 4-1**). The project had two principal goals: 1) to ensure that archaeological deposits, if present, would be identified and their research value evaluated; and 2) complete the field work in a timely manner. The Phase I portion of the project focused on the installation of a new water main in front of the Vogel Belt Complex. The length of this water main segment was approximately 31 feet (9 m). The second phased of the project involved the installation of a segment of water main pipe in front of the Spanish Governor's Palace, along the paved sidewalk. Phase II consisted of the removal of pavers in front of the Spanish Governor's Palace, the monitoring of water main trenching, and the replacement of the pavers. These excavations encompassed approximately 129.5 feet (39.5 m) of the paved sidewalk in front of the Spanish Governor's Palace.

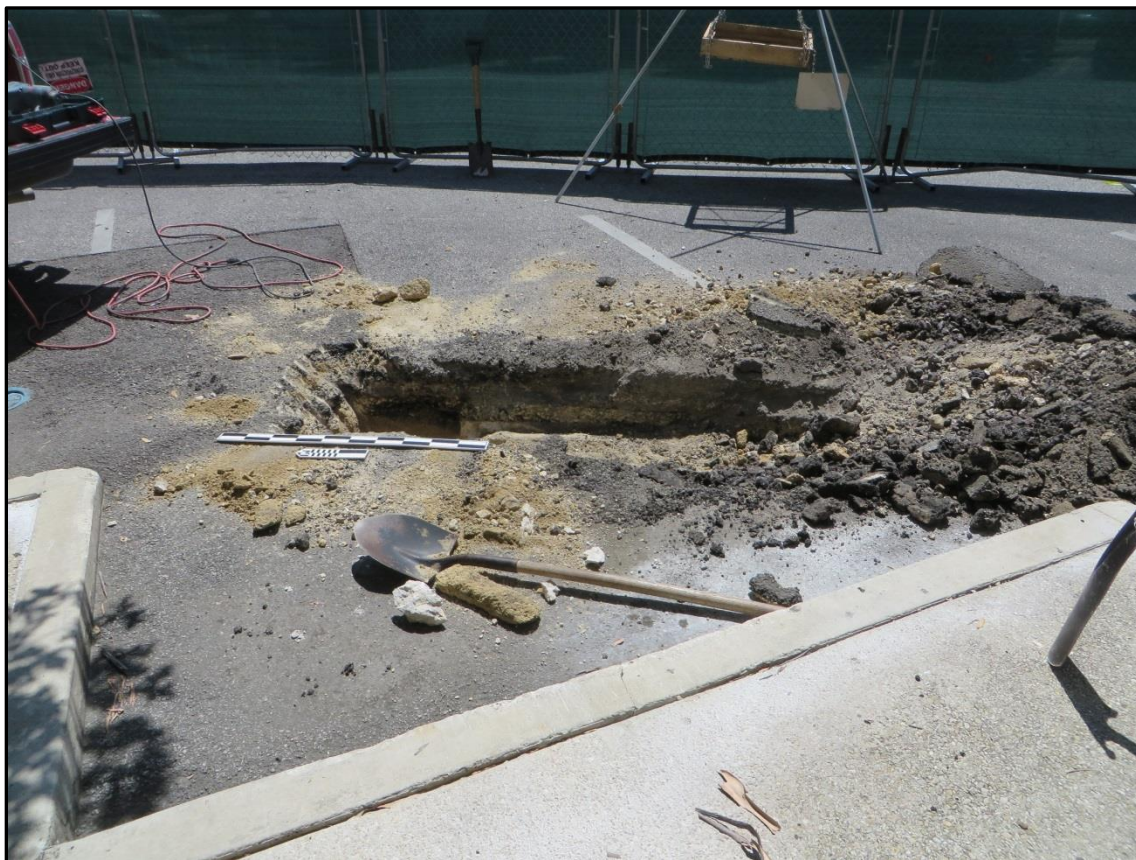
Figure 4-2. The RKEI exploratory trench in Phase I.

On June 9, 2015, staff of **RKEI** assisted by Alamo Backhoe and operator Rick Cavaness, excavated a short exploratory trench in front of the Vogel Belt Complex near the eastern beginning point of Phase I. The goal of this trench was to expose the fill in the original water main trench and examine its contents and the stratigraphy of the trench wall. A water main break that occurred a few years earlier resulted in trenching to expose and repair the valve. The outlines of this trench were still visible in the pavement allowing **RKEI** to place the exploratory trench to straddle the recent work by SAWS and the older portion of the water main line (**Figure 4-2**). A mini-excavator was used to dig the exploratory trench.

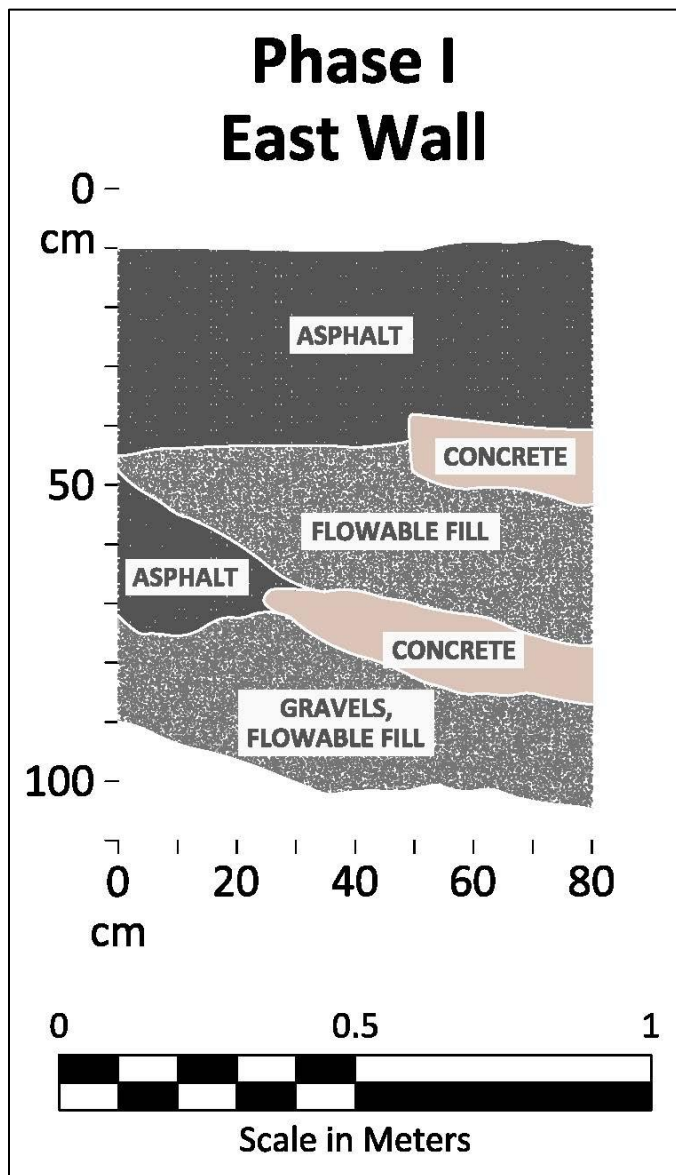
Figure 4-3. East Wall profile of Phase I trench.

In the southern portion of the trench, the upper 40 cm of matrix consisted of a layer of asphalt followed by base (**Figure 4-3**). A layer of concrete was encountered 40 cmbs. The recently patched area in the northern portion of the trench contained a layer of asphalt underlain by flowable fill. The mini-excavator had difficulty breaking through the concrete and the flowable fill. A hammer drill was utilized to help

break through the material. The upper layer of concrete extended to approximately 50 cmbs. Beneath the concrete was a layer of flowable fill followed by another layer of concrete at 68 cmbs. The second layer of concrete was approximately 15 to 20 cm thick. Below the concrete, the remainder of the matrix consisted of a mix of gravels and flowable fill. The trench was excavated to a terminal depth of 3 feet (1 m) bs to insure that the old water main line would not be damaged during the excavations.

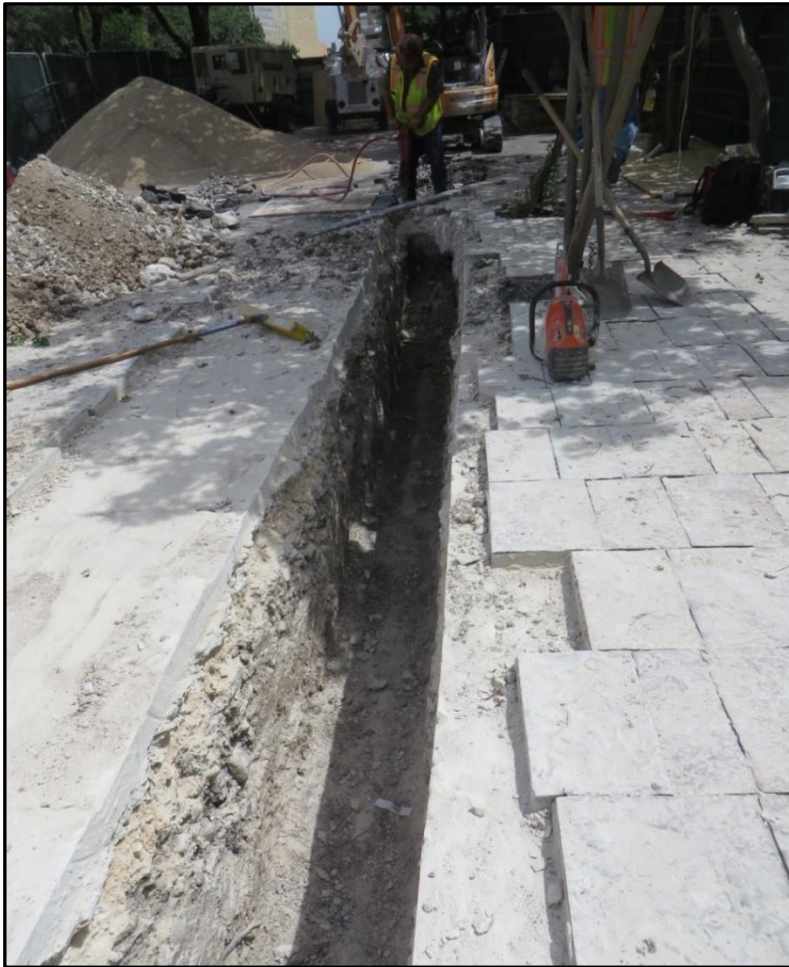
Figure 4-5. Use of the impact hammer. Portion of the Phase II trench, facing south.

Prior to the inception of the trenching, the limestone pavers had to be removed. The pavers were imbedded into a layer of concrete that was approximately 20 cm in thickness. Once the limestone paver blocks were removed, an impact hammer and small jackhammer were used to break through the underlying concrete. Approximately 10 m of the northern section of the trench, contained caliche gravels below the flowable fill (**Figure 4-5**). The water line was encountered within the gravels. A small section of the trench exhibited brown clay loam soils associated with landscaping, specifically nearby trees that are planted through the sidewalk. No cultural material was noted within the matrix associated with the trees.

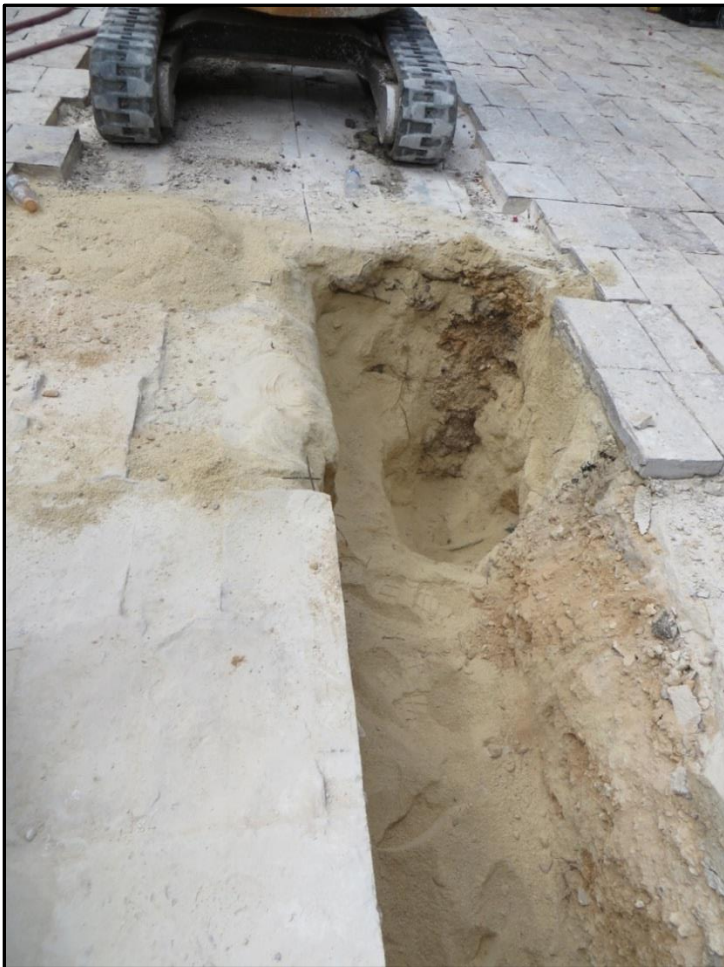
Figure 4-6. Phase II trench showing sand and water line servicing the Spanish Governor's Palace.

A section of the trench, approximately 2 m in length, contained construction sand and water utility lines that serviced the Spanish Governor's Palace (**Figure 4-6**). The matrix surrounding the line leading to the Spanish Governor's Palace was very moist in comparison to the rest of the trench.

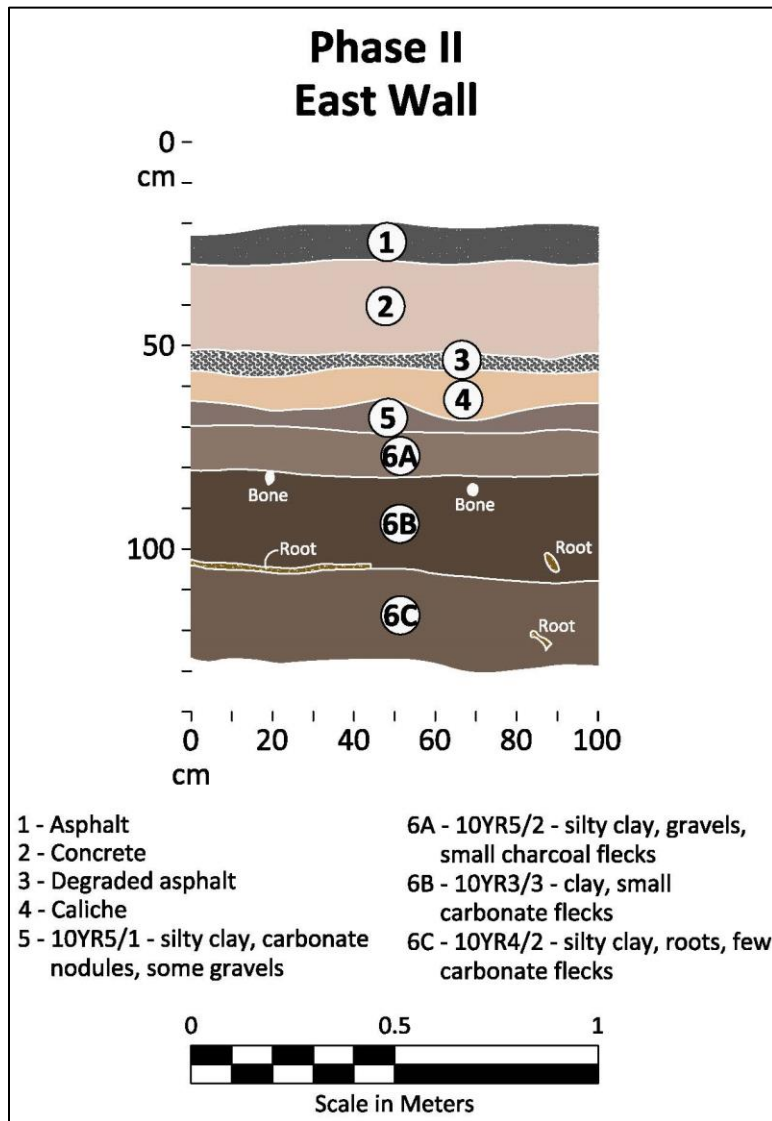
Figure 4-8. East Wall profile of Phase II off-set trench showing intact soils and cultural zone.

Following the inspection of the south wall of the off-set trench, the 3 m long east wall of the trench was cleared and a 1 m section was profiled. The east wall profile indicated that the thick intact soil zone that contained cultural materials in the south wall profile, could be subdivided into three sub-units. The only one of these sub-units that contained *in situ* cultural materials was Zone 6B found between 80 and 103 cmbs (Figure 4-8).

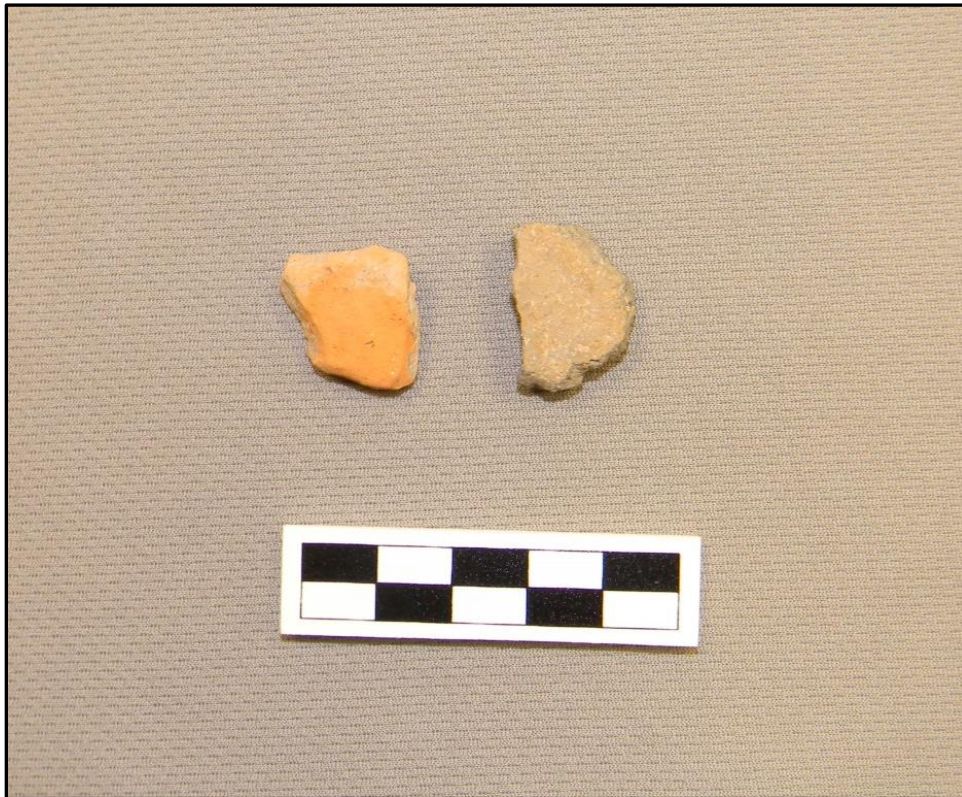
Figure 5-1. Native American Ware recovered from the southern end of Phase II trench.

Prehistoric Toyah Phase, archaeologists generally assume that Goliad Wares are a continuation of the Toyah Phase technological tradition into historic times. However, the exact relationship between Goliad and Leon Plain Wares is not known, nor do we have a clear understanding of how indigenous groups acquired the knowledge to make bone tempered ceramics. The continuity of the technological details between the two types suggests that historic Indians were directly exposed to descendants of Toyah Phase potters or that vestiges of the Toyah Phase extend into the Spanish Colonial Period. Two fragments of Native-made ceramic were recovered from the back dirt derived from the short off-set trench near the southern terminus of the Phase II trench (**Figure 5-1**).

The two small fragments recovered from the trench range from reddish brown to brown color and have an even core that matches the color of the two faces. The lack of a dark gray core indicates that the specimens were fired in an oxidizing environment and at sufficiently high temperatures to burn off the organics that typically accumulate and remain in the center of the typical Goliad specimens. The paste lacks a noticeable sand component and as such it matches the Navarro clays found in abundance throughout the upper reach of the San Antonio River basin. The small specks of white inclusions appear

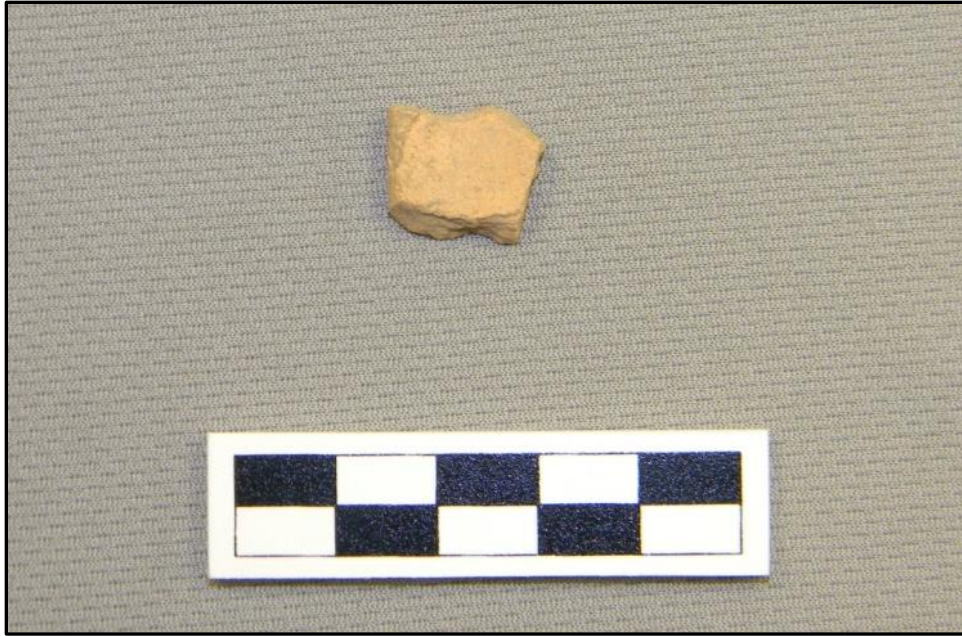
Figure 5-2. Wheel thrown ceramic recovered from Phase II trench, possible Valero Ware.

One rim sherd of an unglazed wheel thrown vessel was recovered in the trench backdirt (**Figure 5-2**). The wheel thrown variety of ceramic that was encountered during the project likely is Valero Ware, but it does not exhibit the red-brown paint decoration on the exterior. These sherds exhibit the same orange paste as Valero Wares and are uniform in color due to a controlled firing atmosphere. The orange pasted body exhibits the striation lines characteristic of manufacture on a pottery wheel. The manufacture of these vessels is believed to have occurred in Mexico throughout the eighteenth century and into the nineteenth century (Fox and Ulrich 2008). The vessels are typically large and may have been used for water storage.

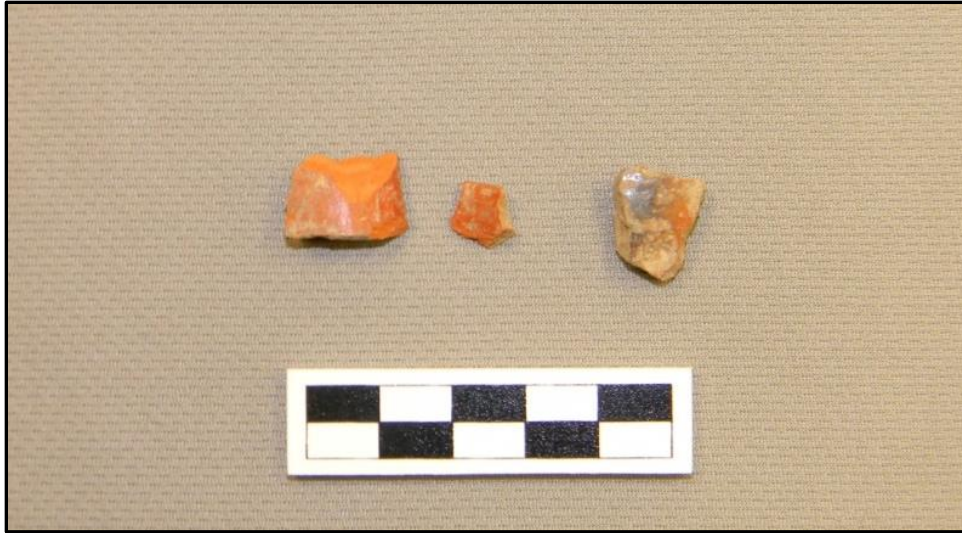
Figure 5-3. Three fragments of Red Burnished ware.

Three sherds of Red Burnished Ware sherds were recovered from the southern portion of the Phase II trench (**Figure 5-3**). Two of the three sherds represent rims. Red Burnished Wares are another variety of unglazed earthenware that was recovered during trenching. Although never officially designated as a type, this ware is characterized by the color of the paste and the surface treatment. It was first recognized by Curtis Tunnell at Mission San Lorenzo and at Mission Valero (Fox and Ulrich 2008). It has been encountered at many other Spanish Colonial sites in Texas.

Red Burnished Ware is characterized by a dark red to black paste with a highly polished surface. The paste is fine-grained and uniform throughout the sherds. The vessels were coated with a thin red slip that was burnished to a high gloss in most areas. Matte areas were present but contained glossy swirls and loops as decoration. Often firing created spalls that leave the sherd surface speckled by white or black (Fox and Ulrich 2008). The Red Burnished vessels were handmade, possibly in Central Mexico, throughout the eighteenth century (Fox and Ulrich 2008).

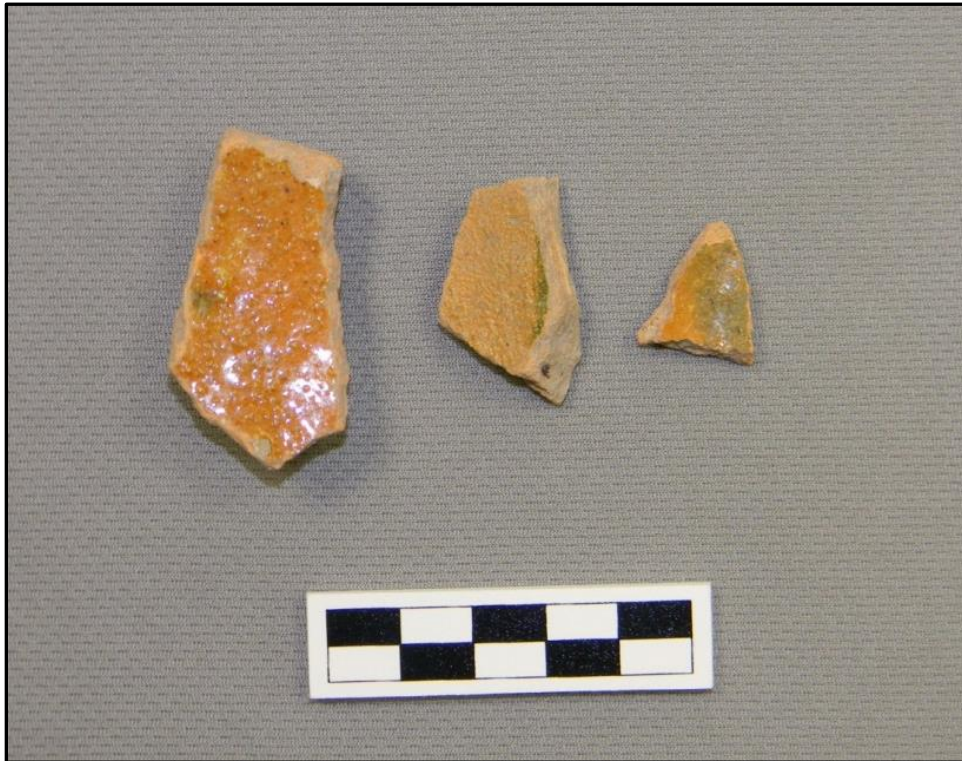
Figure 5-4. Yellow and Green Lead Glazed wares.

immature lead glazed. One of the three Yellow and Green Glazed sherds was located in the profiled wall of the trench. The sherd was recovered from Layer 4 as the wall was cleared for the profile. The sherd represented a vessel base. The remaining three sherds were body sherds that were collected from the trench (**Figure 5-4**).

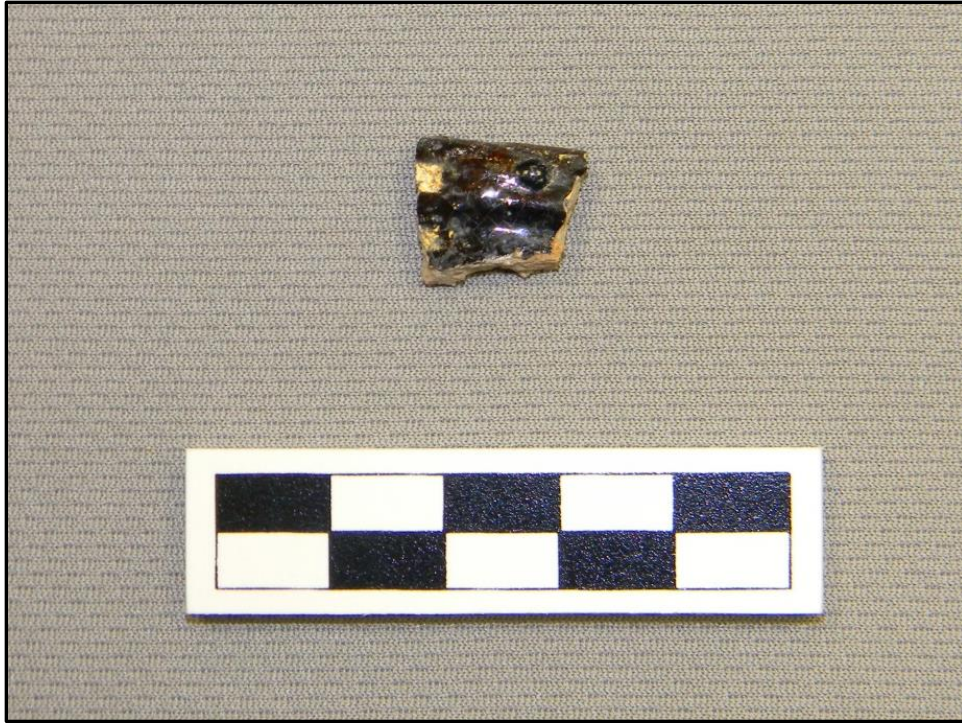
Two varieties of Black Lusterware have been noted at sites in Texas, both of these originating from Mexico. One variety exhibits a buff colored paste, while the other exhibits a terra cotta paste. The single example recovered from the southern portion of the Phase II trench was a rim sherd that exhibited the buff colored paste (**Figure 5-5**). The terra cotta pasted versions were recorded as being produced in Michoacan, Mexico between 1750 and 1850 (Fox and Ulrich 2008). It is thought that the buff pasted versions are contemporaneous.

Figure 5-5. Mexican Black Lusterware.
