Final Report for Archeological Survey

Farm-to-Market Road (FM) 457 Swing Bridge Replacement Project at Gulf Intracoastal Waterway in Matagorda County, Texas.

CSJ: 0605-01-060

November 9, 2017

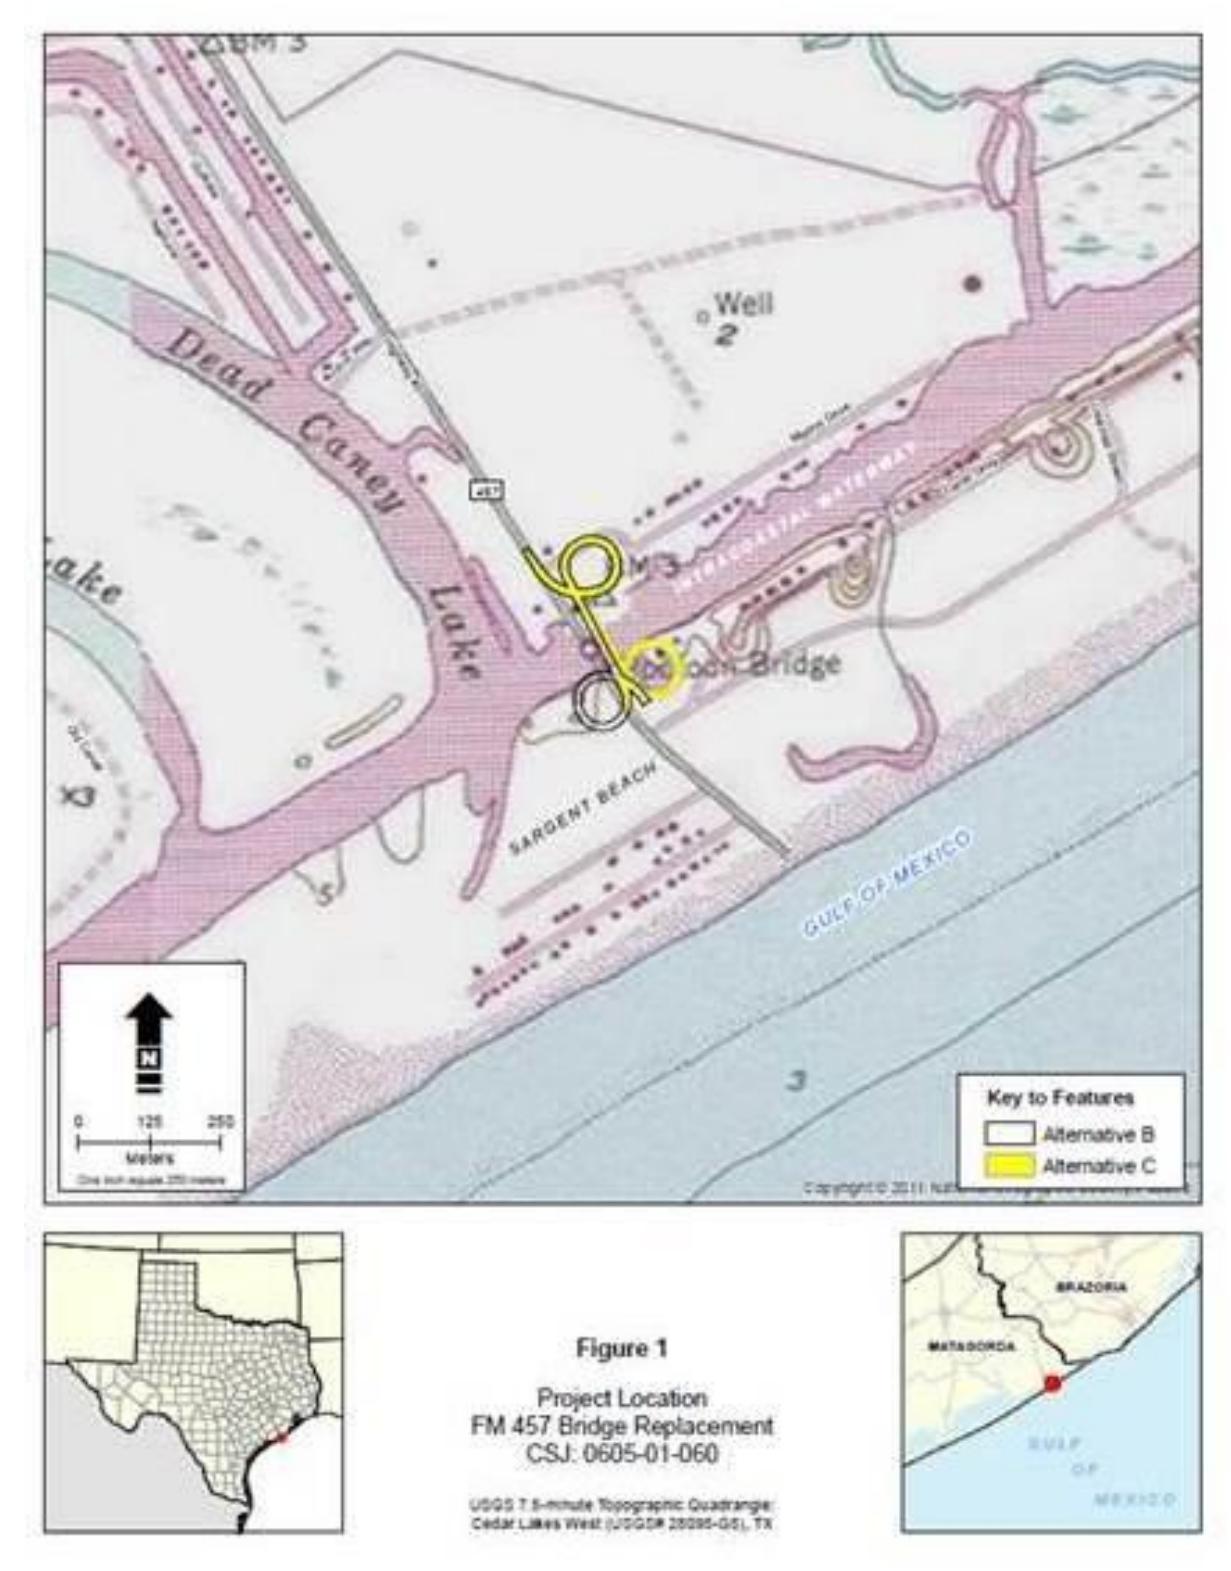
Figure 2. Proposed location of bridge replacement project (Alternative C is the preferred alternative) within APE on topo map.

Project Description and Impacts: The proposed project is located in Matagorda County, Texas (Figure 1). Construction activities will include boring holes for support piers, installing concrete beams, piers, and pillars, and paving. All construction activities will take place within the previously acquired State-owned ROW. The proposed project would replace the existing pontoon swing bridge with an elevated bridge that would allow vehicular and marine traffic to move unimpeded (Figure 2)

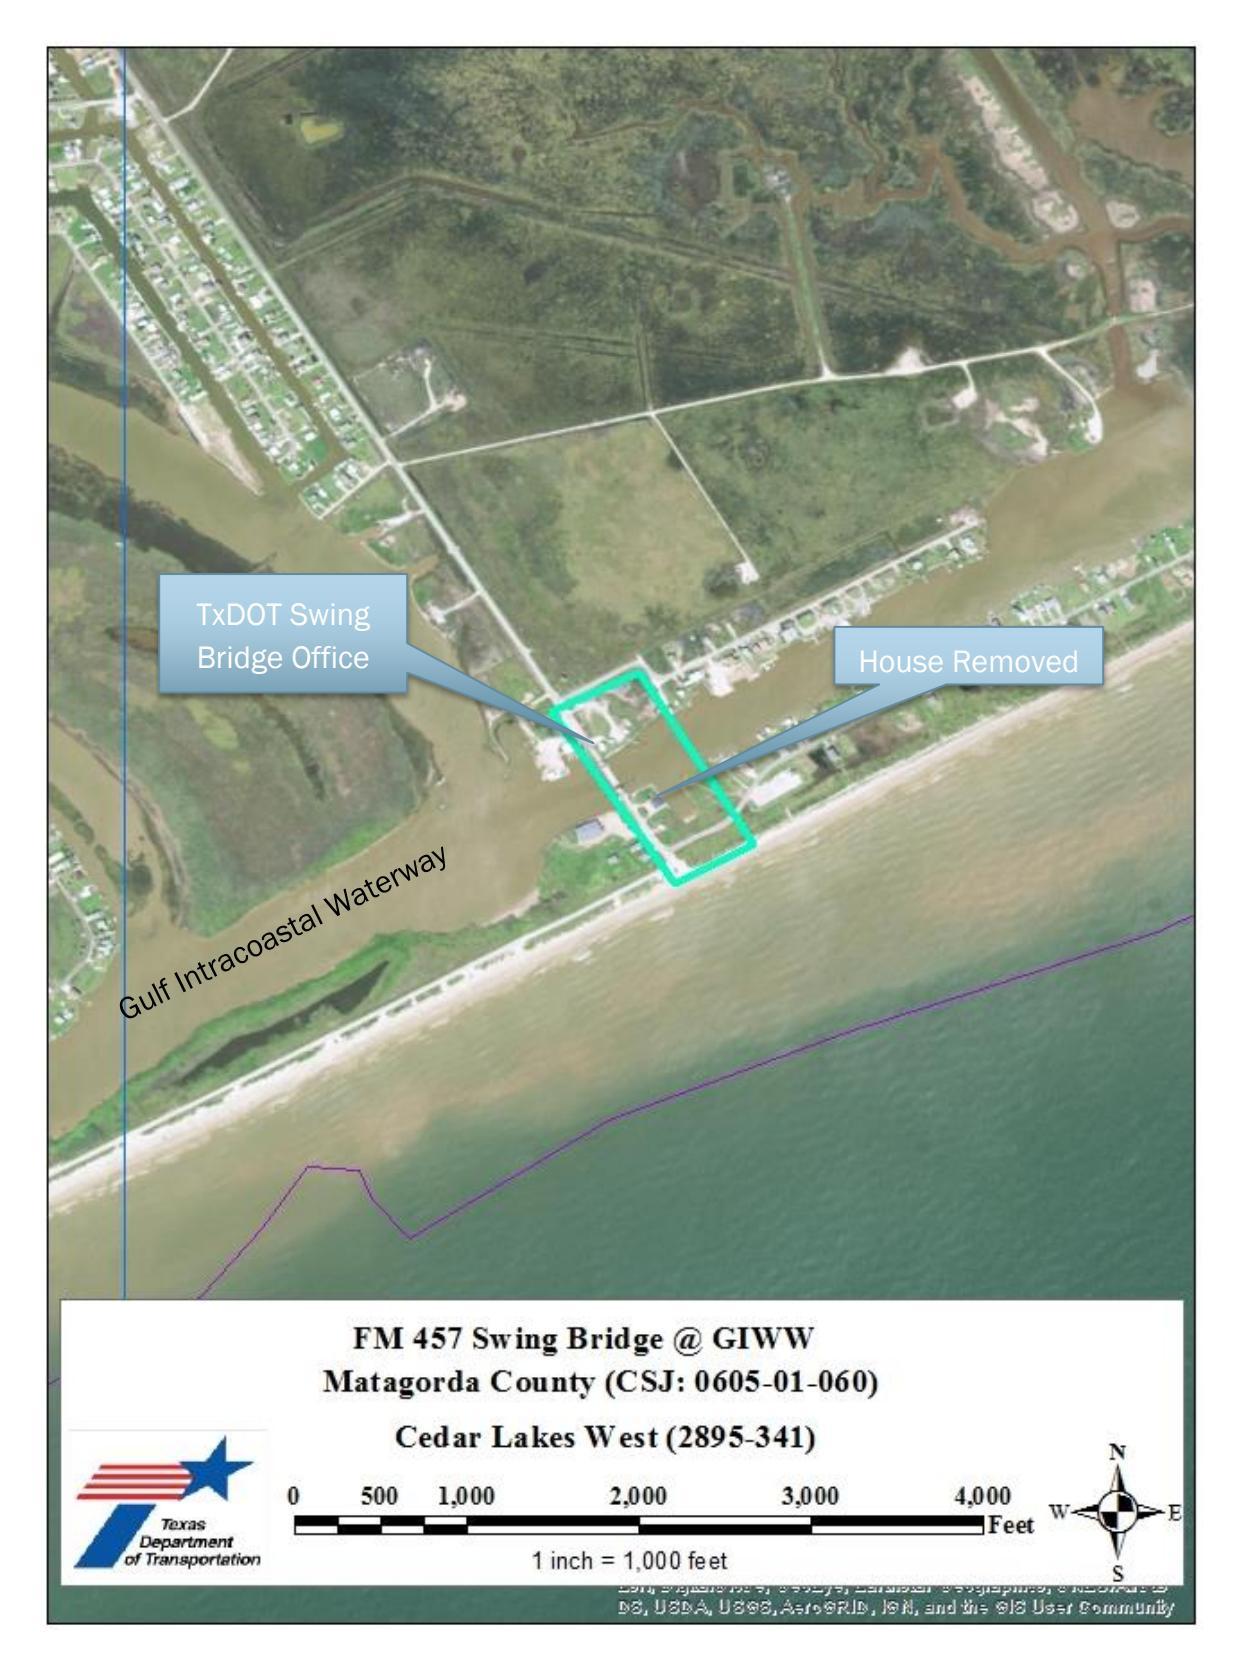
Figure 3. Project APE on an aerial photograph.

Area of Potential Effects (APE): The APE is defined as the proposed project length (3,107 feet) within new and existing FM 457 ROW, measuring 24 to 30 feet wide, the 4.2 acres of new proposed ROW, and the 10-foot depth of construction impacts. Total acreage of the APE measures 6.125 acres (Figure 3).

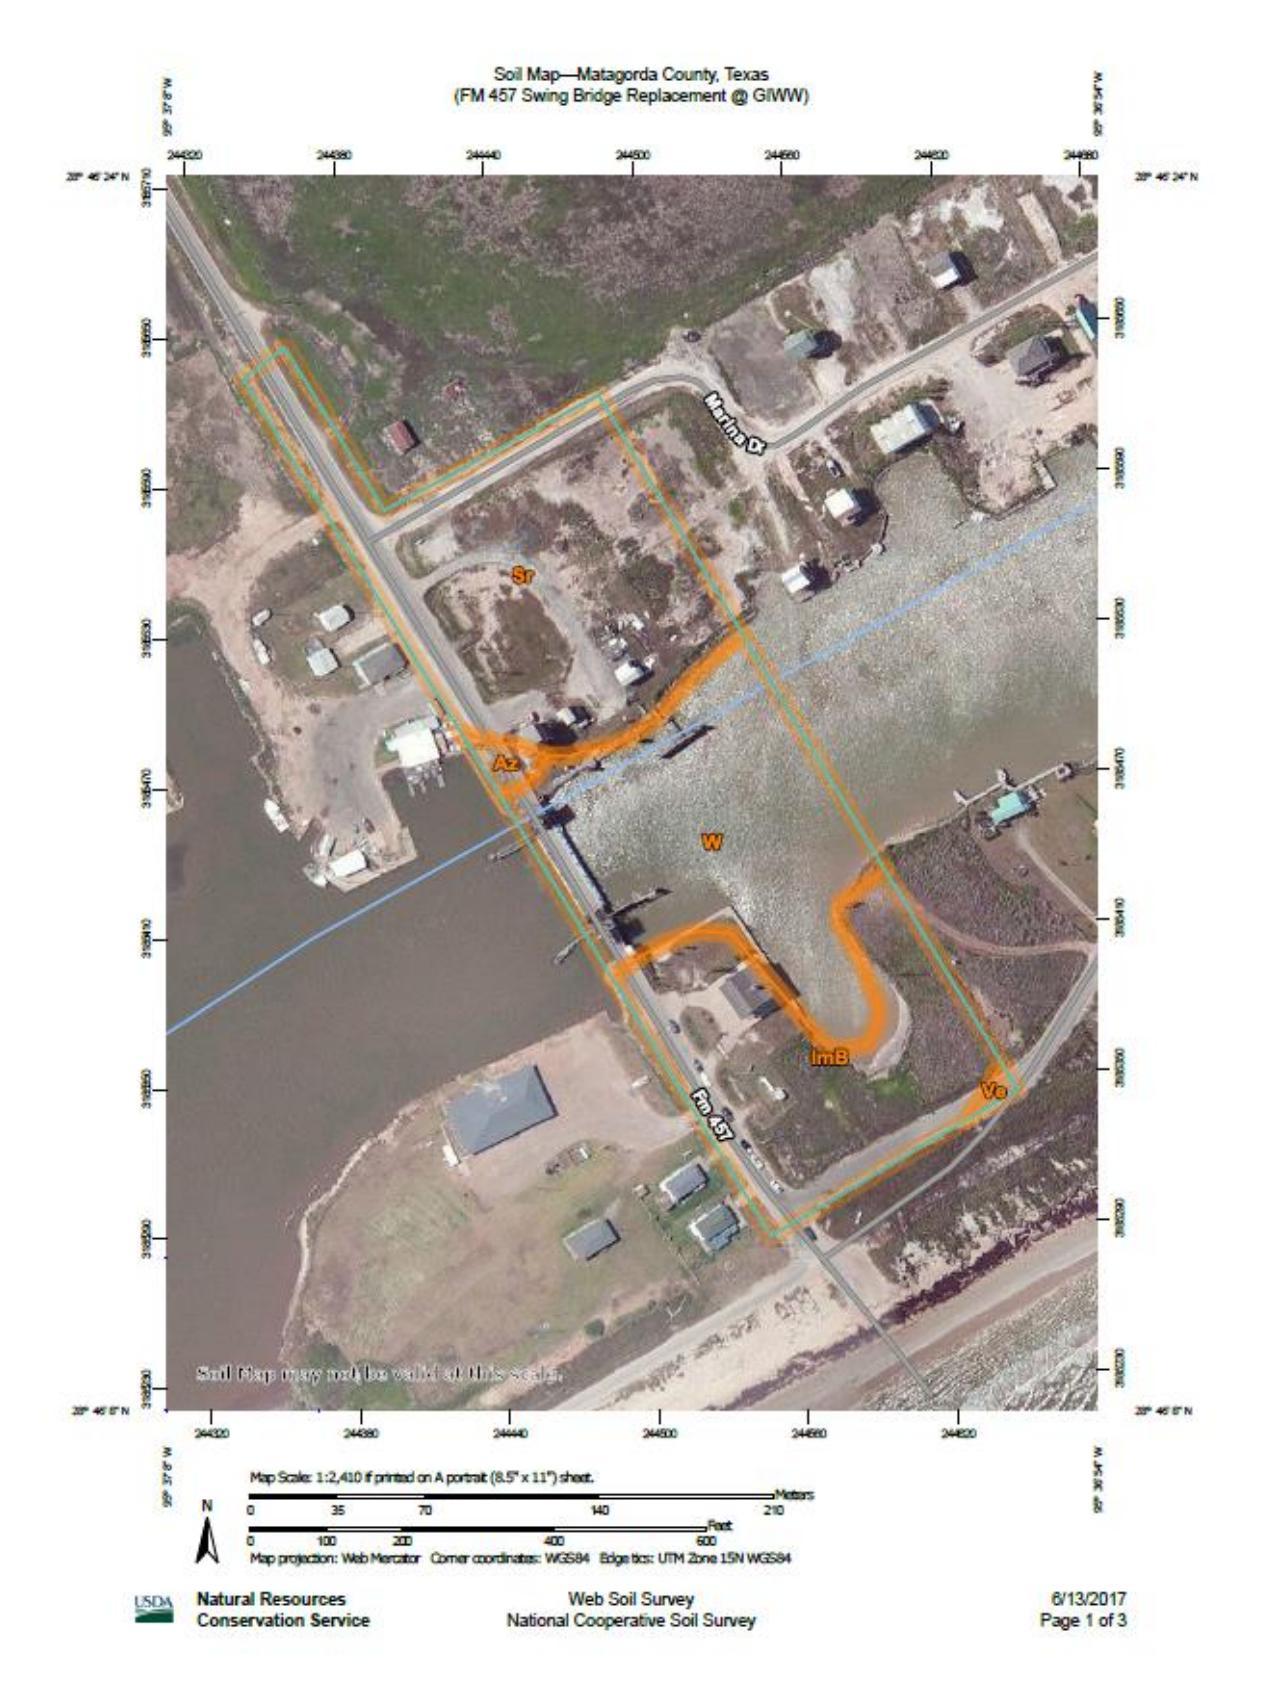
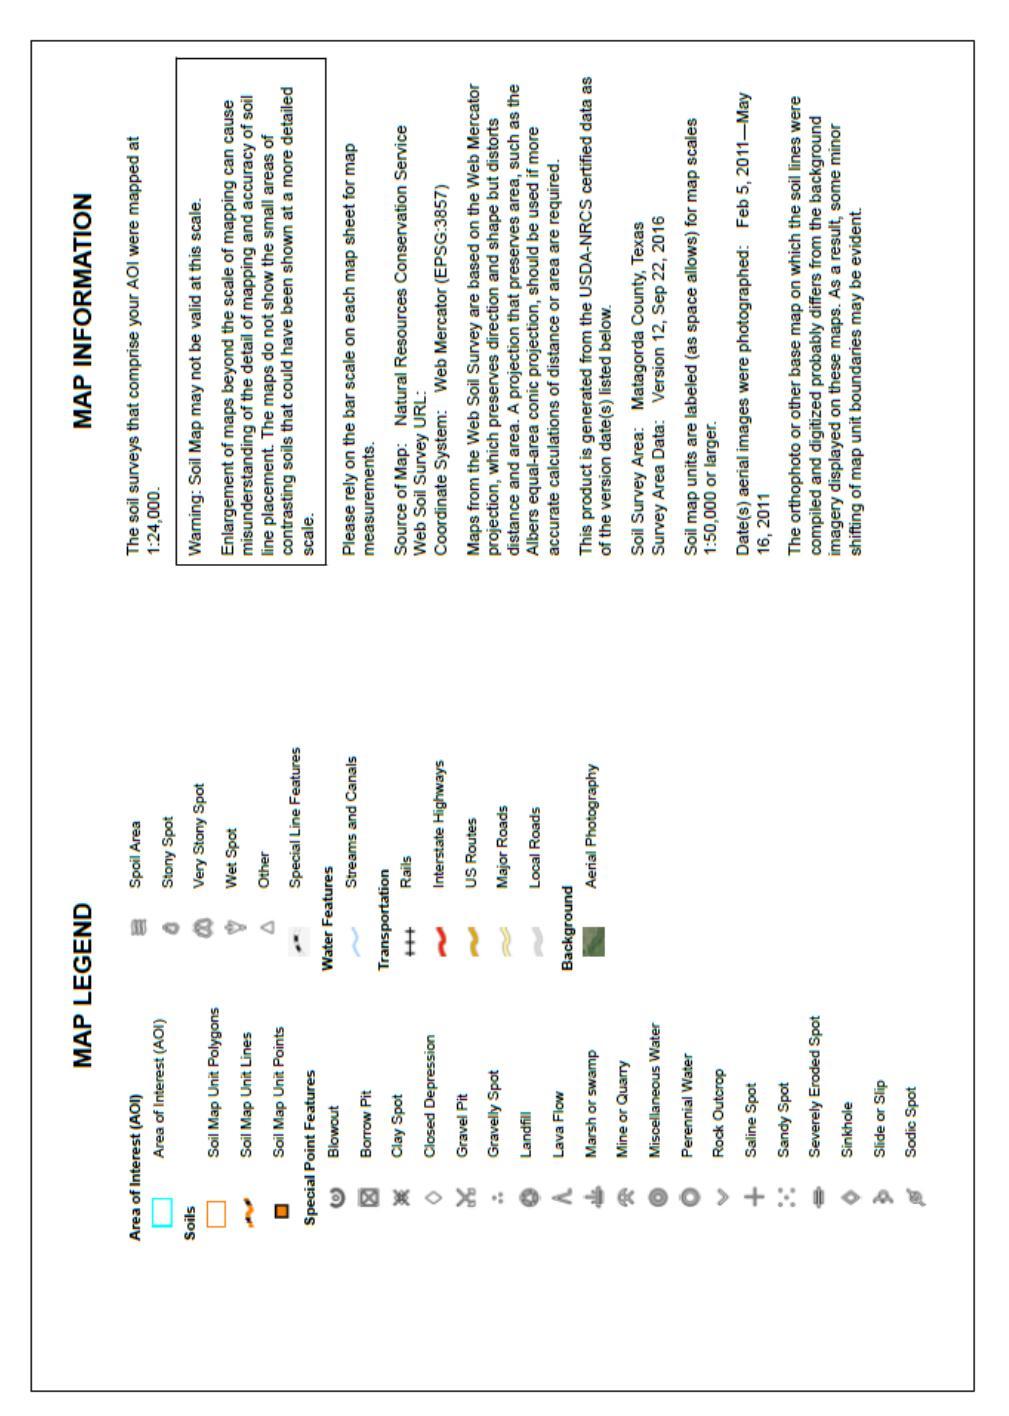
Figure 4. Mapped soils within the APE.

Figure 4. Mapped soils within the APE (con't.).

Soils: The APE is composed of Asa silty clay loam, Ijam clay, Surfside clay, and Velasco clay (Figure 3). The Asa soil is a deep, well-drained soil formed in loamy alluvium of Holocene age; this soil is on nearly level coastal flood plain and observed on slopes ranging from 0 to 1 percent. The Ijam soil is a deep, poorly-drained soil dredged from marine channels and observed as mounded deposits on the landscape; this soil consists of sandy and/or loamy dredge spoil that is used as fill and is usually observed on slopes ranging from 0 to 1 percent. The and Velasco soils are deep, very poorly-drained soils formed in calcareous, saline, clayey alluvium of Holocene age; this soil is on nearly level coastal flood plain and observed on slopes ranging from 0 to 1 percent (Natural Resources Conservation Service 2017).

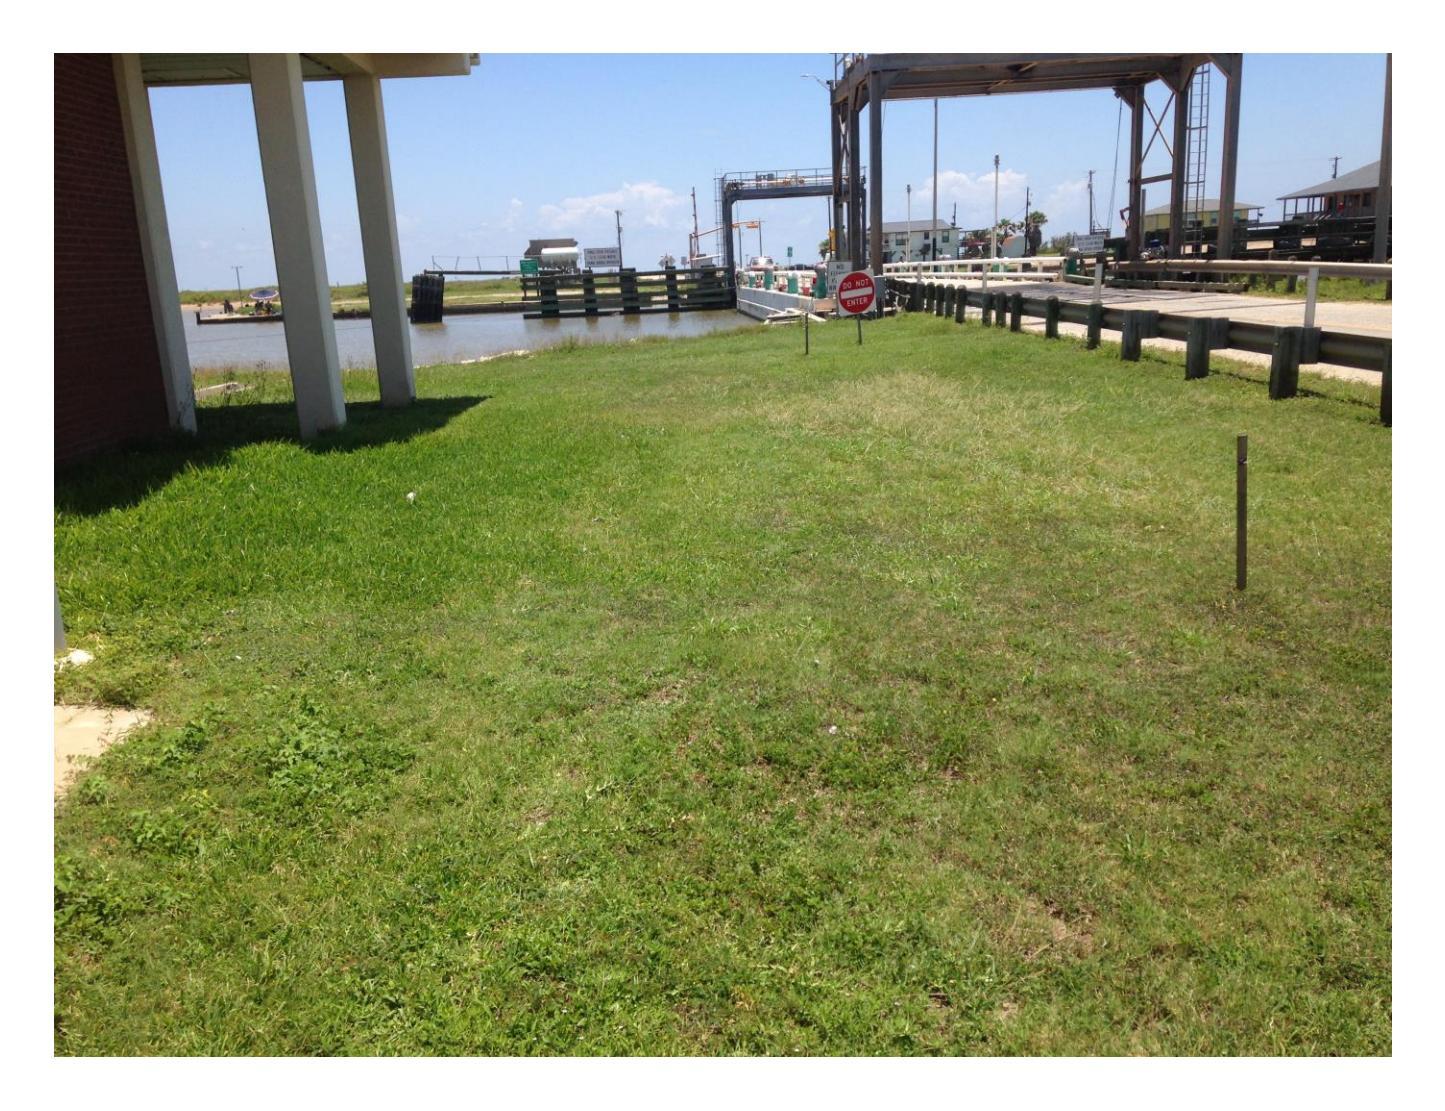
Figure 5. Well-maintained ROW within the APE in NE Quadrant; opposite side of GIWW is a cleared vacant lot in the SE Quadrant. This is the side where circular bridge ramps will be located

Land Use: The entirety of the APE is within existing ROW. The existing ROW consists entirely of the FM 457 roadway, the existing swing bridge, and previously developed properties acquired by TxDOT for use as State-owned ROW. The majority of the APE consists of a relatively thick fill-section of disturbed fill overlying the coastal marshes (Figures 5 & 6).

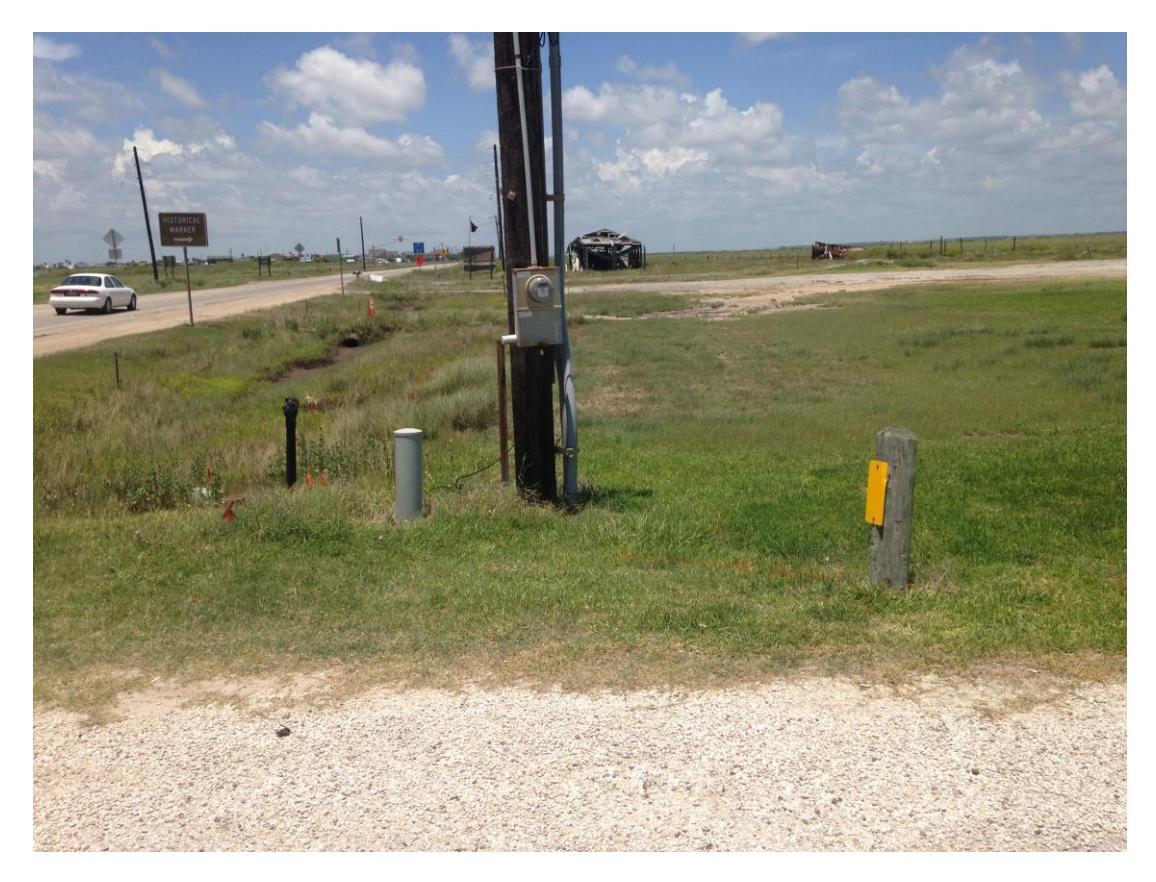
Figure 6. Opposite direction from the previous photo showing the APE still within in NE Quadrant, bridge ramp side of APE.

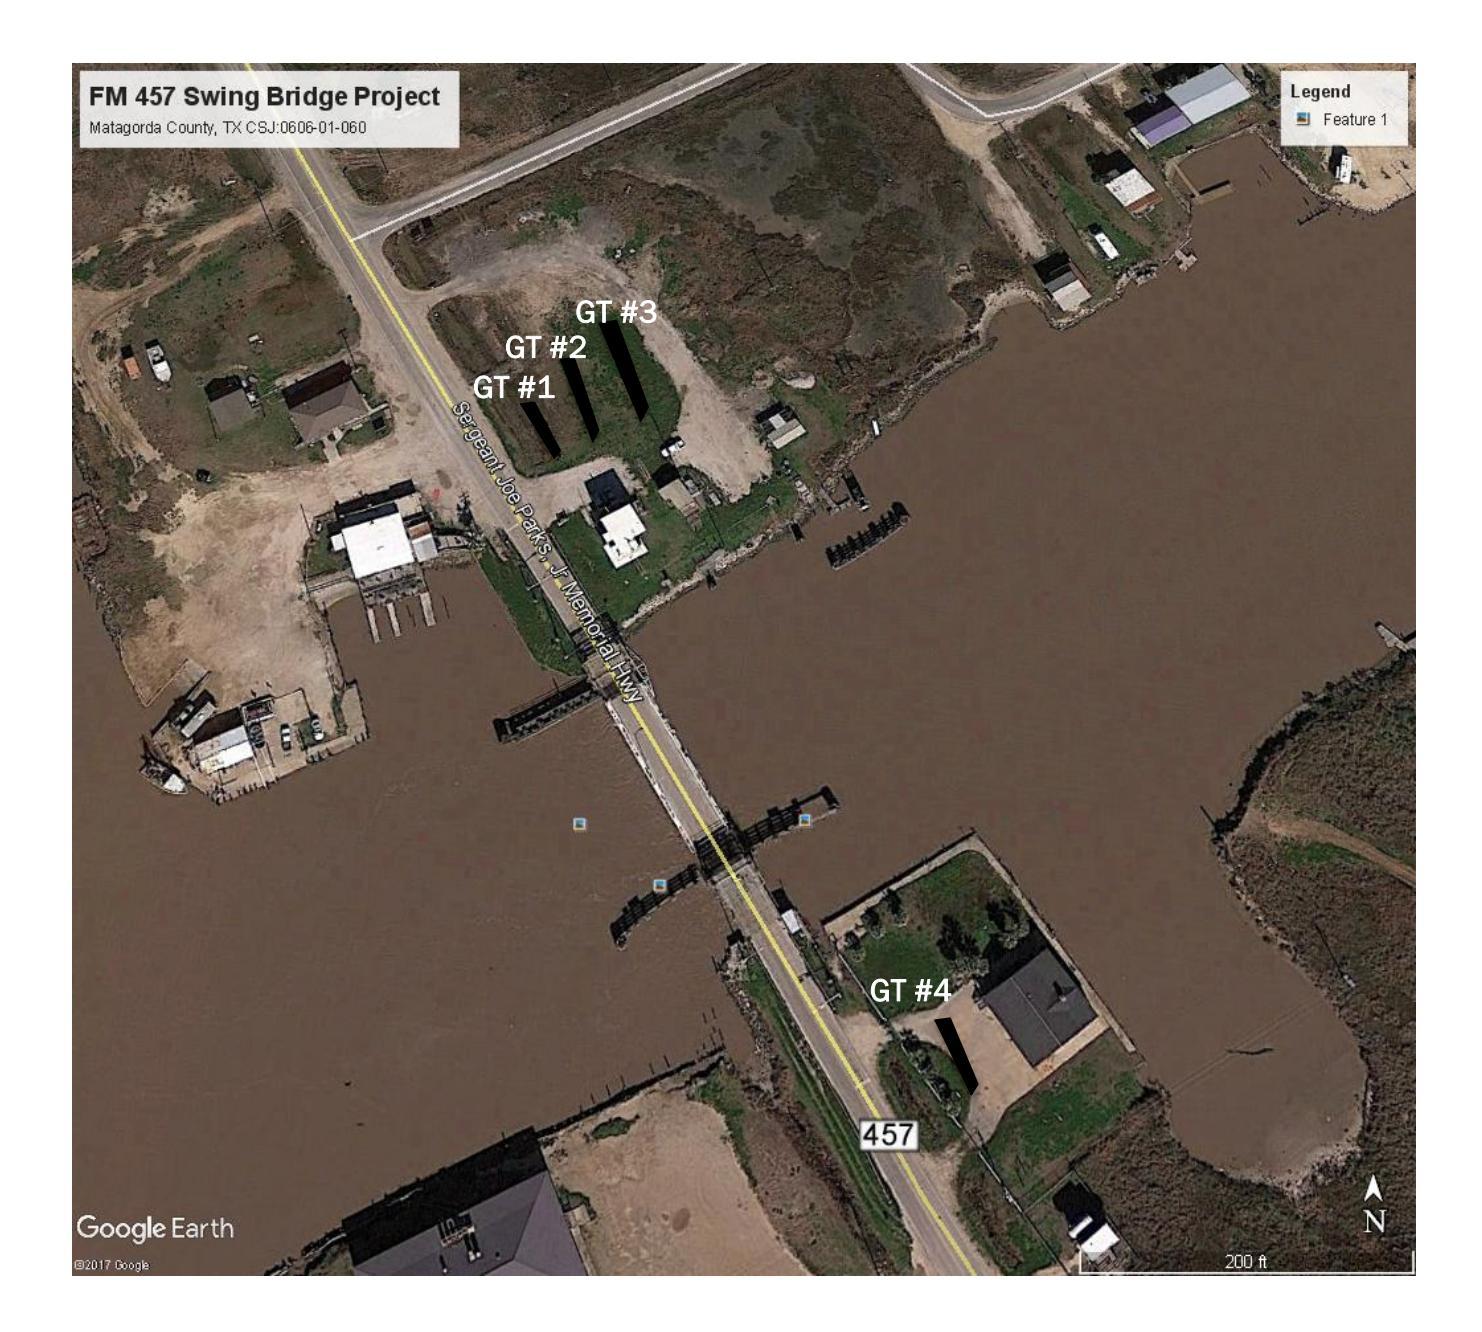
Figure 7. Location of mechanical trenches within APE.

Project Area Description: The APE was assessed via four mechanical trenches (Figure 7). Only the bridge replacement portion of this proposed project warranted a survey. The remainder of the APE is previously disturbed and does no warrant an inventory. The pedestrian survey revealed that the majority of the ground surface within the APE is extensively disturbed by previous developmental activities, exhibiting an abundance of modern trash and debris, and did not warrant an archeological investigation. Of the four mechanical trenches, these were excavated to approximately 10 meters (approximately 33 feet) in length, at least one meter (just over three feet) in width, and to approximately one and a half to two meters (approximately five to seven feet) in depth (Figures 8 to 13). Disturbances were observed to approximately four feet below the surface. This included dredge spoil materials, construction debris and modern trash, and numerous abandoned utility lines for water, telephone, and septic systems drain fields. The APE was found to be sterile of any archeological materials or features, no Confederate earthworks were encountered. The only artifacts encountered two bottles, the oldest a 1940's bottle of Nu-Grape soda at approximately three feet in depth (Figures 14 and 15).

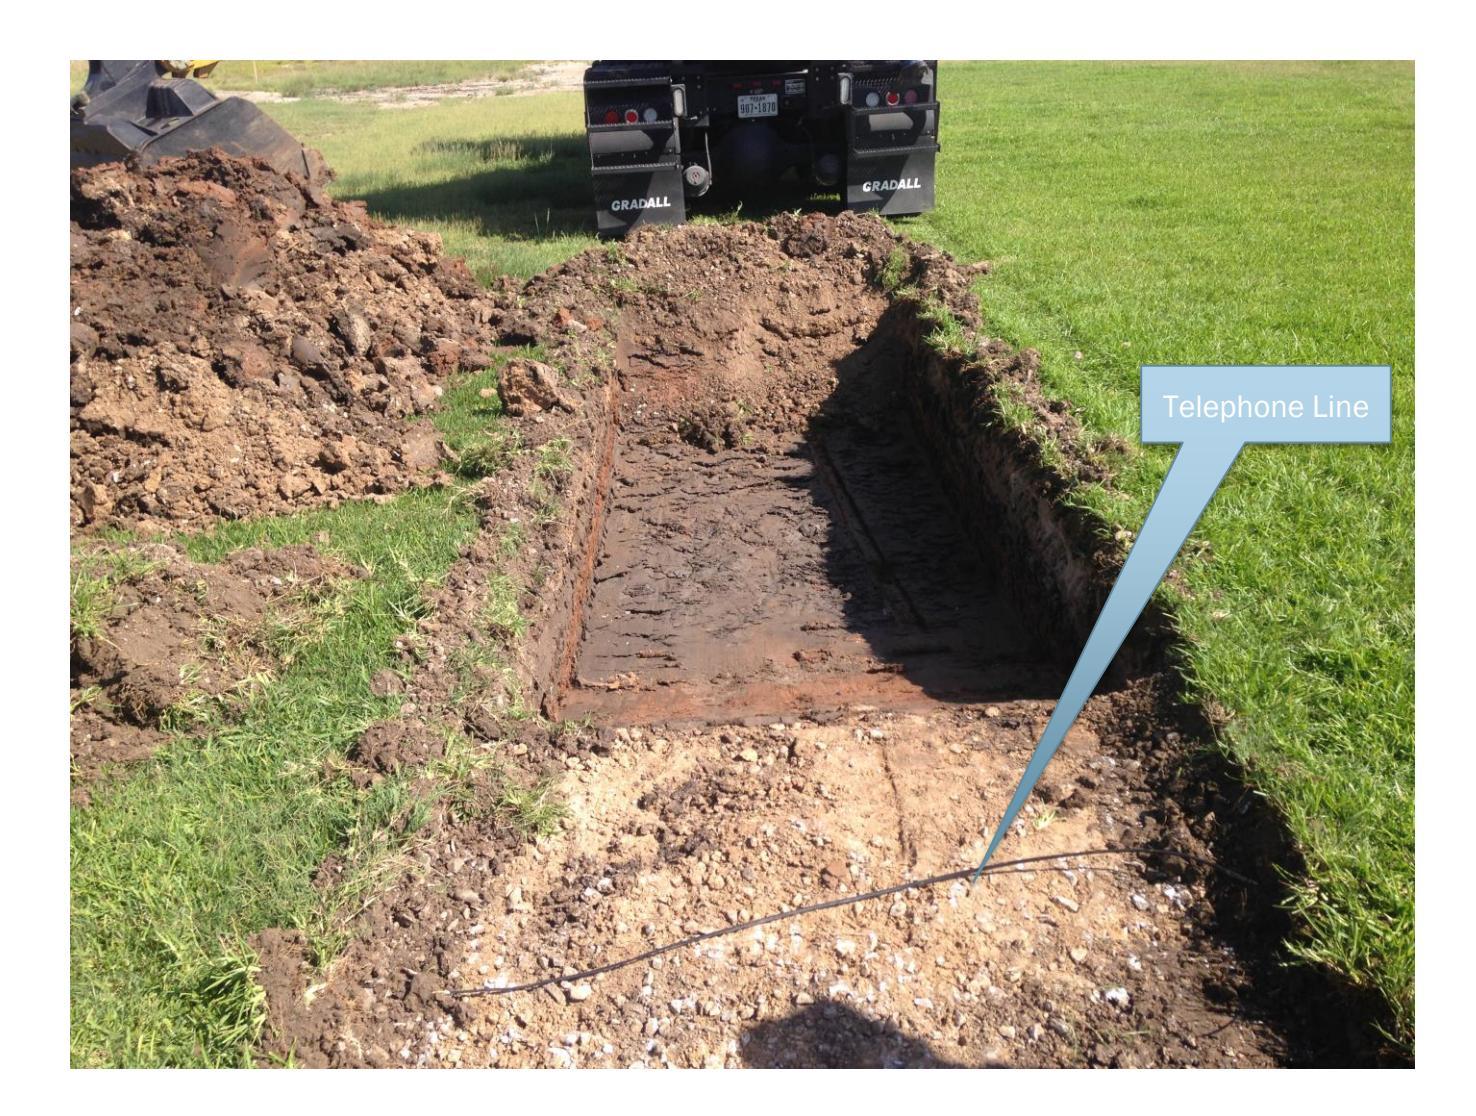
Figure 8. Gradall trench number one.

APE Integrity: Previous developmental activities and maintenance within the APE of the proposed project area have heavily modified the APE. There is a relatively thick layer of disturbed fill overlying the entirety of the areas investigated. Below this, portions of the APE have been disturbed by utility installation to a depth of approximately three to four feet below the ground surface (BTGS). Below this, only sterile clay was encountered to a depth of approximately five to seven feet BTGS.

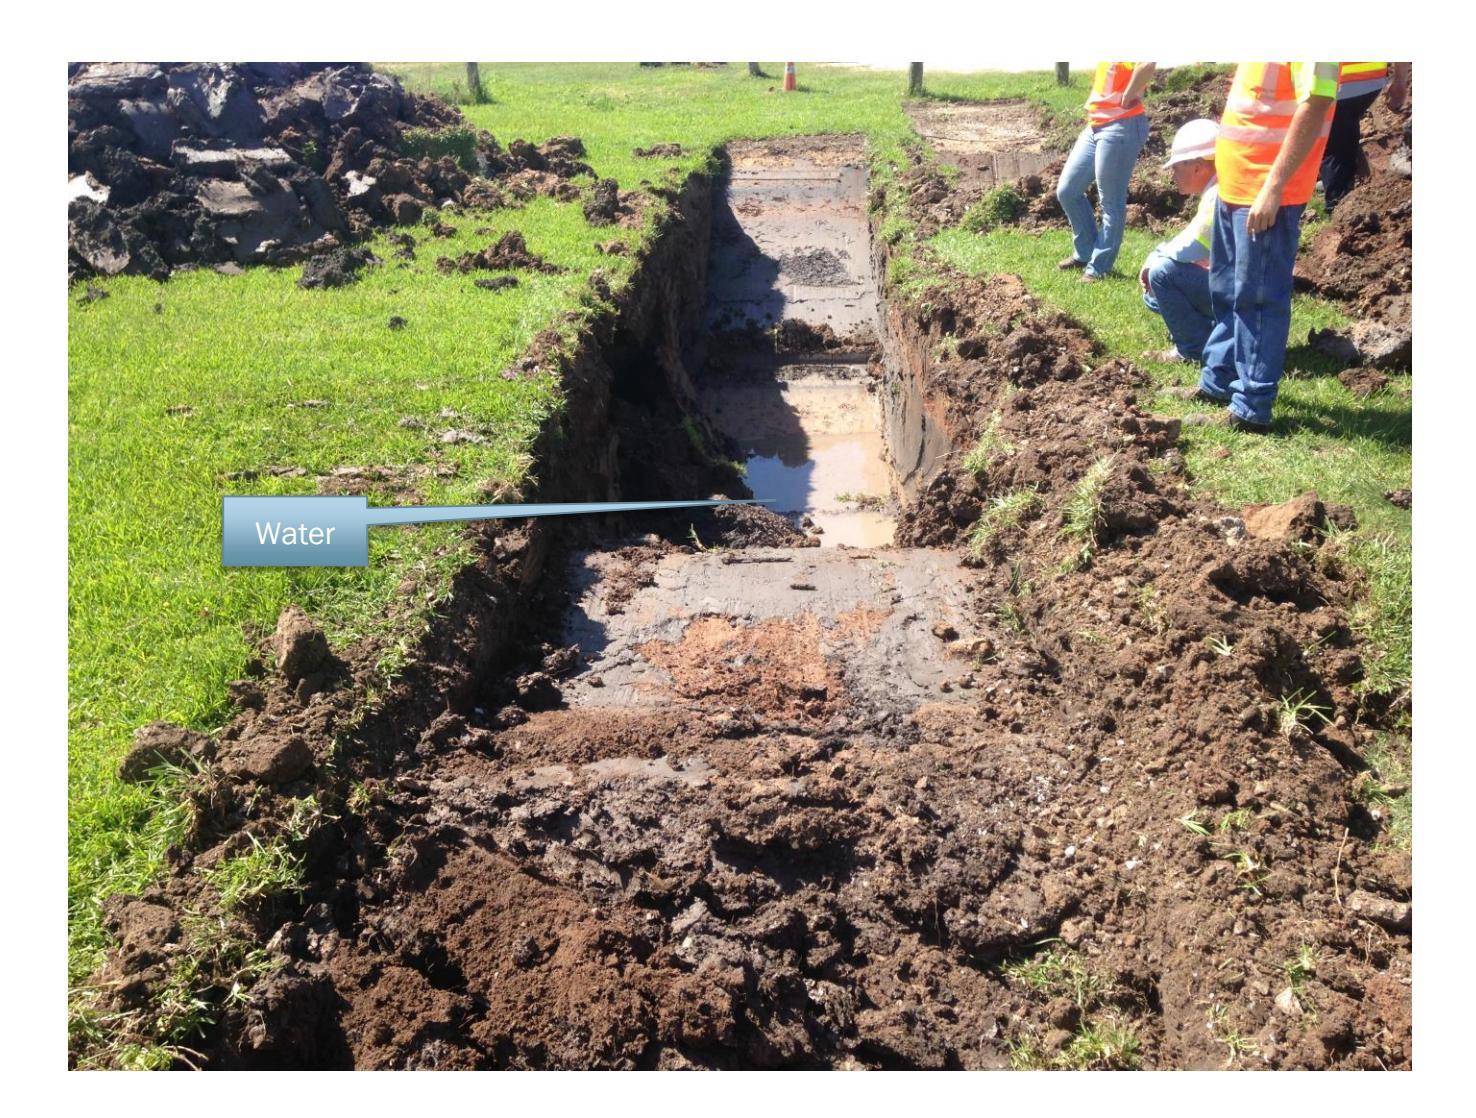
Figure 9. Gradall trench number two.

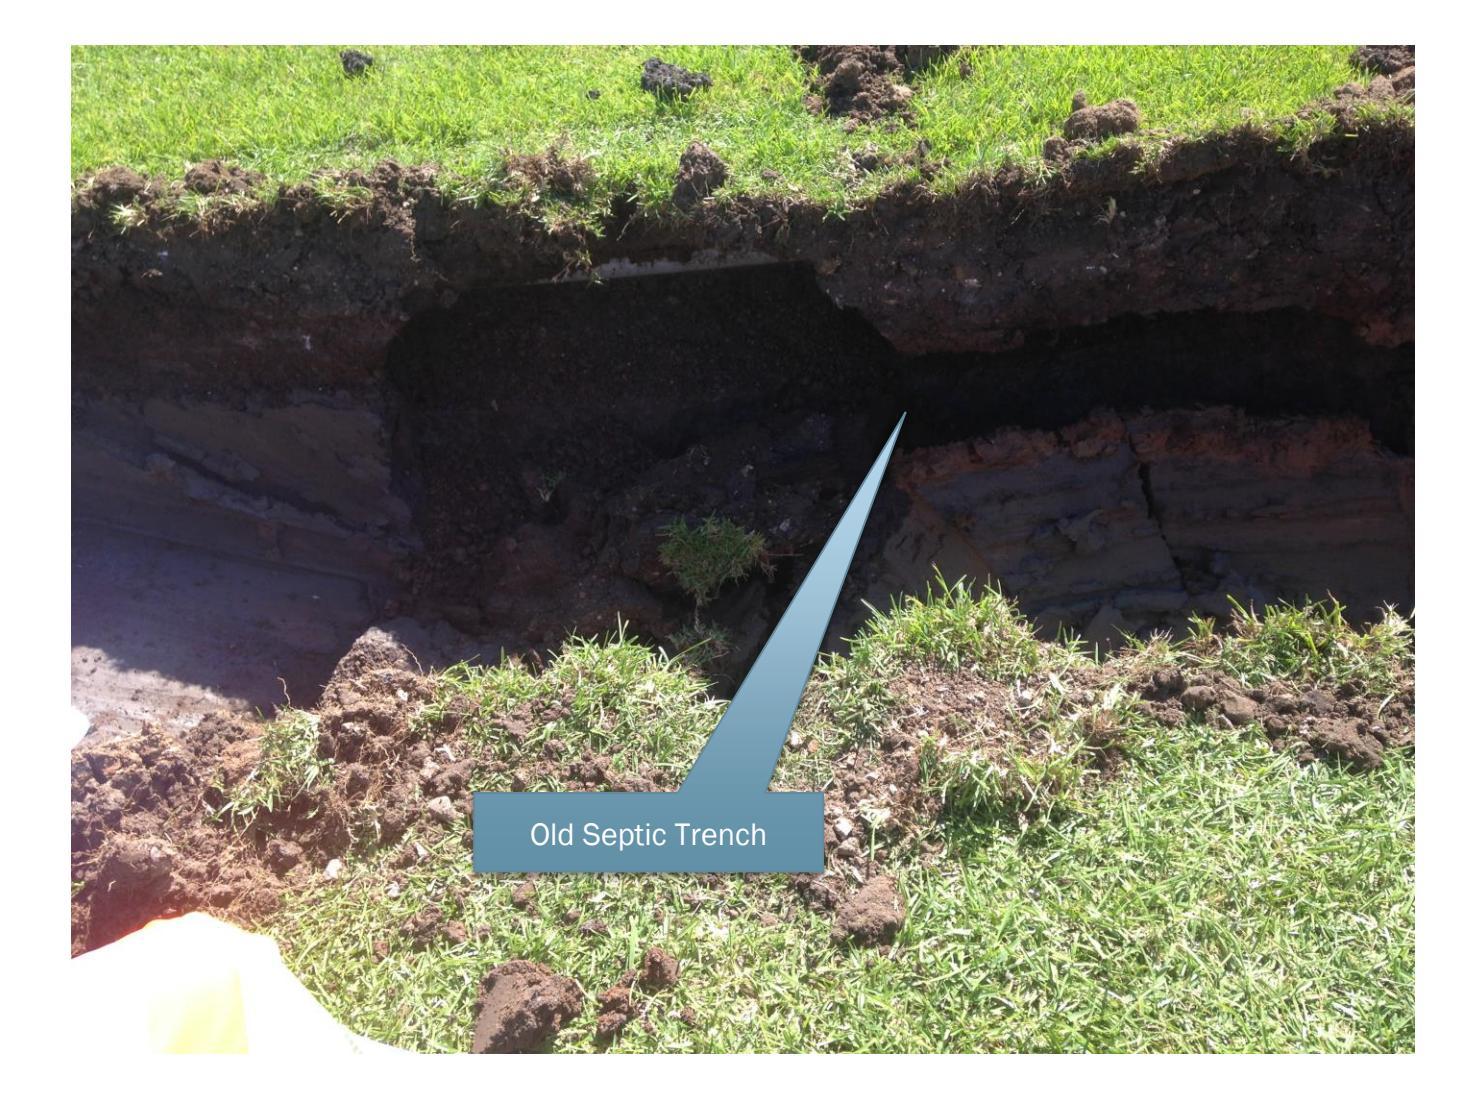
Figure 10. Gradall trench number two, east wall, notice septic line.

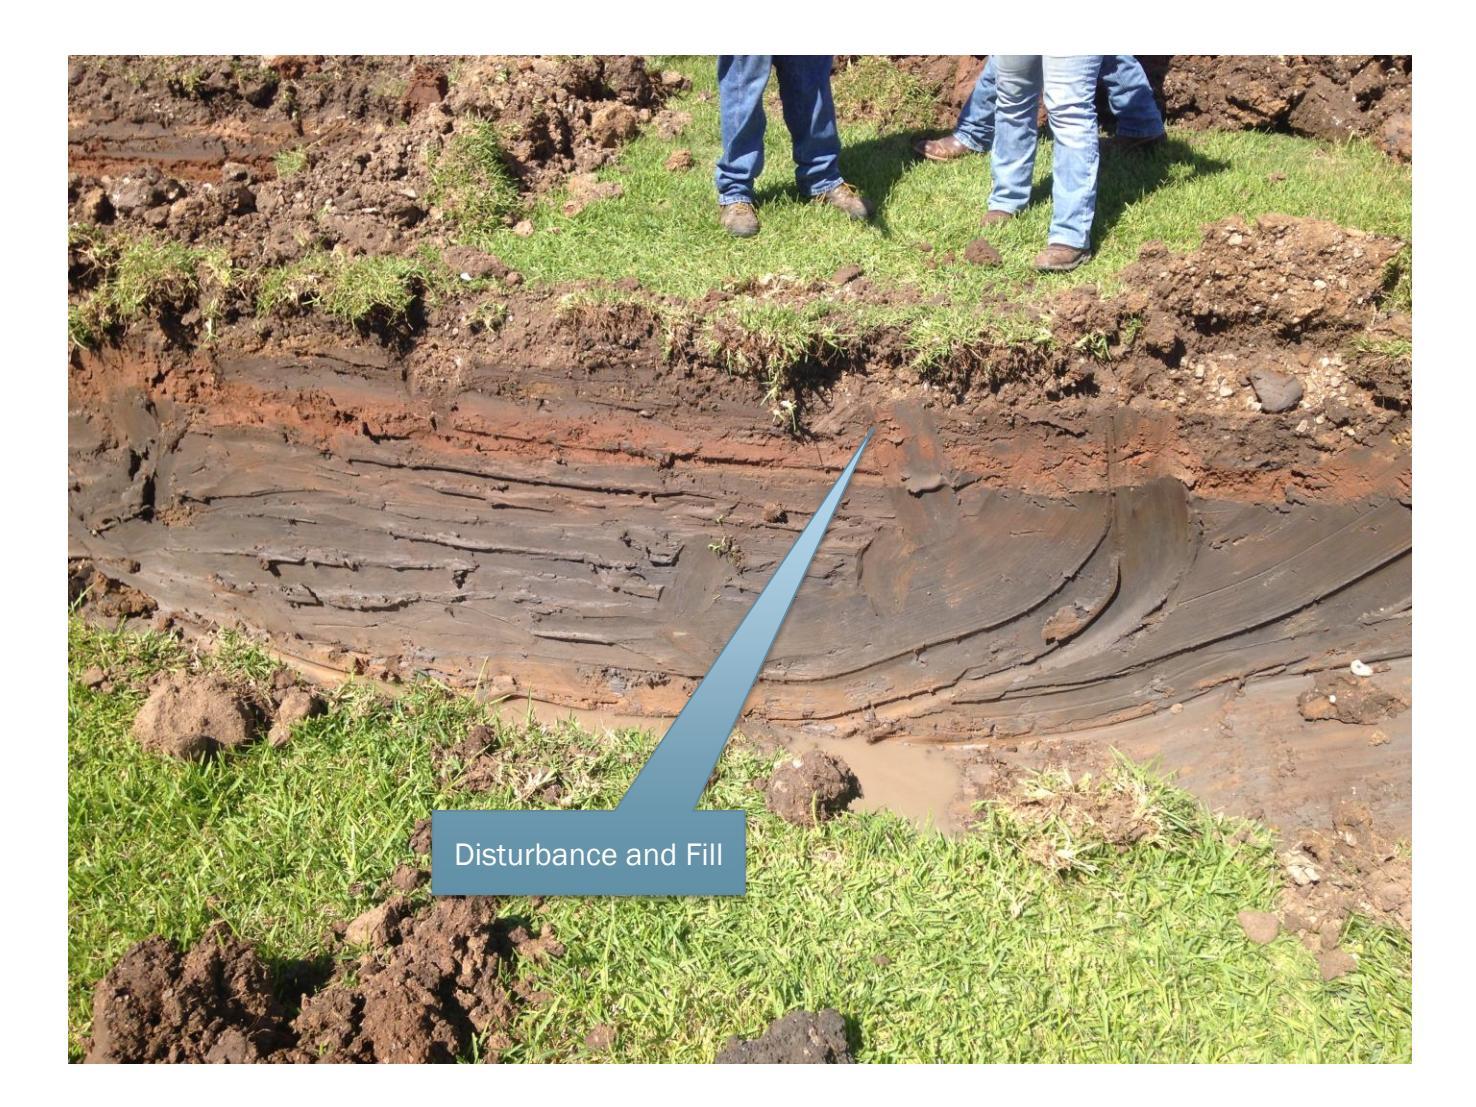
Figure 11. Gradall trench number two, west wall.

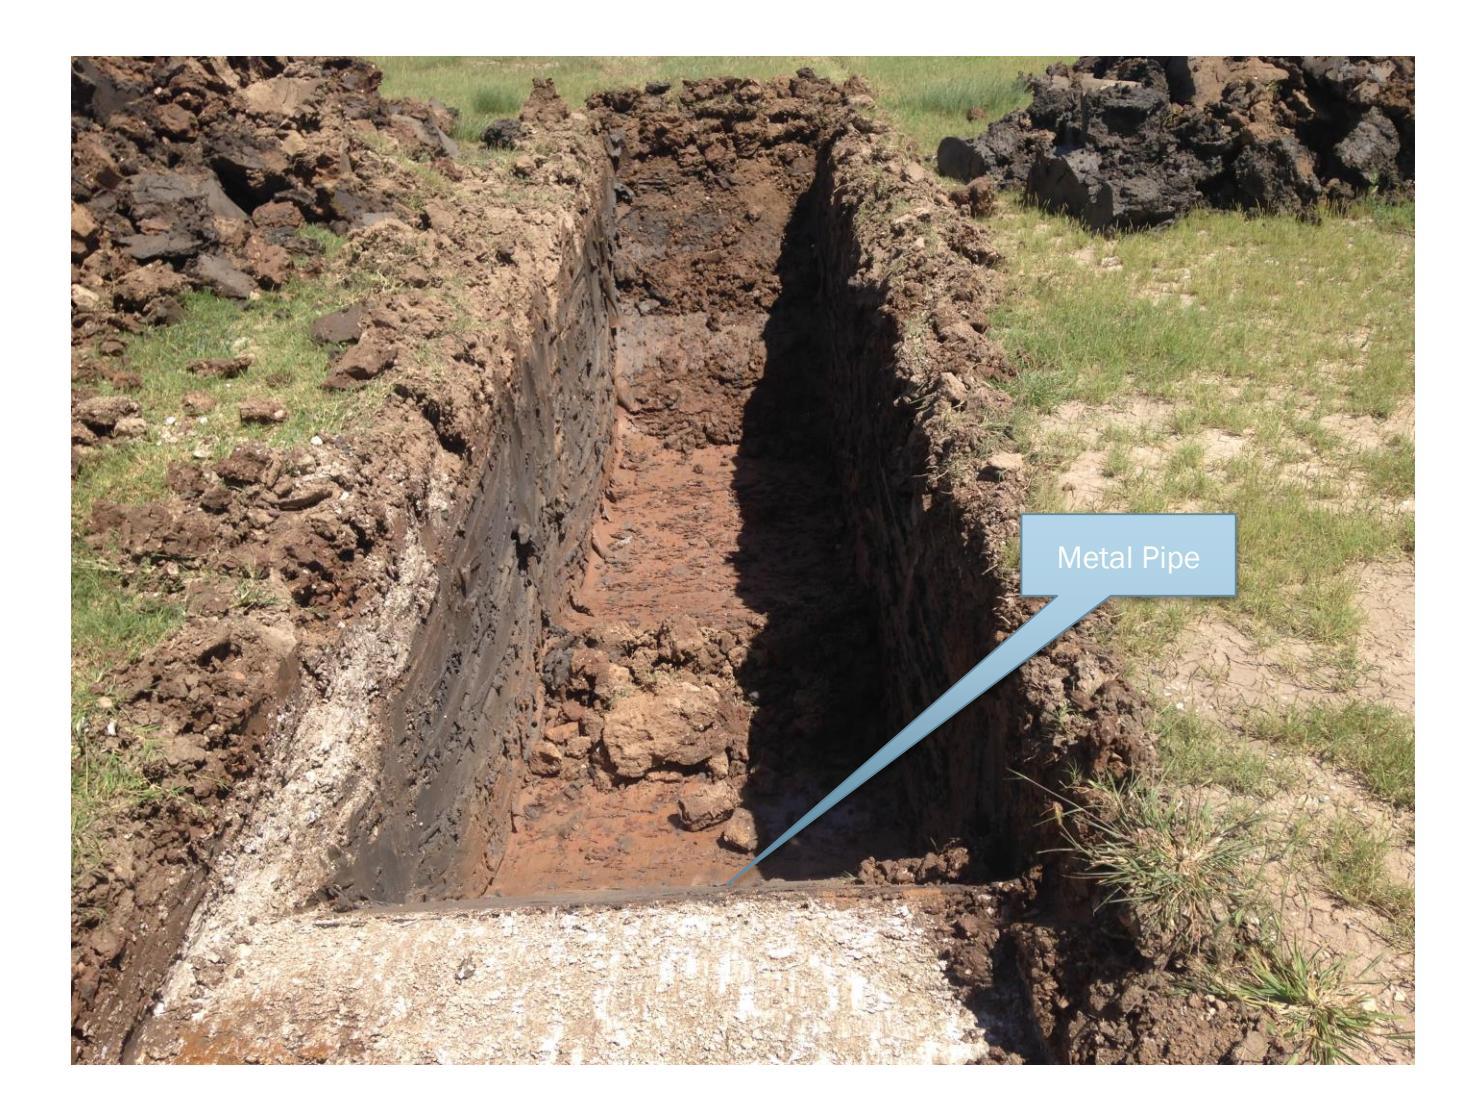
Figure 12. Gradall trench number three.
