Final Report for Archeological Survey

Farm-to-Market Road (FM) 457 Swing Bridge Replacement Project at Gulf Intracoastal Waterway in Matagorda County, Texas.

CSJ: 0605-01-060

November 9, 2017

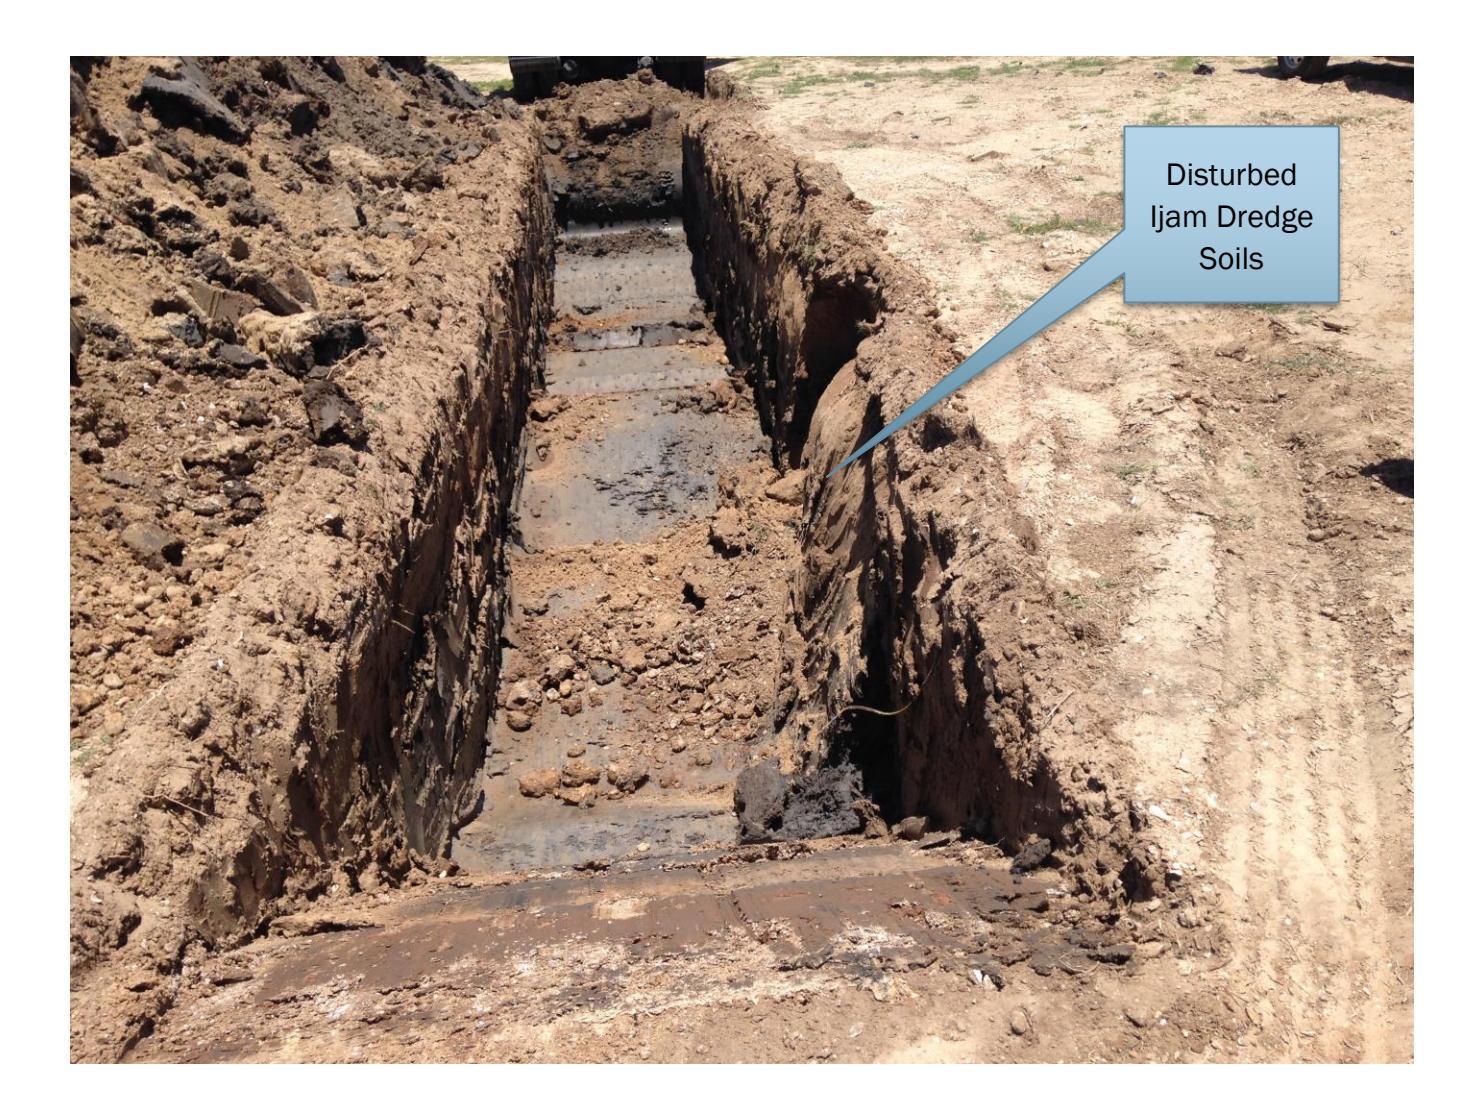
Figure 13. Gradall trench number four.

APE Integrity: Previous developmental activities and maintenance within the APE of the proposed project area have heavily modified the APE. There is a relatively thick layer of disturbed fill overlying the entirety of the areas investigated. Below this, portions of the APE have been disturbed by utility installation to a depth of approximately three to four feet below the ground surface (BTGS). Below this, only sterile clay was encountered to a depth of approximately five to seven feet BTGS.

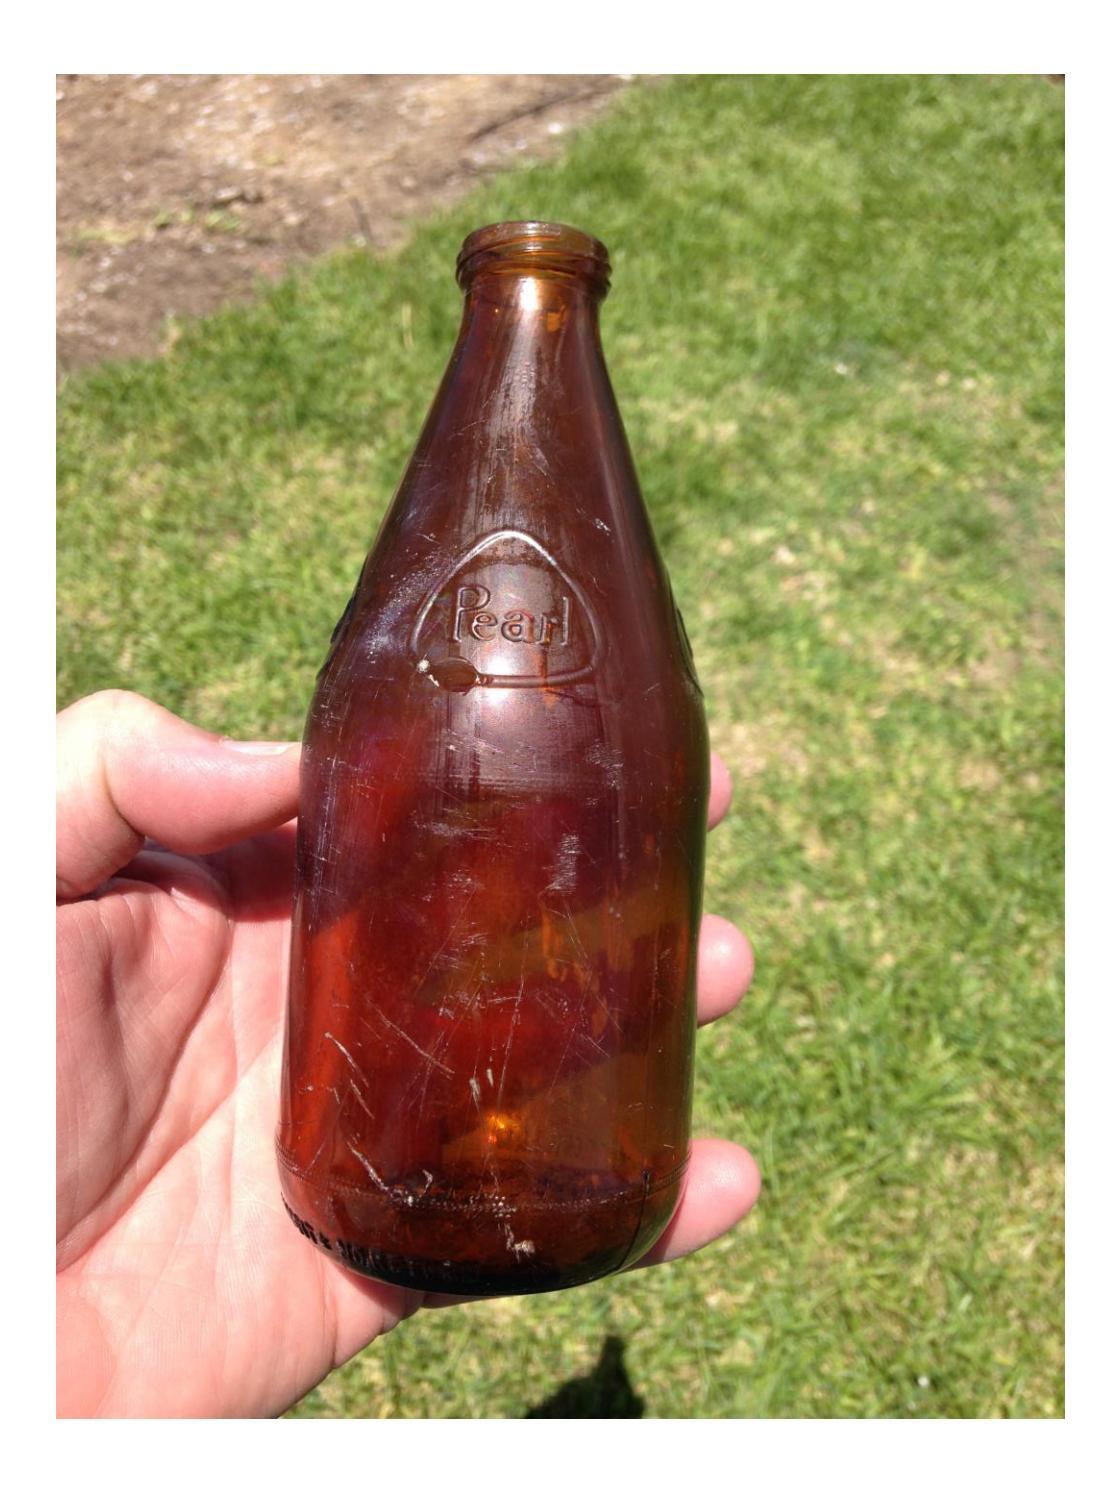
Figure 14. 1960's Pearl beer bottle.

Project Area Description: The APE was assessed via four mechanical trenches (Figure 7). Only the bridge replacement portion of this proposed project warranted a survey. The remainder of the APE is previously disturbed and does no warrant an inventory. The pedestrian survey revealed that the majority of the ground surface within the APE is extensively disturbed by previous developmental activities, exhibiting an abundance of modern trash and debris, and did not warrant an archeological investigation. Of the four mechanical trenches, these were excavated to approximately 10 meters (approximately 33 feet) in length, at least one meter (just over three feet) in width, and to approximately one and a half to two meters (approximately five to seven feet) in depth (Figures 8 to 13). Disturbances were observed to approximately four feet below the surface. This included dredge spoil materials, construction debris and modern trash, and numerous abandoned utility lines for water, telephone, and septic systems drain fields. The APE was found to be sterile of any archeological materials or features, no Confederate earthworks were encountered. The only artifacts encountered two bottles, the oldest a 1940's bottle of Nu-Grape soda at approximately three feet in depth (Figures 14 and 15).

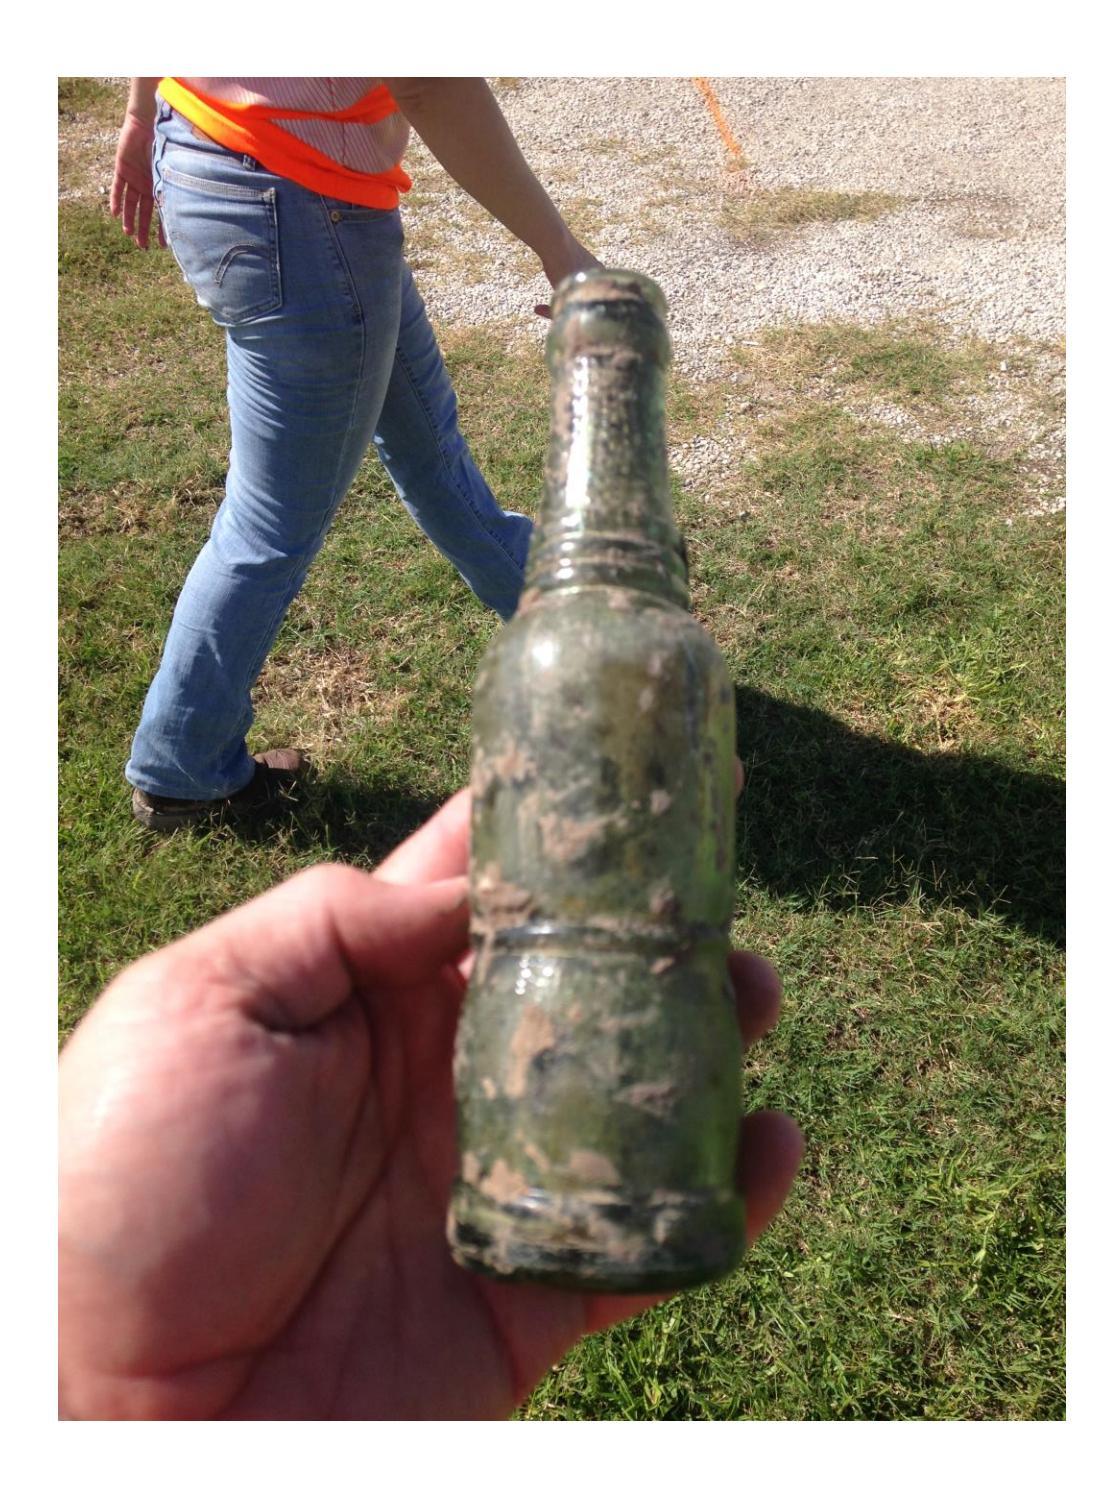
Figure 15. 1940's Nu-Grape soda bottle.
