## Archaeological Monitoring of the HEB-GSA Parking Lot: Impacts to the San Pedro Acequia

**Center for Archaeological Research**  
**The University of Texas at San Antonio**  
**Archaeological Survey Report, No. 279**  
**1998**

In October, 1997, the Center for Archaeological Research of The University of Texas at San Antonio monitored parking lot construction activities at the Federal Center (41BX622), part of the old United States Arsenal, in downtown San Antonio, Texas. The new parking lot, being constructed by H. E. Butt Grocery Company on land leased from the General Services Administration, will impact a section of the San Pedro Acequia which runs beneath an existing parking lot in the same location. The monitoring of these activities documented two sections of the acequia and corrected previous projections of the acequia's route. It is CAR's recommendation that the monitoring and documentation project has mitigated any adverse effects to the acequia.

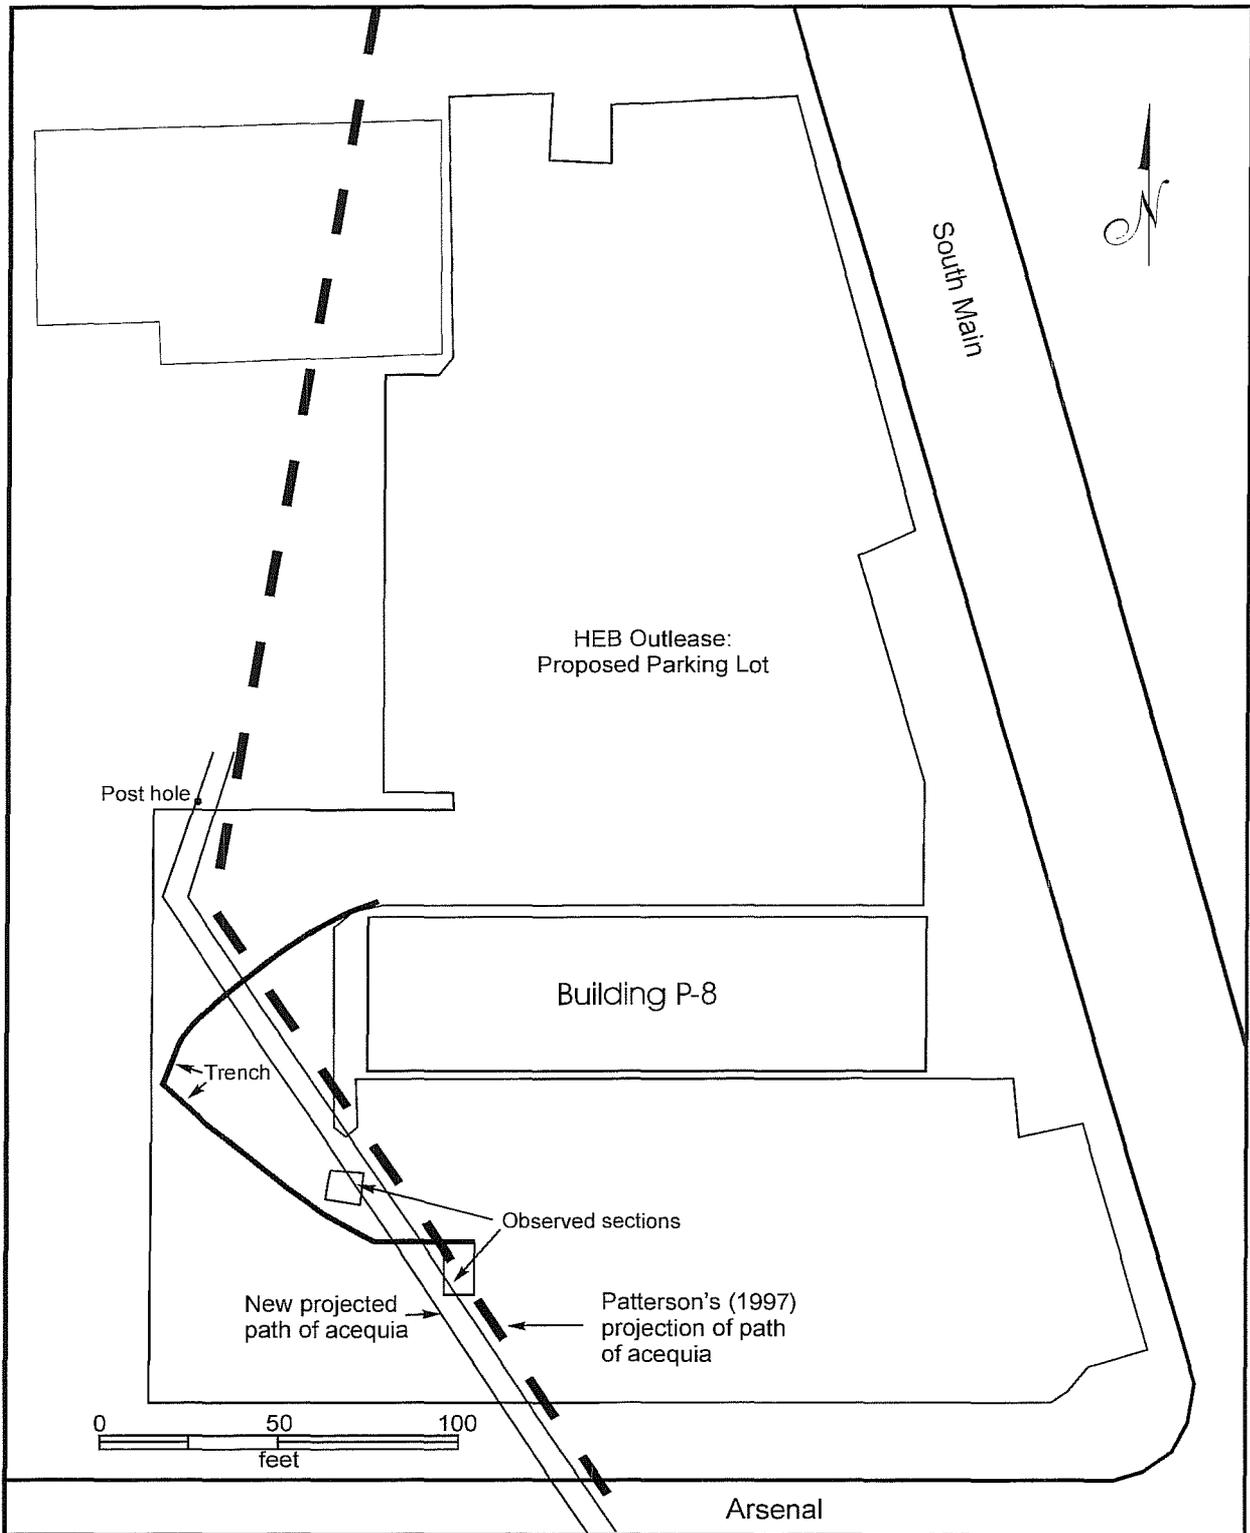
Figure 2. Map of project area with projected path of the San Pedro Acequia.

began drilling holes to set the post. The first hole drilled, to the northeast of building P-8, struck a limestone block of the west wall of the acequia (Figure 2). Examination of the hole revealed that the top stone of the acequia was four inches below the present surface and extended to the depth of the hole, some 24 inches. None of the other postholes encountered the acequia.

Further monitoring was delayed until October 13 when the Ditch Witch-riding rock saw was available. Trench excavation began at the fence line to the west of Building P-8 and proceeded toward the southeast. The acequia was exposed 31.5 ft south of the building (Observed Section 1, Figure 2). The eastern wall was badly disturbed at this point but was still easily discerned. The western wall was fully intact three inches below the compacted gravel base. The acequia was five feet wide at this point through the angled saw cut. The cut extended to a depth of 26 inches. No artifacts were observed in this disturbance.

On October 21, the contractor called to report that a section of the acequia had been exposed by further base preparation. The area, slightly northwest of Observed Section 1, was covered until the archaeologist could arrive on the site. Once the gravel base was removed and the area uncovered, the western wall of the acequia (Observed Section 3) was measured and photographed. Based upon the observed sections and the path of the acequia to the south of Arsenal Street (Figure 4), as documented by the 1904 Sanborn Insurance maps, the proposed path of the acequia as plotted by Patterson (1997) was corrected (Figure 2). Monitoring was terminated at that point since further construction would have no impact on the acequia.

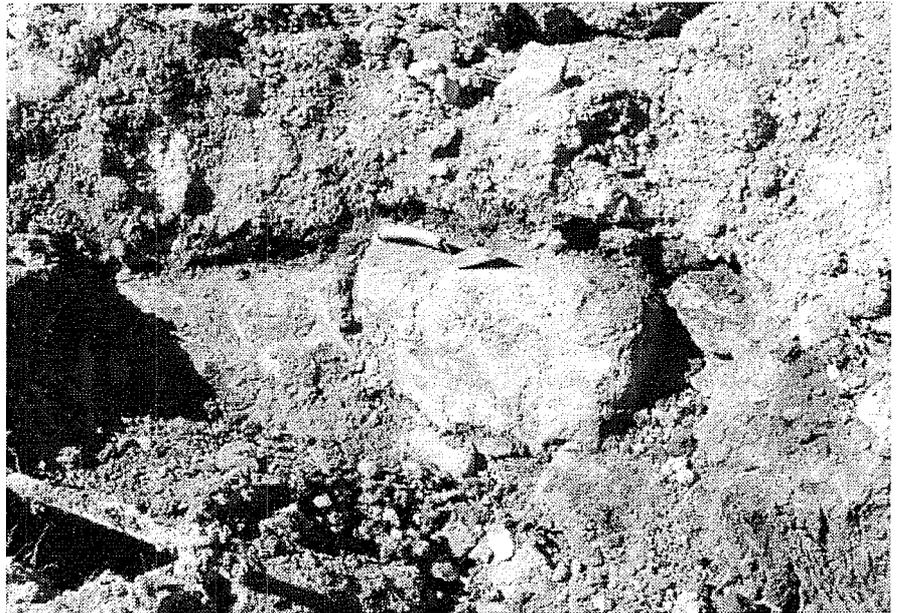
The following day, a cut from the southwest corner of Building P-8 severed a telephone cable, making it necessary to clear an area to the east of the first cut where the acequia was observed. This revealed a fully intact section of the east wall (Observed Section 2). It was constructed of quarried limestone, ashler dressed, with a rough exterior exposed by the clearing (Figure 3). The blocks averaged 12 x 28 x 6 inches in size.

Figure 3. *Photograph of a section of the east wall of the acequia.*

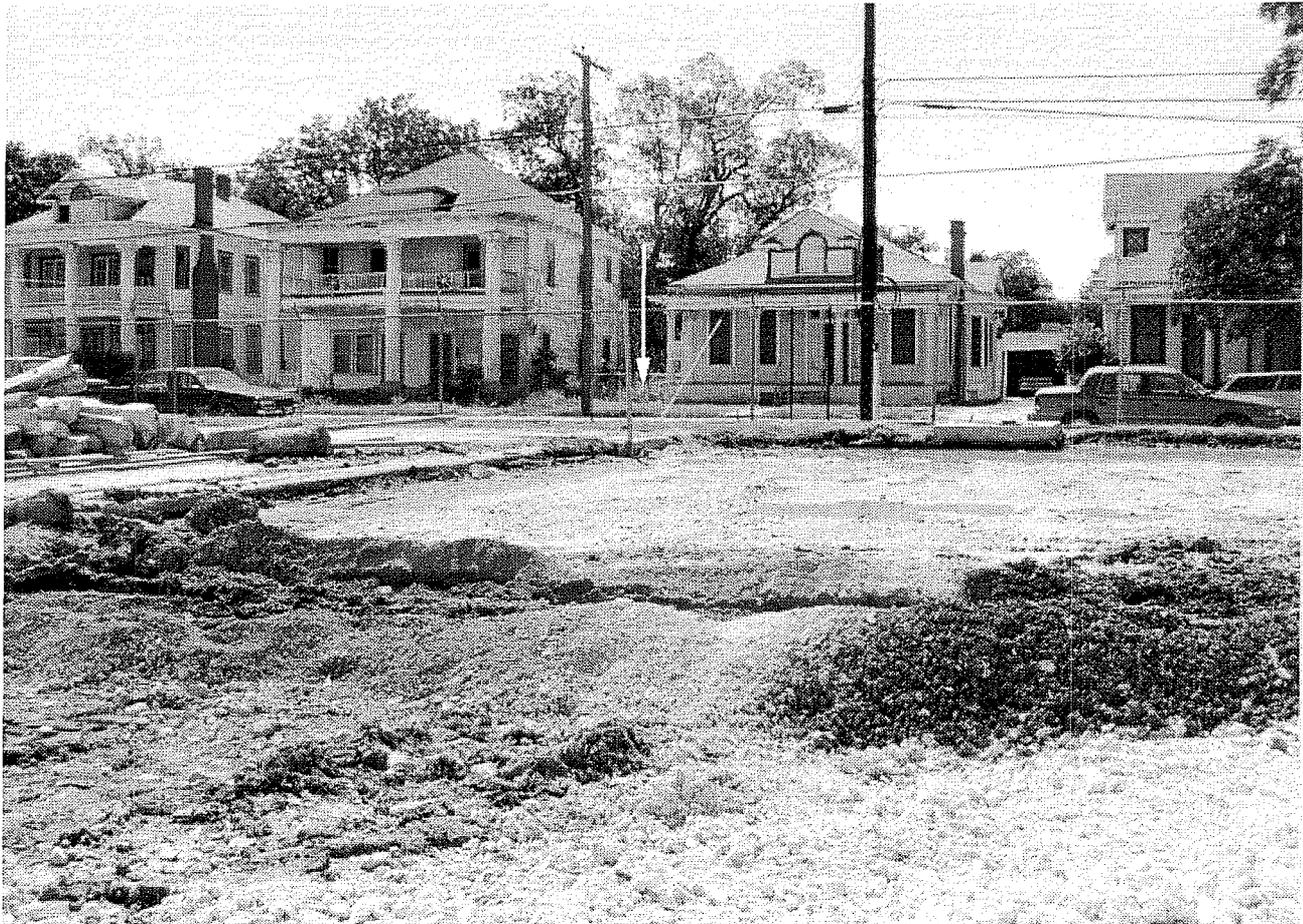
Figure 4. *Project area looking south toward Arsenal Street. The path of the acequia across Arsenal is marked with the white arrow.*

This monitoring of the San Pedro Acequia has served the purpose of further documenting the nature of the construction and course of the channel beyond the known path in this area (Figure 4) and the section excavated farther to the south at the site of the 1981 study (Frkuska 1981). The section observed during this monitoring is probably the result of the construction of 1881 to straighten the acequia as recommended by the Ditch Commissioner to the City Council (CCM, E:311). CAR recommends that the monitoring-level investigations have mitigated the impacts to the acequia. Since all further work for this project is to be surface in nature, no further archaeological investigations are recommended at this time. However, should future work be undertaken in further developments additional monitoring should be considered.
