## **Archeological Testing Associated with the Stabilization of the Convento at Mission San Juan Capistrano (41BX5), San Antonio, Bexar County, Texas**

Center for Archaeological Research  
The University of Texas at San Antonio  
Archaeological Report, No. 358  
©2005

Texas Antiquities Committee Permit No. 3655

Prepared for:  
National Park Service  
San Antonio Missions National Historical Park  
San Antonio, Texas

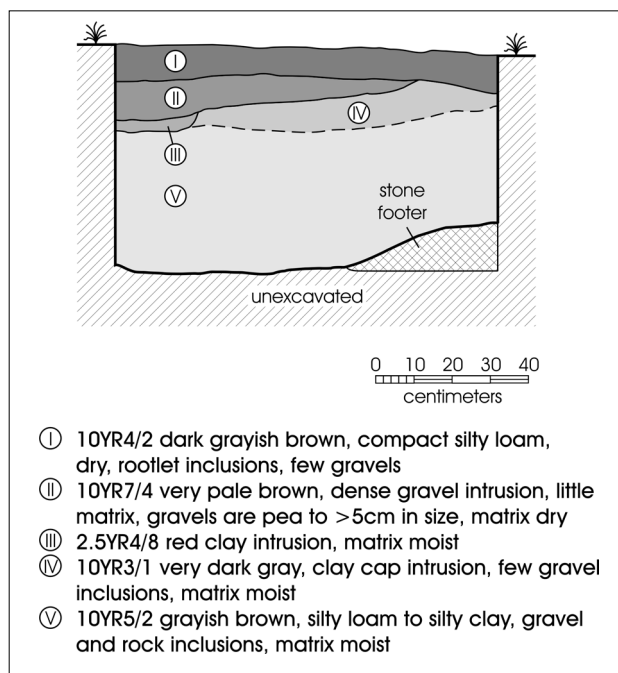
Figure 3-1. Profile of the east wall of Unit A.

Unit A was located at the northeast corner of the convento (see Figure 2-1). The excavation revealed five stratigraphic zones within the unit (Figure 3-1). The first zone was a dark grayish brown (10YR 4/2) compact silty loam. The zone had a high gravel content and root inclusions were common throughout. The second zone was a very pale brown (10YR 7/4) silty clay. This zone also contained a high concentration of gravel. The gravel concentration in these two zones ranged from 30% to 40%. The third zone was a red clay lens (2.5YR 4/8). A very dark gray (10YR 3/1) clay layer formed Zone IV. The bottom boundary of this zone was very diffuse. The soil in Zone V was a grayish brown (10YR 5/2) silt loam to silty clay loam. Zones I through III and a portion of IV were excavated as Level 1 (0–20 cm below datum [cmbd]), while Level 2 consisted of Zones III, IV, and V. Level 3 (40–60 cmbd) was entirely within Zone V. At the end of Level 3, a stone footer (foundation stone) was exposed along the south wall of the unit.

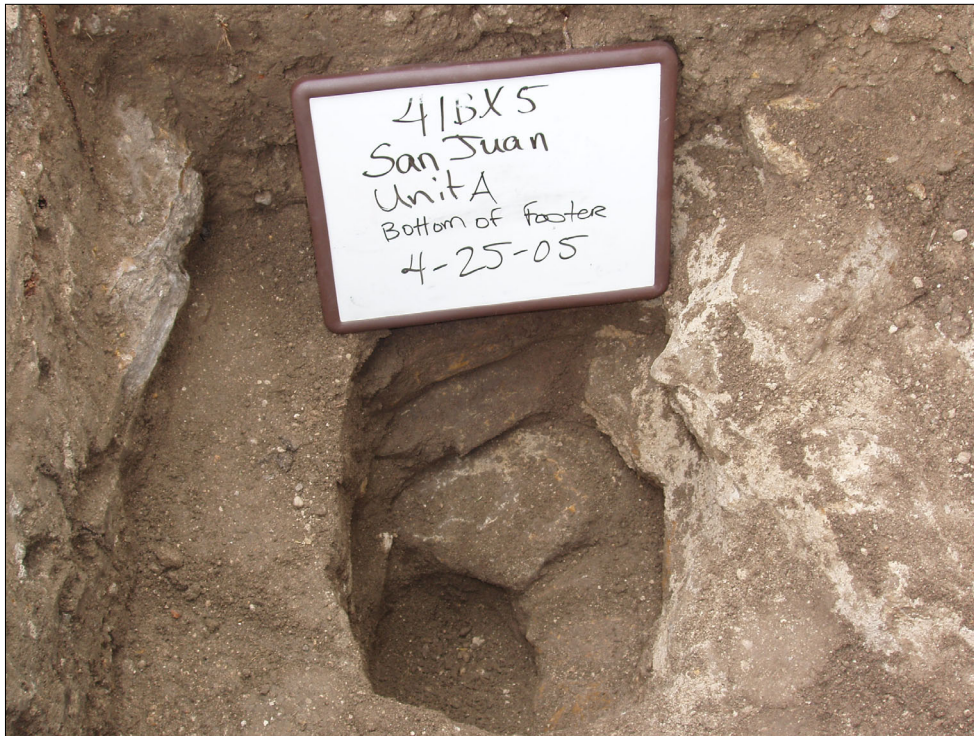
Figure 3-2. Shovel test excavated north of the footer in Unit A.

On April 25, 2005, the CAR crew returned to excavate an exploratory shovel test within Unit A to determine the depth of the footer (Figure 3-2). The shovel test measured approximately 50 cm in diameter. Level forms were not kept and the soil was not screened. Just below the footer, at about 90 cmbd, a course of stones was encountered that did not appear to be connected to the footer. The bottom of the stones was reached at 100 cmbd (40 cm below the terminal depth of the initially excavated unit).

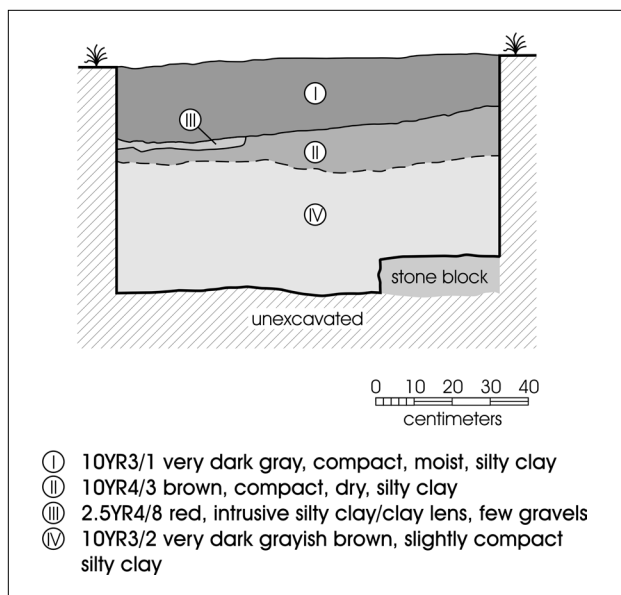
Figure 3-3. Profile of the south wall of Unit B.

Unit B was located along the east side of the convento (see Figure 2-1). This unit contained four stratigraphic zones. A cut-stone step feature was located along the west margin of the unit at 53–54 cmbd. It extended to the terminal depth of the unit, 60 cmbd (Figure 3-3). Stratigraphic Zone I consisted of a dark gray (10YR 3/1) moist silty clay. The second stratigraphic zone was a brown (10YR 4/3) dry silty clay. The third zone encountered in Unit B was a thin lens of red (2.5YR 4/8) clay that was not evident in the profile of the west wall. Zone IV consisted of a dark grayish brown (10YR 3/2) silty clay. Level 1 (0–20 cmbd) contained Zones I and II, while Level 2 (20–40 cmbd) consisted of Zones II, III and IV. The entirety of Level 3 (40–60 cmbd) consisted of Zone IV.

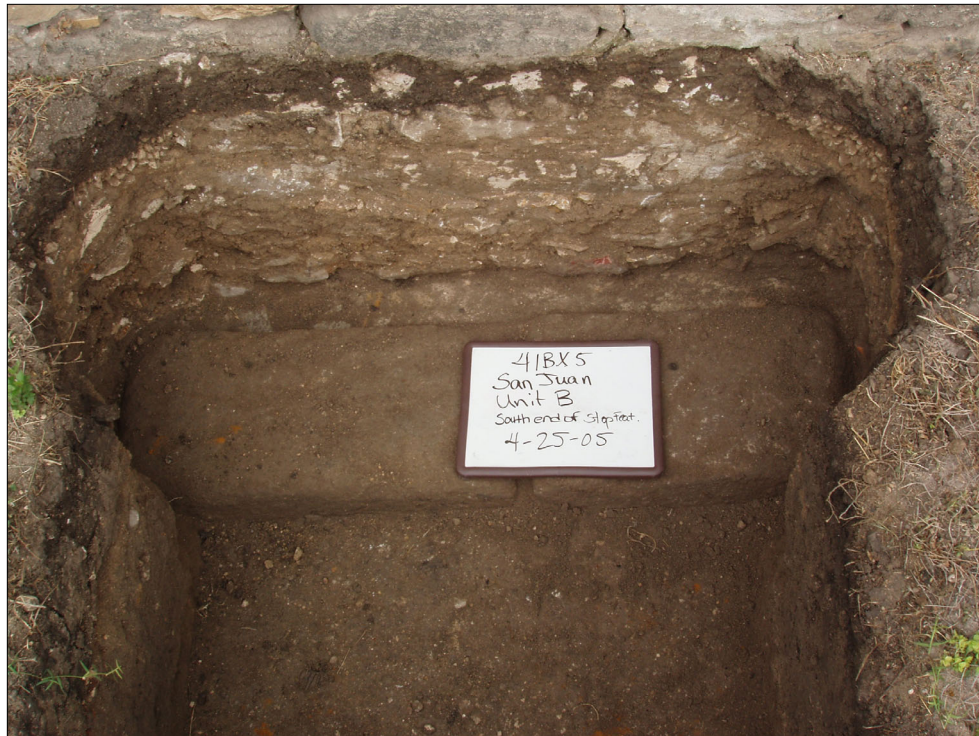
Figure 3-4. Cut-stone step feature in Unit B.

On April 25, 2005, the cut-stone feature in the western portion of Unit B was further exposed to the north and south (Figure 3-4). The feature consisted of two cut stones, reminiscent of the German masonry tradition (Susan Snow, personal communication 2005). The two cut stones were positioned atop a platform of flat sandstone pavers and limestone fragments to produce a level surface. Between the wall foundation and the stones, a roughly 12-cm gap was filled with flat sandstone pavers cut and fit together. Several layers of the sandstone pavers were stacked to fill the gap. The seam between the two stones was filled with smaller fragments of the sandstone pavers. The two stones created a step 150 cm long and 20 cm high.

produced artifacts that represent the mid to late nineteenth century, and the presence of the stone step poses an interesting question. It is possible that the stones were placed to provide a step for a doorway along the east wall of the convento, although there is no evidence of a door located above the step. The placement of the step was done with care, though its purpose is not known at this time. Unit D revealed portions of the original sandstone wall foundation, though the matrix was a mix of concrete and sandstone construction debris. Cultural material was disturbed within the first two levels, but Level 3 produced the most promising possibility of undisturbed sediments.

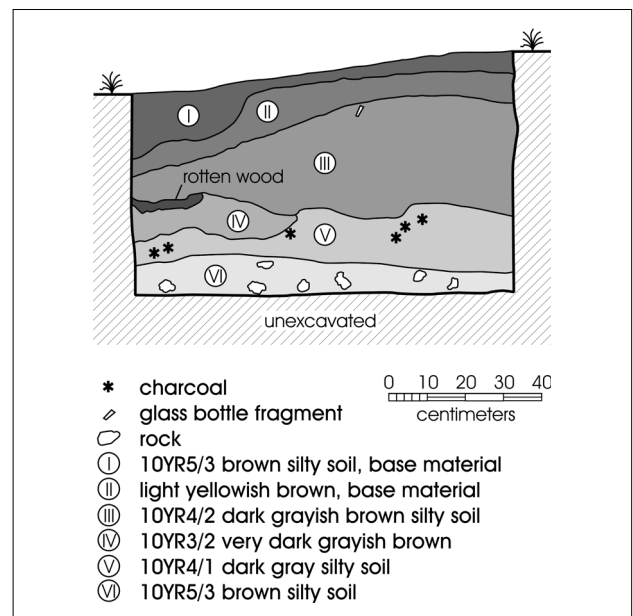
Figure 3-5. Profile of the north wall of Unit C.

Unit C was located on the northwest side of Room 19 (see Figure 2-1). Six stratigraphic zones were identified in the unit. Zones I and II consisted of a gravel fill, while Zones III through VI ranged from gray to brown silts (Figure 3-5). Level 1 consisted of stratigraphic Zones I and II, while Level 2 contained Zones III and IV. Level 3 (40-60 cmbd) included depositional Zones V and VI. Two pipes were encountered in Level 2 (20-40 cmbd). One was a 1-inch gray PVC pipe found at 30 cmbd (Figure 3-6). The second, a 2.5-inch gray PVC pipe, was encountered at 37 cmbd. Both pipes ran through the unit in an east-west direction and appeared to continue under the wall of Room 19. Directly under the pipes was a layer of ash in the easternmost half of the unit that was disturbed matrix from the pipe installation. Excavation of this unit was terminated at 60 cmbd.

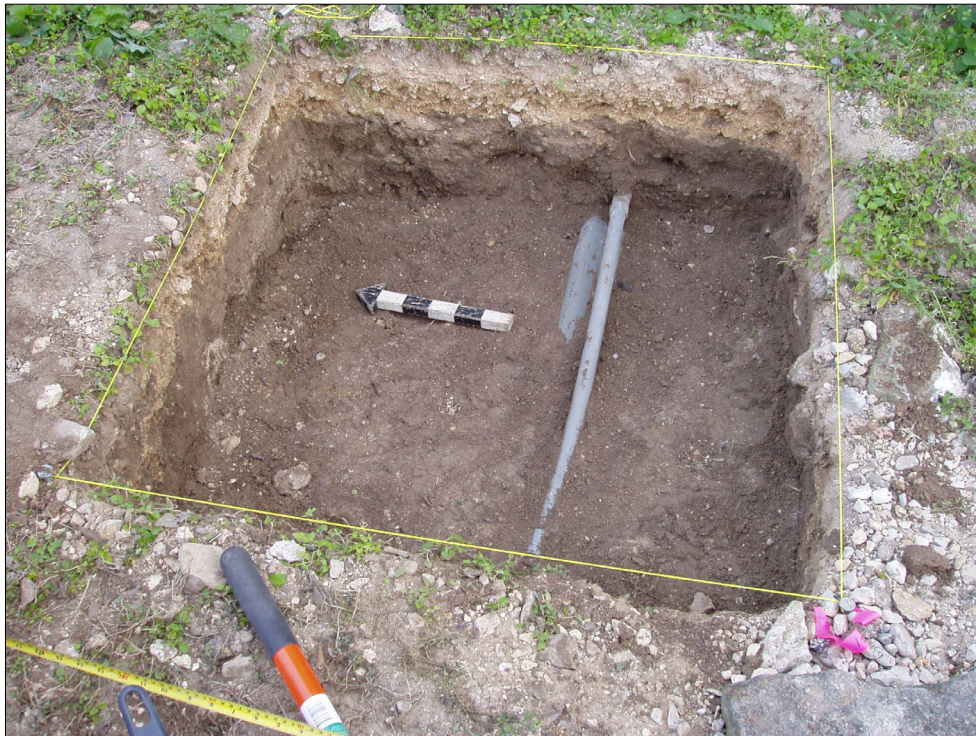
Figure 3-6. Pipes exposed in Unit C.

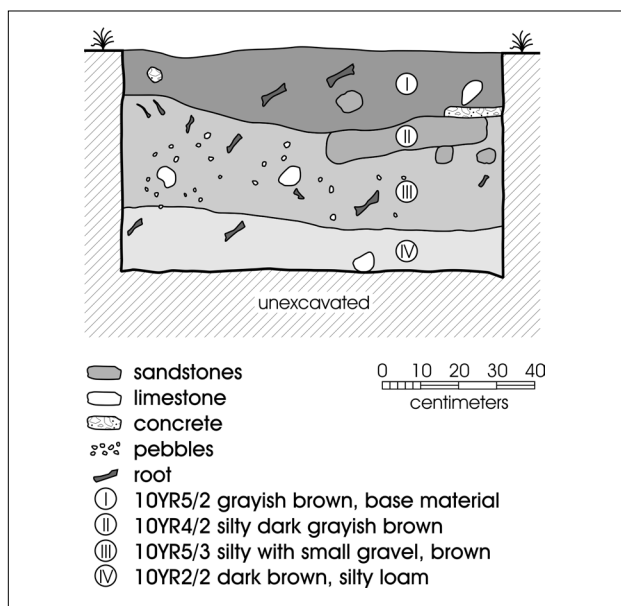
Figure 3-7. Profile of the east wall of Unit D.

Unit D was located on the south side of Room 21/Room 22 (see Figure 2-1). Four depositional/stratigraphic zones were defined in this unit. The first zone, contained within excavation Level 1 (0–20 cmbd), was heavily disturbed (Figure 3-7). The grayish brown (10YR 5/2) fill contained numerous chunks of concrete and sandstone construction refuse. The sandstone foundation of the building was exposed along the north wall of the unit during excavation. The second zone, which spanned Level 2 (20–40 cmbd) and extended into the top of Level 3 (40–60 cmbd), continued to exhibit signs of disturbance, although the matrix became less disturbed toward the bottom of the zone. The matrix in this zone was comprised of brown silty soil with small gravel inclusions. Stratigraphic Zone III consisted of a silty brown matrix and was contained within Level 2. The fourth stratigraphic zone included the majority of Level 3

(40–60 cmbd). This dark brown (10YR 2/2) silty loam zone exhibited fewer disturbances and a decrease in gravel inclusions. Excavation of this unit was terminated at 60 cmbd. Stabilization activity will not impact below 60 cm.

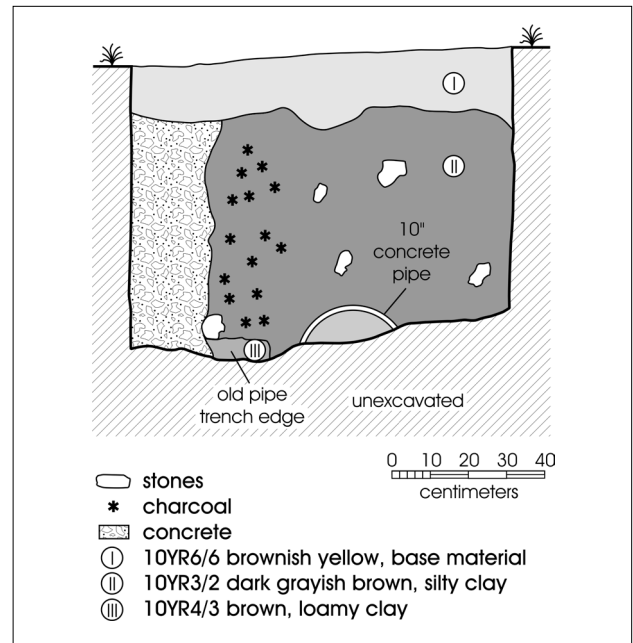
Figure 3-8. Profile of the west wall of Unit E.

Unit E was placed on the west side of the convento and abutting the north side of one of the buttresses (see Figure 2-1). Four stratigraphic zones could be distinguished in this unit. Zone I consisted of brownish yellow (10YR 6/6) fill that reached a maximum thickness of 18 cm and was entirely contained within Level 1. Beneath the fill, a layer of concrete that adjoined the buttress was noted along the south edge of the unit. It extended into the south portion of the unit approximately 20 cm (Figure 3-8). The remainder of the soil in the unit (Levels 2–4, 20–80 cmbd) consisted of a dark grayish brown silty clay with charcoal and stone inclusions. Stratigraphic Zone II extended through Levels 2–4, while Zone III was contained within Level 4. A 10-inch

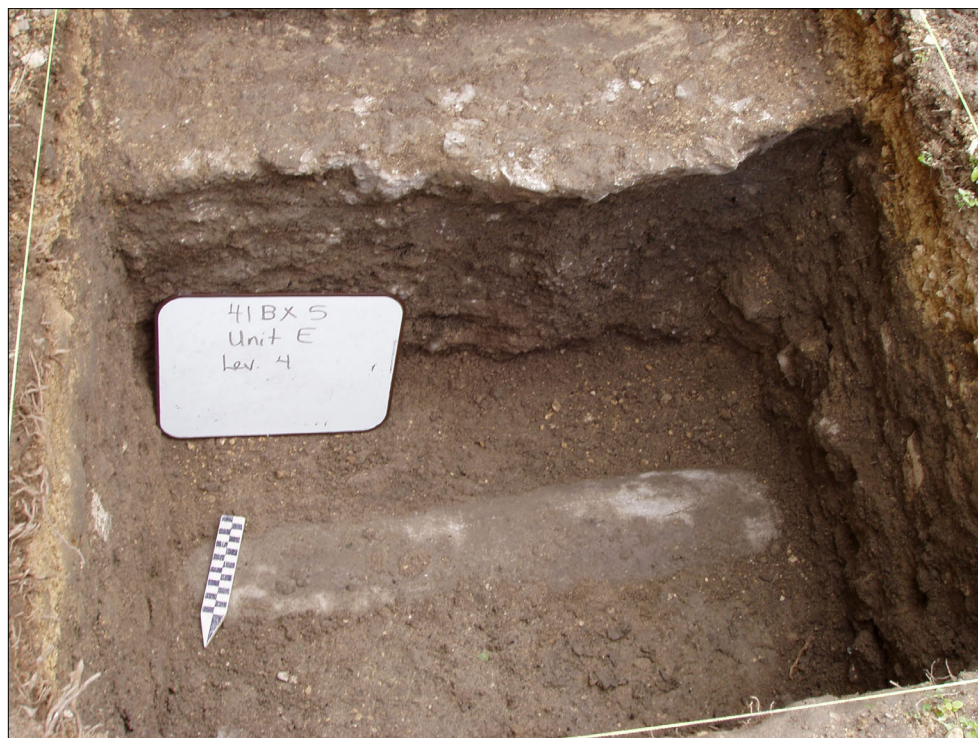
Figure 3-9. Pipe running parallel to buttress in Unit E.

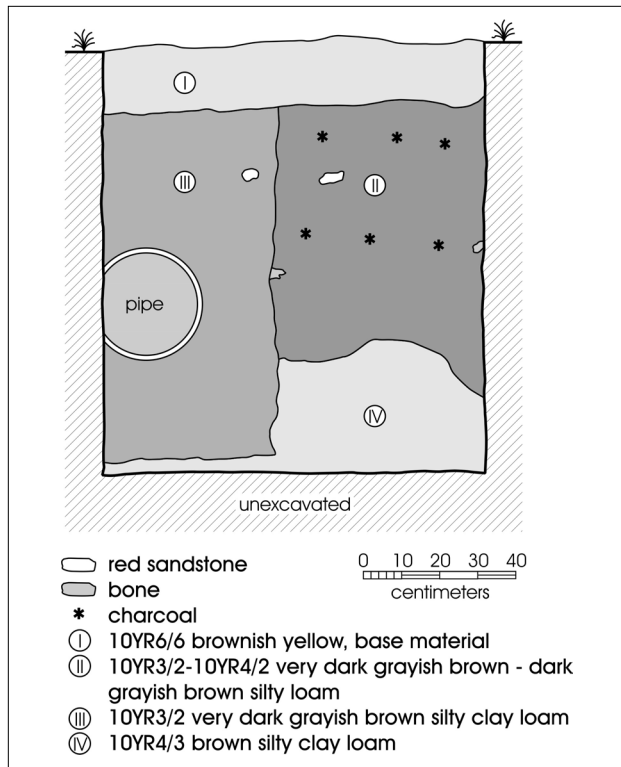
Figure 3-10. Profile of the north wall of Unit F.

(20-120 cmbd). It had very straight demarcation lines and ended in a flat surface, and represented trench fill (Figure 3-10). It consisted of dark (10YR 3/2) silty clay loam. A pipe was encountered at 54 cmbd and extended to a depth of 80 cmbd (Figure 3-11) within the trench fill (Zone III). Underneath the undisturbed matrix was a brown (10YR 4/3) silty clay loam which, on the west side of the unit, was contained within Level 6. Zone IV was contained within Levels 5 and 6 on the east side of the unit. The bottom of the buttress was encountered at 110 cmbd.

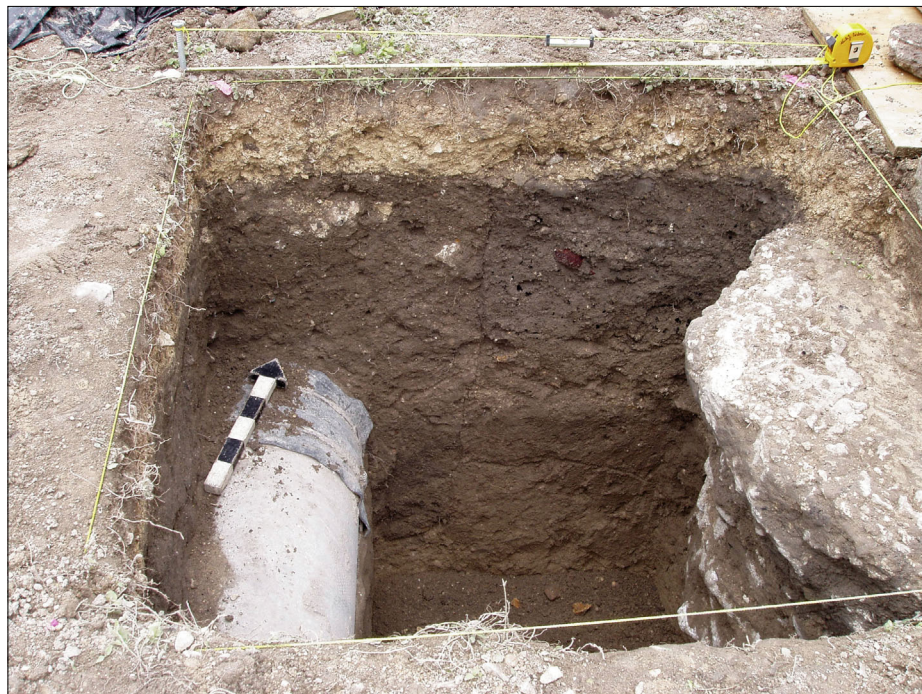
Figure 3-11. Pipe and buttress exposed in Unit F.

Finally, the excavation of Units E and F exposed the sub-surface portion of one of the buttresses of the convento. The condition of the building material is good and requires no improvements. In addition, and more importantly, it was determined that the buttresses serve no load-bearing functions and are strictly decorative. Therefore, at this time, no additional work will be carried out that will impact any of the buttresses surrounding the convento.

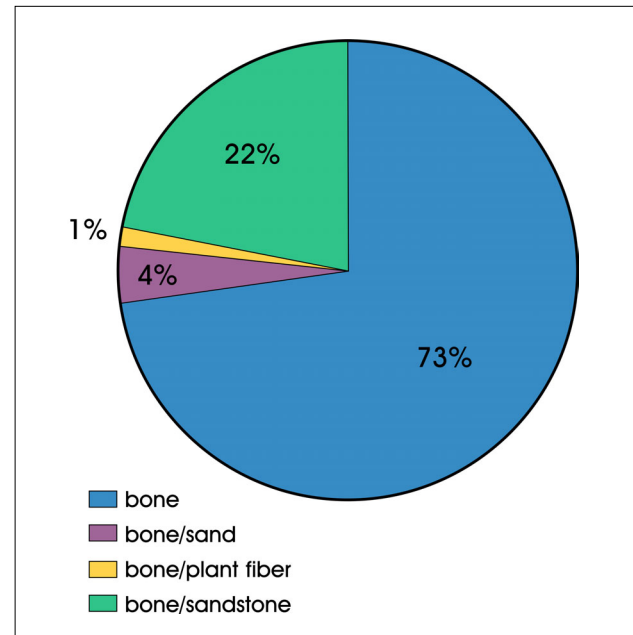
Figure 5-1. Percentages of temper types in Goliad ceramics.

The aplastic inclusions found in the ceramics included bone, plant fiber, sand and sandstone. Crushed bone was a tempering agent in all sherds and in 73% of the sherds it was the sole tempering ingredient (Figure 5-1). Twenty-two percent of the sherds contained both sandstone and bone. Only 4% (n=3) of the sherds contained a mixture of bone and sand, while only one percent (n=1) contained bone and plant fiber. Only sparse amounts of temper were present in 55% of the sherds, 11% contained abundant amounts of

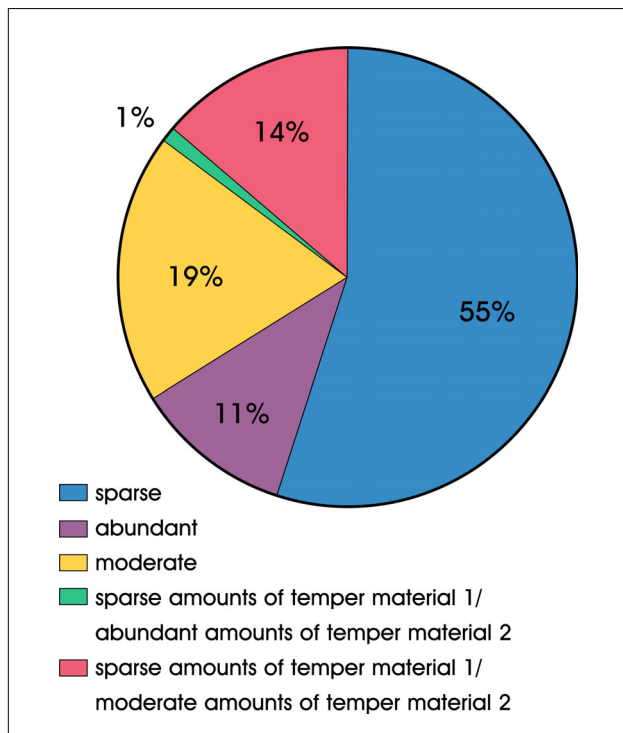
Figure 5-2. Percentages of temper material density in Goliad ceramics.

temper, and 19% contained moderate amounts of temper (Figure 5-2). In cases when bone was not the only tempering agent, but sand and/or sandstone were also included, sandstone was significantly more common than sand.

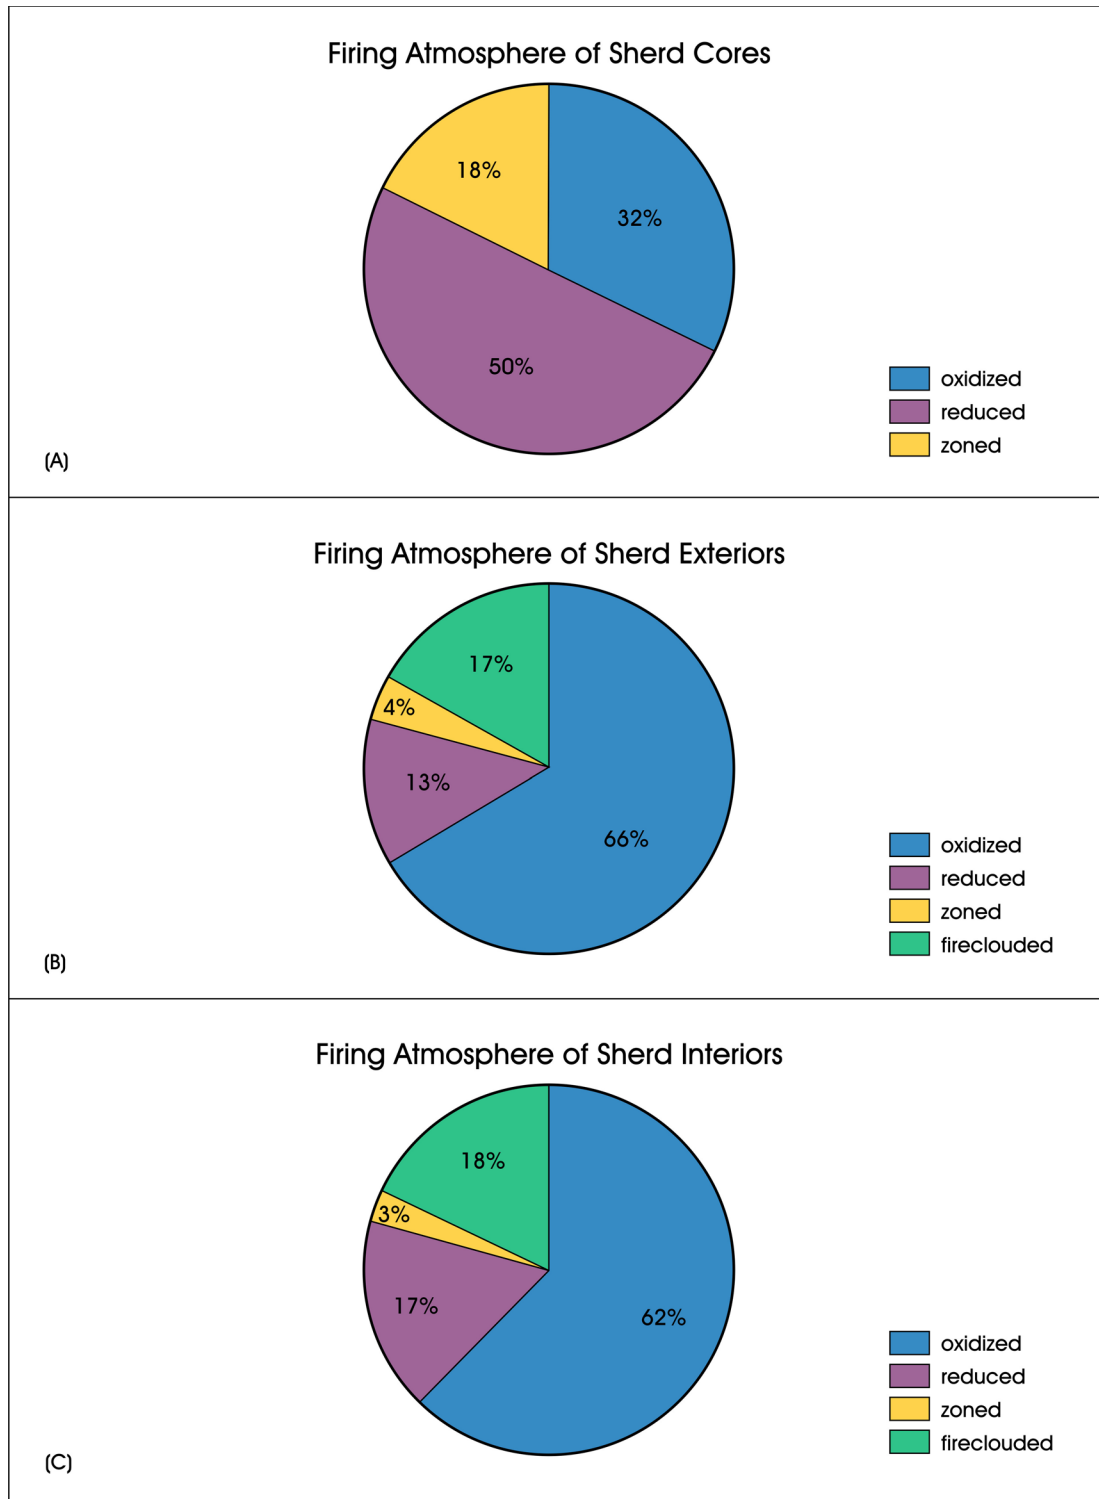
Figure 5-3. The firing atmosphere of Goliad sherd cores, exteriors and interiors (percentages).

The firing atmosphere was determined by examining the color of the vessel sherd. It is assumed that the potters of Goliad wares used an open fire technique. Typically, open fires are used for low-fired, unglazed wares, and there is considerable variation in the temperature with this technique (Rice 1987:156). The colors of brown, gray or black signal reduced firing, which indicates insufficient oxygen. This atmosphere usually occurs in low-temperature or short-period firing. Lighter-colored sherds, such as red and orange, indicate oxidization, which is characterized by sufficient oxygen in the firing atmosphere. Examination of the sherd cores shows a higher percentage (50%) were reduced, followed by oxidized 32%, and a very small percentage were zoned (18%; Figure 5-3a). A majority of the sherds analyzed had oxidized exterior surfaces (66%; Figure 5-3b), while the remainder exhibited fireclouded (17%), reduced (13%), and zoned (4%) exterior surfaces. The interiors of the sherds had a higher percentage of oxidized surfaces (62%), followed by fireclouded (18%) and reduced (17%) surfaces (Figure 5-3c). Alteration of the vessel color can also occur during its use and the post-depositional environment (Rice 1987).

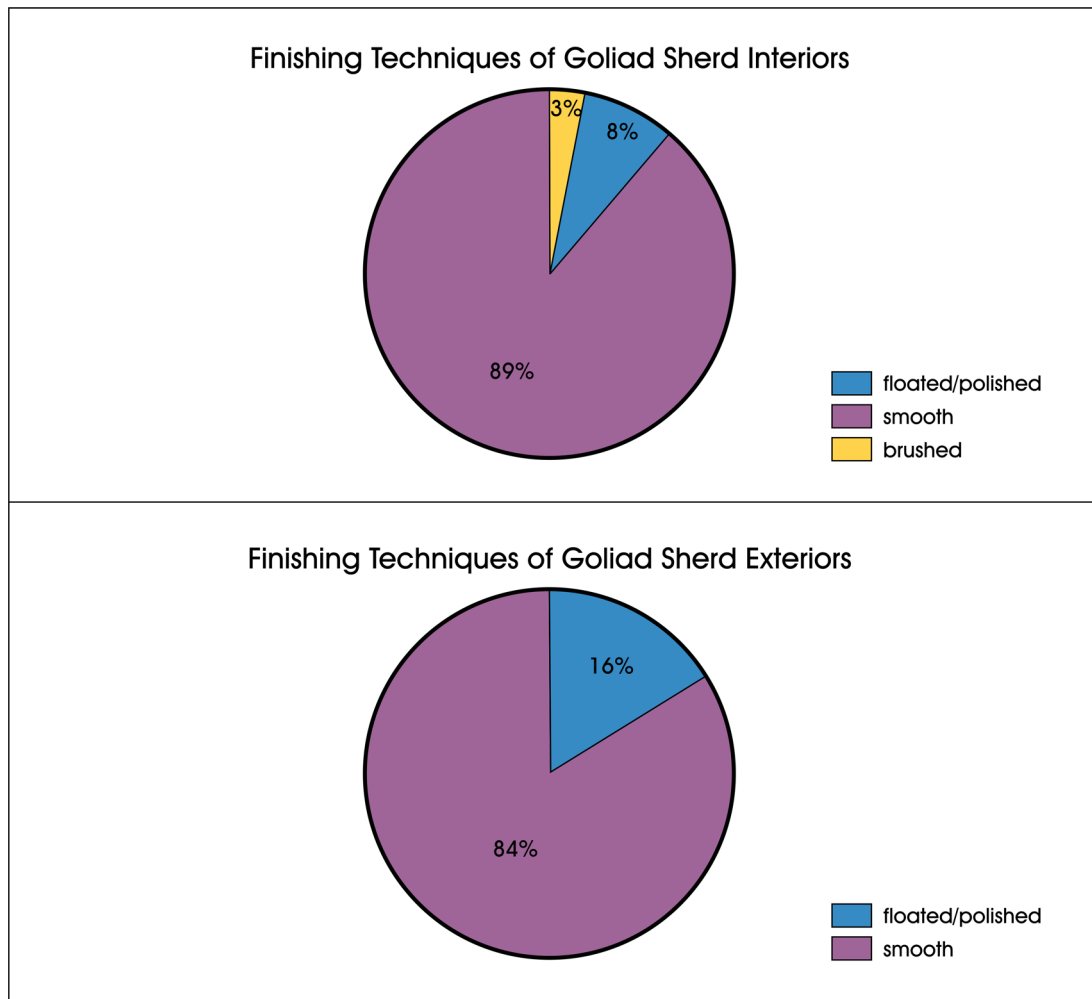
Figure 5-4. Finishing techniques of Goliad sherd interior and exterior surfaces (percentages).

The finishing and decoration of Goliad sherds was noted for both the interior and exterior portions of the sherds (Figures 5-4 and 5-5). The majority of sherd interiors (89%) and exteriors (84%) were recorded as smooth (Figure 5-4). The terms floated and polished were used to indicate sherd surfaces that were smoothed intentionally (Ulrich et al. 2005). Sixteen percent of sherd exteriors exhibited signs of polishing or floating, while this finishing technique only appeared on 8% of sherd interiors. Minimal decoration was seen on the examined sherds (Figure 5-5). One rim sherd was painted on the interior with red paint. Eight percent of the sherds had evidence of smudging on the interior, which is a characteristic of open firing (Rice 1987:158). Asphaltum, which may have been applied for decoration or mending purposes, was evident on the exterior of 3% of the sample sherds. Goliad ceramics at Mission Espíritu Santo rarely had decorated surfaces compared to Mission Rosario ceramics (Ricklis 2000; Ulrich et al. 2005). Forty-three percent of the Goliad ceramics sample from Rosario displayed asphaltum decoration (Ricklis 2000:106).

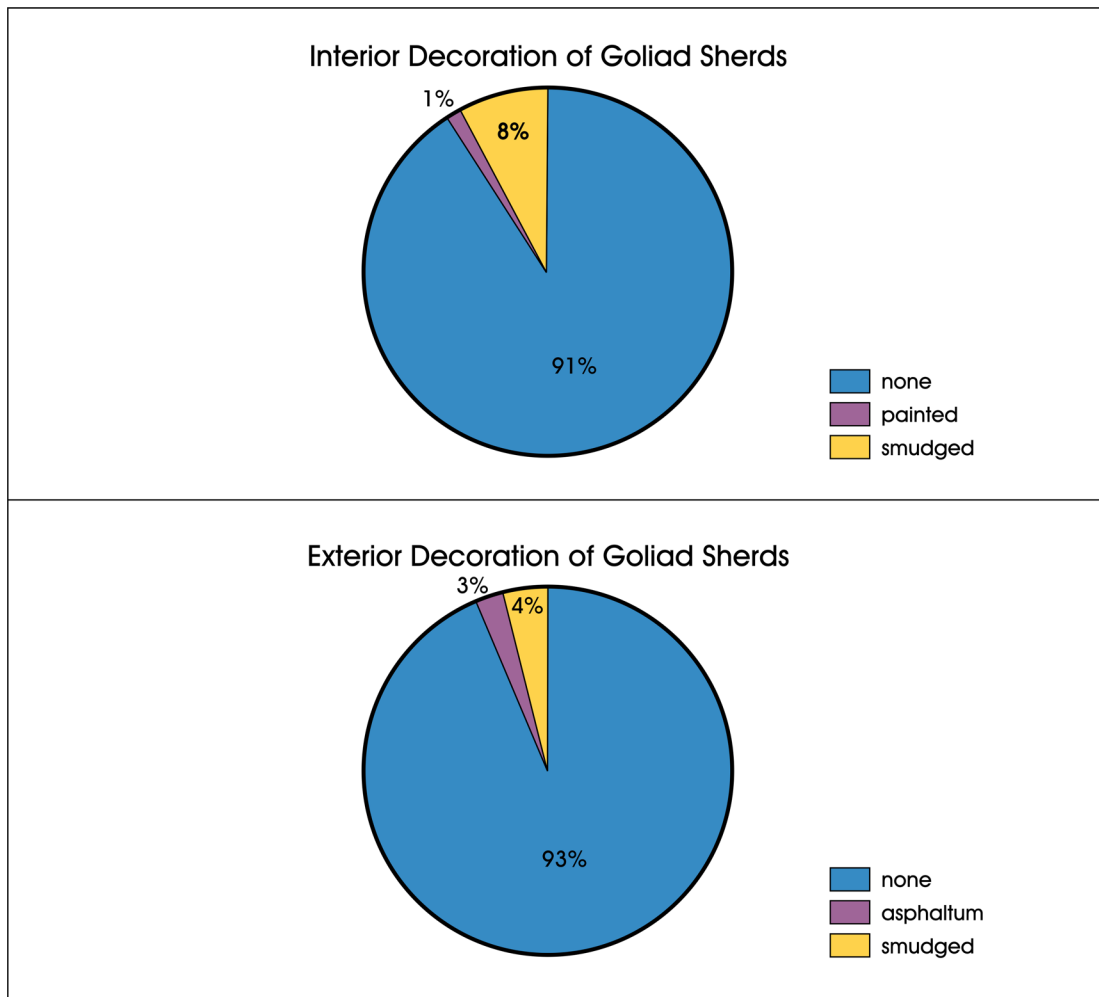
Figure 5-5. Decoration of Goliad sherd interior and exterior surfaces (percentages).
