**Center for Archaeological Research
The University of Texas at San Antonio
Archaeological Survey Report, No. 207
1991**

**TESTING OF THE SAN JOSE MISSION ACEQUIA,
SAN ANTONIO MISSIONS NATIONAL HISTORICAL PARK,
BEXAR COUNTY, TEXAS**

The purpose of this project was to locate and identify the acequia madre, or main irrigation ditch, where it ran between the east wall of Mission San José and San Jose Drive and to trace out the location of another ditch, part of which was found during road construction in the area in 1981. After confirmation of the location of the main ditch through deed and archival research, a backhoe was used to precisely locate the ditch on the site. The second ditch was relocated and its course followed to the north boundary of the park property in this area. The secondary ditch appears to be a lateral which once took off from the main ditch somewhere north of Pyron Road and rejoined it some distance to the south, in order to irrigate the fields outside the east wall.

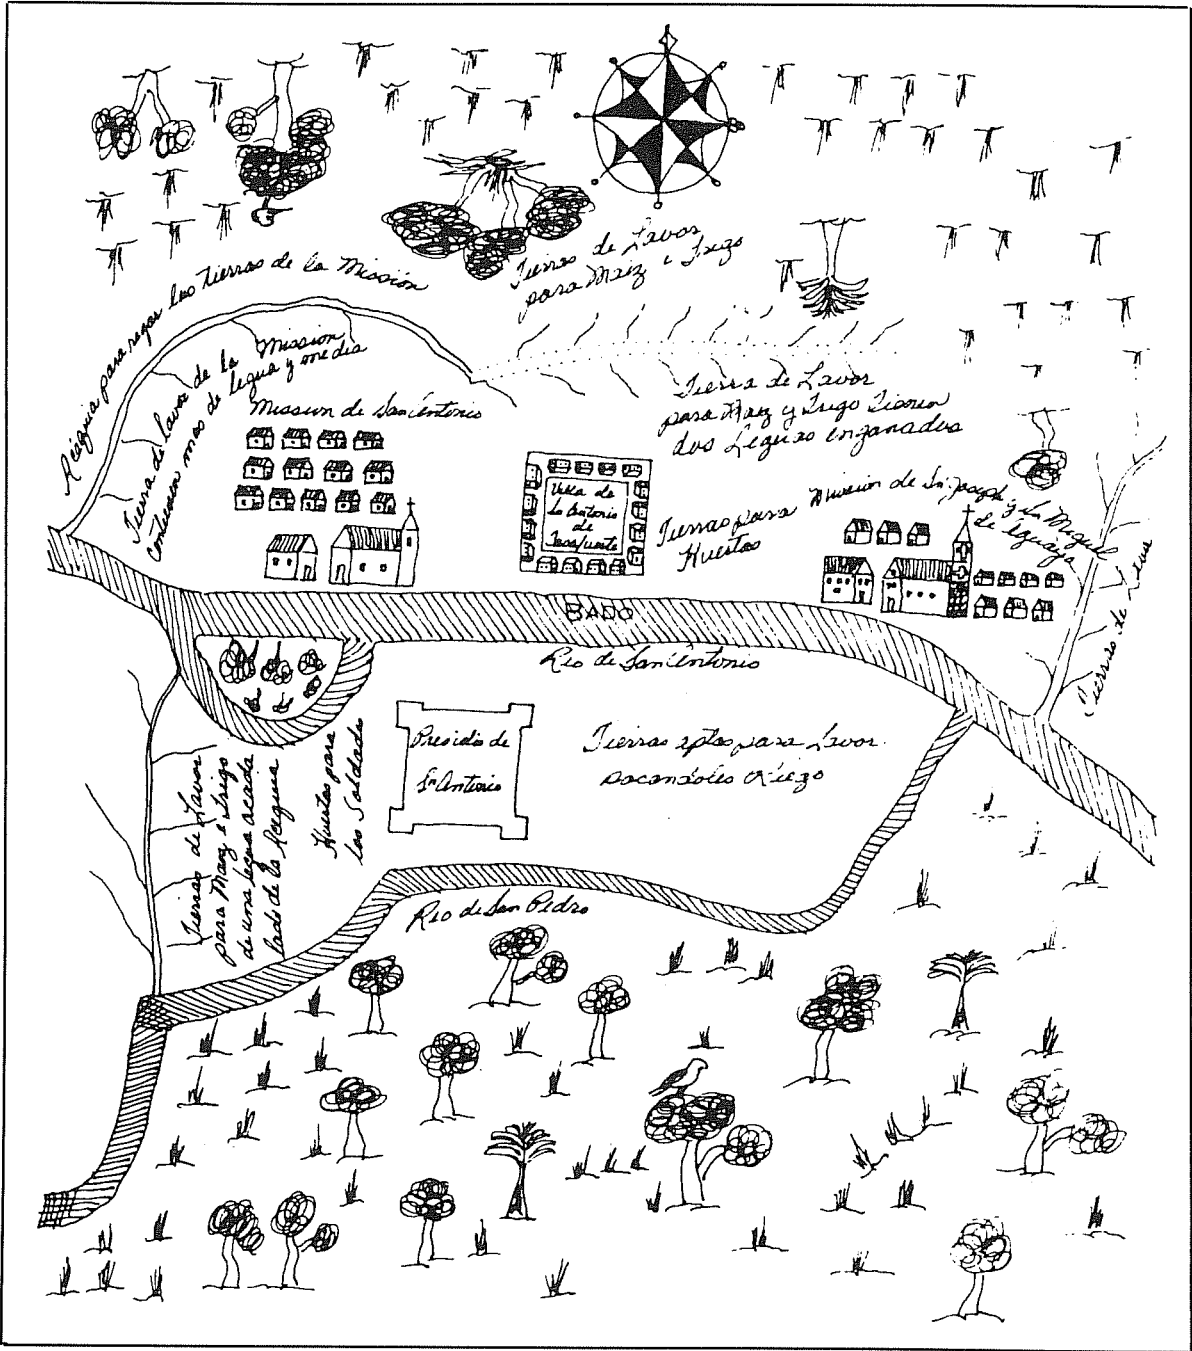
Figure 2. The Study Area in the 1720s. Map made by the Marquis de Aguayo in the late 1720s. Original is in the Archiva General y Publica de la Nacion, Mexico, D.F.

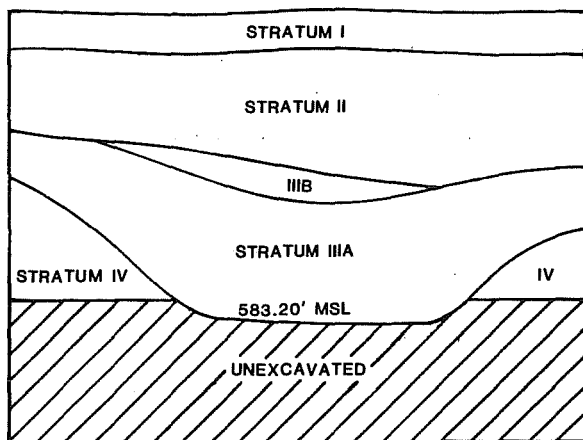
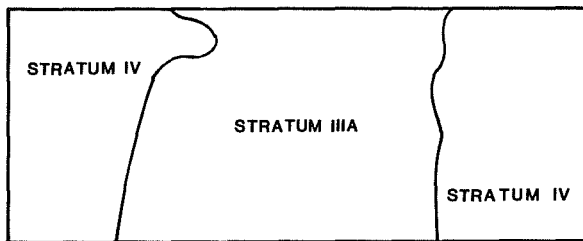
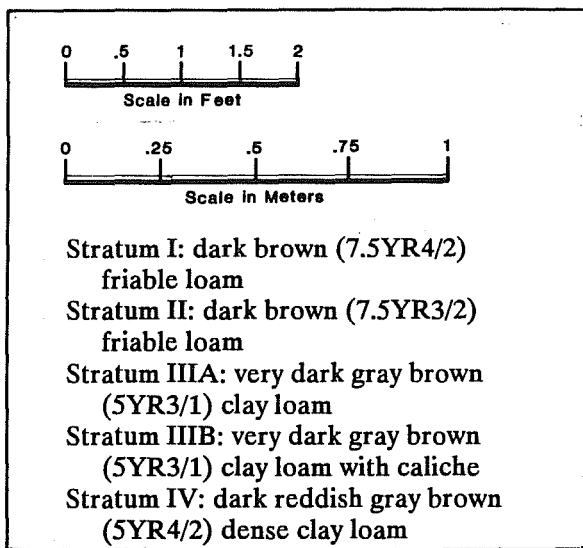
Figure 6. Profile of North Wall of Test Trench 3.

Trench 3 was located parallel to and 30 feet (9.1 m) north of the exploratory trench excavated by the SDHPT as Test Trench 9 (Henderson and Clark 1984:Fig. 3). The profile of the trench indicated a ditch approximately five feet (1.5 m) wide. The bottom of the ditch was found to rest on the caliche subsoil at about 32 inches (81 cm) below the present surface. This corresponds well with the findings of the SDHPT archaeologists (Henderson and Clark 1984:Fig. 9), allowing for the higher elevation of the soil surface in the area to the north of the street. The CAR crew recorded the elevation of the bottom of the ditch at Trench 3 to be 583.2 feet (ca. 177 m) MSL.

The stratification within the trench was similar to that found in Trenches 1 and 2, with the addition of a layer of humus-stained loam at the surface that was not clearly visible in the two previous trenches (Fig. 6). The same irregular outline of the ditch was visible where it was cut into the caliche gravel subsoil as was observed by the SDHPT crew (Henderson and Clark 1984:Figs. 11 and 12). In addition, the very bottom of the ditch yielded a sherd of Indian-made *Goliad* ware and a few bone fragments, similar to the artifacts found farther south in the ditch in 1984 (Henderson and Clark 1984:Fig. 11). The only other artifacts found were in the first stratum: one stoneware bowl sherd, blue-spattered design (Fig. 4,d); three pale green glass goblet sherds (Fig. 4,g); three clear glass bottle sherds; one spark plug "CHAMPION H-10" (Fig. 4,f); and one window glass fragment.

PLAN OF FLOOR AT 30 INCHES DEPTH

Here, again, these are post-1900 in date. Trench 3 was an exploratory trench, and as such was extended well beyond the area of the ditch, both in search of the ditch and in order to confirm that the anomaly was indeed a man-made ditch rather than an accident of the local geological formations. No other similar disturbances were found in the entire length of the trench, and it was apparent that the ditch found in 1981 was the only such disturbance crossing the immediate area.

During excavation of Trench 3, a lense of soil containing numerous fragments of white caliche gravels and occasional small pieces of bone was found to overlie the center of the trench. When Trench 4 was begun ca. 30 feet to the north, the same lense was found. This trench was also dug to the level of the bottom of the ditch to confirm the findings in Trench 3. In the upper stratum, late artifacts were found: one galvanized wire nail and one clear glass fragment. Within the fill on the bottom of the ditch were two sherds of *Goliad* ware (Fig. 4,a,b), a large bovine bone, and a small fragment of glass.
