Testing of the San Jose Mission Acequia, San Antonio Missions National Historical Park, Bexar County, Texas

**Center for Archaeological Research
The University of Texas at San Antonio
Archaeological Survey Report, No. 207
1991**

Texas Antiquities Committee Permit No. 1007

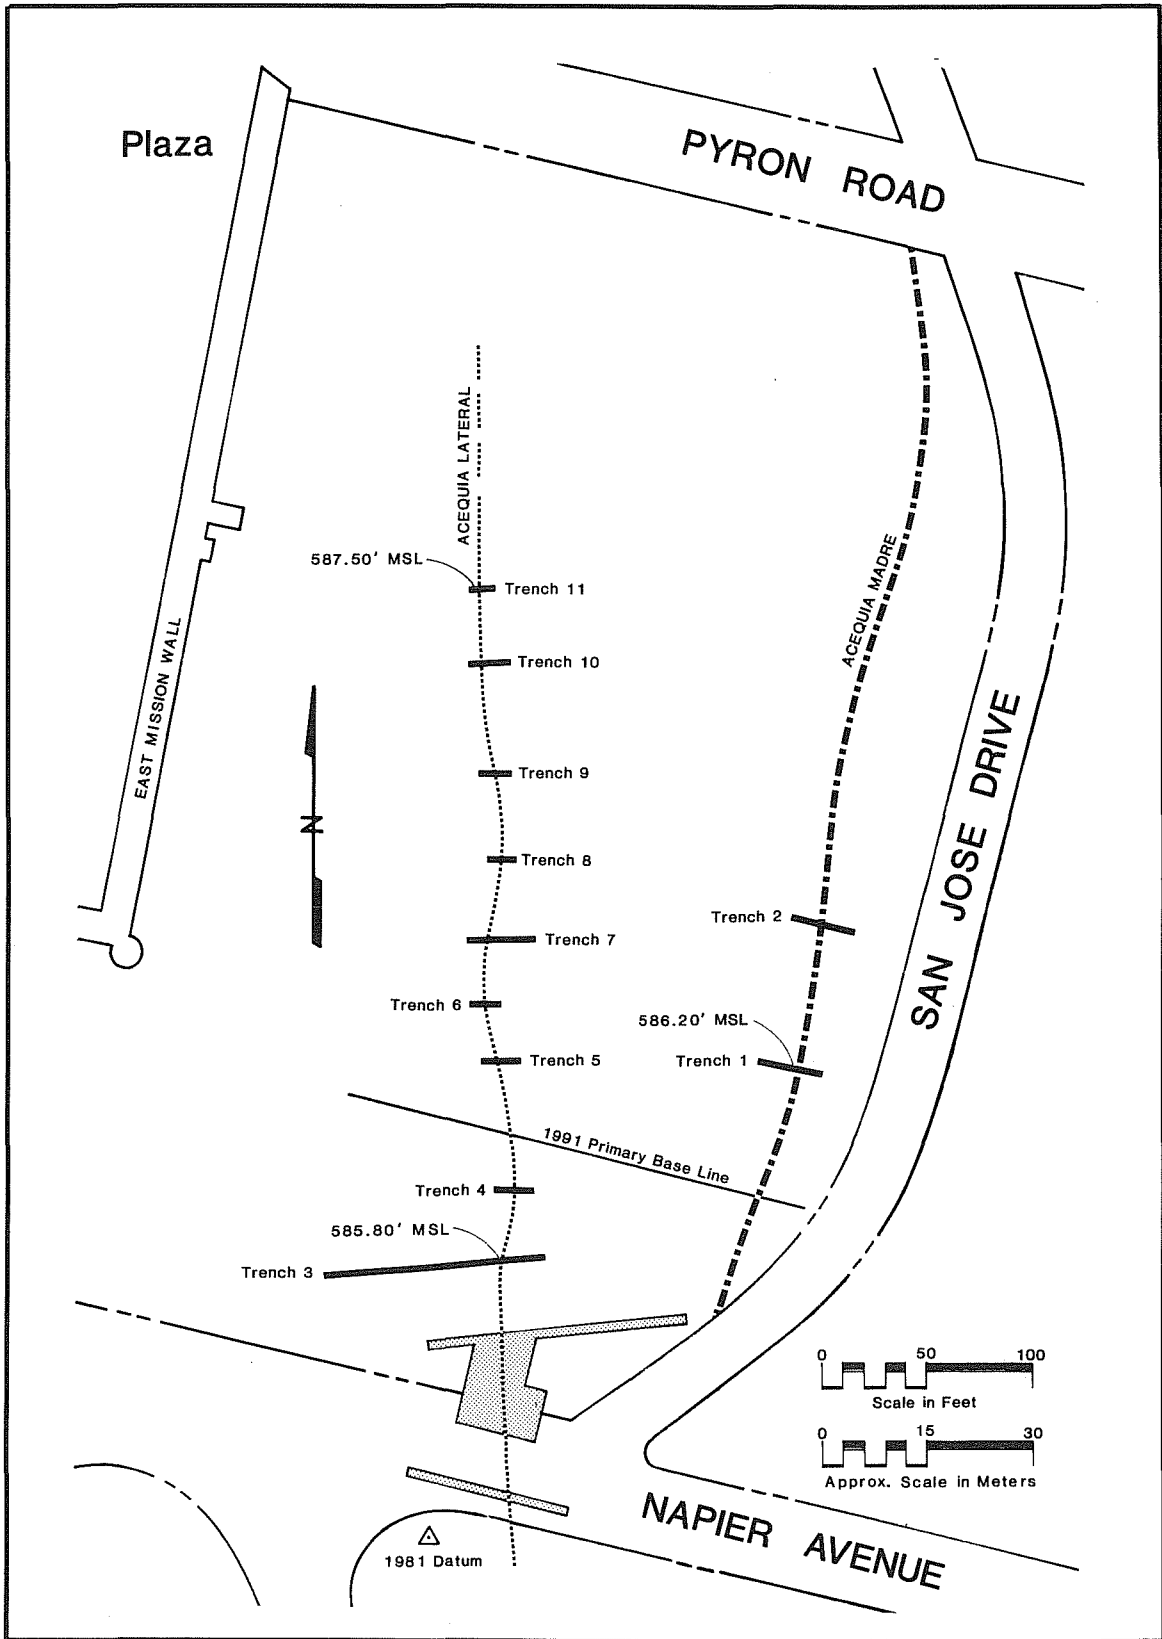
Figure 3. Test Excavations.

Two backhoe trenches were excavated across the line of the acequia madre or main ditch. Trench 1 (Fig. 3) was located approximately on a line with the south wall of the mission. It was dug to a maximum depth of 38 inches (96.5 cm) through very dark gray (11YR3/1) clay loam, dark reddish gray (5YR4/2) clay loam, and into white (10YR8/2) caliche gravels at ca. 30 inches (76 cm) beneath the surface. The outline of the bottom center of the ditch was visible cut into the caliche, but it was difficult to discern the width of the ditch in profile. This may be due to periodic flooding and washing out of walls in post-mission times when the ditch was no longer carefully tended.

location of the main ditch had been confirmed, the backhoe was moved to the continuation of the line of the SDHPT ditch, north of Napier Avenue (Fig. 3). A series of backhoe trenches across this ditch followed it north to the fence line of a private property owner which blocked further investigation.

Trenches 5-11 were excavated across the line of the ditch, which was easily recognized because the lense of caliche gravels in each case lay above the ditch, or perhaps in what was once the top of it. The centerline of the ditch was then plotted on the site map.

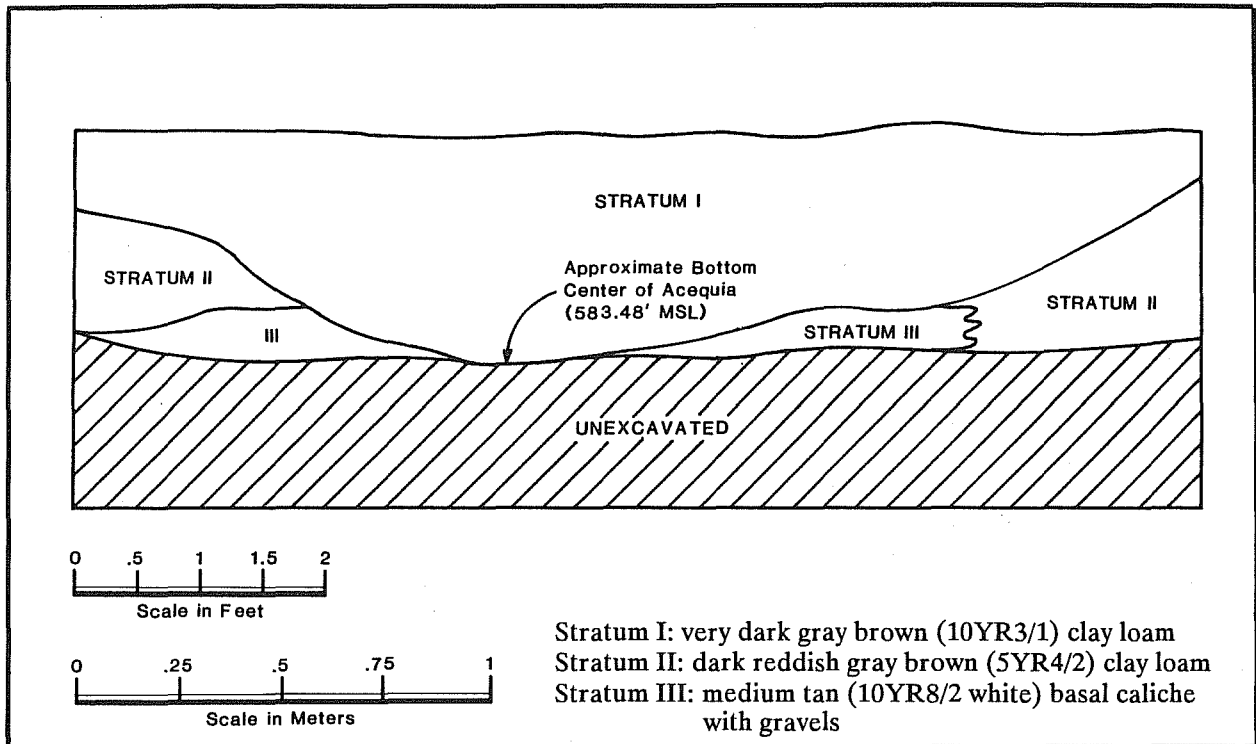
Figure 5. Profile of North Wall of Test Trench 2.

Trench 2 was located ca. 70 feet (21.3 m) north of Trench 1. The outline of the ditch was clearly visible in the profile of the trench (Fig. 5). The same soil strata were encountered as in Trench 1. At this point, the ditch appeared to be about 10 feet (3 m) wide and 20 inches (51 cm) deep, measured from the present surface.

Comparison of the profiles of Test Trenches 1 and 2 with those recorded by CAR archaeologists on acequias elsewhere in the San Antonio area (Valdez and Eaton 1979:Fig. 5; Frkuska 1981:Figs. 8-10; Cox 1988:Fig. 2) confirm that this is the acequia madre, even without the evidence from the deed records and early plat maps. The second, smaller ditch appears to be a lateral or branch of the main ditch, probably intended to irrigate the field between the main ditch and the east wall of the mission. The artifacts found in the bottom of this feature, both in 1981 and during this project, can be securely dated to the mission

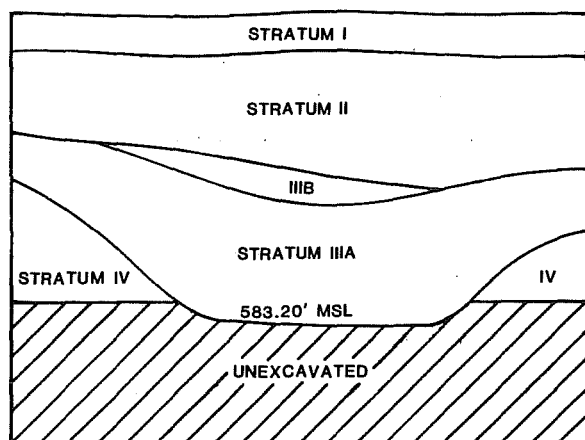
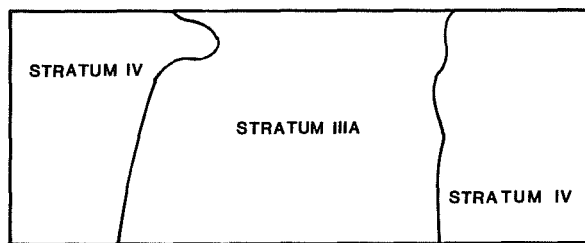
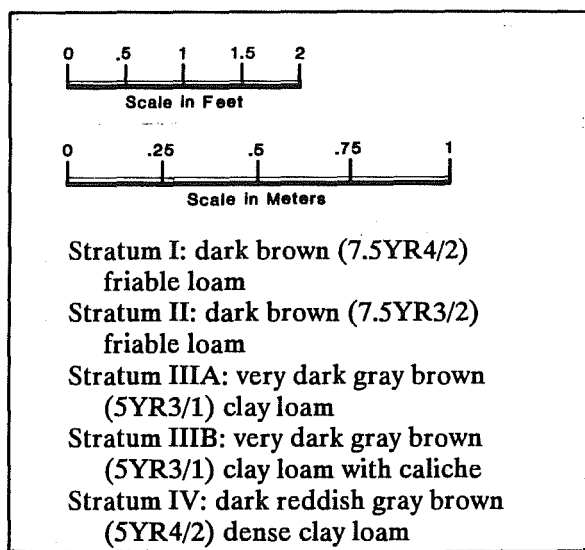
Figure 6. Profile of North Wall of Test Trench 3.

Trench 3 was located parallel to and 30 feet (9.1 m) north of the exploratory trench excavated by the SDHPT as Test Trench 9 (Henderson and Clark 1984:Fig. 3). The profile of the trench indicated a ditch approximately five feet (1.5 m) wide. The bottom of the ditch was found to rest on the caliche subsoil at about 32 inches (81 cm) below the present surface. This corresponds well with the findings of the SDHPT archaeologists (Henderson and Clark 1984:Fig. 9), allowing for the higher elevation of the soil surface in the area to the north of the street. The CAR crew recorded the elevation of the bottom of the ditch at Trench 3 to be 583.2 feet (ca. 177 m) MSL.

The stratification within the trench was similar to that found in Trenches 1 and 2, with the addition of a layer of humus-stained loam at the surface that was not clearly visible in the two previous trenches (Fig. 6). The same irregular outline of the ditch was visible where it was cut into the caliche gravel subsoil as was observed by the SDHPT crew (Henderson and Clark 1984:Figs. 11 and 12). In addition, the very bottom of the ditch yielded a sherd of Indian-made *Goliad* ware and a few bone fragments, similar to the artifacts found farther south in the ditch in 1984 (Henderson and Clark 1984:Fig. 11). The only other artifacts found were in the first stratum: one stoneware bowl sherd, blue-spattered design (Fig. 4,d); three pale green glass goblet sherds (Fig. 4,g); three clear glass bottle sherds; one spark plug "CHAMPION H-10" (Fig. 4,f); and one window glass fragment.

During excavation of Trench 3, a lense of soil containing numerous fragments of white caliche gravels and occasional small pieces of bone was found to overlie the center of the trench. When Trench 4 was begun ca. 30 feet to the north, the same lense was found. This trench was also dug to the level of the bottom of the ditch to confirm the findings in Trench 3. In the upper stratum, late artifacts were found: one galvanized wire nail and one clear glass fragment. Within the fill on the bottom of the ditch were two sherds of *Goliad* ware (Fig. 4,a,b), a large bovine bone, and a small fragment of glass.
