## Archaeological Testing of Historic Sites to be Affected by Construction of IH 410 Through the San Antonio Missions National Park City of San Antonio, Bexar County, Texas

ARCHAEOLOGICAL TESTING OF HISTORIC SITES TO BE AFFECTED BY  
CONSTRUCTION OF IH 410 THROUGH THE SAN ANTONIO MISSIONS NATIONAL PARK  
CITY OF SAN ANTONIO, BEXAR COUNTY, TEXAS

Texas  
State Department of Highways and Public Transportation  
Highway Design Division  
December 1986

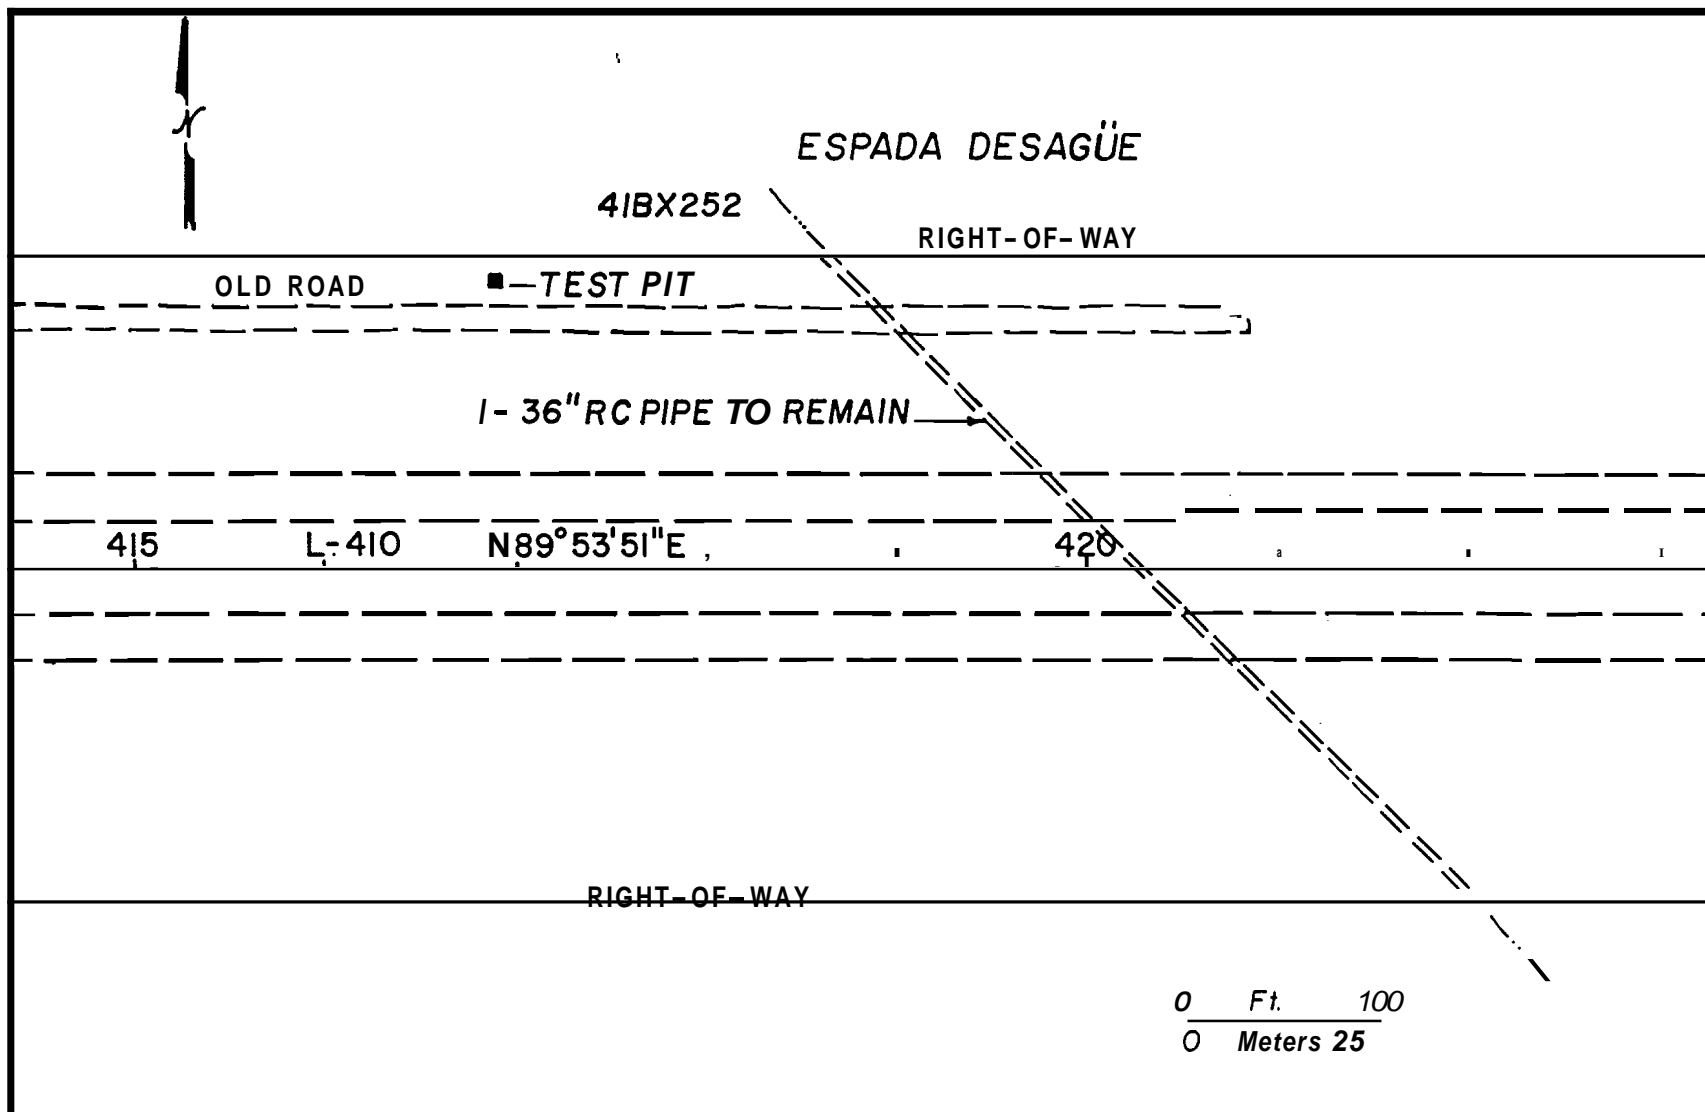
FIGURE 3. Location of test pit near the Espada desagüe and Site 41BX252.

however, that a 36-in. concrete pipe occupied the former channel of this desague (Fig. 3). That being the case, demonstrated by documentation provided by SDHPT District 15, it was decided not to excavate TT 3 (Fig. 3).

Hand testing of Site 41BX252 (Figs. 2 and 3) consisted of the excavation of a 1- by 1-meter test pit to a depth of 5-10 cm below the surface. The test pit was located on the north edge of the right-of-way. Excavated deposits were passed through a 0.25-in. mesh hardware cloth screen. Artifacts encountered were placed in an appropriately labeled bag. They were subsequently washed, labeled, and cataloged.
