**HISTORICAL ASSESSMENT AND ARCHEOLOGICAL SURVEY
OF 4.9 MILES OF FM 2092 FROM MENARD TO FIVEMILE CROSSING,
MENARD COUNTY, TEXAS**

REPORTS OF INVESTIGATIONS, NUMBER 155

ARCHEOLOGICAL STUDIES PROGRAM, REPORT NO. 103

November 2007

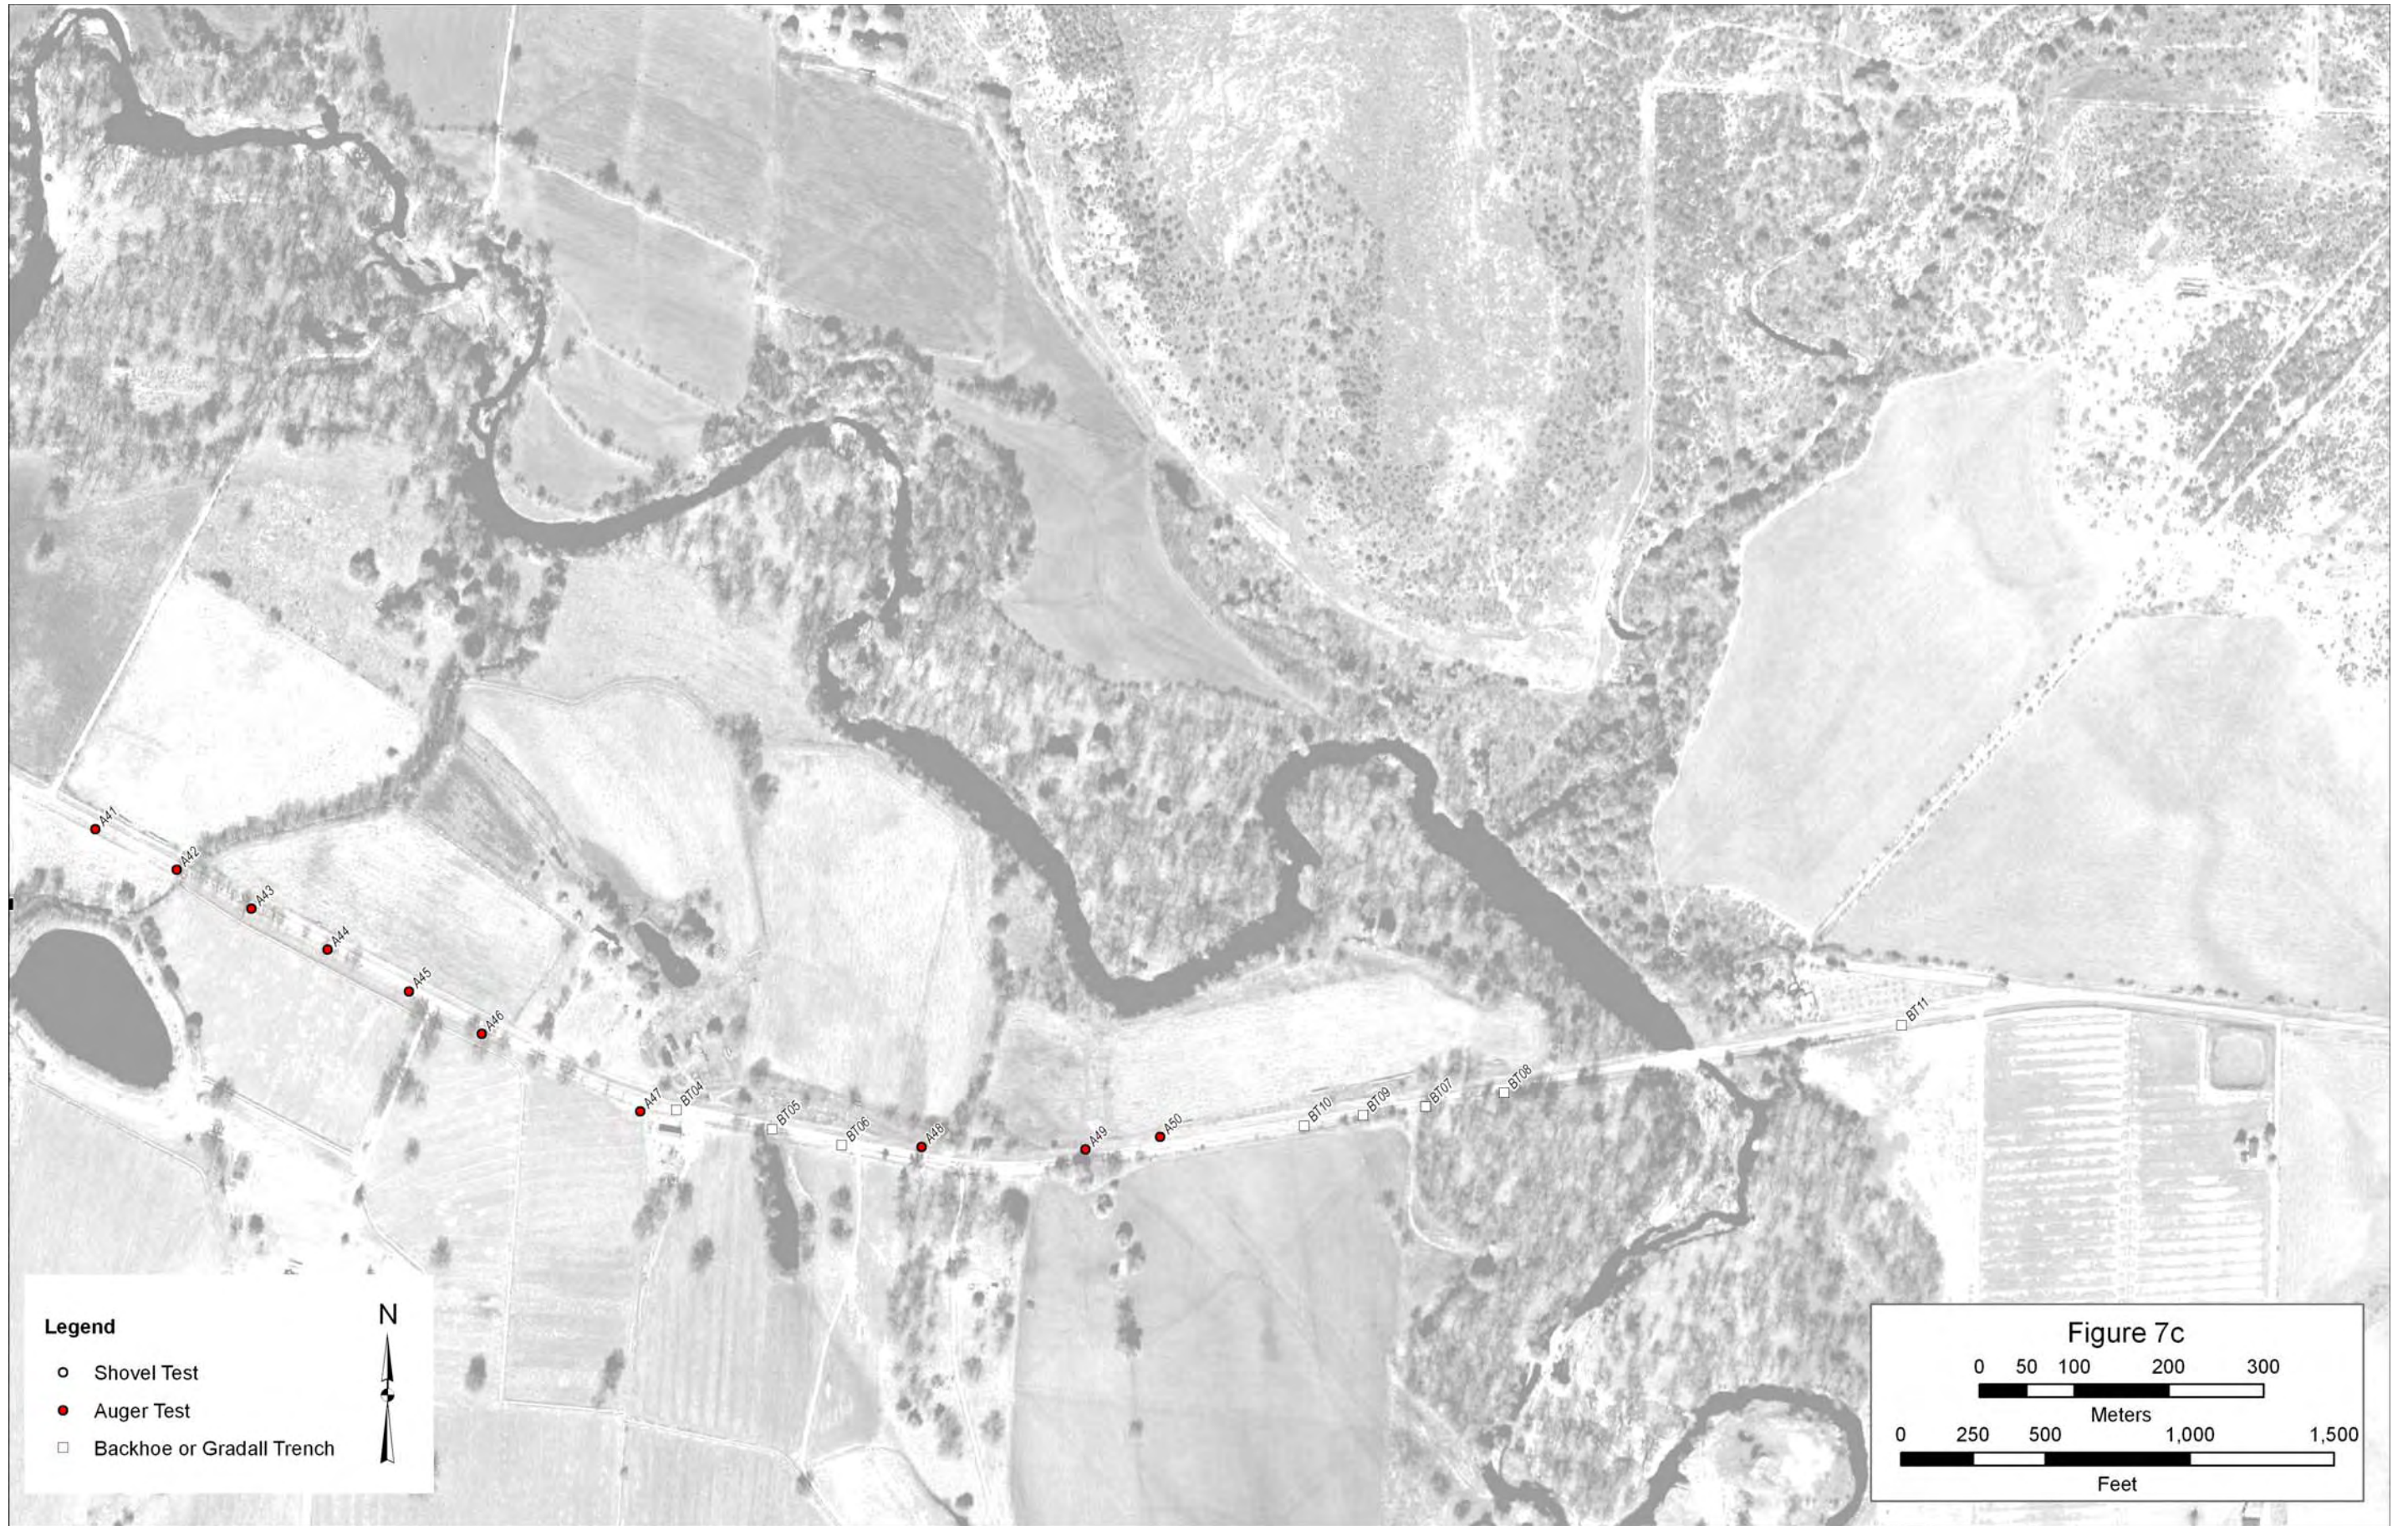
Figure 7. Project map showing locations and excavations at 19 recorded archeological sites along FM 2092. The base is 2004 aerial imagery from the U.S. Department of Agriculture, National Agricultural Imagery Program, obtained from the Texas Natural Resources Information System. Note: Figure 7 is in three parts designated as 7a, 7b, and 7c, from east to west.

Table 5 summarizes all of the recorded sites in and near the FM 2092 project area, and their locations are shown in Figure 7. During the survey, eight of the previously recorded sites were found to be outside the project area and between 100 m and 700 m away from the road. The right of way was also inspected for 10 previously recorded sites, and archeological remains were found associated with 5 of these. The survey also discovered and documented 9 new sites. Of the 19 sites known to be adjacent to or extend into the FM 2092 right of way, 4 are historic, 6 are prehistoric, and 9 have both historic and prehistoric components.
