**Cultural Resources Survey of the Proposed Franklin 1A
Elevated Storage Tank and Access Road, El Paso County,
Texas**

Texas Antiquities Permit No. 8114

September 2017_Final Report

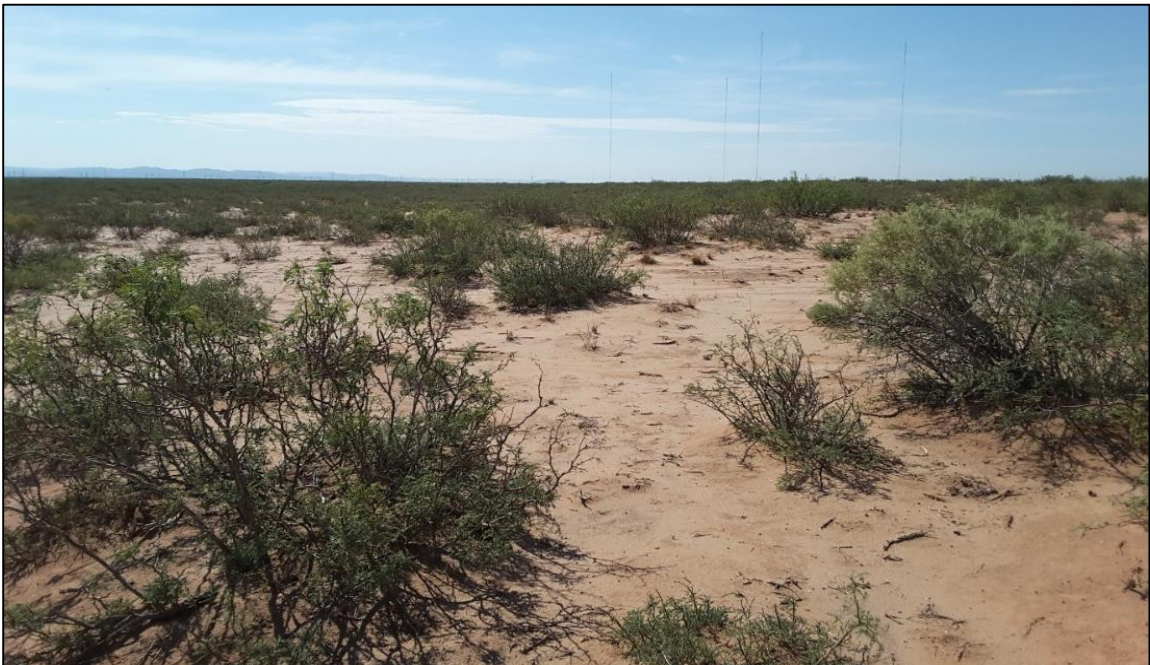
Current landforms consist of poorly-developed mesquite-stabilized dune fields, areas of interdunal deflation, and shallow sand sheets characterized by gravelly alluvium (Figure 2-1). Impacts to the parcel currently noted result from ongoing eolian and erosional deflation and previous highway development; a graded easement parallels the current survey corridor. The soils throughout the project area consist of unconsolidated eolian sediments, light tan sandy loams, and low to moderate amounts of alluvium-related gravels and cobbles.

Figure 2-1. Photograph showing the general environmental condition of the project area, looking east.

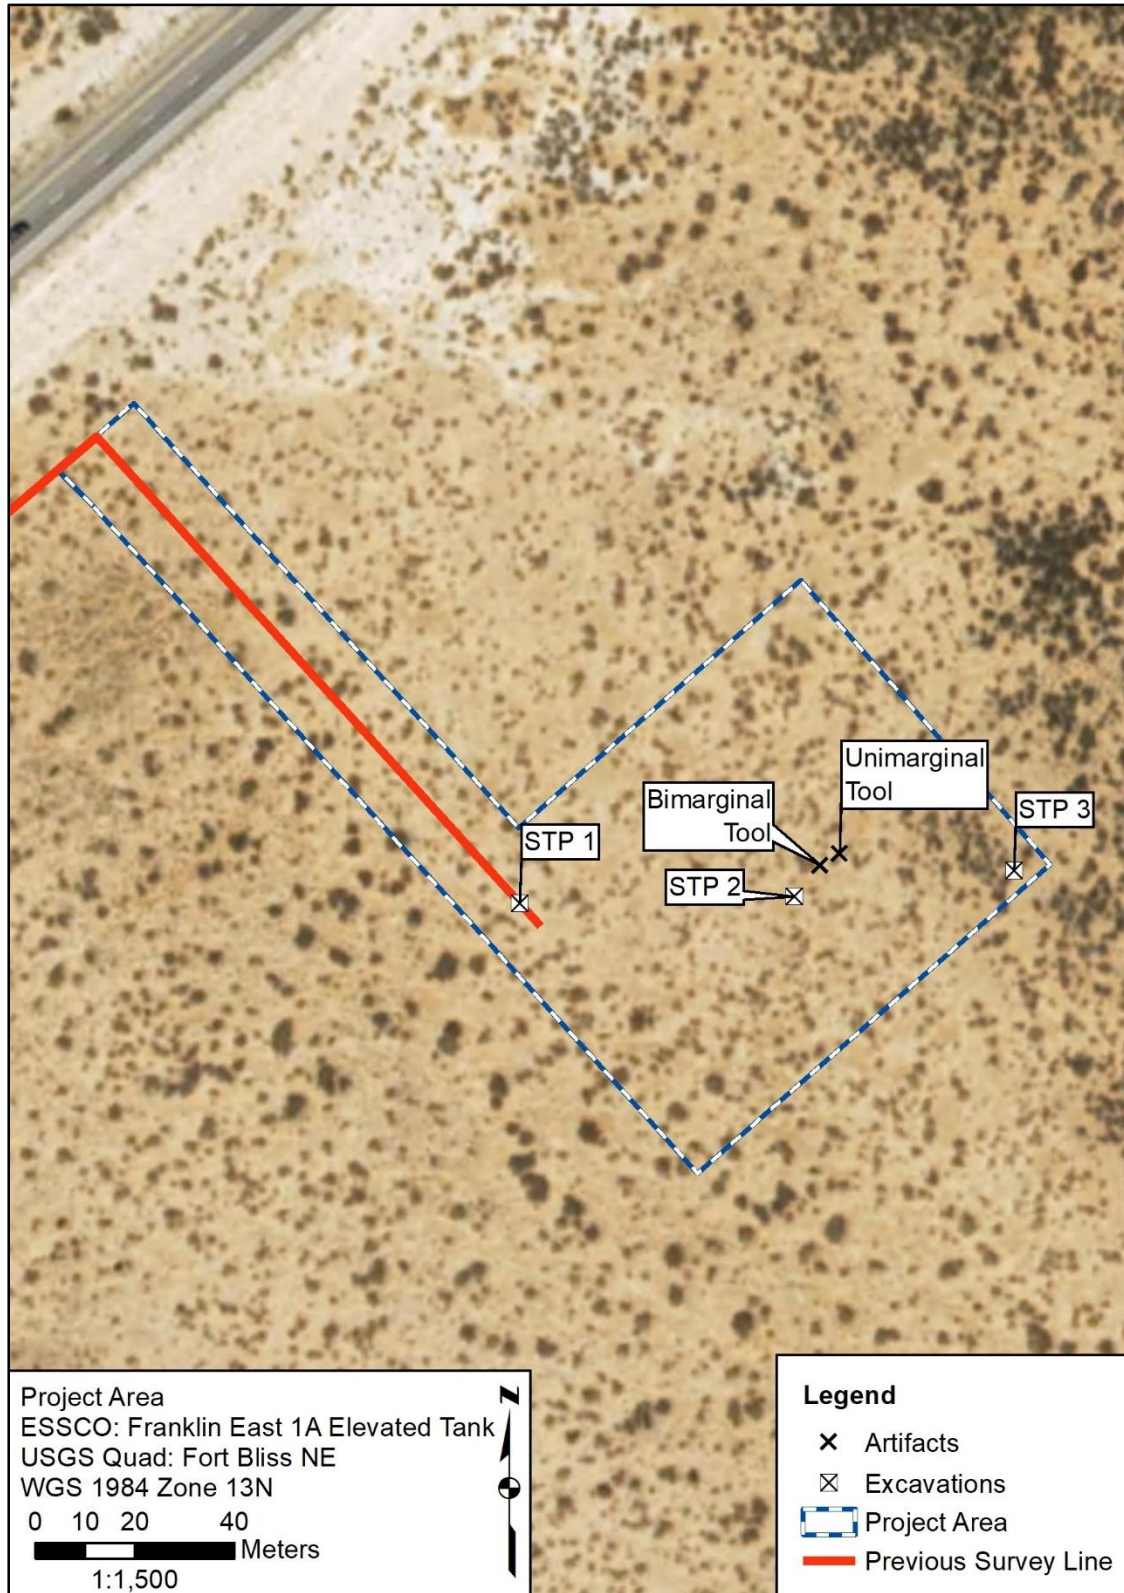
This project entailed an intensive pedestrian survey of a 3.0-acre parcel in El Paso County, Texas. The survey was confined to the access road corridor and water tank footprint, which run perpendicular to U.S. Highway 54 (Figure 4-1). The condition of the project area appeared to be generally intact; however, the far western margins of the access road corridor closest to the highway exhibited a higher level of disturbance. In these areas, disturbance from road expansion, drainage, and maintenance were clearly evident (Figure 4-2 and Figure 4-3). Moreover, eolian deflation and alluvial action has, over time, removed and redistributed sediments, creating deflation basins and gravel deposits throughout the project area. Low-to-medium sized mesquite-stabilized coppice dunes anchor sediments in the parcel. Ephemeral rills and several shallow arroyos have impacted the landscape. Dune margins and exposed dune facies were closely examined for evidence of buried cultural deposits. No archaeological sites were identified; two isolated occurrences were encountered.

Figure 4-1. Map of project area, shovel test pits, and isolated occurrences.

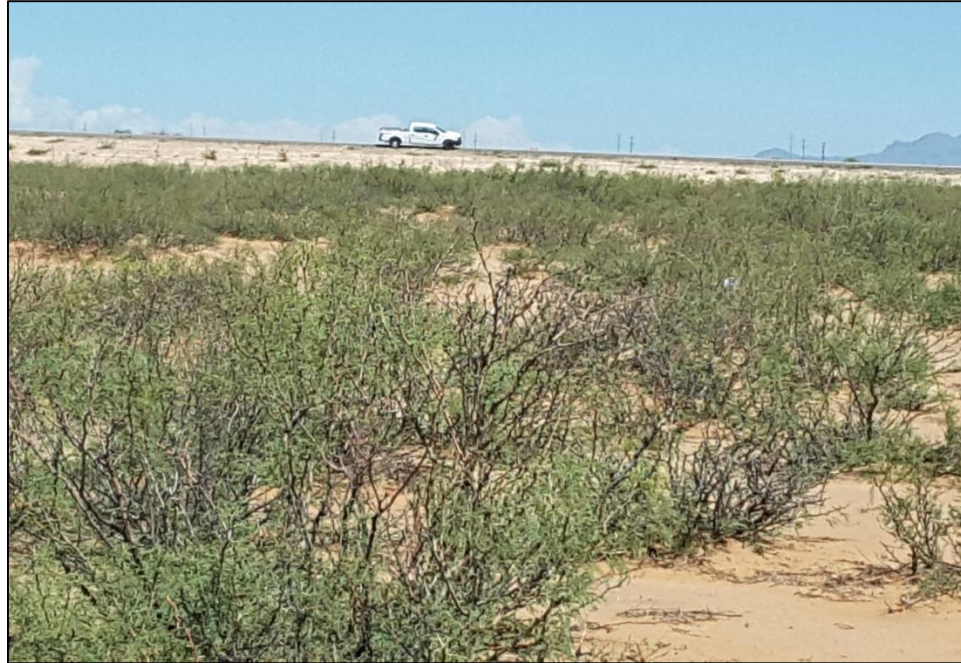
Figure 4-2. Northwest portion of the survey parcel, looking west toward U.S. Highway 54.

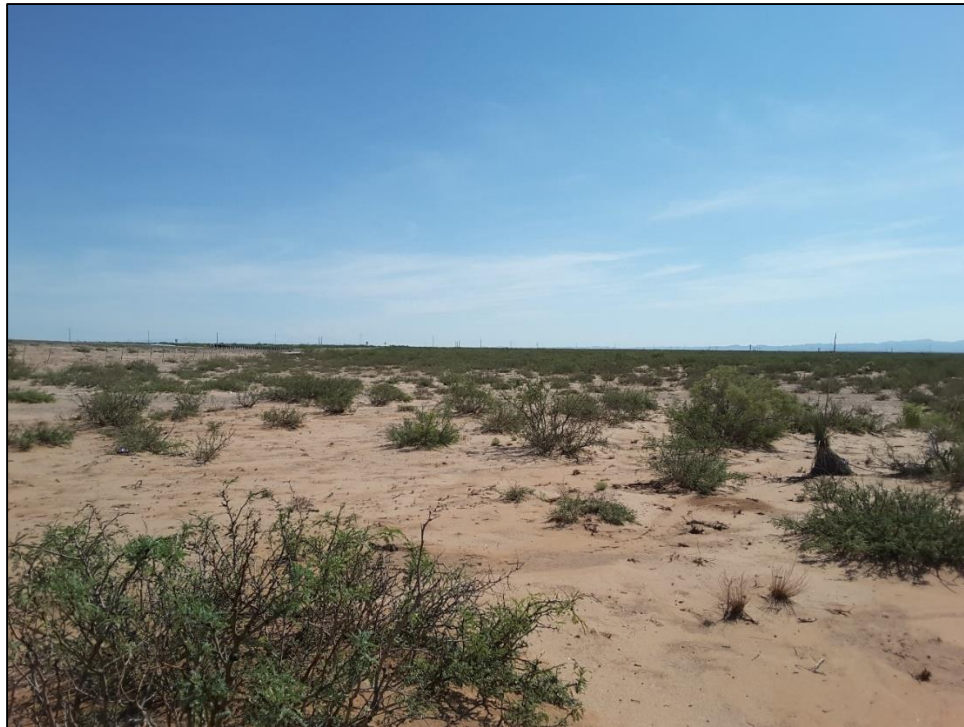
Figure 4-3. Southern portion of the survey parcel looking north-northeast along U.S. Highway 54.

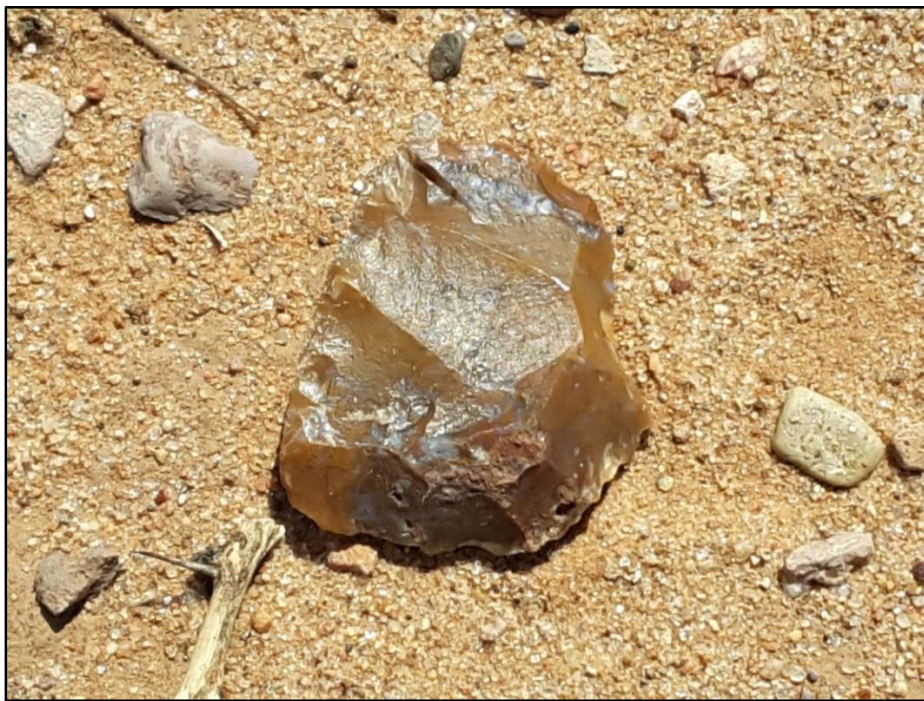
The second isolated occurrence was a bimarginal chert tool (Figure 4-5). This tool was made from a more homogenous, less coarse tan-brown chert and measured approximately 8-cm in length. Platform preparation is visible along the proximal end; several extending flake scars are also present. The edge preparation and overlapping flake scars suggest, that prior to detachment, this piece was one edge of a core. Post-detachment modification resulted in the shaping of the distal end as evidenced by the sharp edge angle and supporting flake scars. No other artifacts were encountered during the survey. Both artifacts were thoroughly documented in-field and no further action is recommended.

Figure 4-5. Isolated Occurrence 2, a tan-brown bimarginal chert tool.

It is recommended that the information potential of the isolated occurrences has been exhausted through documentation, and no further work is merited. Based upon the results of this process, Versar recommends that the proposed development of the Franklin 1A Elevated Storage Tank and access road will not have an adverse effect on any historic properties within the proposed APE.

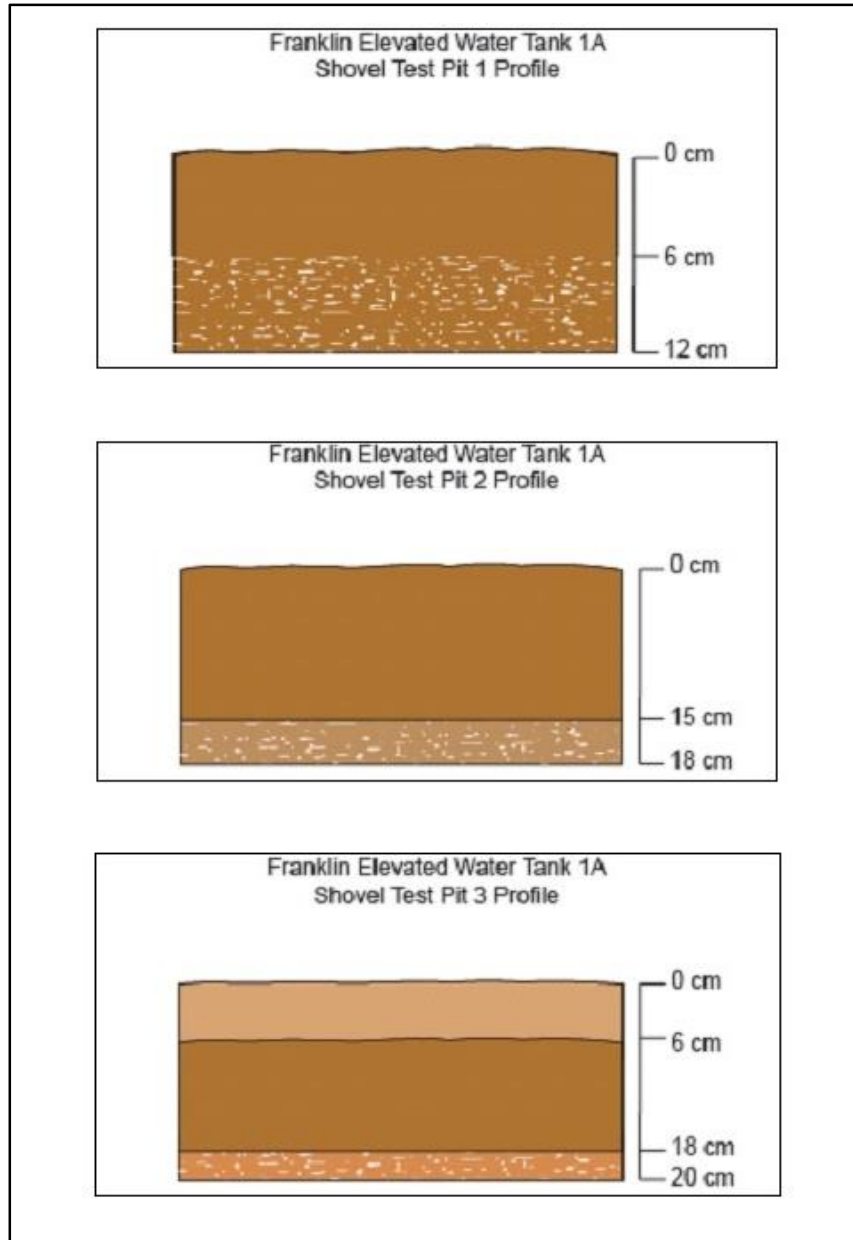
Finally, in order to assess the potential for buried archaeological deposits and examine the contextual integrity of the project area, three shovel tests were excavated within the proposed footprint of the Franklin 1A elevated water tank (Figure 4-6). All sediments removed from the shovel tests were screened through 1/8th-inch hardware mesh. The shovel tests did not reveal any buried archaeological remains. The stratigraphic data are presented below.

Figure 4-6. Stratigraphic sequences exposed in Shovel Tests 1-3.

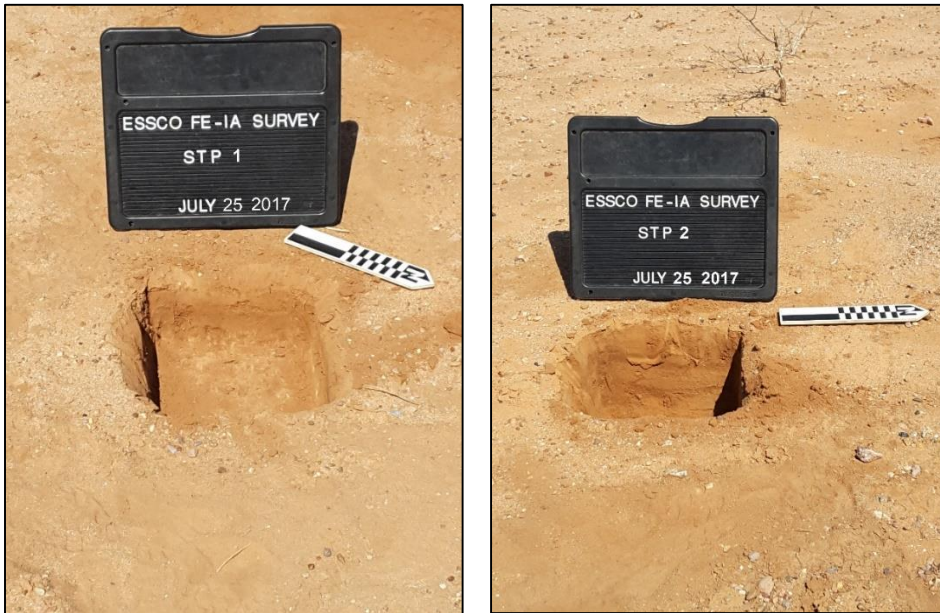
Shovel Test 1 was placed in the northwest corner of the survey parcel in an area characterized by low-lying coppice dunes and interspersed with sandsheets (Figure 4-7). Maximum depth was 12-cm, with the first 6-cm consisting of unconsolidated sandy sediments followed by 6-cm of semi-compact silty sand with caliche flecking. No cultural materials were encountered.

Shovel Test 2 was placed near the center of a survey parcel in a sandsheet between several low-lying dunes (Figure 4-7). Maximum depth was 18-cm, with the first 15-cm consisting of unconsolidated sands, followed by 3-cm of lighter brown, calcic, semi-compact sediments. No cultural materials were encountered.

Figure 4-7. Image showing Shovel Test 1 and 2 excavated within the survey parcel, looking southwest and west, respectively.

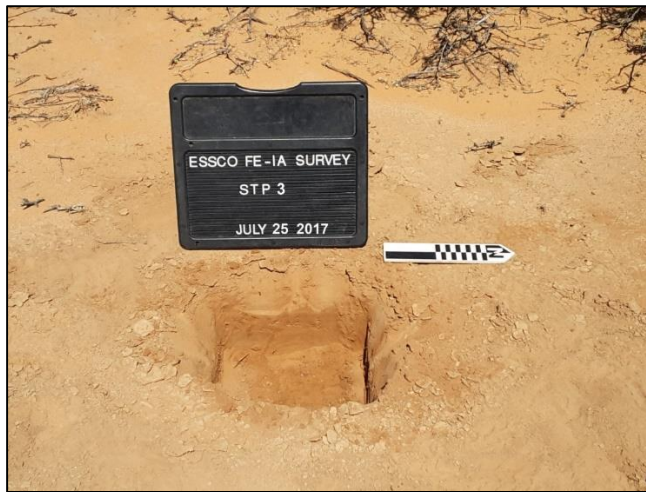
Shovel Test 3 was placed in the southeastern corner of the project area in an area with increased vegetation at the base of a small dune (Figure 4-8). Maximum depth was 20-cm, with the first 6-cm consisting of light brown loose sands, followed by 12-cm of dark brown, more consolidated sand, with the last 2-cm characterized by a semi-compact calcic stratum of light red, silty sand. No cultural materials were encountered.

Figure 4-8. Image showing Shovel Test 3, looking west.
