**Banita Creek Sanitary Sewer Replacement
Nacogdoches County, Texas**

Texas Antiquities Permit #5967

Prepared by:
Deep East Texas Archaeological Consultants
15369 FM 1878
Nacogdoches, Texas 75961

DETAC Project Number 398

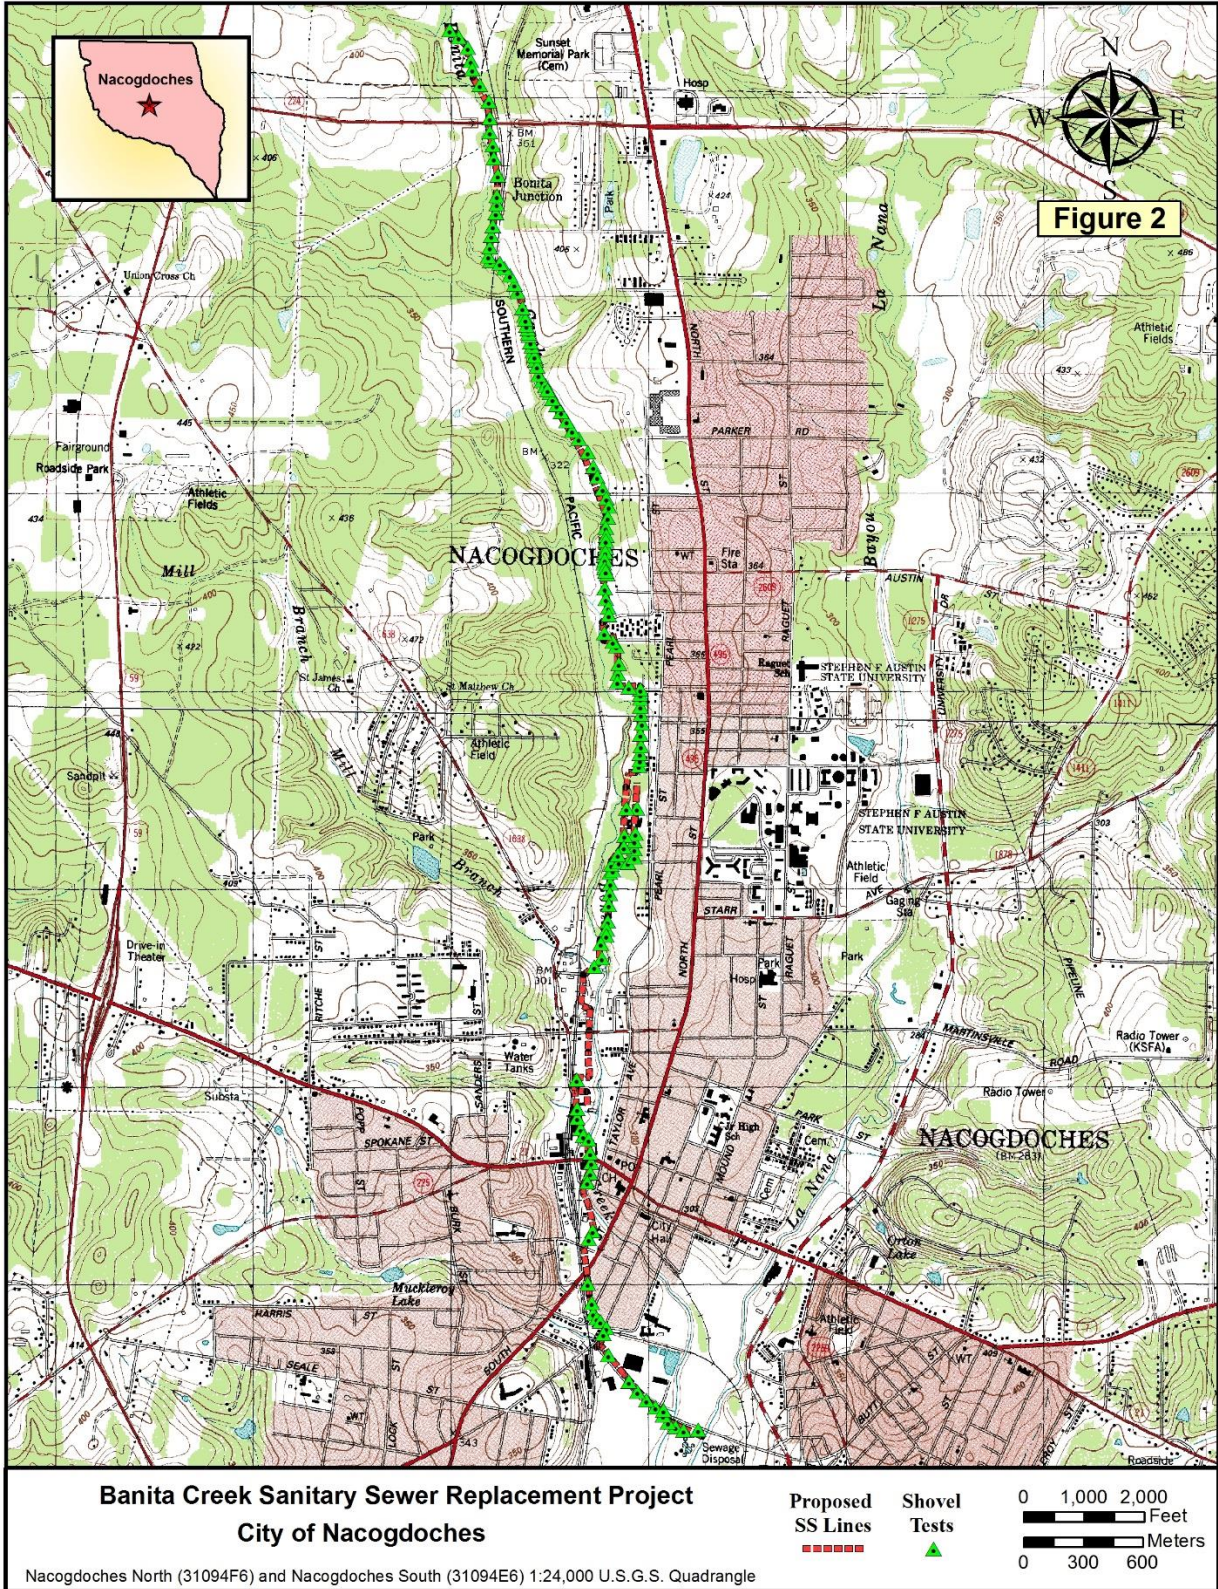
Figure 2. Project area with Shovel Tests.

DETAC excavated 150 shovel tests across 5.4-kilometers of the proposed project area for a spacing density of approximately 44 per mile with an individual spacing of approximately 36-meters (Figure 2). According to the Natural Resource Conservation Service's (NRCS) Official Soil Series Description (OSD), the soils within the proposed project area include the Hannahatchee – Urban Complex that is frequently flooded. Shovel testing found soil conditions similar to the NRCS soil survey with varying depths, colors, and textures (Table 1).

No cultural resources were located during the survey. All of the shovel tests were negative and no artifacts were collected.
