**INTENSIVE CULTURAL RESOURCES
SURVEY FOR EL PASO NATURAL GAS
PROJECT: TEXAS GAS SERVICE LINE
EXPANSION LATERAL AND METER
STATION,
EL PASO COUNTY, TEXAS**

Prepared for
Kinder Morgan, Inc.

Prepared by
SWCA Environmental Consultant

January 2015

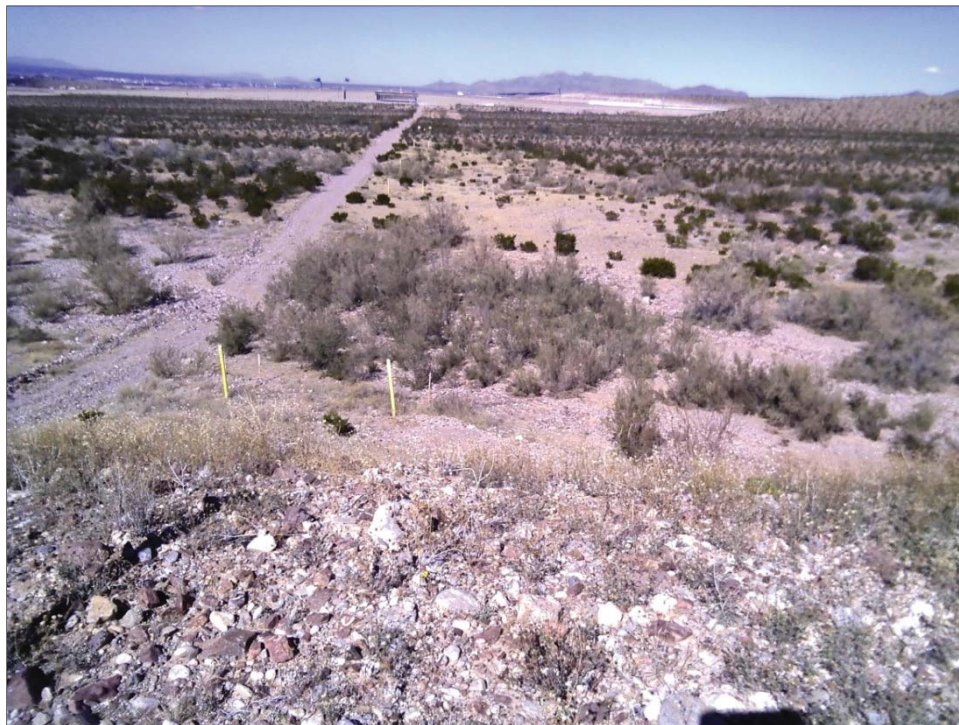
Figure 1. MP 3+3064 - Proposed location of Transmountain Delivery Meter Station, facing north (Digital Roll 31122, Frame T15-2707).

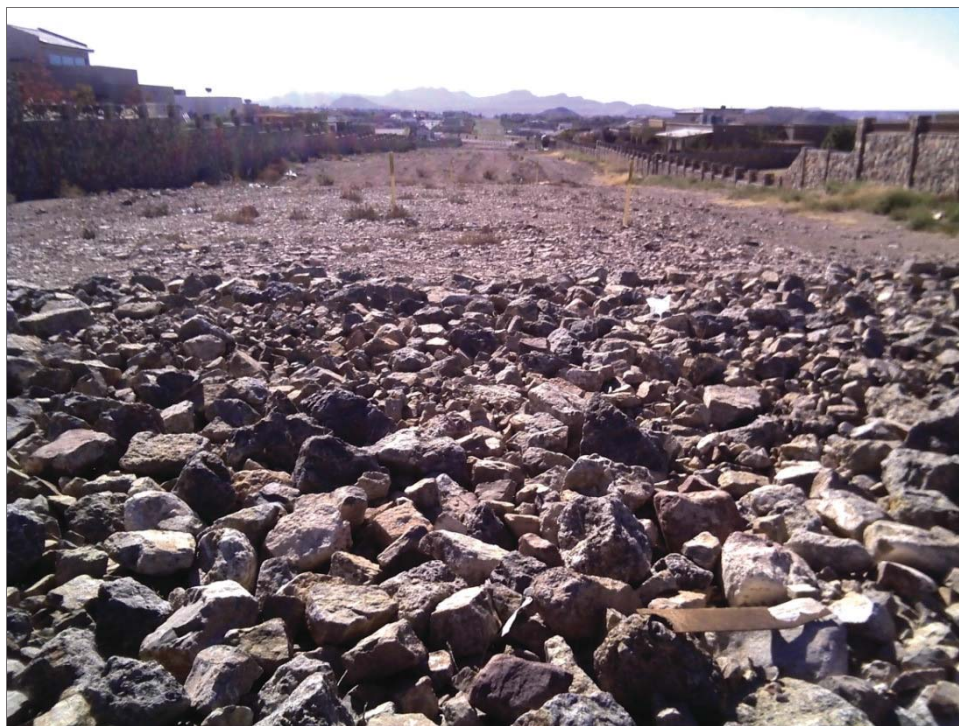
Figure 2. MP 0+0000 - Location of new pressure regulation station, facing south (Digital Roll 31122, Frame T11-6091).

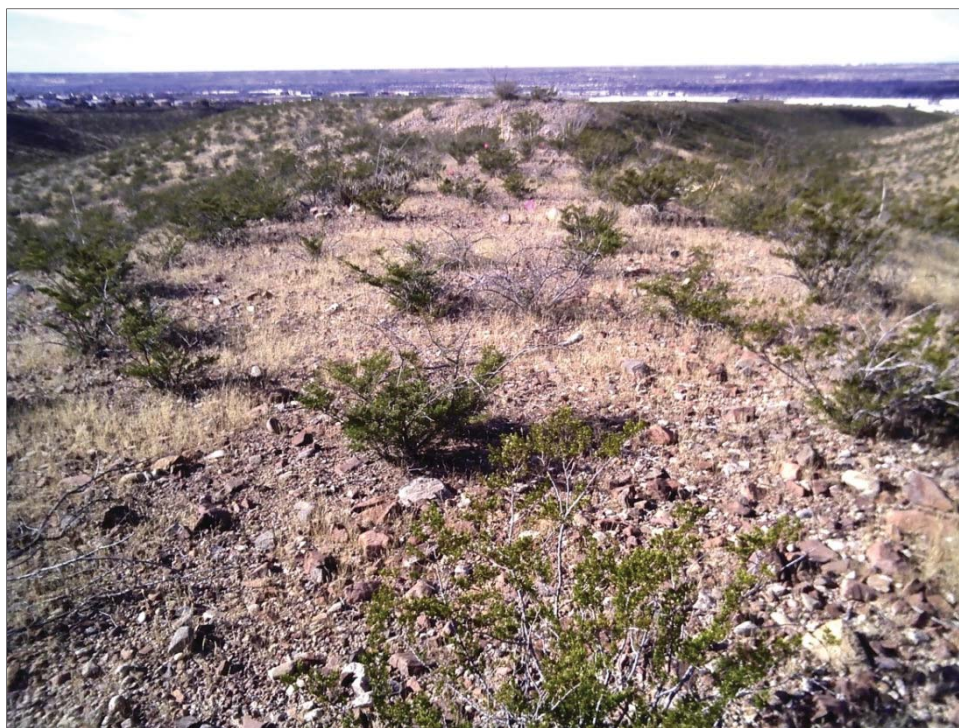
This site is a lithic scatter with two hearth features (Figure 6 and Figure 7). The site measures 27 m (northeast-southwest) × 17 m (northwest-southeast) (86 × 56 feet). The site is estimated to be 90 percent intact and is in good condition with little disturbance of the artifacts and features. The pipeline and access road does not appear to have caused any disturbance to the site. No artifacts were observed in the pipeline scar or road cut, suggesting that the site boundary does not extend that far west. The estimated maximum depth of subsurface cultural deposits is 0 to 10 cm, based on the location of the site atop a rocky hill with some deflation from wind and water erosion. Creosotebush, yucca, and grasses slightly obscure surface visibility, which is estimated at 70 percent.

Figure 6. Site overview of 41EP7108, facing southeast (Roll 31122, Frame T11-7327).

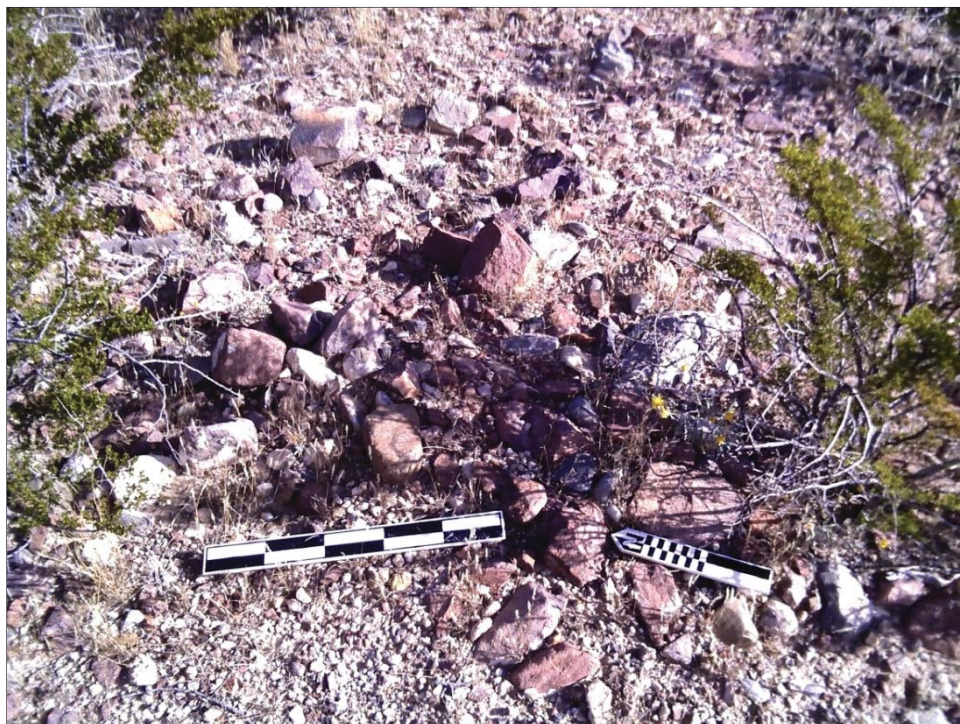
Feature 1 is a poorly preserved rock-ringed hearth measuring 1.2 m east-west by 1.0 m north-south. The stones forming the ring are partially disarticulated but the north and west margins still appear in place and partially imbedded in sediments. The stones consist of locally available rhyolite and granite. These stones range in size from 10 to 25 cm in maximum dimension. A couple of the igneous rocks show evidence of scorching and thermal fracturing. The surrounding ground surface is a dense desert pavement of the same material derived from the alluvial fan upon which the site is located.

Figure 8. Feature 1 at 41EP7108, view north-northeast (Digital Roll 31122, Frame T11-1352).

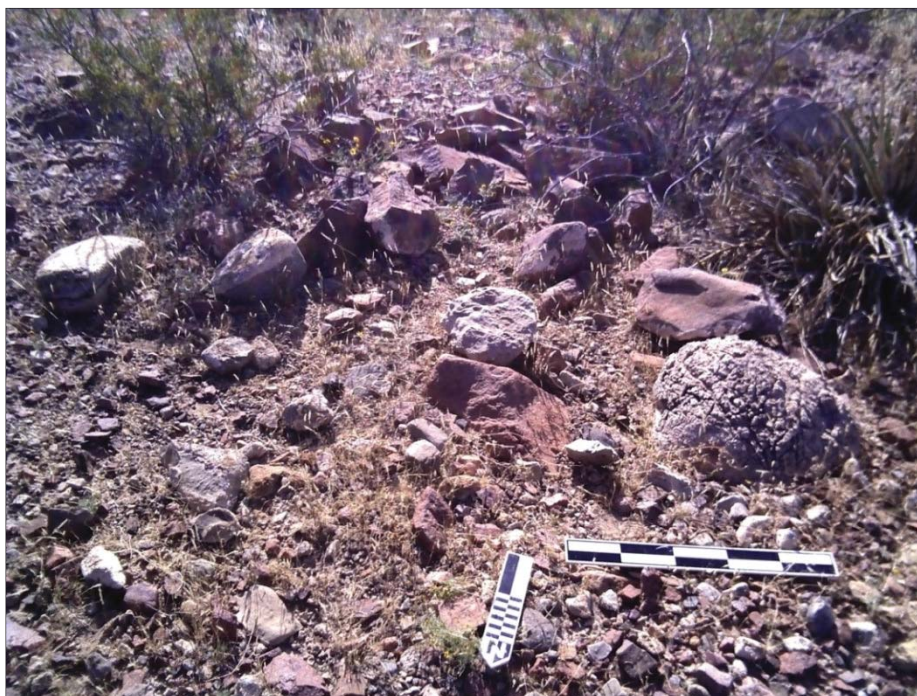
Feature 2 consists of a disarticulated concentration of cobbles and boulders of locally available igneous and limestone rock. This feature measures approximately 1.8 m east-west by 2.4 m north-south. The stones measure 15 to 40 cm in maximum dimension. The function of this concentration is undetermined. A few of the boulders are embedded in the sediments. Feature 2 is located at the south shoulder slope of the ridge. Some material appears to be eroding downslope to the south. A couple flakes of Thunderbird black rhyolite are located in the immediate vicinity of this concentration of rock.

Figure 9. Feature 2 at 41EP7108, view south (Digital Roll 31122, Frame T11-0825).

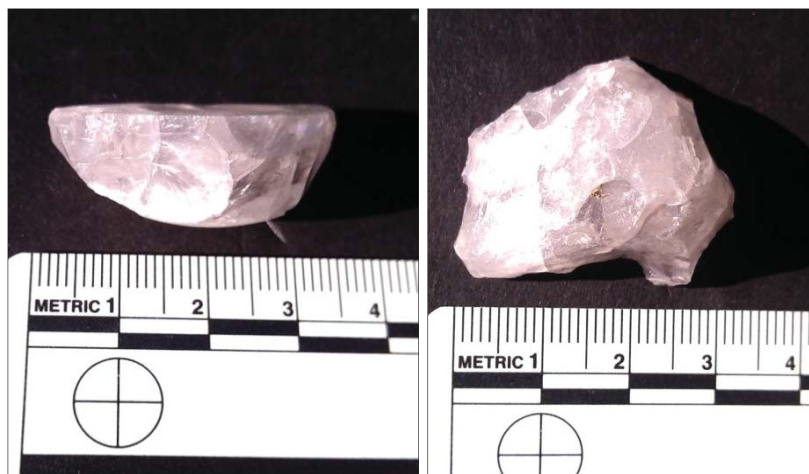
In total, one IO was recorded during the course of this investigation (Figure 11). IO 1 consists of a purple glass decorative shard that exhibits unifacially worked flaked modification on all four margins. Flaking appears to be cultural and measures 3.2 cm long, 2.8 cm wide, and 1.4 cm thick. Flake scars originate on the flat side and terminate on the rounded side, similar to a unidirectional core. It appears to be fashioned into a steep beveled scraper. It is unknown if this item represents a historically modified artifact or if it is modern. It was found atop a modern push pile of asphalt, concrete, and rebar at the head of a shallow drainage.

Figure 11. IO 1 (Digital Roll 31122, Frame T11-1402 and T11-4042).
