**CULTURAL RESOURCES SURVEY
FOR THE EASTERN PORTION OF THE BELL COUNTY
WCID NO. 1 TREATED WATER LINE (PHASE II),
BELL COUNTY, TEXAS**

Final Report

Texas Historical Commission
TAC Permit # 7259

Prepared by:
aci consulting
1001 Mopac Circle
Austin, Texas 78746

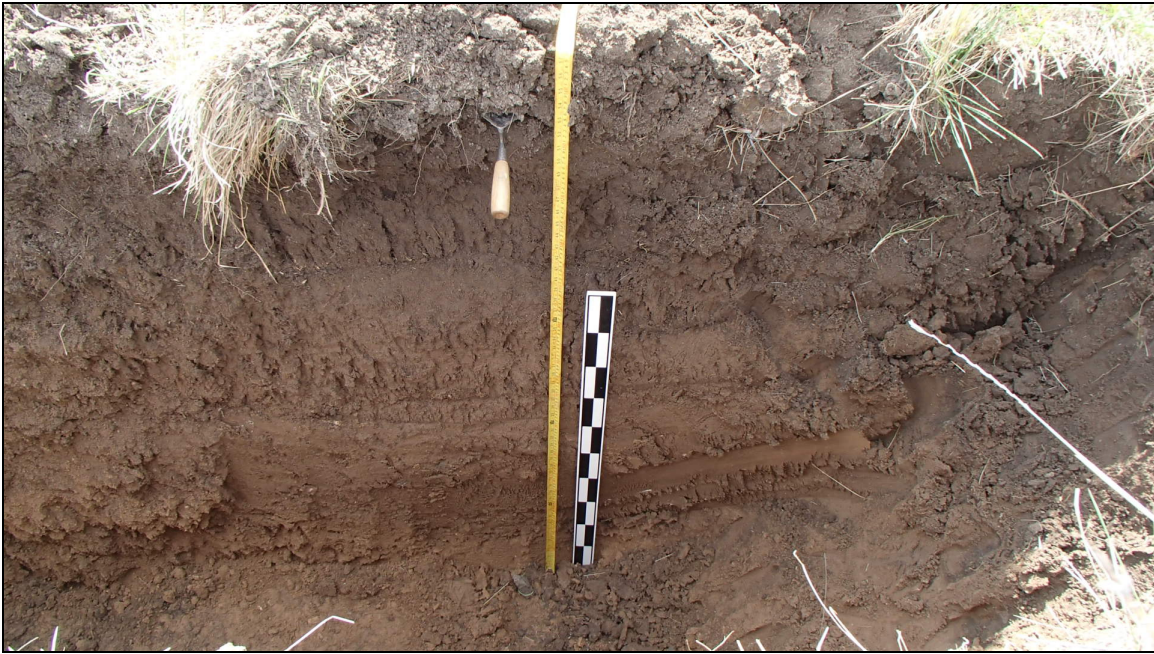
Figure 6. BHT 1 south wall.

Backhoe trenching was conducted in the Lampasas River floodplain (Figure 5). One backhoe trench (BHT 1) was placed approximately 50 meters north of the site centroid for previously recorded site 41BL1277 (Figure 6). The site was recorded to consist of a few chert flakes, and was not relocated within the backhoe trench. Two more trenches (BHT 2 and 3) were placed on either side of BHT 1, and both were also negative for cultural material. BHT 2 was located closer to the Lampasas River, and the water table was encountered at approximately 1.5 meters below ground surface (Figure 7). BHT 3 was placed toward the upland area and was no longer within the floodplain (Figure 8). The trenches were approximately 100 meters apart, and were oriented in the direction of the proposed water line.

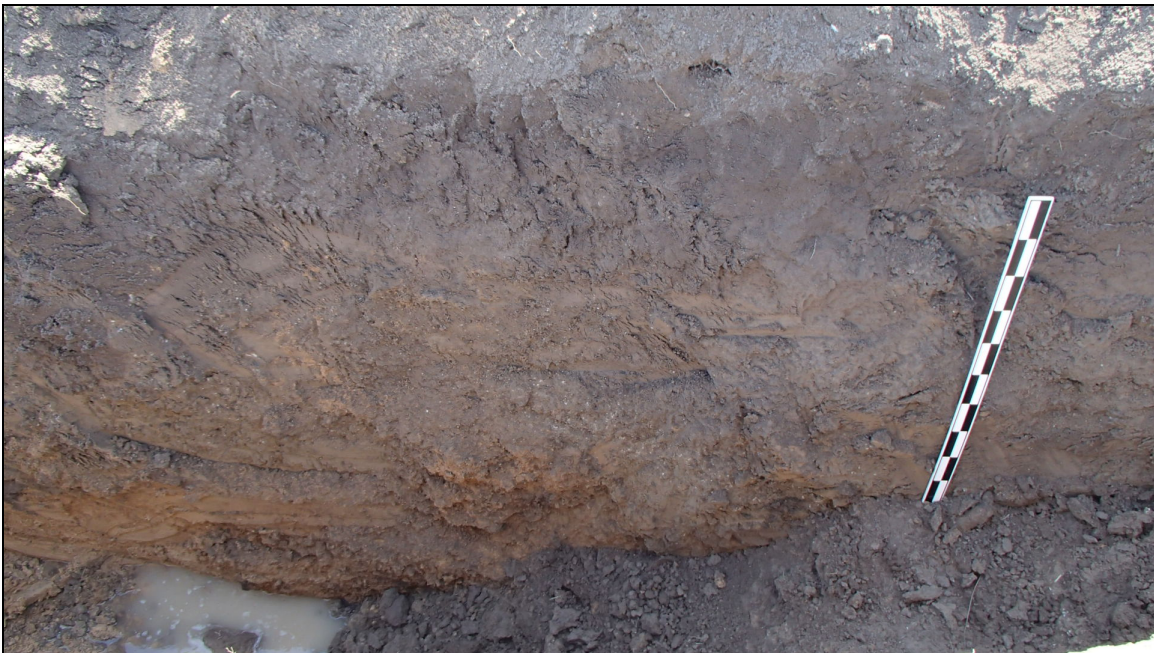
Figure 7. BHT 2 south wall, note the water table.

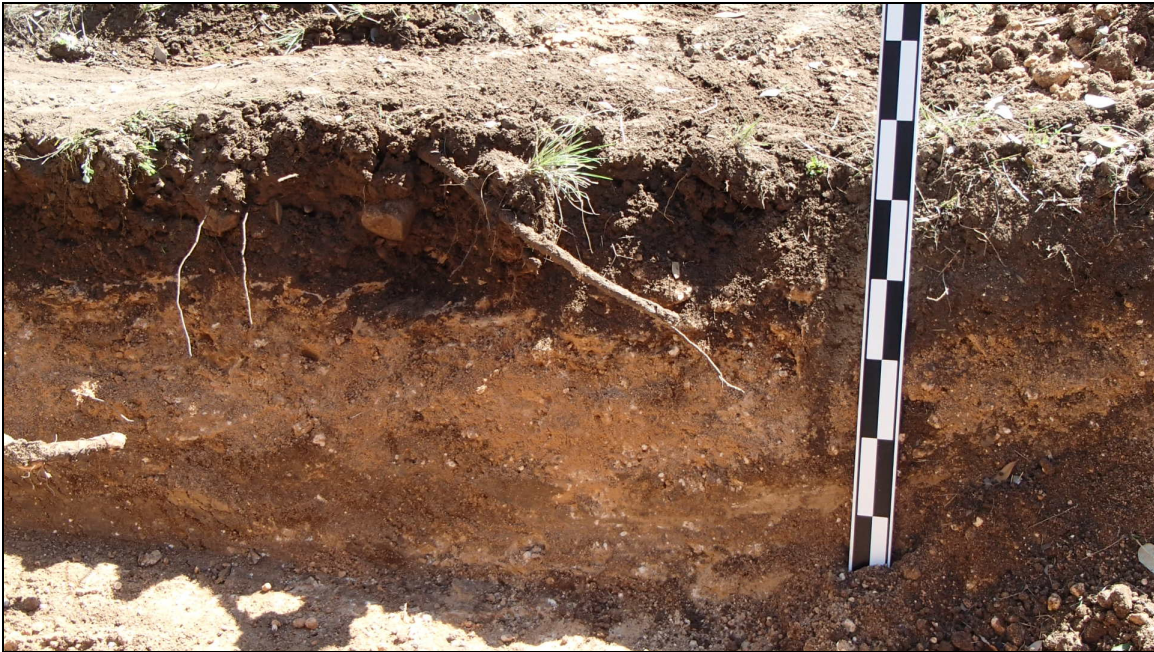
Figure 8. BHT 3 south wall, shallow soil.

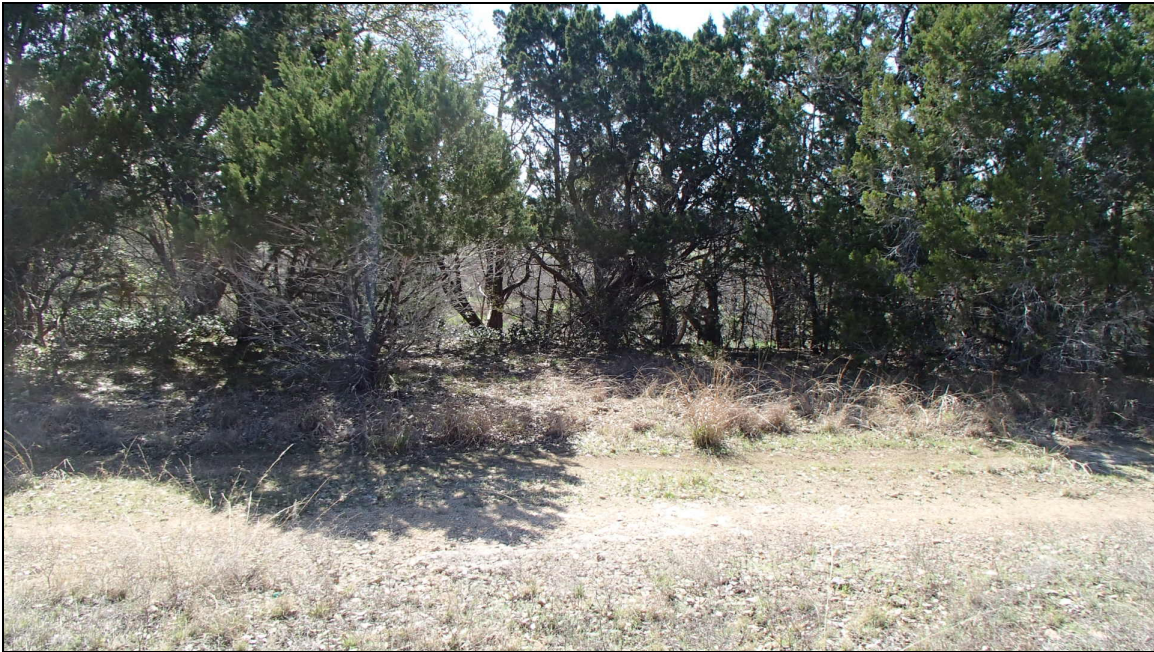
Previously recorded site 41BL1276 was relocated within the APE on the eastern edge of the Lampasas River on USACE property, on a bluff overlooking the flood plain. Ashe juniper and live oaks dominate the overstory, with dense mixed grasses and prickly pear common in the understory vegetation (Figure 10). Ground surface visibility was approximately 50 percent. The site has been previously disturbed from the construction and heavy use of a 2-track road that runs along the western boundary of the site. Roughly 20 percent of the site remains intact, as it has been mostly destroyed from traffic, looting, and erosion.

The site is a surface scatter with an expression from approximately 80 meters north to south and 50 meters west to east. Artifacts consisted of limestone fire-cracked rocks, a burned chert cobble fragment, burned chert flakes, chert flakes (2 utilized), chert scrapers, and an exhausted core with fossil cortex (Figure 11). The soil was shallow and did not contain buried deposits as evidenced by shovel tests. Site 41BL1276 appears as described on the original site form. The lack of contextual integrity, cultural features, or diagnostic artifacts, indicates that the portion of the site within the APE is not eligible for listing on the NRHP or as a SAL. However, the NRHP eligibility of the portion of the site outside the APE remains undetermined. The site will be avoided nonetheless as it falls within the area that will be bored underneath the Lampasas River. No further work is recommended for site 41BL1276.

Figure 10. Overview of previously recorded site 41BL1276, toward the Lampasas River floodplain.

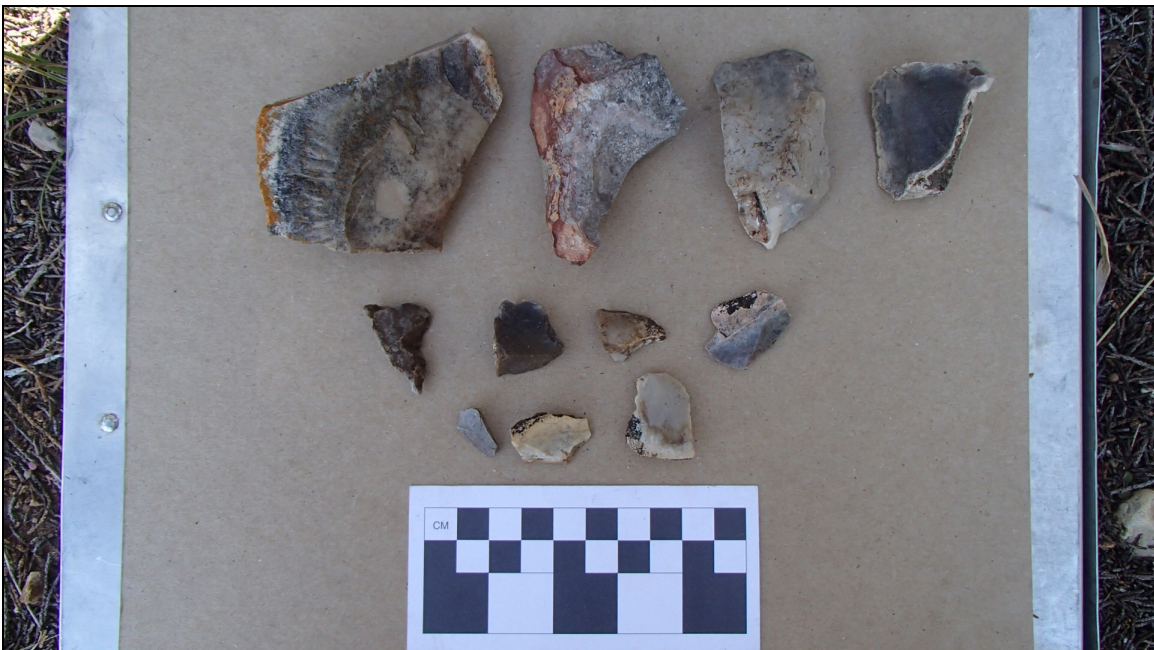
Figure 11. Representative artifacts from previously recorded site 41BL1276.

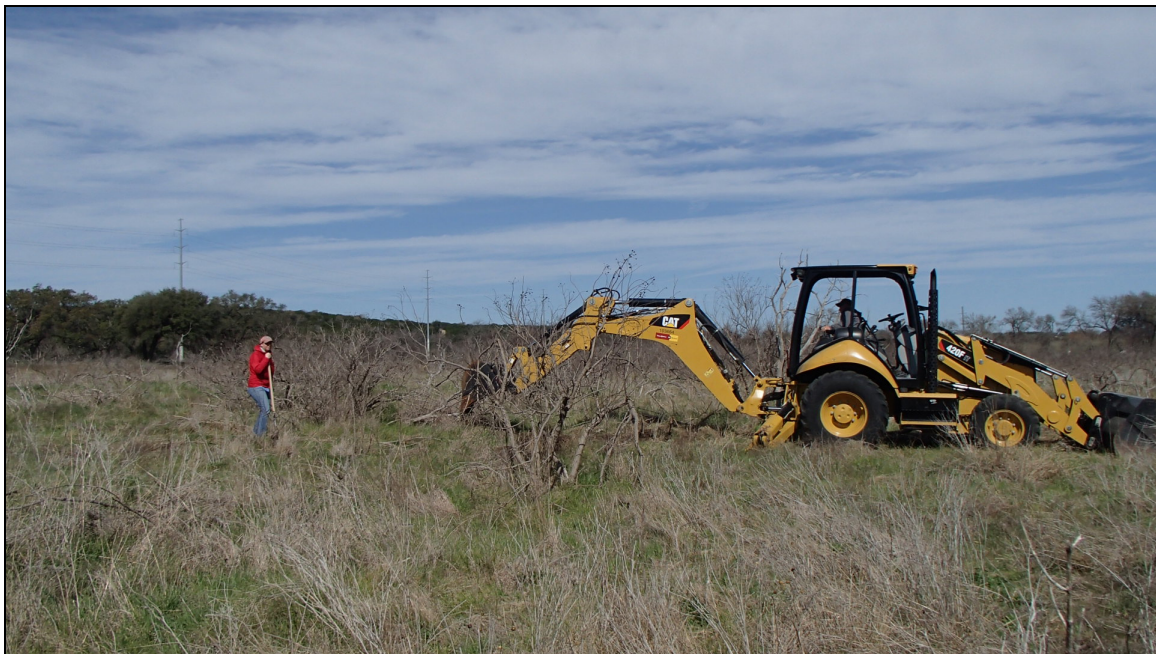
Previously recorded site 41BL1277 is located within the floodplain of the Lampasas River on USACE property. The site was originally recorded as part of the Stillhouse Hollow Lake survey in 2010, when flakes were recovered from two shovel tests. At that time, it was recommended that backhoe trenching should be conducted at the site if there were to be any development in that area (Atlas 2017). The site centroid is approximately 50 meters south of the current APE, so a backhoe trench (BHT 1) was excavated on the centerline directly north of the site (Figure 12). No cultural material was located in the trench, nor was located in the adjacent backhoe trenches. Site 41BL1277 is not present within the current APE.

Figure 12. Backhoe trench located in proximity to previously recorded site 41BL1277, facing north.

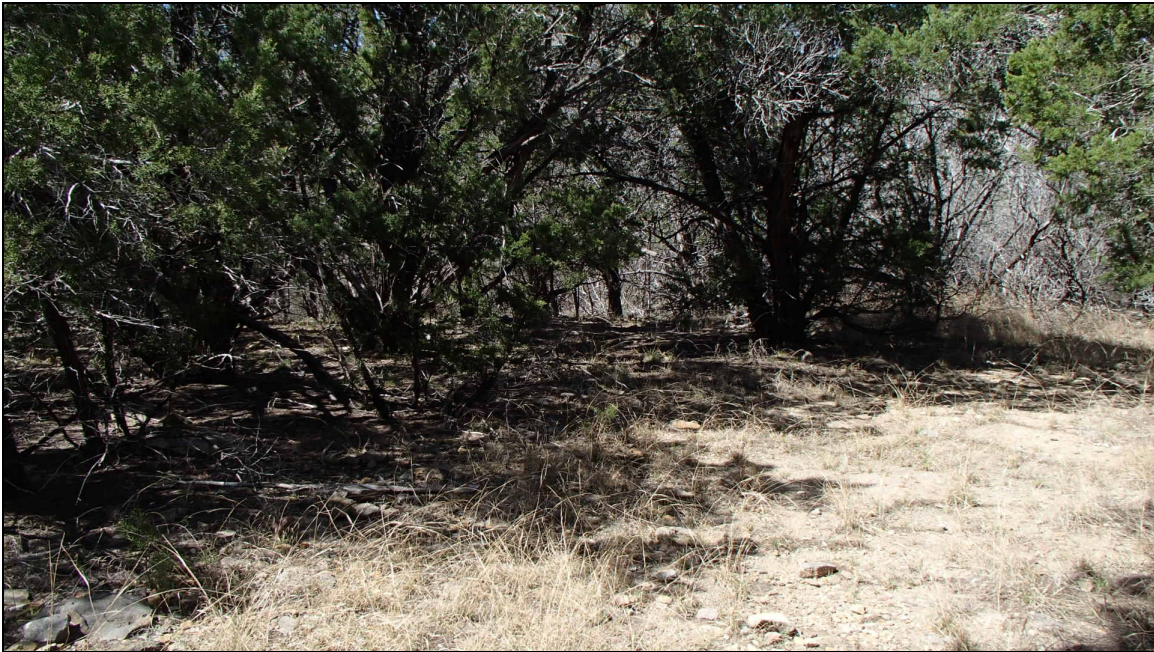
Site 41BL1398 was located on the north bank of a tributary to the Lampasas River, on top of a low, exposed rock rim. The site size is 40 meters east to west by 30 meters north to south (Figure 13). Vegetation consisted of mixed juniper and oak, and ground surface visibility was approximately 70 percent (Figure 14). The site appears to be have been significantly disturbed from erosion and looting;

two separate piles of artifacts were located during the recording of the site and, despite the density of artifacts, no diagnostic artifacts were recovered.

Figure 14. Overview of site 41BL1398, facing southwest.

There were approximately 50 artifacts per square meter, including all stages of lithic reduction. Bifaces, utilized flakes, unifaces, cores, tested cobbles, and the tip of an arrow point were also documented (Figure 15). Some artifacts showed signs of heat treatment. Materials present consisted of chert, sandstone, and quartzite cobbles. Lastly, mussel shell and fire-cracked rock were also present. One possible feature was located and it appeared to be a shallow pit with a concentration of mussel shell with burned rock creating an ephemeral ring around the possible pit. However, very little remains intact and it appears this may have been a looter's pit due to a collection of artifacts placed on a nearby boulder. Since the majority of site 41BL1398 appears to be out of the right of way, the far west portion of the site is ineligible for NRHP or SAL within the ROW. However, the remainder of the site is of undetermined eligibility. If the pipeline alignment is moved further east into 41BL1398, additional testing may be necessary.

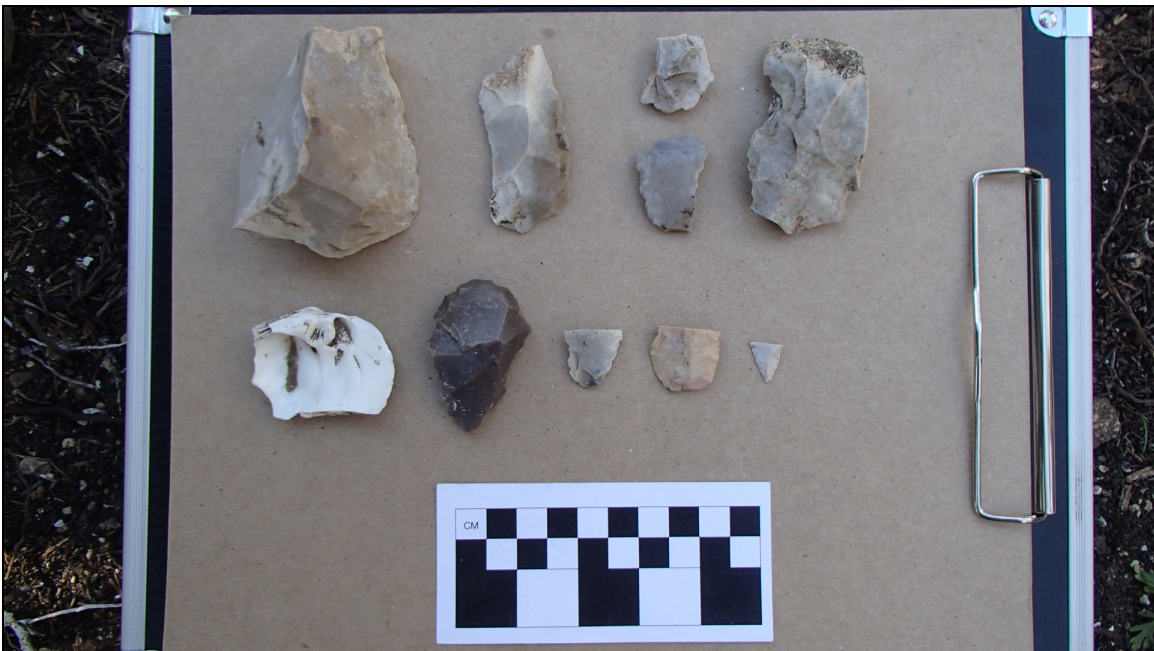
Figure 15. Representative artifacts from 41BL1398.

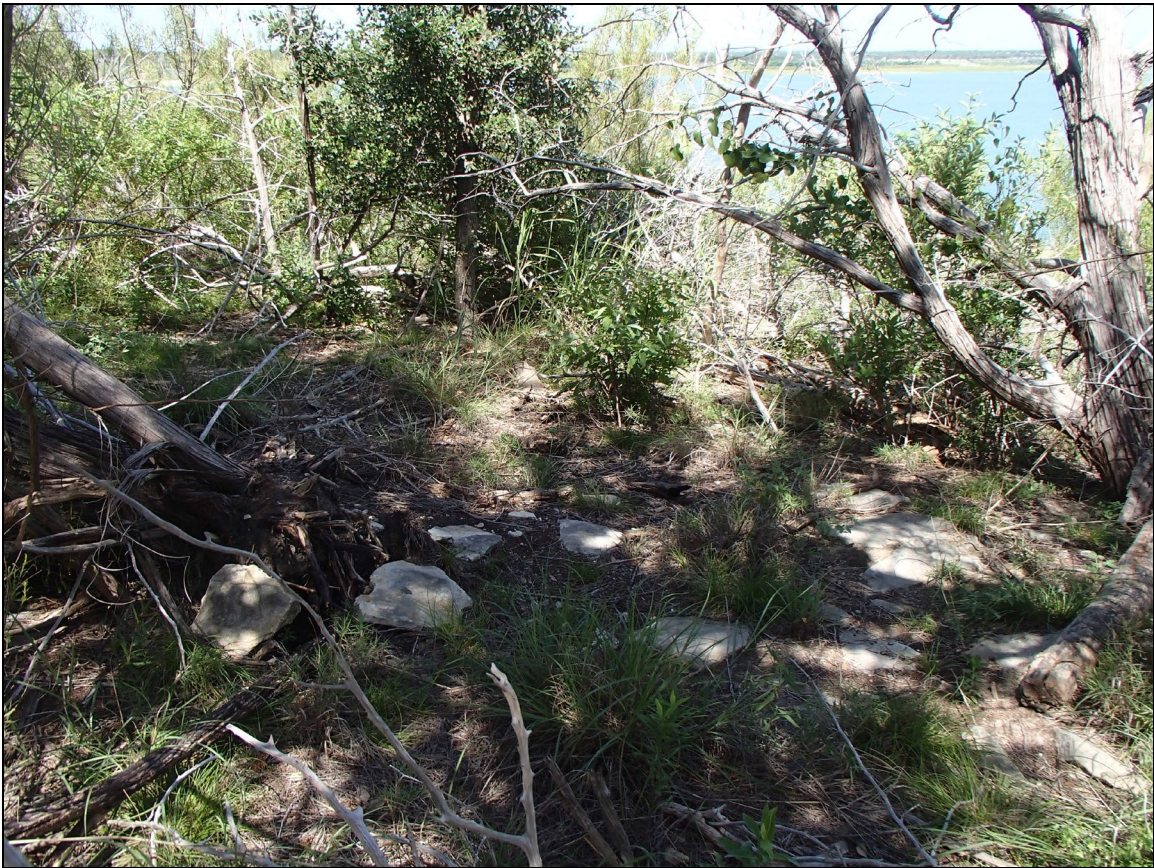
The proposed raw water intake is located in an area covered with dense understory vegetation as well as dead Ashe junipers (Figure 16). The Purves association deposits were very shallow and bedrock was exposed in patches throughout the parcel. No shovel tests were dug due to shallow or absent deposits. No artifacts or other prehistoric or historic features were discovered.

Figure 16. Raw water intake, bedrock at surface, facing northwest.
