## Archaeological Monitoring of the HEB-GSA Parking Lot: Impacts to the San Pedro Acequia

**Center for Archaeological Research**  
**The University of Texas at San Antonio**  
**Archaeological Survey Report, No. 279**  
**1998**

In October, 1997, the Center for Archaeological Research of The University of Texas at San Antonio monitored parking lot construction activities at the Federal Center (41BX622), part of the old United States Arsenal, in downtown San Antonio, Texas. The new parking lot, being constructed by H. E. Butt Grocery Company on land leased from the General Services Administration, will impact a section of the San Pedro Acequia which runs beneath an existing parking lot in the same location. The monitoring of these activities documented two sections of the acequia and corrected previous projections of the acequia's route. It is CAR's recommendation that the monitoring and documentation project has mitigated any adverse effects to the acequia.

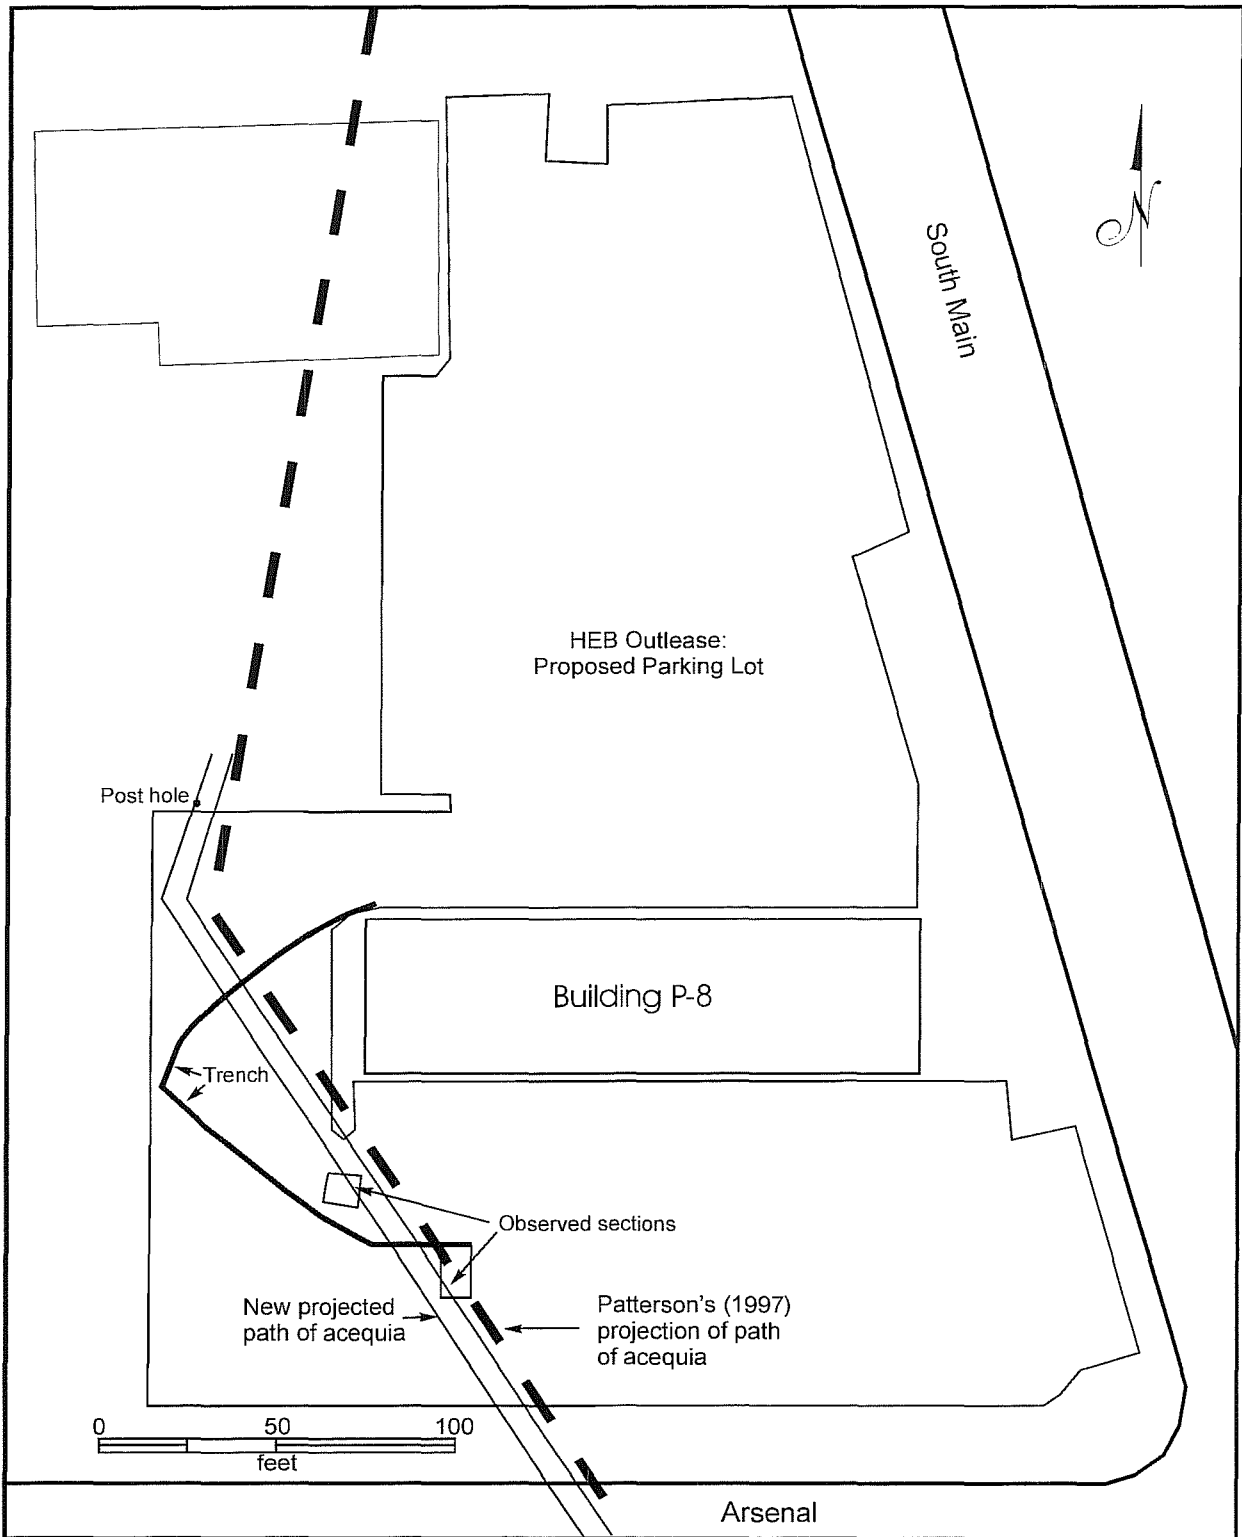
Figure 2. Map of project area with projected path of the San Pedro Acequia.

began drilling holes to set the post. The first hole drilled, to the northeast of building P-8, struck a limestone block of the west wall of the acequia (Figure 2). Examination of the hole revealed that the top stone of the acequia was four inches below the present surface and extended to the depth of the hole, some 24 inches. None of the other postholes encountered the acequia.

Further monitoring was delayed until October 13 when the Ditch Witch-riding rock saw was available. Trench excavation began at the fence line to the west of Building P-8 and proceeded toward the southeast. The acequia was exposed 31.5 ft south of the building (Observed Section 1, Figure 2). The eastern wall was badly disturbed at this point but was still easily discerned. The western wall was fully intact three inches below the compacted gravel base. The acequia was five feet wide at this point through the angled saw cut. The cut extended to a depth of 26 inches. No artifacts were observed in this disturbance.

On October 21, the contractor called to report that a section of the acequia had been exposed by further base preparation. The area, slightly northwest of Observed Section 1, was covered until the archaeologist could arrive on the site. Once the gravel base was removed and the area uncovered, the western wall of the acequia (Observed Section 3) was measured and photographed. Based upon the observed sections and the path of the acequia to the south of Arsenal Street (Figure 4), as documented by the 1904 Sanborn Insurance maps, the proposed path of the acequia as plotted by Patterson (1997) was corrected (Figure 2). Monitoring was terminated at that point since further construction would have no impact on the acequia.
